**DOT/FAA/TC-18/22**

# **Performance Assessment of the Vestas IntelliLight™ X-Band System as an Aircraft Detection Lighting System (ADLS)**

Final Report

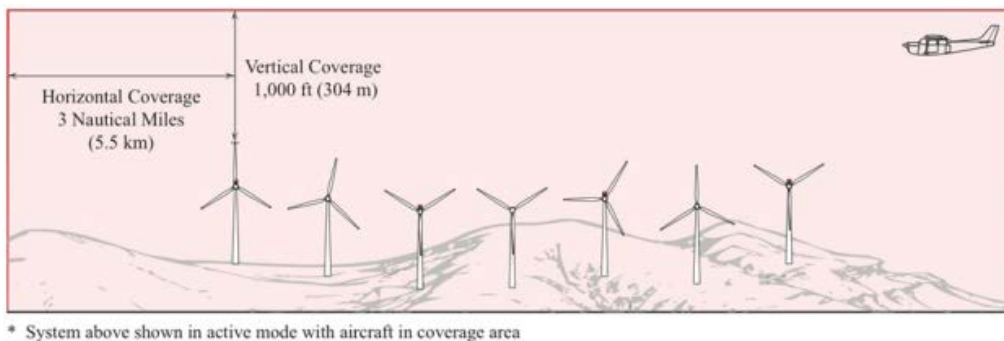
1. The system should be designed with sufficient sensors to provide complete detection coverage for aircraft that enter a three-dimensional volume of airspace, or coverage area, around the obstruction(s) (see figure 1), as follows:

Figure 1. Required ADLS Detection Coverage [1]

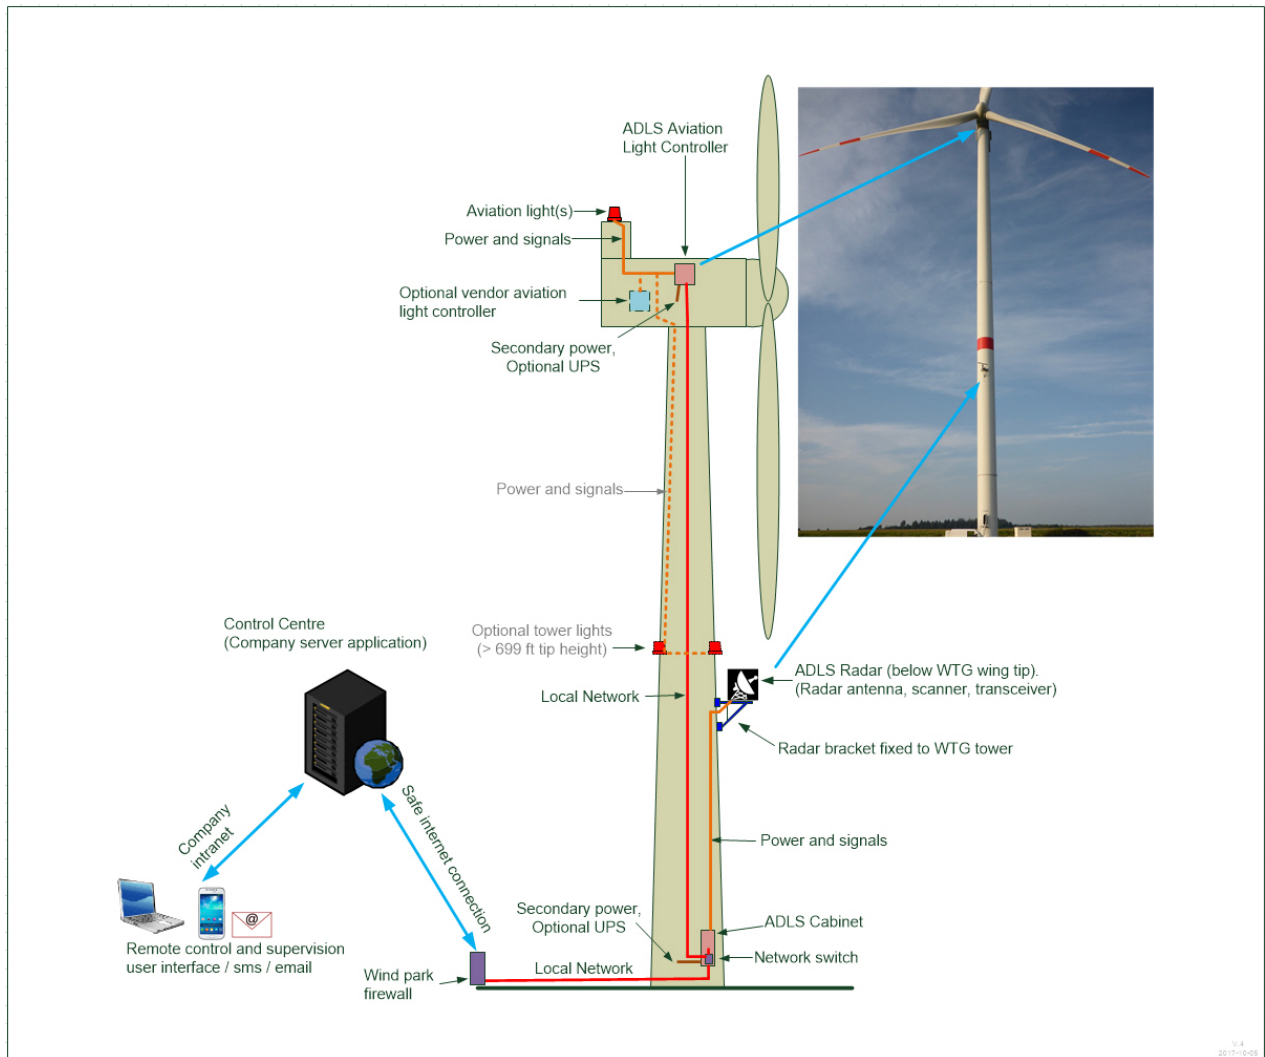
Figure 2 shows an overview of the Vestas IntelliLight system concept for a wind turbine installation. The primary components of the Vestas IntelliLight system consist of the radar unit(s), aviation light controller (ALC), and Vestas IntelliLight Control Center (ICC).

Figure 2. Vestas IntelliLight Systems Overview Diagram [4]

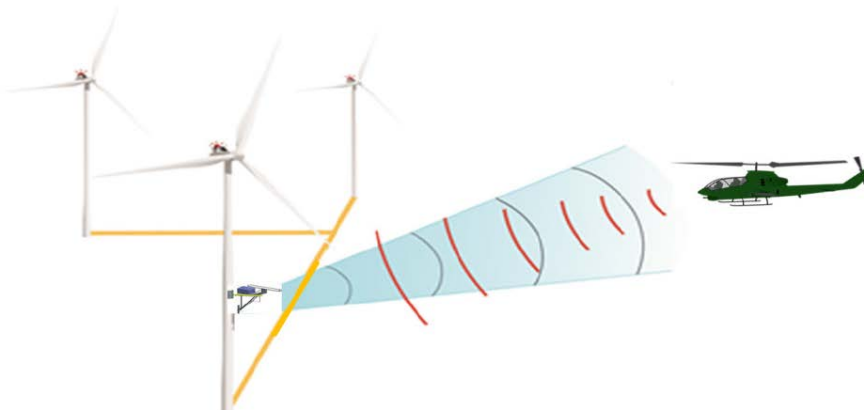
The Vestas IntelliLight system uses rotating solid-state, two-dimensional, X-band radar units with pulse compression Doppler technology. These radar units are positioned at locations on or near the obstruction(s) to provide coverage for low-level aircraft flying near the FAA-required warning volume. For typical wind farm applications, the radar units are mounted on the side of wind turbines at heights typically between 66 ft (20 m) and 197 ft (60 m) AGL [4]. The specific mounting height and layout is site specific and depends on factors such as site complexity, nearby terrain and ground structures, turbine tower structure, and the amount of clearance required to avoid turbine blade tips from obscuring the radar [4]. Figure 3 shows an example of this mounting configuration. The radar antenna and transceiver cabinet are mounted outside of the tower, while the radar processor unit and other Vestas IntelliLight components are mounted optionally inside the tower.

Figure 3. Vestas IntelliLight Radar Mounted on a Wind Turbine [4]

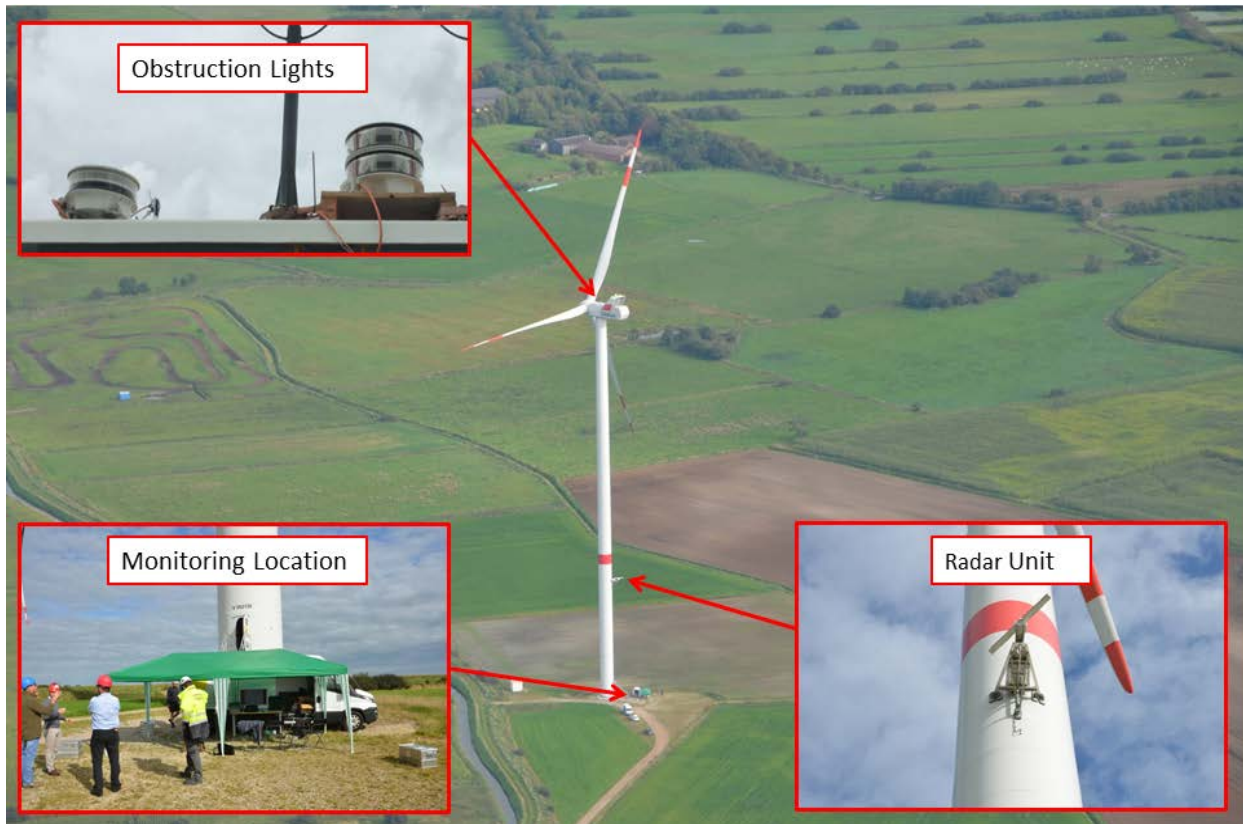
Figure 8 shows an overview of the Vestas IntelliLight system installation on a wind turbine at the Braderup Wind Park. This installation consisted of the following components [6]:

- A radar unit mounted on the side of the wind turbine tower
- An ALC unit mounted inside the turbine
- A temporary monitoring location at ground level beneath the turbine
- Two obstruction lights on top of the nacelle

Figure 8. Vestas IntelliLight System Installation at the Braderup Wind Park

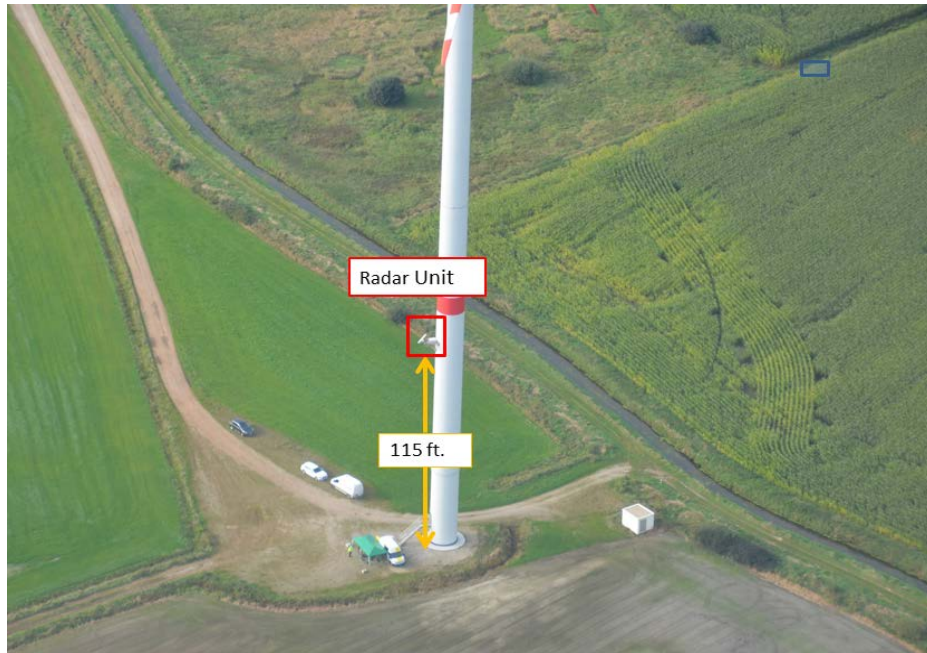
The radar was mounted at a height of 115 ft (35 m) AGL, as shown in figure 9.

Figure 9. Vestas IntelliLight Radar Position

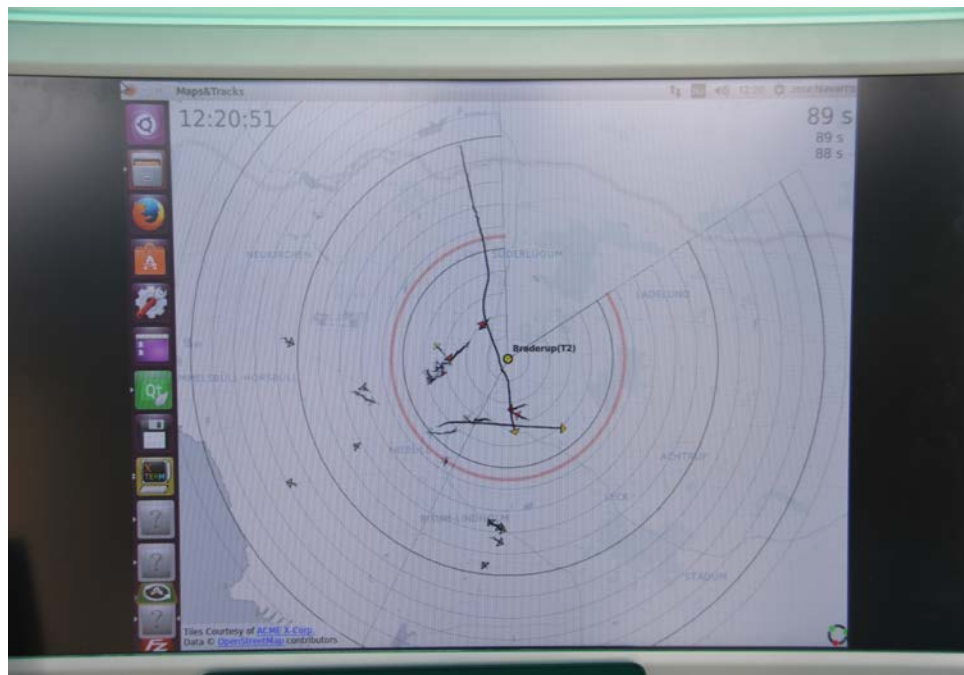
Beneath the turbine, a pop-up tent was set up by Vestas for ATR personnel to monitor the Vestas IntelliLight system's performance. This pop-up tent included a computer monitor showing live radar tracks and system status, as shown in figure 10. It should be noted, this computer monitor (graphical user interface) was only available for the assessment.

Figure 10. Radar Interface Monitored During Assessment

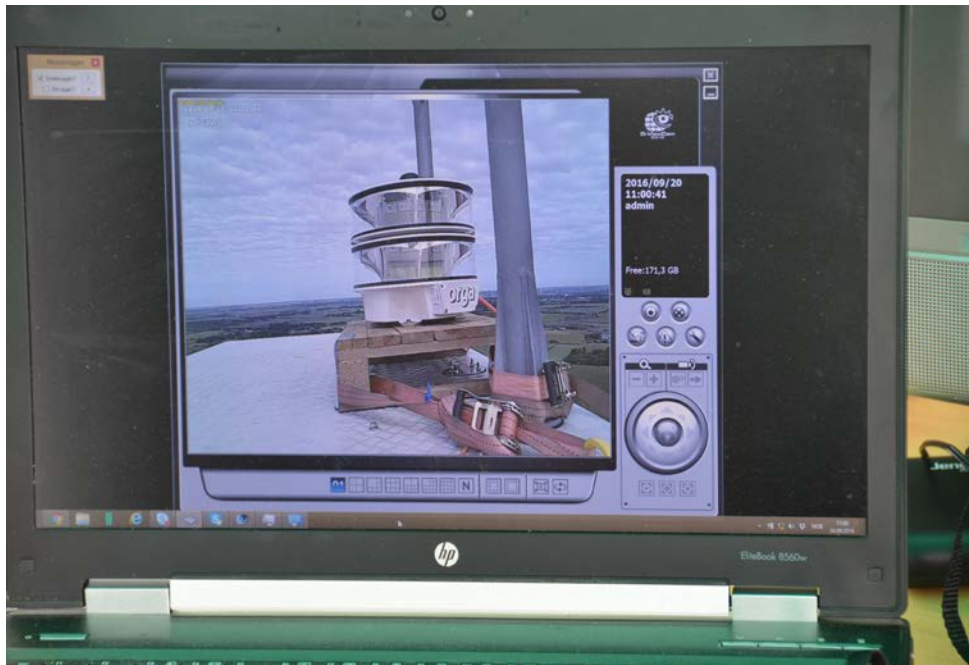
The Vestas IntelliLight system was connected to a low-intensity, red obstruction light and a high-intensity, flashing obstruction light installed on the wind turbine nacelle. Both types of obstruction lights were visible from the aircraft during the assessment. To allow FAA ATR personnel on the ground to monitor these lights, Vestas personnel installed a webcam to transmit video on a computer monitor at ground level, as shown in figure 11. It should be noted, the video feed was only available for the assessment. An additional steady burning obstruction light controlled by the Vestas IntelliLight system was also installed at ground level by Vestas to provide ATR personnel additional evidence the system was functioning as required.

Figure 11. Camera Feed Used to Monitor Obstruction Light Status During Braderup Assessment

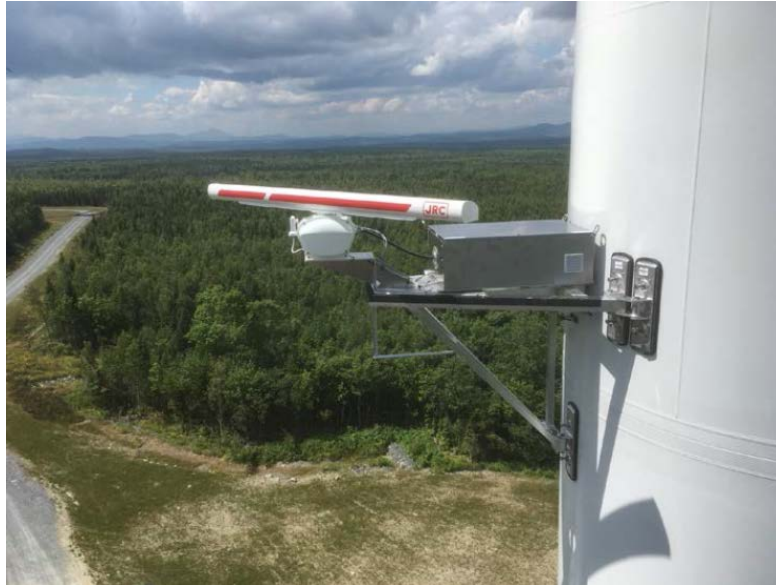
The Vestas IntelliLight system assessed at the Hancock Wind Project site consisted of the same X-band radar sensor and other system hardware assessed at the Braderup Site. Figure 15 shows this radar installed at the Hancock site. Unlike the setup at the Braderup Wind Park, there were now three radars installed (rather than a single unit), providing 360° coverage of the site. All radars were installed at a height of 115 ft AGL on turbines at the following locations and azimuths (shown in figure 16) [7]:

Figure 15. Example of Radar Installed at Hancock Wind Project [7]

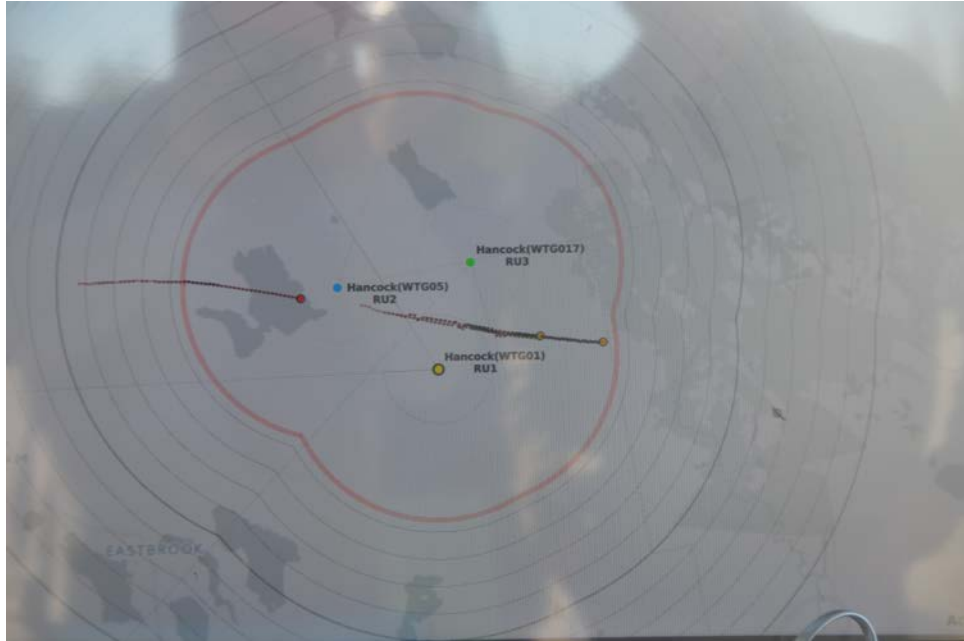
The monitoring setup provided for FAA ATR personnel to observe the system performance was similar to that used at the Braderup Wind Park site. Beneath the southernmost radar site, a pop-up tent was set up by Vestas for ATR personnel to monitor the Vestas IntelliLight system's performance. This pop-up tent included a computer monitor showing live radar tracks and

system status, as shown in figure 17. As with the Braderup site, it should be noted that this computer monitor (graphical user interface) was only available for the assessment.

Figure 17. Radar Interface Monitored During Assessment

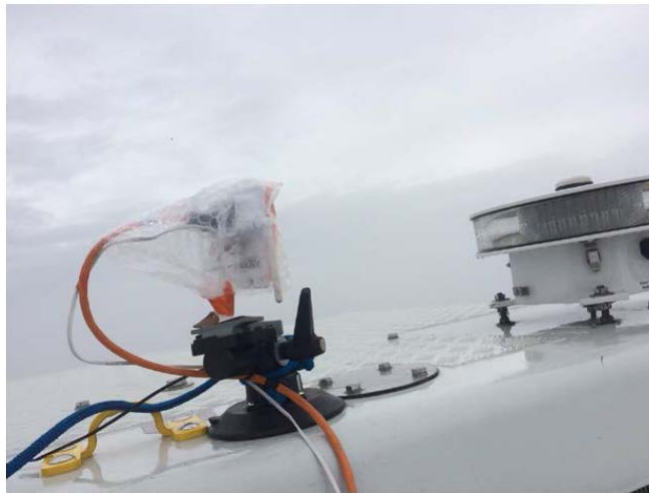
For the purpose of the assessment, the Vestas IntelliLight system at the Hancock Wind Project was connected to a single L-864/865 obstruction light installed on a wind turbine nacelle. To allow FAA ATR personnel on the ground to monitor the light, Vestas personnel installed a webcam to transmit video on a computer monitor at ground level, as shown in figure 18. It should be noted, the video feed was only available for the assessment.

Figure 18. Webcam Used to Monitor Obstruction Light Status During Assessment [7]

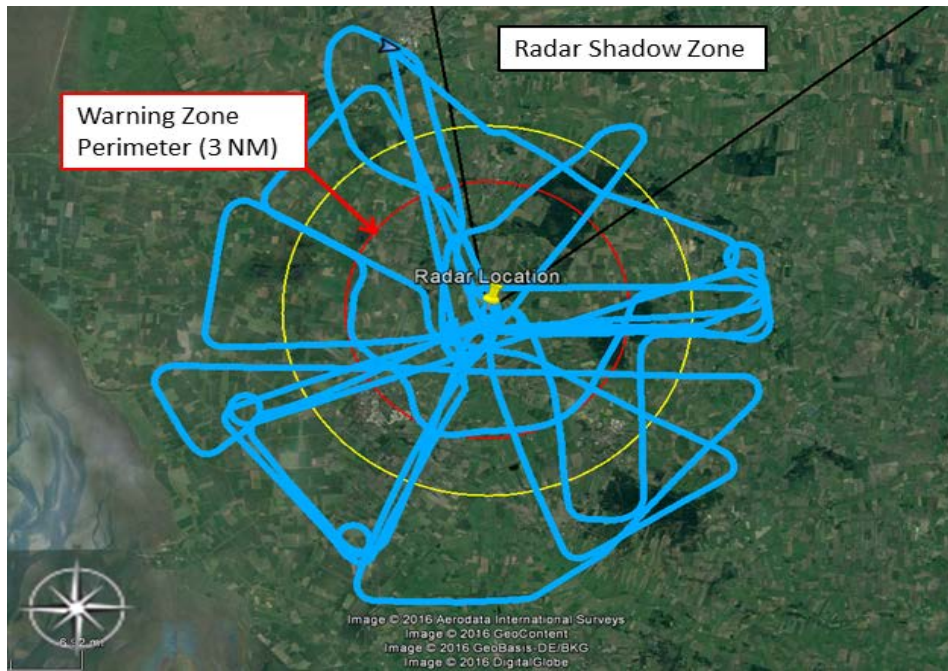
ATR personnel used the Cessna 172 aircraft shown in figure 19 to conduct the flight pattern tests. These flights were operated out of the Tønder Airport, located outside the city of Tønder, Denmark. Figure 20 shows a Google Earth™ map image overlaid with the flight tracks (shown in light blue) recorded by a global positioning system (GPS) unit on board the aircraft over the course of the two flights.

Figure 20. The GPS Flight Track Data From the Aircraft: Braderup Assessment

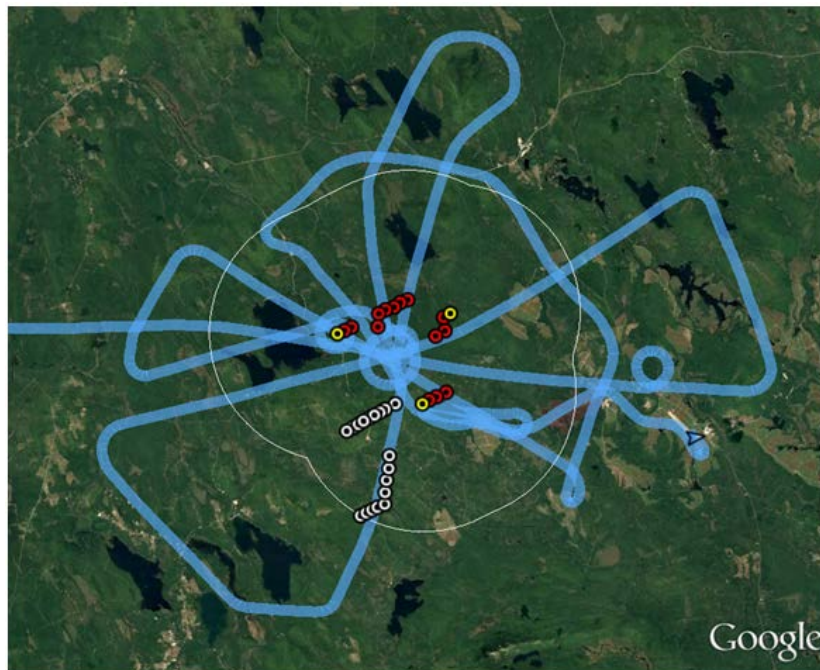
ATR personnel used a Cessna 172 aircraft to conduct the flight maneuvers. These flights were operated out of the Bangor International Airport, located outside the city of Bangor, Maine. Figure 21 shows a Google Earth™ map image overlaid with the flight tracks (shown in light blue) recorded by the FAA's global positioning system (GPS) unit on board the aircraft over the course of the flight.

Figure 21. The GPS Flight Track Data From the Aircraft: Hancock Assessment

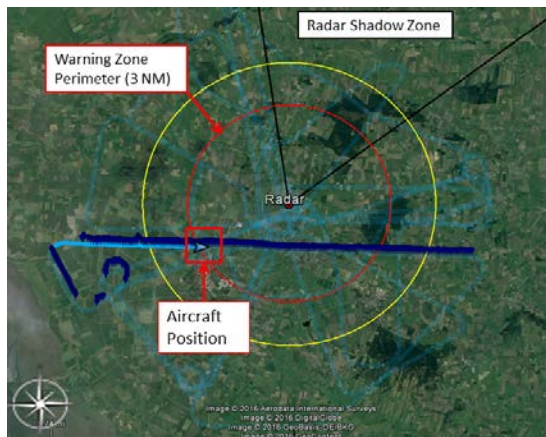
Figure 30. Flight Directly Through the Warning Zone at 2000 ft AGL (Events 27-30)

#### Event 27:

- Aircraft approaches the warning zone from the west.
- Lights are off.

#### Event 28:

- Aircraft is detected and tracked by radar prior to reaching the warning zone.
- Lights are off.

#### Event 29:

- Aircraft penetrates the warning zone heading to the east.
- Lights are on.
- Aircraft is continuously monitored within the warning zone.

#### Event 30:

- Aircraft exits the warning zone to the east.
- Lights are off.

The Vestas IntelliLight system was able to detect and track the aircraft at distances of 5.4 and 6 NM from the radar when approaching the warning zone at 1500 and 2000 ft AGL, respectively. The Vestas IntelliLight system was able to activate the obstruction lights when the aircraft entered the warning zone, continuously monitor the aircraft while inside the zone, and deactivate the lights upon exiting the zone. Figures 29 and 30 show events 23-30 for these flight patterns.

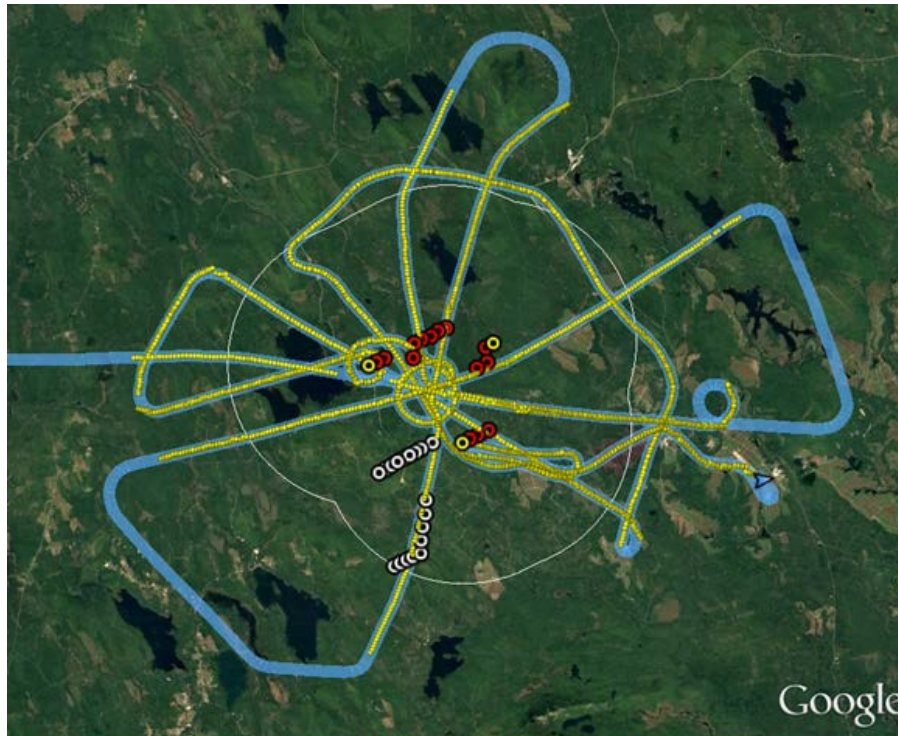
Figure 39. Vestas IntelliLight System Cumulative Radar Tracks (Yellow) Overlaid on the FAA Aircraft's GPS Tracks (Light Blue)

Figure 39 shows a record of the entire FAA assessment flight pattern and radar tracks from the Vestas IntelliLight system. The yellow lines represent the real-time tracks produced from the Vestas IntelliLight system, and the light blue lines represent the tracks recorded by the GPS on board the aircraft. As with the Braderup assessment, the radar tracks from the Vestas IntelliLight system matched the GPS tracks very closely. The system provided adequate coverage to activate the obstruction light when the aircraft reached a distance of 3 NM (5.5 km) from the obstructions. The only interruption in radar tracking occurred during a brief period of time when the aircraft was directly over one of the radar units and occurred at an altitude above the required coverage volume.

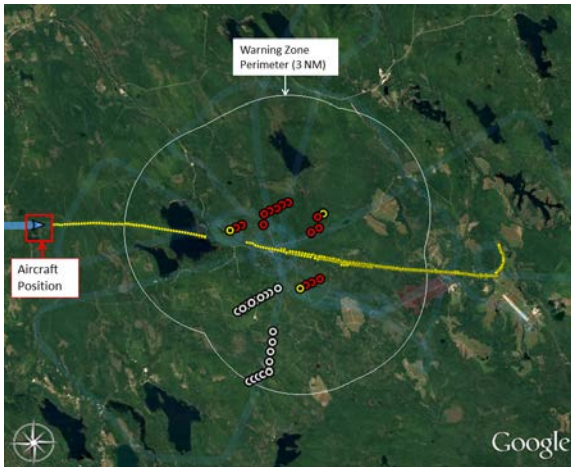
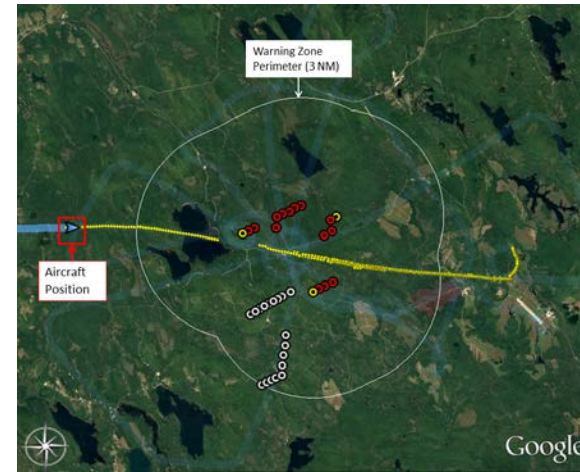
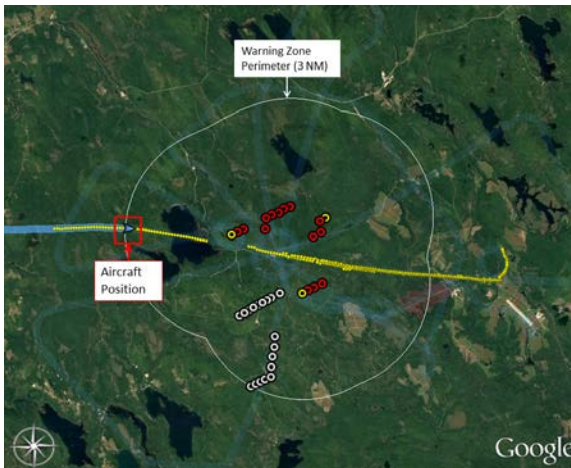
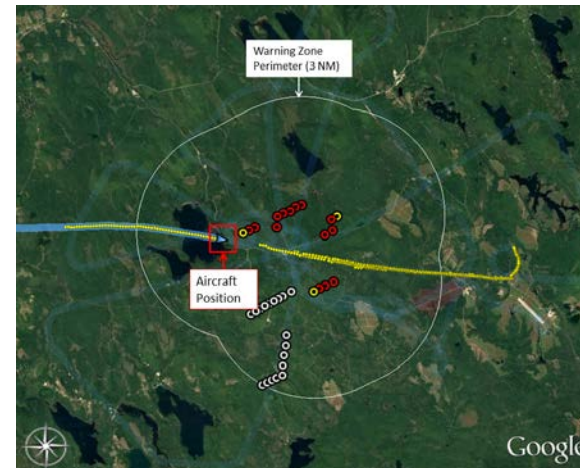
Figure 40. Flight Directly to and Over the Wind Turbine Farm at 2300 ft MSL From the West (Events 1-4)

- Aircraft approaches the warning zone from the west.
- Light is off.

- Aircraft is detected and tracked by radar prior to reaching the warning zone.
- Light is off.

- Aircraft penetrates the warning zone perimeter heading east.
- Light is on.
- Aircraft is monitored within the warning zone.

- Radar track is lost passing over the radar cone of silence.
- Light remains on due to lost aircraft timer.

The Vestas IntelliLight system was able to detect the aircraft each time it flew through the warning zone at altitudes of 2300, 1500, and 1200 ft MSL, which each occurred at three different headings. The radar was able to detect and track the aircraft from distances of 5, 6, and 4.8 NM, respectively. The Vestas IntelliLight system was able to activate the obstruction light when the aircraft entered the warning zone, continuously monitor the aircraft while inside the zone, and deactivate the light upon exiting the zone. The only interruption in radar tracking occurred during a brief period of time when the aircraft was directly over one of the radar units and occurred at 2400 ft MSL, which was above the required coverage volume height (2087 ft MSL). Figures 40 through 43 show events 1-14 for these flight patterns.

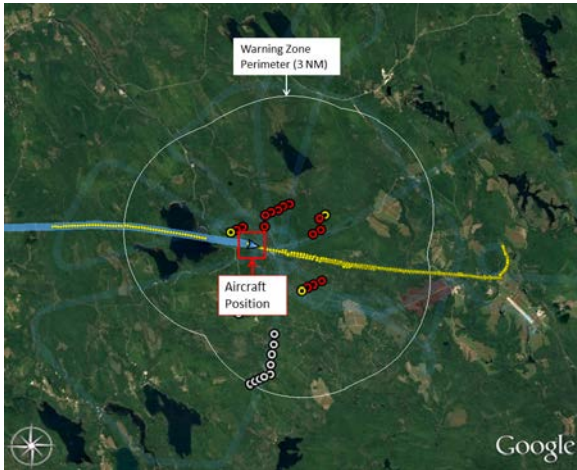
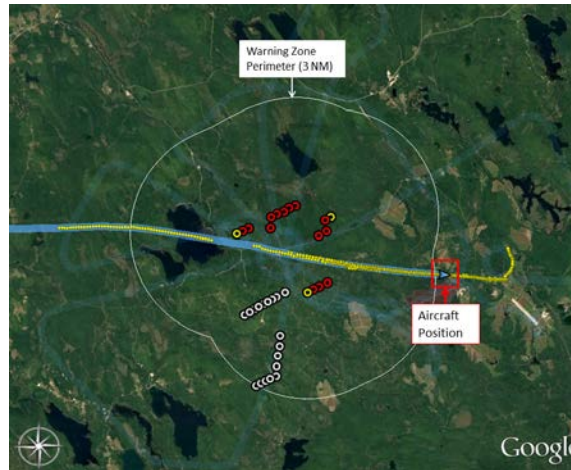
Figure 41. Continuation of Flight Directly to and Over the Wind Turbine Farm at 2300 ft MSL From the West (Events 5 and 6)

- Aircraft continues to fly east and is reacquired by the radar upon leaving the radar cone of silence.
- Aircraft is monitored within the warning zone.
- Light remains on.

- Aircraft exits the warning zone to the east.
- Light is off.

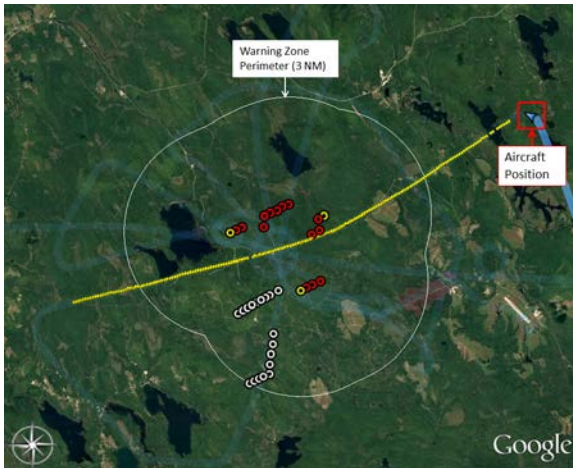
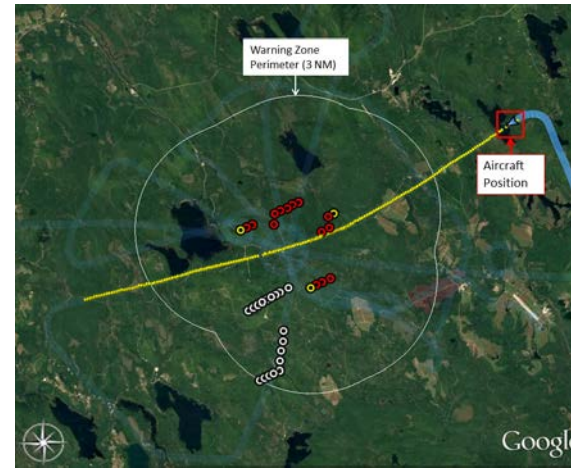
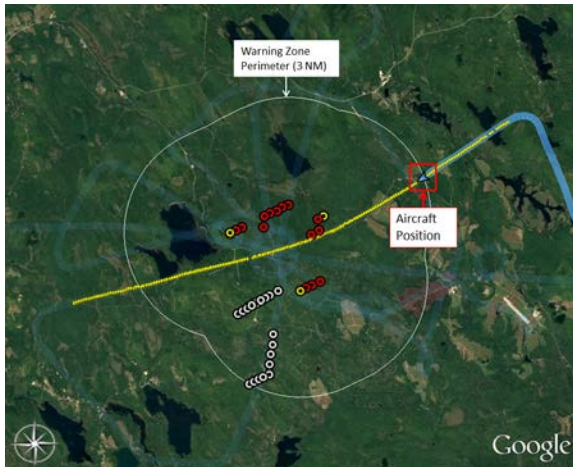
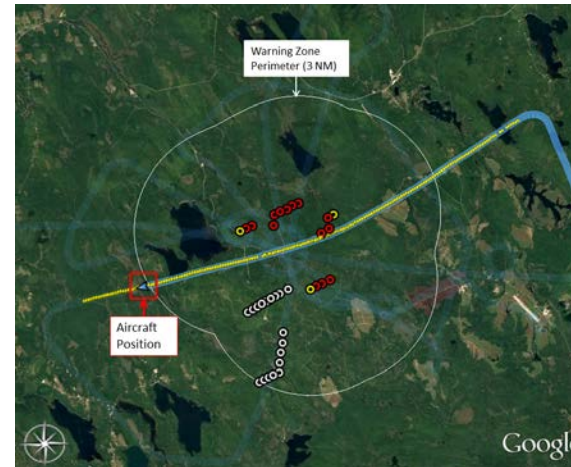
Figure 42. Flight Directly to and Over the Wind Turbine Farm at 1500 ft MSL From the Northeast (Events 7-10)

- Aircraft approaches the warning zone from the northeast.
- Light is off.

- Aircraft is detected and tracked by radar prior to reaching the warning zone.
- Light is off.

- Aircraft penetrates the warning zone perimeter heading to the southwest.
- Light is on.
- Aircraft is continuously monitored within the warning zone.

- Aircraft exits the warning zone to the southwest.
- Light is off.

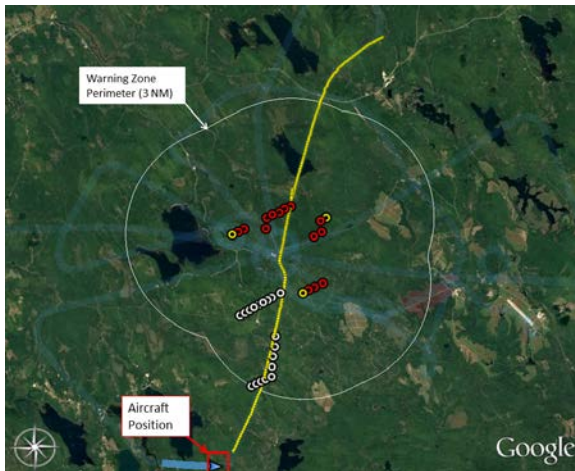
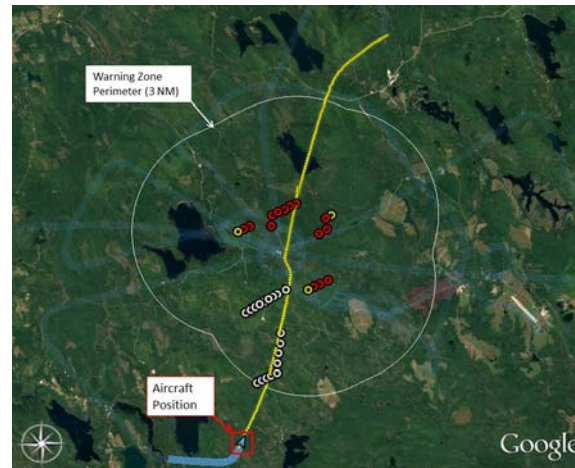
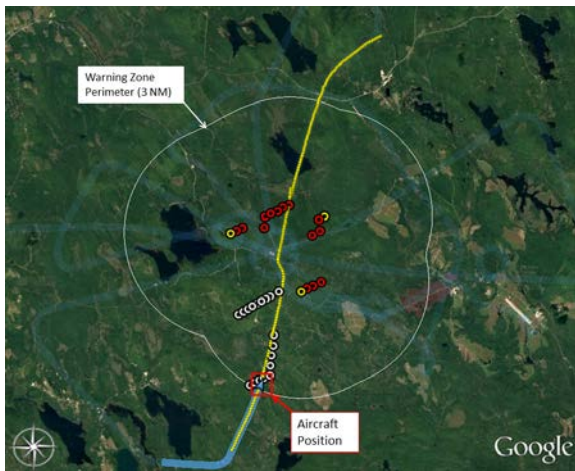
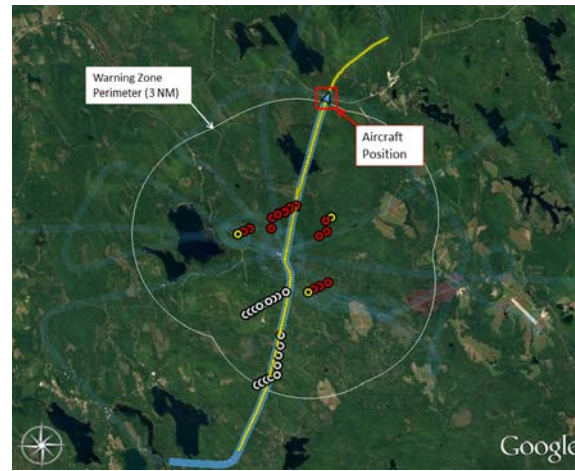
Figure 43. Flight Directly to and Over the Wind Turbine Farm at 1200 ft MSL From the South (Events 11-14)

- Aircraft approaches the warning zone from the south.
- Light is off.

- Aircraft is detected and tracked by radar prior to reaching the warning zone.
- Light is off.

- Aircraft penetrates the warning zone perimeter heading to the north.
- Light is on.
- Aircraft is continuously monitored within the warning zone.

- Aircraft exits the warning zone to the north.
- Light is off.

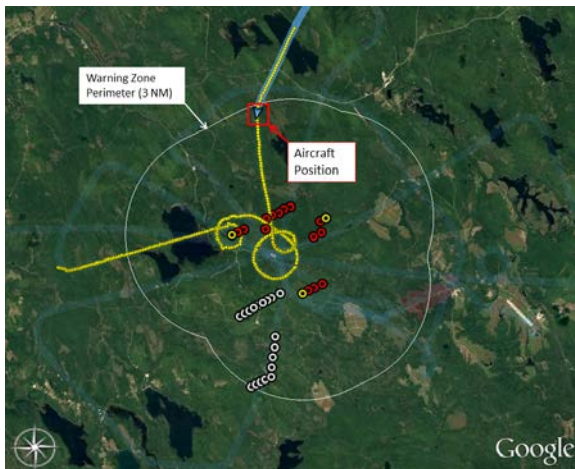
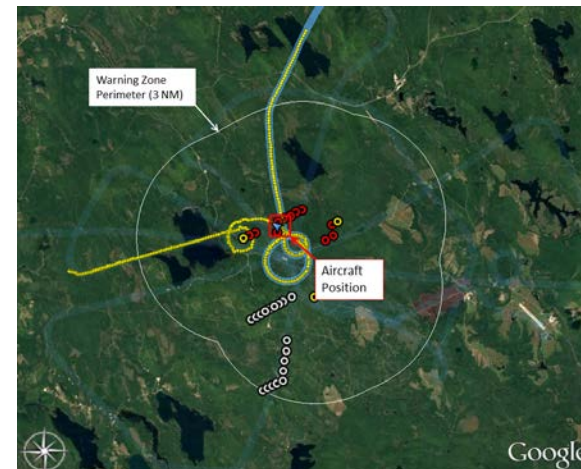
Figure 44. Circling Flight Over the Wind Turbine Farm at 1700 ft MSL, Exiting to the West (Events 15-18)

- Aircraft approaches the warning zone from the north.
- Light is off.

- Aircraft is detected and tracked by radar prior to reaching the warning zone.
- Light is off.

- Aircraft penetrates the warning zone perimeter heading to the south.
- Light is on.

- Aircraft completes two tight turns over the wind turbine farm.
- Light remains on.

The Vestas IntelliLight system was able to detect and track the aircraft at a distance of 5.4 NM. The Vestas IntelliLight system was able to activate the obstruction light when the aircraft entered the warning zone, continuously monitor the aircraft while completing several tight turns at two locations inside the zone, and deactivate the light upon exiting the zone. Figures 44 and 45 show events 15-20 for these flight patterns.

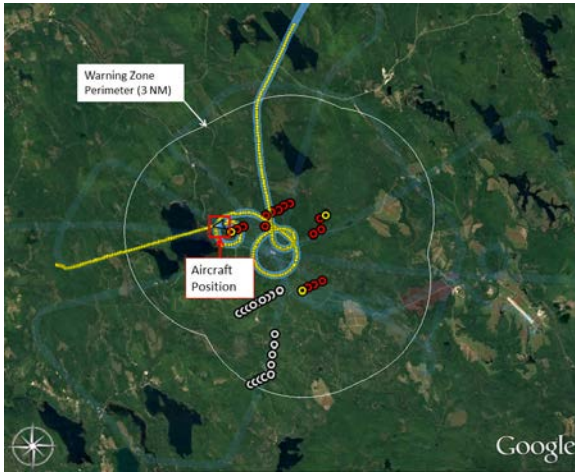
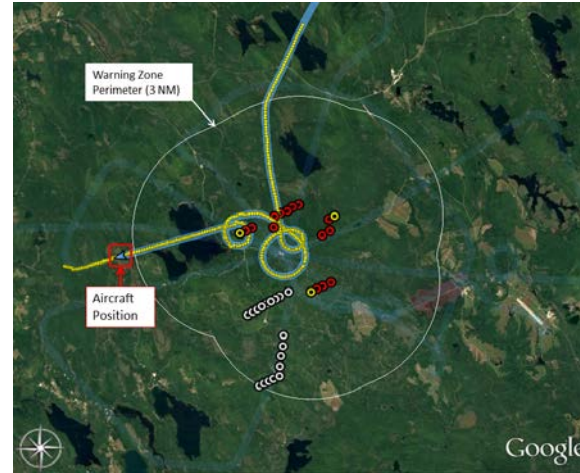
Figure 45. Continuation of Circling Flight Over the Wind Turbine Farm at 1700 ft MSL, Exiting to the West (Events 19 and 20)

- Aircraft completes an additional turn directly over the western radar sensor.
- Aircraft is monitored continuously within the warning zone.
- Light remains on.

- Aircraft exits the warning zone to the west.
- Light is off.

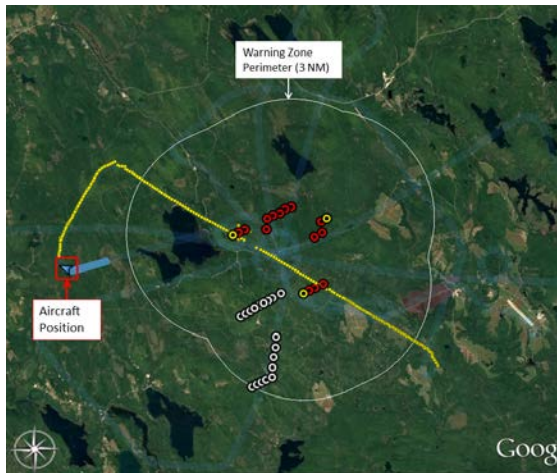
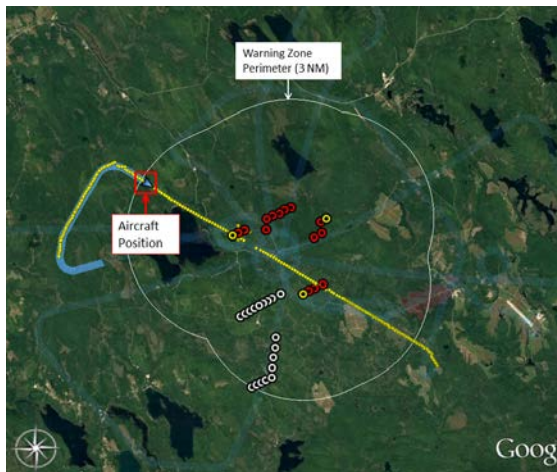
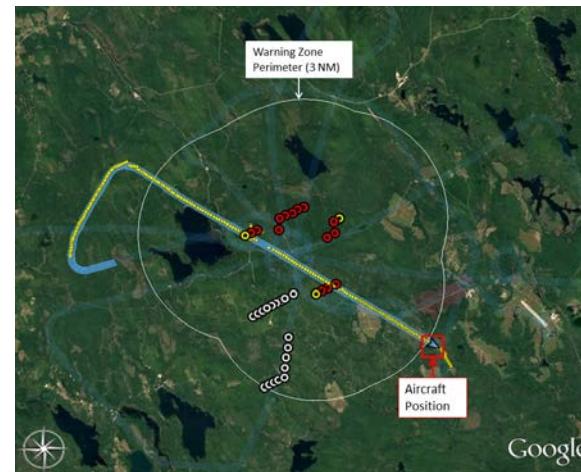
Figure 46. Descending Flight Into the Warning Zone (Events 21-24)

- Aircraft approaches the warning zone from the west.
- Light is off.

- Aircraft is detected and tracked by radar prior to reaching the warning zone.
- Light is off.

- Aircraft penetrates the warning zone perimeter heading to the southeast.
- Aircraft is monitored within the warning zone, with a brief interruption occurring over radar.
- Light is on.

- Aircraft exits the warning zone to the southeast
- Light is off.

The Vestas IntelliLight system was able to activate the obstruction light when the aircraft entered the warning zone, monitor the aircraft while inside the zone as the aircraft descended rapidly from 3400 to 1700 ft MSL, and deactivate the light upon exiting the zone. A brief interruption in radar monitoring of approximately 5 seconds occurred during this maneuver; however, the light remained on due to the lost aircraft timer. Figure 46 shows events 21-24 for this flight pattern.

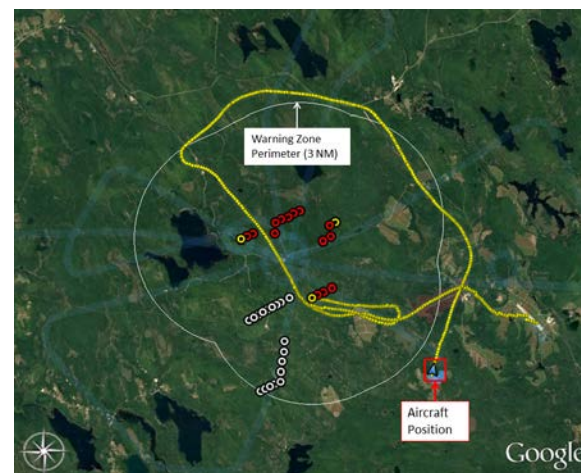
- Aircraft approaches the warning zone from the southeast.
- Light is off.

- Aircraft is detected and tracked by radar as it flies along the warning zone perimeter.
- Light is off.

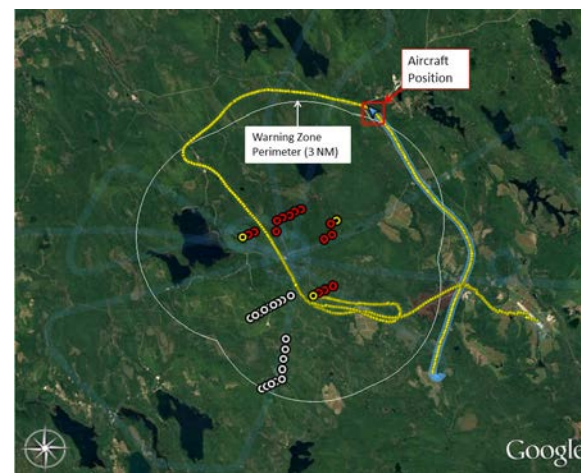
## Event 27:

- Aircraft penetrates the warning zone perimeter heading to the northwest.
- Light is on.
- Aircraft is continuously monitored within the warning zone.

aircraft entered the warning zone, continuously monitored the aircraft while inside the zone, and deactivated the light upon exiting the zone. Figure 47 shows events 25-28 for this flight pattern.

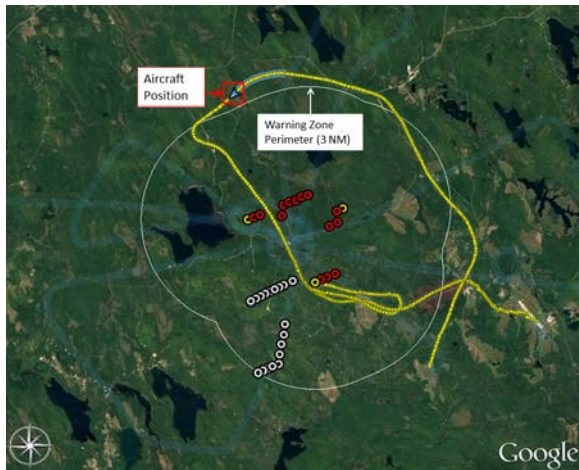
## Event 28:

- Aircraft exits the warning zone to the northwest.
- Light is off.

Figure 47. Flight Along the Warning Zone Perimeter at 1200 ft MSL (Events 25-28)

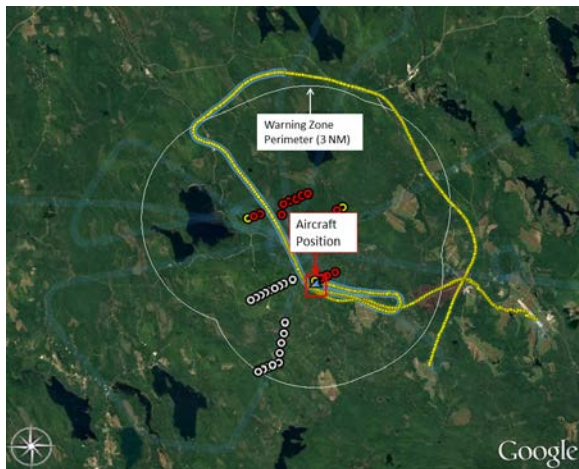
## Event 30:

- Aircraft penetrates the warning zone perimeter heading to the southeast.
- Light is on.

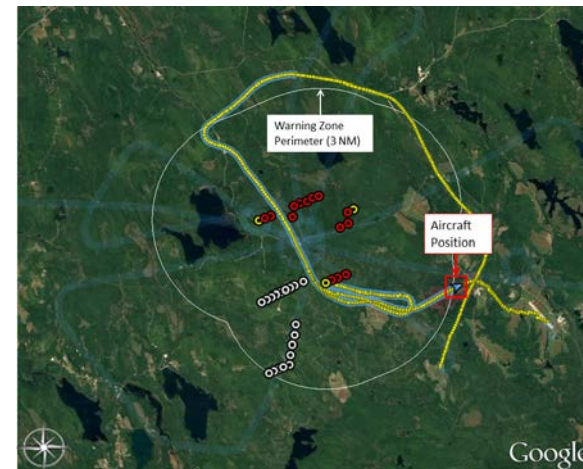
## Event 31:

- Aircraft completes two tight turns over the wind turbine farm while descending.
- Light remains on.
