## 27704.00 Region 1 ADA – 2025

### Auburn, Intersection of Turner Street and Dennison Street

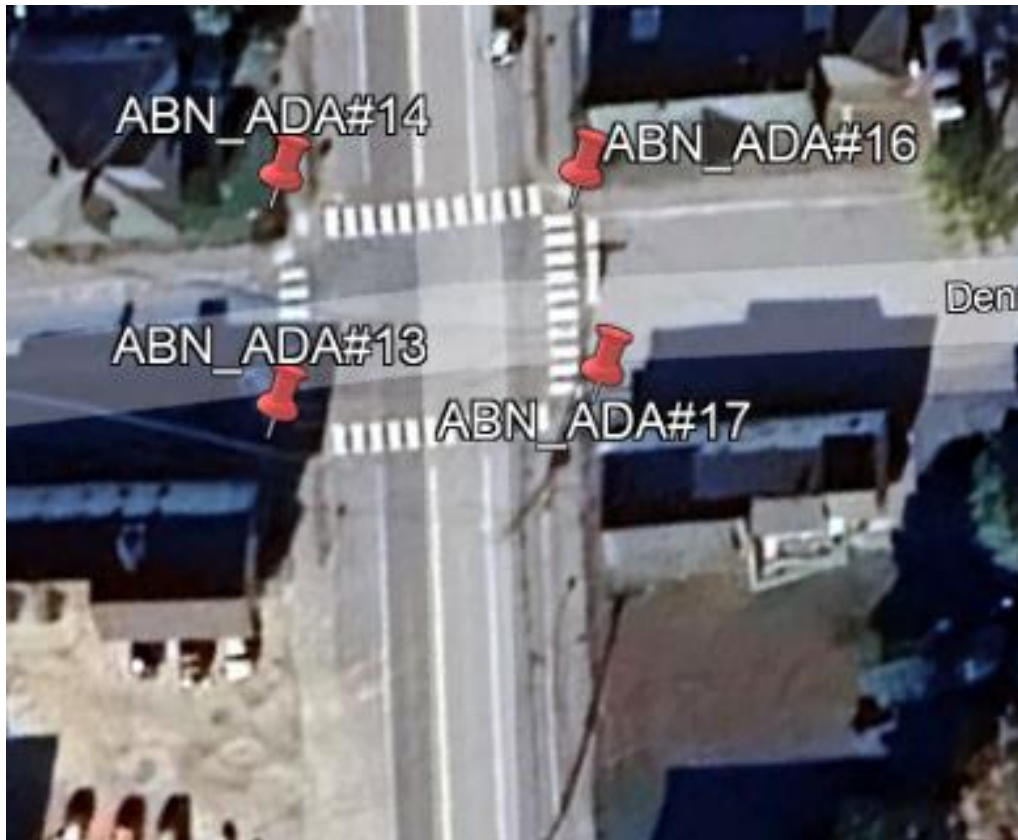
Reconstruct Pedestrian Ramp on LT side of Dennison Street (West)

- Reconstruct similar to Standard Detail 801(22)
- Remove and repave approximately 50 SF of HMA sidewalk
- Regrade approximately 50 SF of sidewalk
- Remove 3 LF section of granite curb
- Move remaining 9 LF of granite curb (including terminal section) to end of removed 3 LF of granite curb area
- Install 16 SF (4~4 SF) detectable warning field (DWF) in an "L" shaped pattern (3 plates across width of opening, 1 plate parallel to sidewalk leading up to terminal curb)

Reconstruct Pedestrian Ramp on RT side of Dennison Street (West)

- Reconstruct similar to Standard Detail 801(16)
- Remove and repave approximately 150 SF of HMA sidewalk
- Regrade approximately 150 SF of sidewalk
- Remove 3.5 LF section of granite curb at SW portion of ramp and move terminal curb section to end of removed section
- Install 10 LF of radius curb tipping up 5 LF to center of radius and tipping down 5 LF to end of radius
- Maintain portion of sidewalk and curb leading to start of the NW drainage grate
- Construct 6 LF opening with 8 SF (2~4 SF plates) detectible warning field (DWF) starting at the edge of the NW drainage grate
- Construct 5 LF opening with 8 SF (2~4 SF plates) detectible warning field (DWF) starting at end of 10 LF radius curb

Reconstruct Pedestrian Ramp on LT side of Dennison Street (East)

- Construct similar to Standard Detail 801(20)
- Remove and replace approximately 50 SF of HMA sidewalk
- Regrade approximately 50 SF of HMA sidewalk
- Install 10 LF curb ramp opening
- Maintain both left and right parallel ramps
- Install 20 SF (5~4 SF) of radial detectable warning field (DWF) plates across entire width of ramp opening

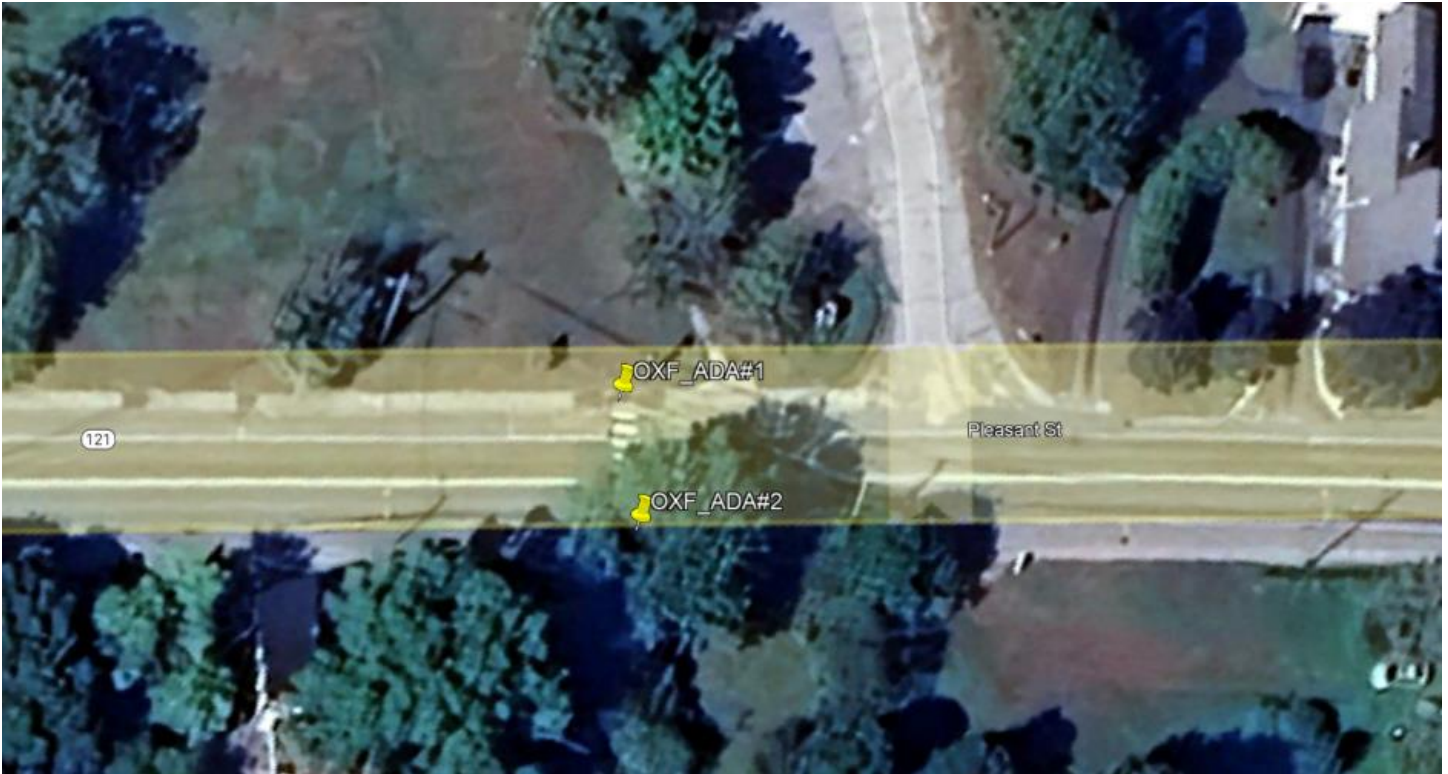
## Oxford, ME-121 (Pleasant Street) at School Entrance

- Reconstruct similar to Standard Detail 801(14)
- Shift ramp 22 LF North
- Remove and replace approximately 420 SF of HMA sidewalk leading up to school entrance
- Regrade approximately 420 SF of sidewalk
- Remove and reset 16 LF of granite curb
- Install 50 LF of new HMA curb
- Construct one 6 LF ramp opening
- Install 12 SF (3~4 SF) detectible warning field (DWF) plates across the entire width of ramp opening

- Reconstruct similar to Standard Detail 801(14)
- Shift ramp 22 LF North
- Remove and replace approximately 300 SF of HMA sidewalk leading up to existing pedestrian pole
- Regrade approximately 300 SF of sidewalk
- Remove and Reset 16 LF of granite curb
- Install 25 LF of new HMA curb
- Construct one 6 LF ramp opening
- Install 12 SF (3~4 SF) detectible warning field (DWF) plates across the entire width of ramp opening

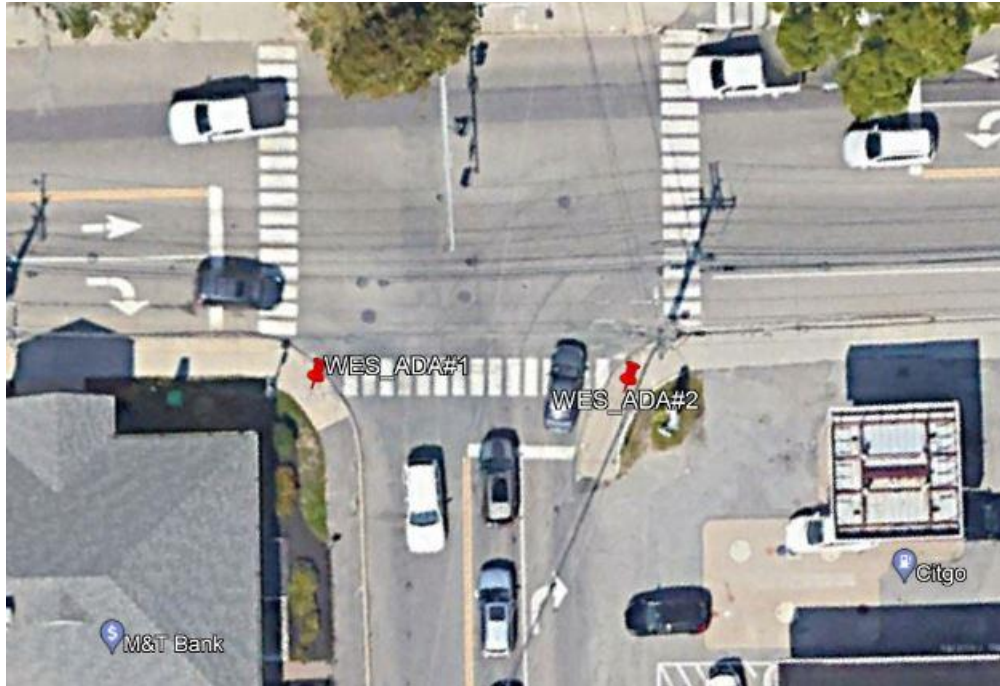
## Westbrook, Spring Street at Main Street (Route 25B)

- Construct similar to Standard Detail 801(16)
- Remove and replace approximately 120 SF of concrete sidewalk
- Regrade approximately 120 SF of sidewalk
- Remove and repave 64 SF (2' X 32') of roadway shoulder
- Remove and reset approximately 20 LF of granite curb
- Construct two 6 LF openings
- Install 24 SF (3~4 SF) detectible warning field (DWF) plates across the entire width of each opening

- Reconstruct similar to Standard Detail 801(16)
- Remove and replace approximately 180 SF of concrete sidewalk
- Regrade approximately 180 SF of sidewalk
- Remove and repave 64 SF (2' X 32') of roadway shoulder
- Remove and reset 22 LF of granite curb at front of ramp
- Remove and reset 24 LF of granite curb at back of ramp
- Construct ramp to include a 6 LF opening on the Spring Street side and a 4 LF opening on the Main Street side
- Ramp on Main Street to match into existing joint at the edge of existing crosswalk
- Install 20 SF (5~4 SF) detectible warning field (DWF) plates across entire width of openings

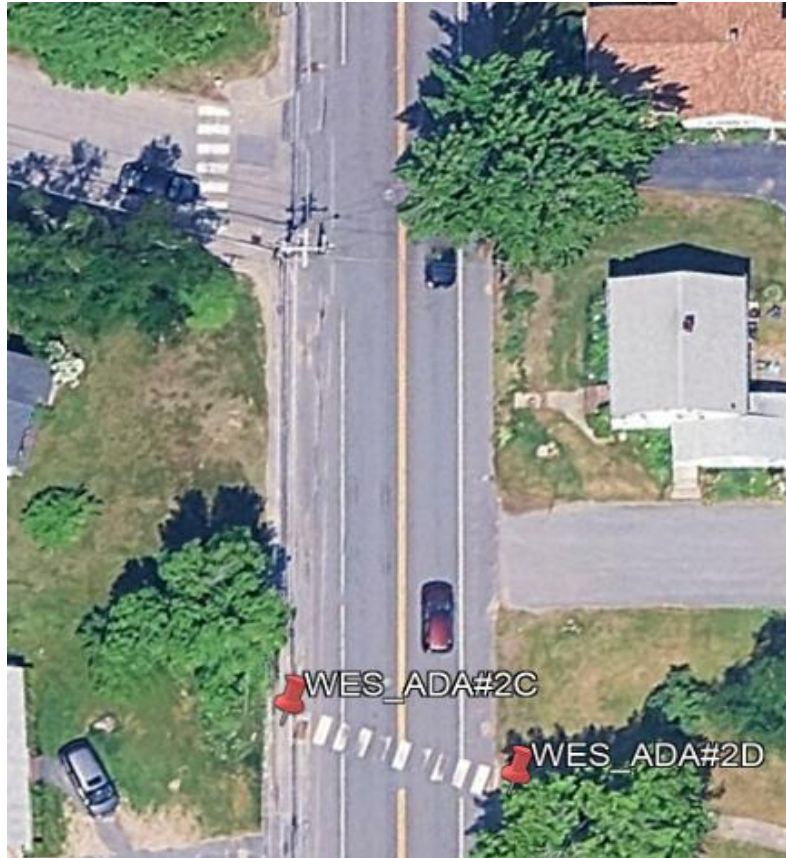
## Westbrook, Spring Street at East Valentine Street

- Reconstruct similar to Standard Detail 801(20)
- Remove and reset 20 LF existing bituminous curb
- Remove and replace approximately 110 SF of HMA sidewalk
- Regrade approximately 110 SF of sidewalk
- Remove and repave 44 SF (2' X 22') of roadway shoulder
- Install two 8 LF terminal sections of asphalt curb on both sides of 6 LF opening
- Construct a 6 LF ramp opening
- Install 12 SF (3~4 SF) detectible warning field (DWF) plates across entire width of opening

- Reconstruct similar to Standard Detail 801(20)
- Remove and replace approximately 100 SF of HMA sidewalk
- Regrade approximately 100 SF of sidewalk
- Construct 8 LF width ramp opening that tapers to existing 5 LF width at top of ramp
- Remove triangular patch of grass on right side of ramp (facing the ramp) and align with the existing edge of walkway just above the ramp
- Install 16 SF (4~4 SF) detectible warning field (DWF) plates across entire width of ramp opening

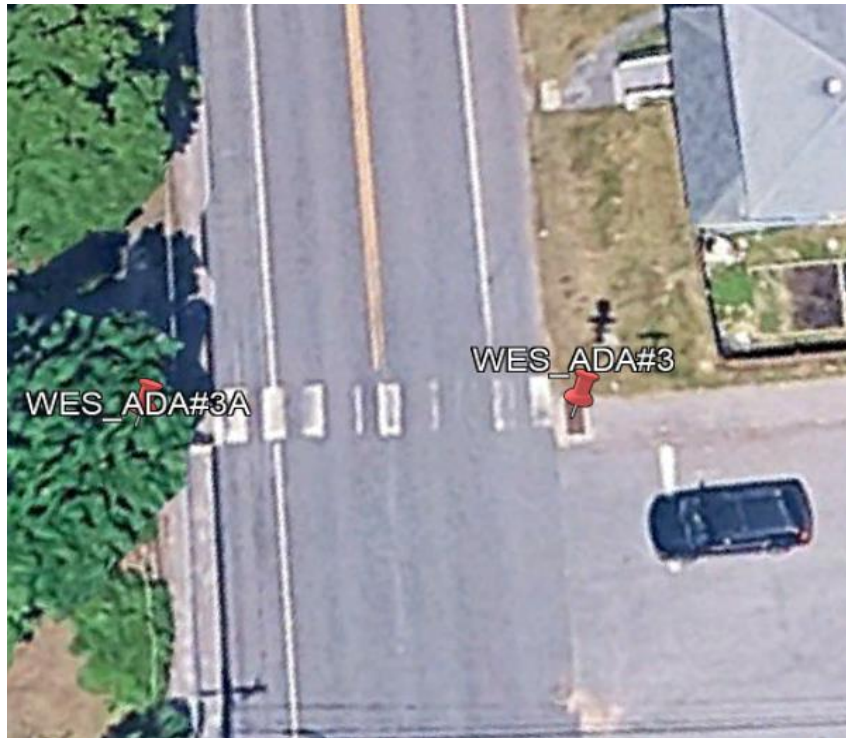
## Westbrook, Spring Street at Glenwood Avenue

- Reconstruct similar to Standard Detail 801(22)
- Remove and replace approximately 75 SF of HMA sidewalk
- Regrade approximately 75 SF sidewalk
- Remove and repave 40 SF (2' X 20') of roadway shoulder
- Install 15 LF of HMA curb type 3 mold 3 along Glenwood Avenue
- Construct a 5 LF ramp opening directly at edge of roadway
- Install 8 SF (2~4 SF) detectible warning field (DWF) plates across entire width of ramp opening
- Technically infeasible as the ramp slope will exceed the maximum of 8.33%. Therefore, the maximum ramp length of 15 LF is utilized.

- Reconstruct similar to Standard Detail 801(27)
- Remove and replace approximately 32 SF of HMA sidewalk
- Regrade approximately 32 SF of sidewalk
- Remove and repave 24 SF (2' X 12') of roadway shoulder
- Remove and reconstruct 8 LF of bituminous curb
- Construct a 5 LF ramp opening
- Install 8 SF (2~4 SF plates) detectible warning field (DWF) plates across entire width of ramp opening

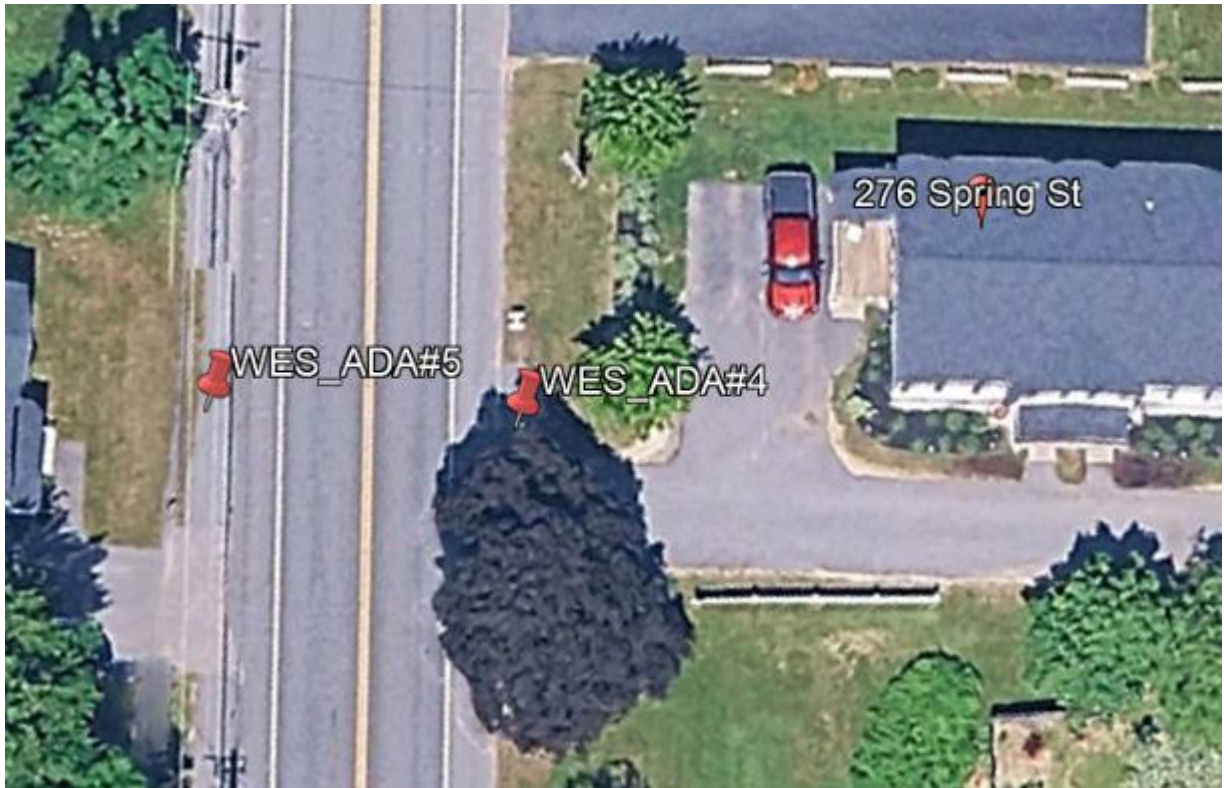
## Westbrook, Spring Street Crossing

- Reconstruct similar to Standard Detail 801(22)
- Remove and Replace 100 SF of HMA sidewalk
- Install 10 SF (2.5~4 SF) detectable warning field (DWF) plates across entire width of ramp opening
- Grade, Loam and Seed 12' x 2' disturbed area
