State of Maine Department of Environmental Protection Bureau of Remediation and Waste Management Division of Technical Services

SUBJECT: Summary of PCB Soil Sample Results Collected December 2019 C. Smith Property, Meddybemps

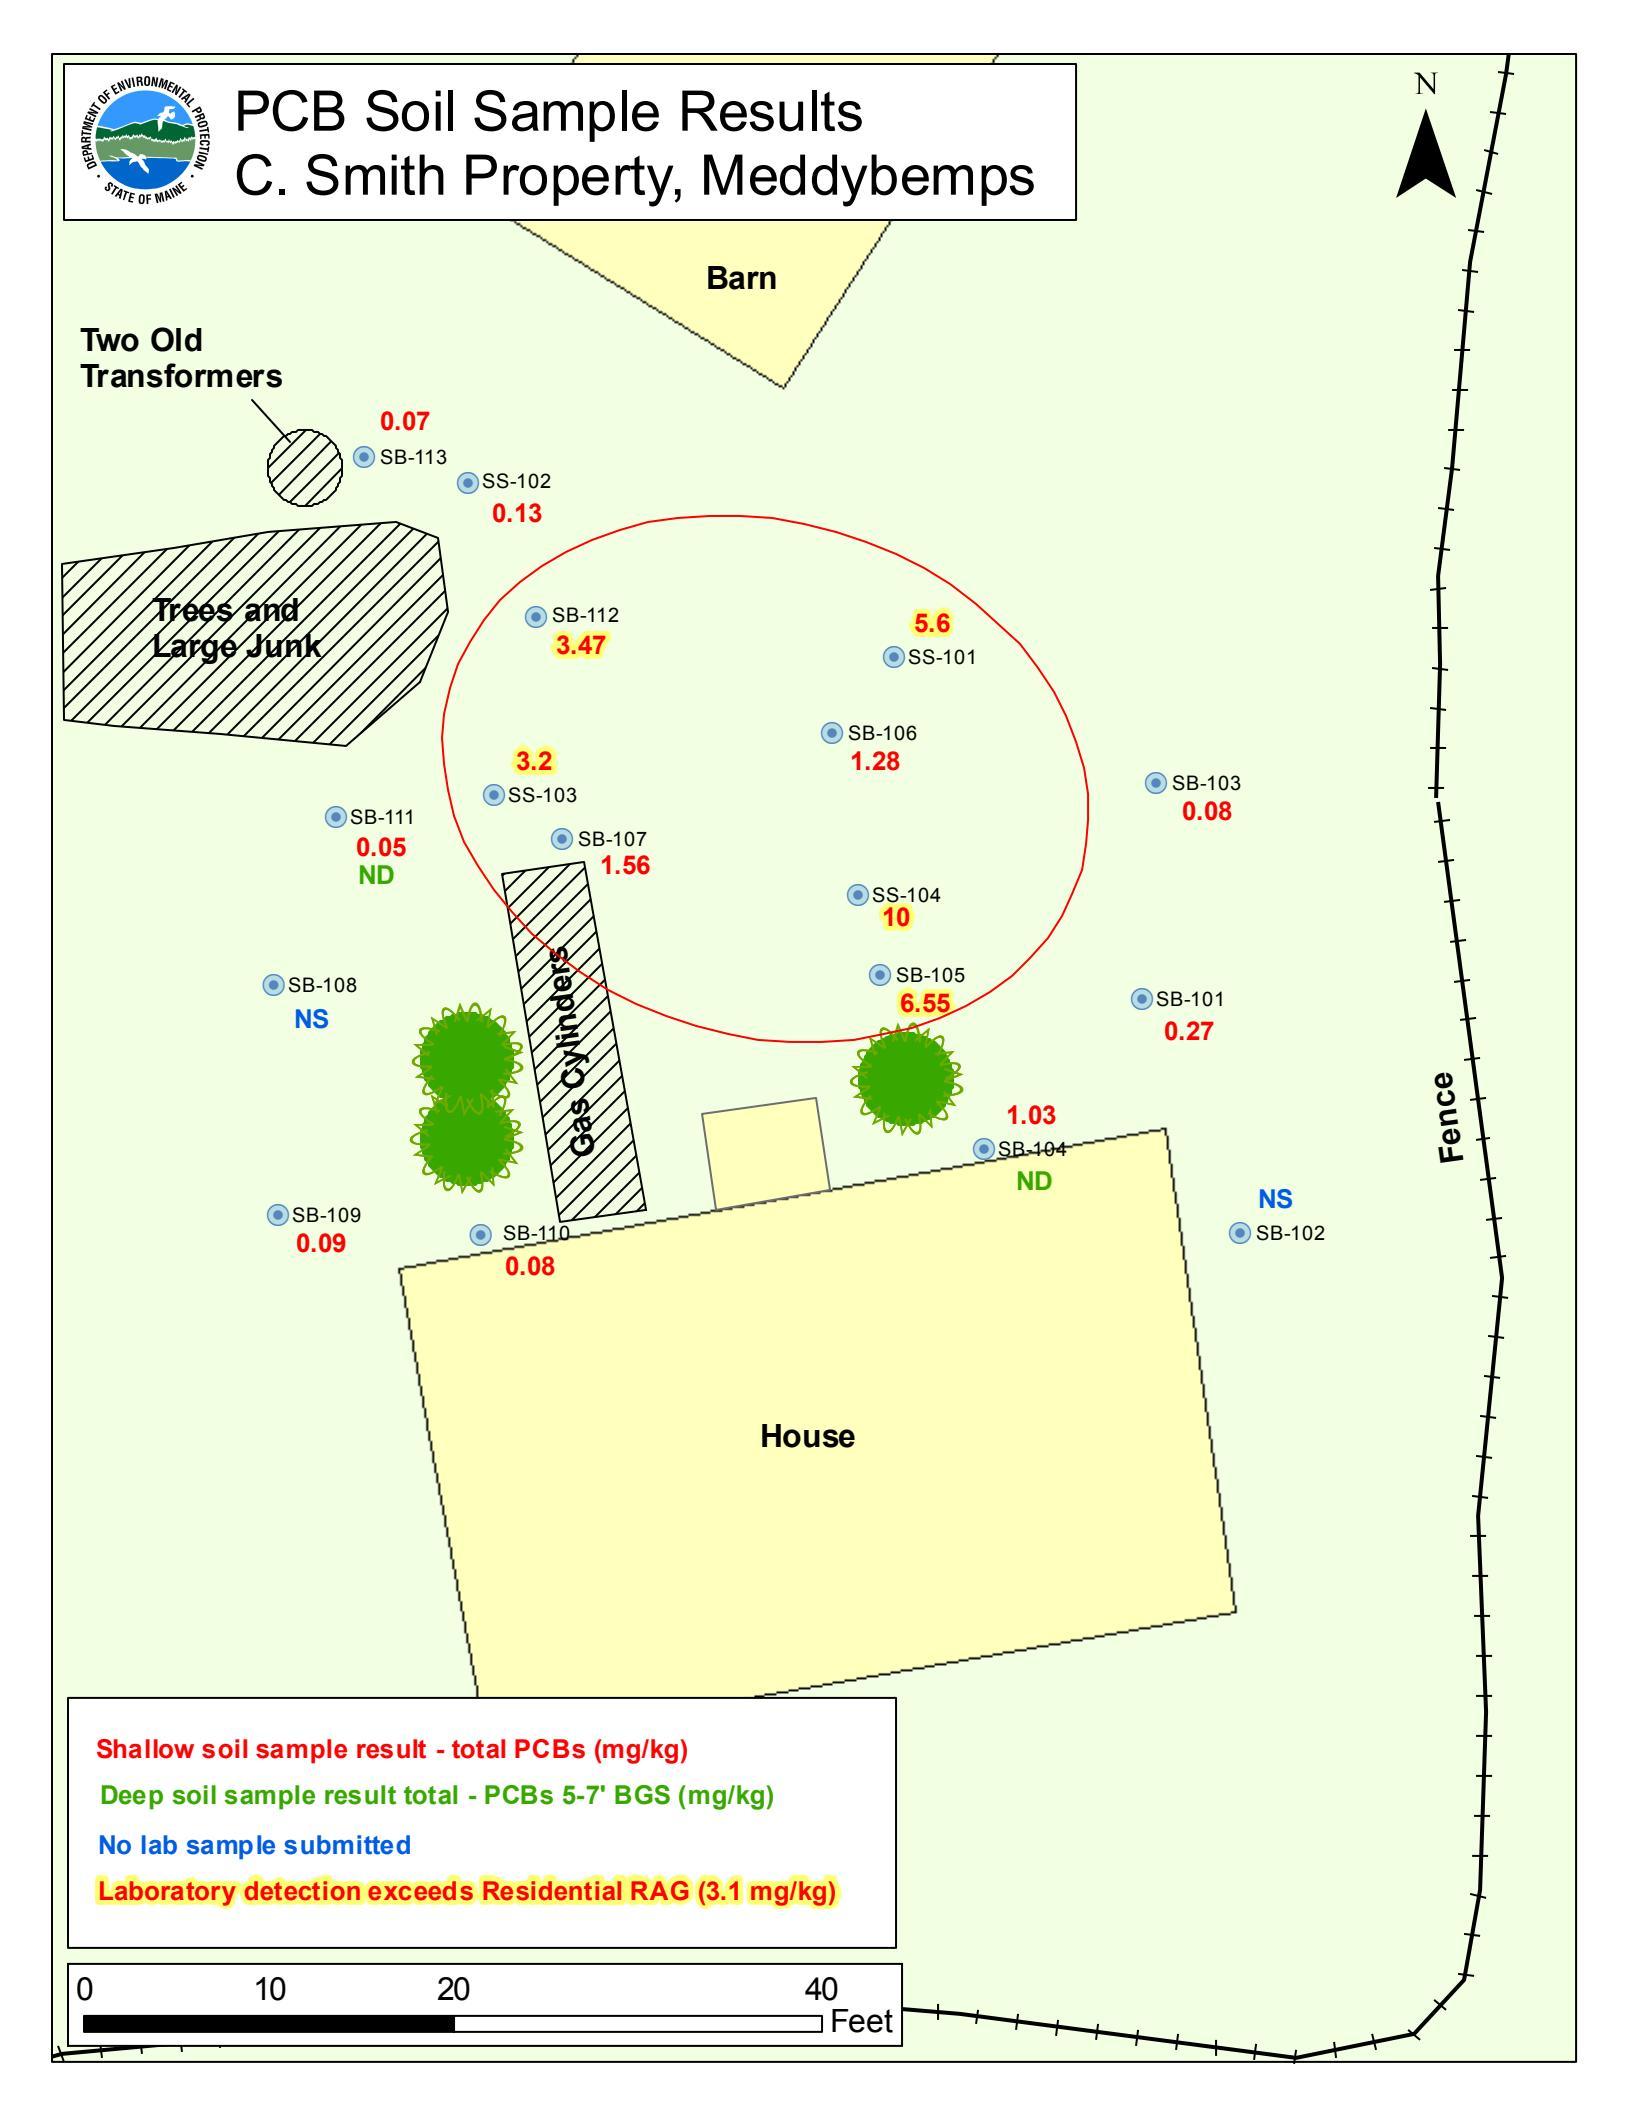
As part of investigation efforts conducted in June 2015, surface soil samples were collected from four locations between the house and the barn located on the subject property and two were collected from the dirt floor within the barn (labeled SS locations on the attached figure). All surface soil samples were tested for VOCs, SVOCs and PCBs. Low level VOCs and SVOCs, primarily PAHs and bis(2-ethylhexyl) phthalate, were detected in the soil samples, all below the associated RAG values. PCBs were detected at three locations (SS-101, SS-103, SS-104) above the residential RAG value.

On December 19th, 2019, further investigation was conducted at the C. Smith site with the purpose of delineating the area of PCB contaminated soil between the house and the barn. Soil samples were collected from a total of thirteen investigation locations (labeled SB locations on the attached figure). Shallow soils at each location were generally sandy-gravelly fill material, becoming fairly dense, finer grained material at depths ranging from 2 to 6 feet. Relatively loose shallow fill materials, with void spaces at several locations,

None of the soil analytical results for total PCBs were greater than 50 ppm; therefore, the contaminated soil would not be considered PCB Remediation Waste under TSCA. The current Maine Residential RAG for total PCBs in soil is 3.1 mg/kg. Using a site-specific risk assessment approach, ProUCL was used to determine the 95% UCL on the mean of the shallow soil sample results. This yielded a recommended UCL of 4.1 mg/kg, which exceeds the residential RAG. The attached figure includes a red oval enclosing the likely area of PCB contaminated soil exceeding the residential RAG. This area is approximately 90 square yards. Assuming an average excavation depth of 5 feet, the removal estimate is approximately 150 cyds of material.
