# Nature-Based Design Practices Case Study Blue Hill Maine

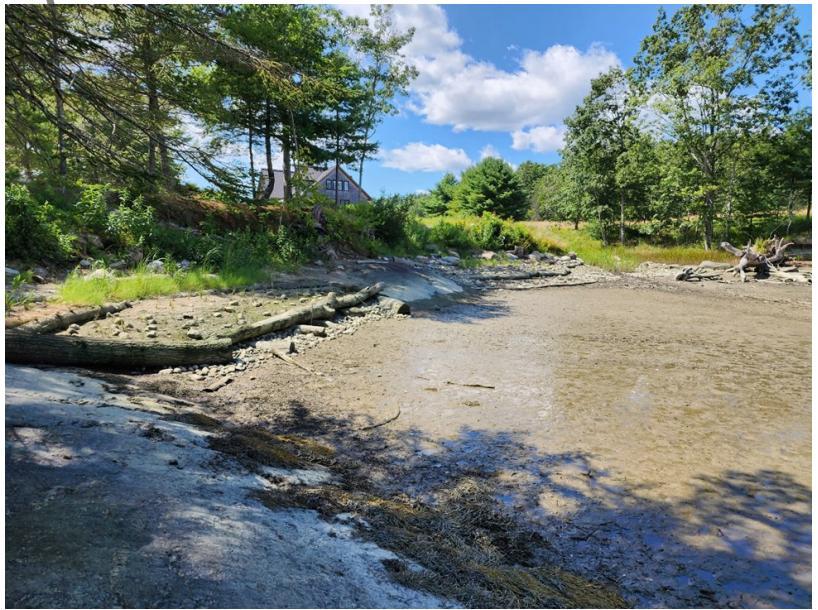
Living shoreline zones and created fringe marsh. Photo courtesy of Nathan Robbins.

The project stabilized over 1,500 linear feet of eroding coastal shorefront using a variety of living shoreline stabilization techniques in combination. To do this, the design incorporated living shoreline zones, including an area of created fringe marsh that was placed father seaward. The lowest zone consisted of a substantial matrix layer supporting marsh grasses and fridge plant species. The next zone above the first consisted of pinned logs, root wads, and small boulders. The final upper zone consisted of the bluff face/upland edge which was enhanced by lifts of coir filled with organics. The project began in 2021, continues to be monitored and the plantings and design have strengthen over time.

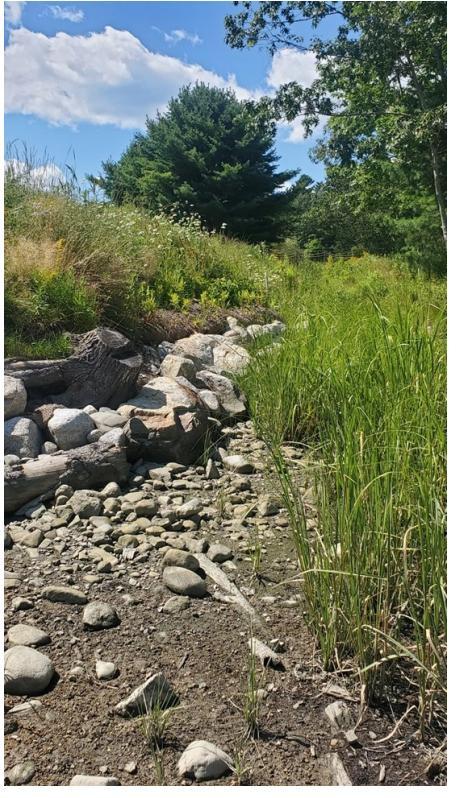
Stabilized bluff and restored streambank. Photo Courtesy of Nathan Robbins.

> US ACOE permitting, to monitor plantings for 5 years, which must be replaced or maintained as necessary to achieve 85% survival annually. Observations were made in 2024, following historic winter storm flooding, and found that the completed structure, coir fabric rolls, marsh restoration structure, and bluff were successfully intact.
