# **Nature-Based Design Practices Case Study**

# Sebago Lake State Park, Maine

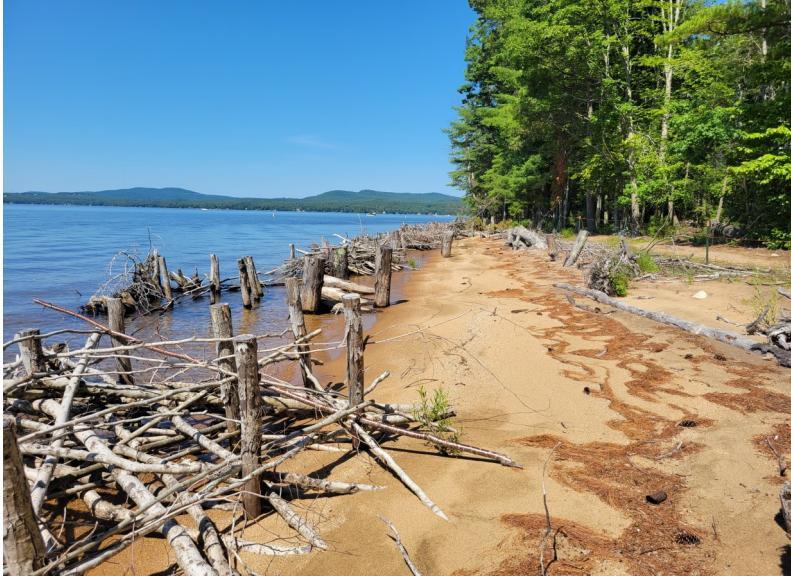
**July 2, 2024:** Vertical Aggradation Rootwad Structures absorb energy from some of the largest breaking waves. Brush aggradation bundles were reinforced with help from volunteers along with 520 live stakes being planted. *Carina Brown, PWD.*

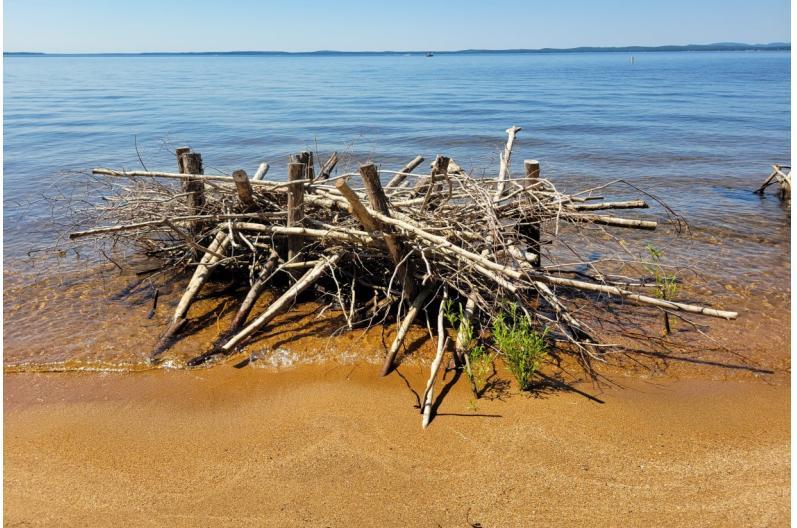
**July 2, 2024:** Brush Aggradation Bundle Structures of branches and brush woven around the upright logs absorb energy from less intense waves and trap sand and sediment carried in waves. Live stakes sprouting new growth. *Carina Brown, PWD.*

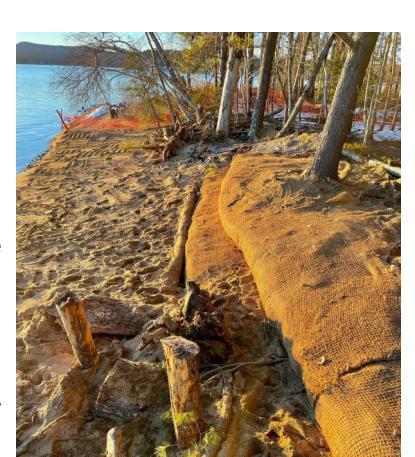
lifts provide a stable upper shoreline into which the plantings can be-

come established to create even na Brown, PWD.

Photo 4: Biodegradable fabric-wrapped soil more stability. Cari-

All practices except for plants were installed by the end of December 2022. Heavy and frequent precipitation events of spring and summer of 2023 and resulting persistent high water levels in the lake resulted in the fabric encapsulated soil lifts failing.

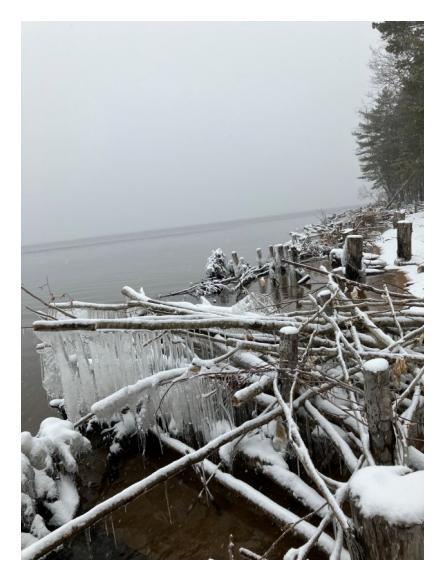
#### January 16, 2024

Photo 5: Lake level is especially high from winter storms. The data used to site these structures put water levels lower than the structures and out of harms way in terms of winter ice sheets. Carina Brown, PWD.

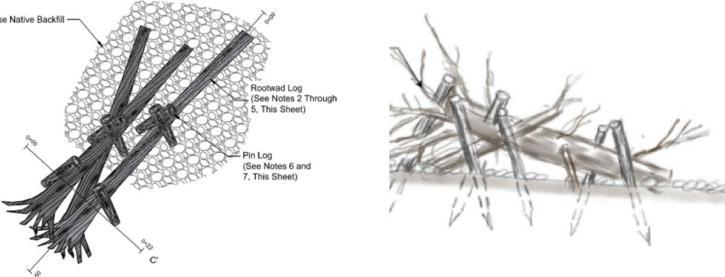
**Design combines Vertical Aggradation Rootwad** Structures, Engineered Log Jams, Post Assisted Wicker Weaves, Brush Aggradation Bundle Structures, Fabric Encapsulated Soil Lifts, and vegetation.
