Coastal Bluffs

Classification and Mapping of Maine's Coastal Bluffs

Bartlett Island Quadrangle, Maine

Open-File No. 03-8

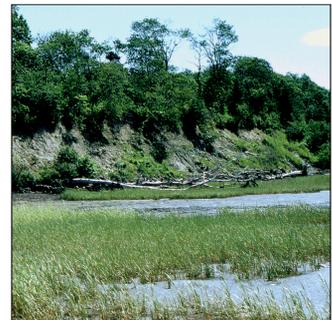
Highly unstable bluff with an unvegetated bluff face and a salt marsh shoreline. Sediments on the bluff face are exposed and fallen tree trunks lie at the base of the bluff. A salt marsh has recently formed on the tidal flat, partly on the top of an old landslide deposit.

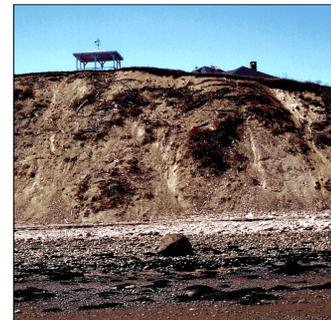
Highly unstable bluff with an unvegetated bluff face and a beach/gravel flat shoreline. The bluff face is too unstable to support vegetation. This bluff, a glacial esker, is eroded by waves to create a mixed sand and gravel beach in front of the bluff.

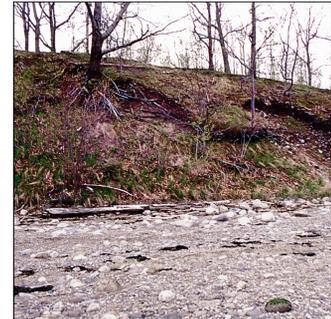
Unstable bluff with a partially vegetated bluff face and a beach/gravel flat shoreline. Slump scars on the bluff face expose sand, gravel, and roots. Fine sediments are removed by waves and currents, leaving gravel to form a beach at the base of the bluff.

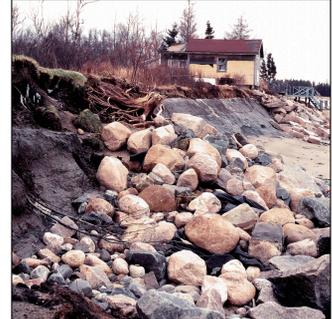
Highly unstable bluff with an unvegetated bluff face and an armored shoreline. This armored bluff is eroding despite an effort to shore it up with riprap, or loosely piled stone blocks. Maintenance at this site could improve bluff stability.

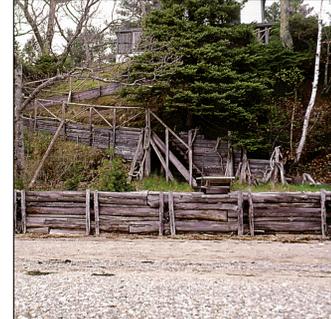
Stable bluff with a vegetated bluff face and an armored shoreline. The bluff face is fully vegetated and supports a mature stand of trees with vertical trunks. The presence of a wooden bulkhead suggests that erosion has occurred in the past.

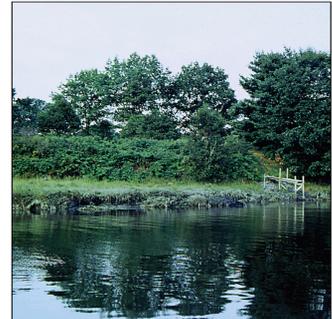
Stable bluff with a vegetated bluff face and a salt marsh shoreline. A low bluff face is covered by shrubs landward of a salt marsh terrace. In this location the mature marsh protects the base of the bluff from rapid erosion and slows bluff recession or retreat.
