Coastal Bluffs

Cape Elizabeth Quadrangle, Maine

Open-File No. 02-182

Types of Bluffs Along Maine's Coast

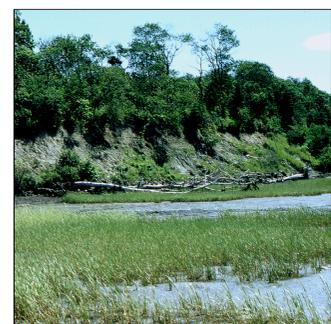
Highly unstable bluff with an unvegetated bluff face and a salt marsh shoreline. Sediments on the bluff face are exposed and fallen tree trunks lie at the base of the bluff. A salt marsh has recently formed on the tidal flat, partly on the top of an old landslide deposit.

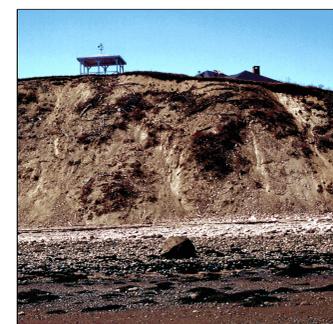
Highly unstable bluff with an unvegetated bluff face and a beach/gravel flat shoreline. The bluff face is too unstable to support vegetation. This bluff, a glacial esker, is eroded by waves to create a mixed sand and gravel beach in front of the bluff.

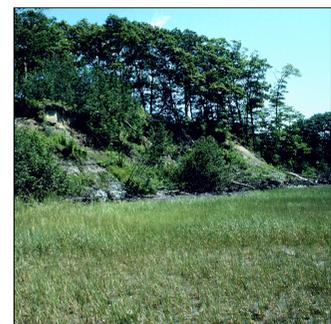
Unstable bluff with a partially vegetated bluff face and a salt marsh shoreline. This bluff, protected by a salt marsh, remains unstable. There are small bushes on the bluff as well as small non-vegetated areas that indicate continuing bluff retreat.

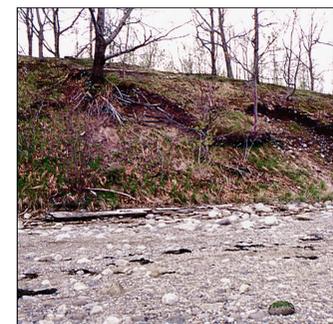
Unstable bluff with a partially vegetated bluff face and a beach/gravel flat shoreline. The bluff face is fully vegetated and supports a mature stand of trees with vertical trunks. The presence of a wooden bulkhead suggests that erosion has occurred in the past.

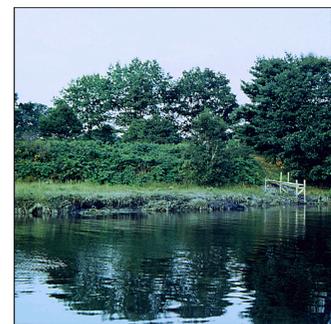
Stable bluff with a vegetated bluff face and a salt marsh shoreline. A low bluff face is covered by shrubs landward of a salt marsh terrace. In this location the mature marsh protects the base of the bluff from rapid erosion and slows bluff recession or retreat.
