Coastal Bluffs

Classification and Mapping of Maine's Coastal Bluffs

Pemaquid Point Quadrangle, Maine

Open-File No. 08-63
 2008

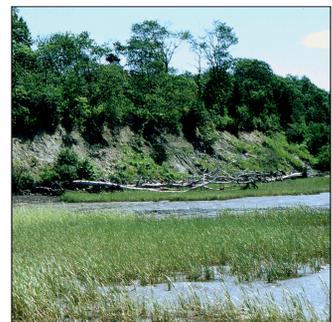
Highly unstable bluff with an unvegetated bluff face and a salt marsh shoreline. Sediments on the bluff face are exposed and fallen tree trunks lie at the base of the bluff. A salt marsh has recently formed on the tidal flat, partly on the top of an old landslide deposit.

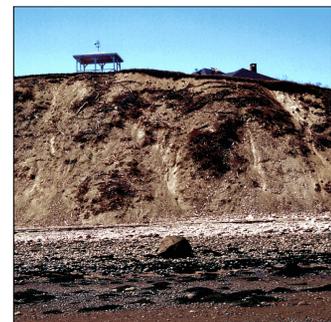
Highly unstable bluff with an unvegetated bluff face and a beach/gravel flat shoreline. The bluff face is too unstable to support vegetation. This bluff, a glacial esker, is eroded by waves to create a mixed sand and gravel beach in front of the bluff.

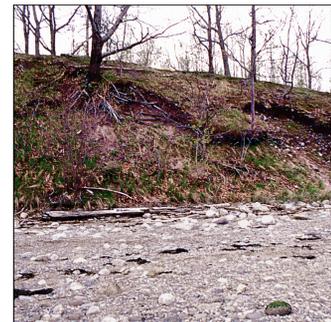
Unstable bluff with a partially vegetated bluff face and a beach/gravel flat shoreline. Slump scars on the bluff face expose sand, gravel, and roots. Fine sediments are removed by waves and currents, leaving gravel to form a beach at the base of the bluff.

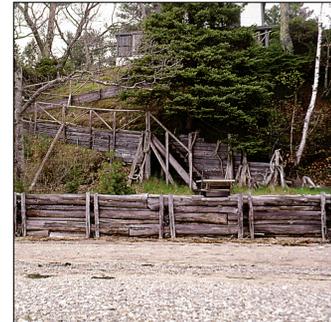
Stable bluff with a vegetated bluff face and an armored shoreline. The bluff face is fully vegetated and supports a mature stand of trees with vertical trunks. The presence of a wooden bulkhead suggests that erosion has occurred in the past.

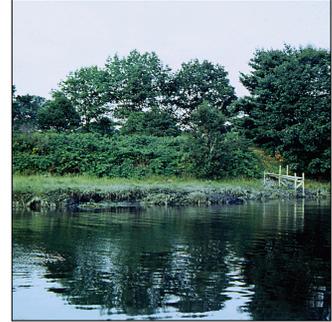
Stable bluff with a vegetated bluff face and a salt marsh shoreline. A low bluff face is covered by shrubs landward of a salt marsh terrace. In this location the mature marsh protects the base of the bluff from rapid erosion and slows bluff recession or retreat.
