# Coastal Bluffs

## Prouts Neck Quadrangle, Maine

Coastal bluff mapping by  
**David A. Sinson, Rebecca A. Nestor,  
 Stephen M. Dickson, and Joseph T. Kelley**

**Open-File No. 02-208  
 2002**

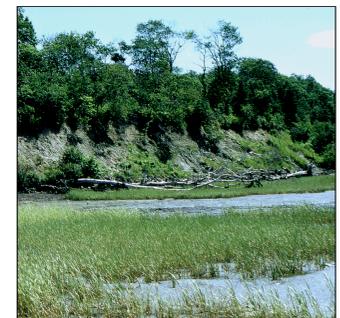
**Highly unstable bluff** with an unvegetated bluff face and a salt marsh shoreline. Sediments on the bluff face are exposed and fallen tree trunks lie at the base of the bluff. A salt marsh has recently formed on the tidal flat, partly on the top of an old landslide deposit.

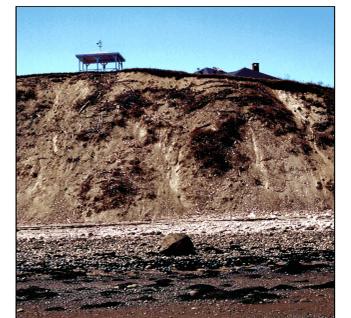
**Highly unstable bluff** with an unvegetated bluff face and a beach/gravel flat shoreline. The bluff face is too unstable to support vegetation. This bluff, a glacial esker, is eroded by waves to create a mixed sand and gravel beach in front of the bluff.

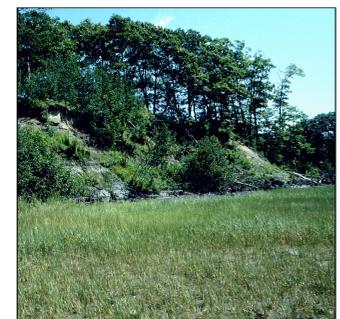
**Unstable bluff** with a partially vegetated bluff face and a salt marsh shoreline. This bluff, protected by a salt marsh, remains unstable. There are small bushes on the bluff as well as small non-vegetated areas that indicate continuing bluff retreat.

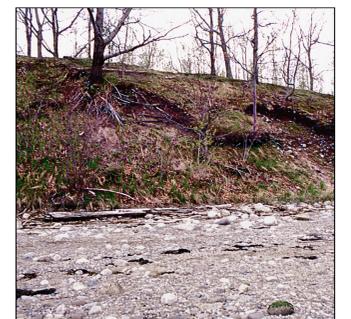
**Unstable bluff** with a partially vegetated bluff face and a beach/gravel flat shoreline. Slump scars on the bluff face expose sand, gravel, and roots. Fine sediments are removed by waves and currents, leaving gravel to form a beach at the base of the bluff.

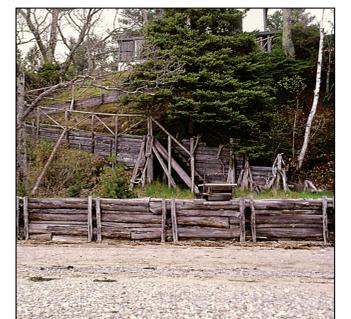
**Stable bluff** with a vegetated bluff face and an armored shoreline. The bluff face is fully vegetated and supports a mature stand of trees with vertical trunks. The presence of a wooden bulkhead suggests that erosion has occurred in the past.

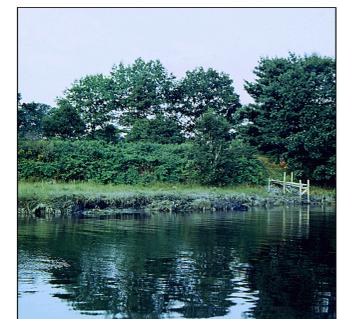
**Stable bluff** with a vegetated bluff face and a salt marsh shoreline. A low bluff face is covered by shrubs landward of a salt marsh terrace. In this location the nature marsh protects the base of the bluff from rapid erosion and slows bluff recession or retreat.
