Songo River Slope –Stability / Shoreline Classification Map

Maine Geological Survey
Natural Resources Information and Mapping Center
Department of Conservation
Augusta, Maine 04333

Maine Geological Survey Open –File No. 98 –124

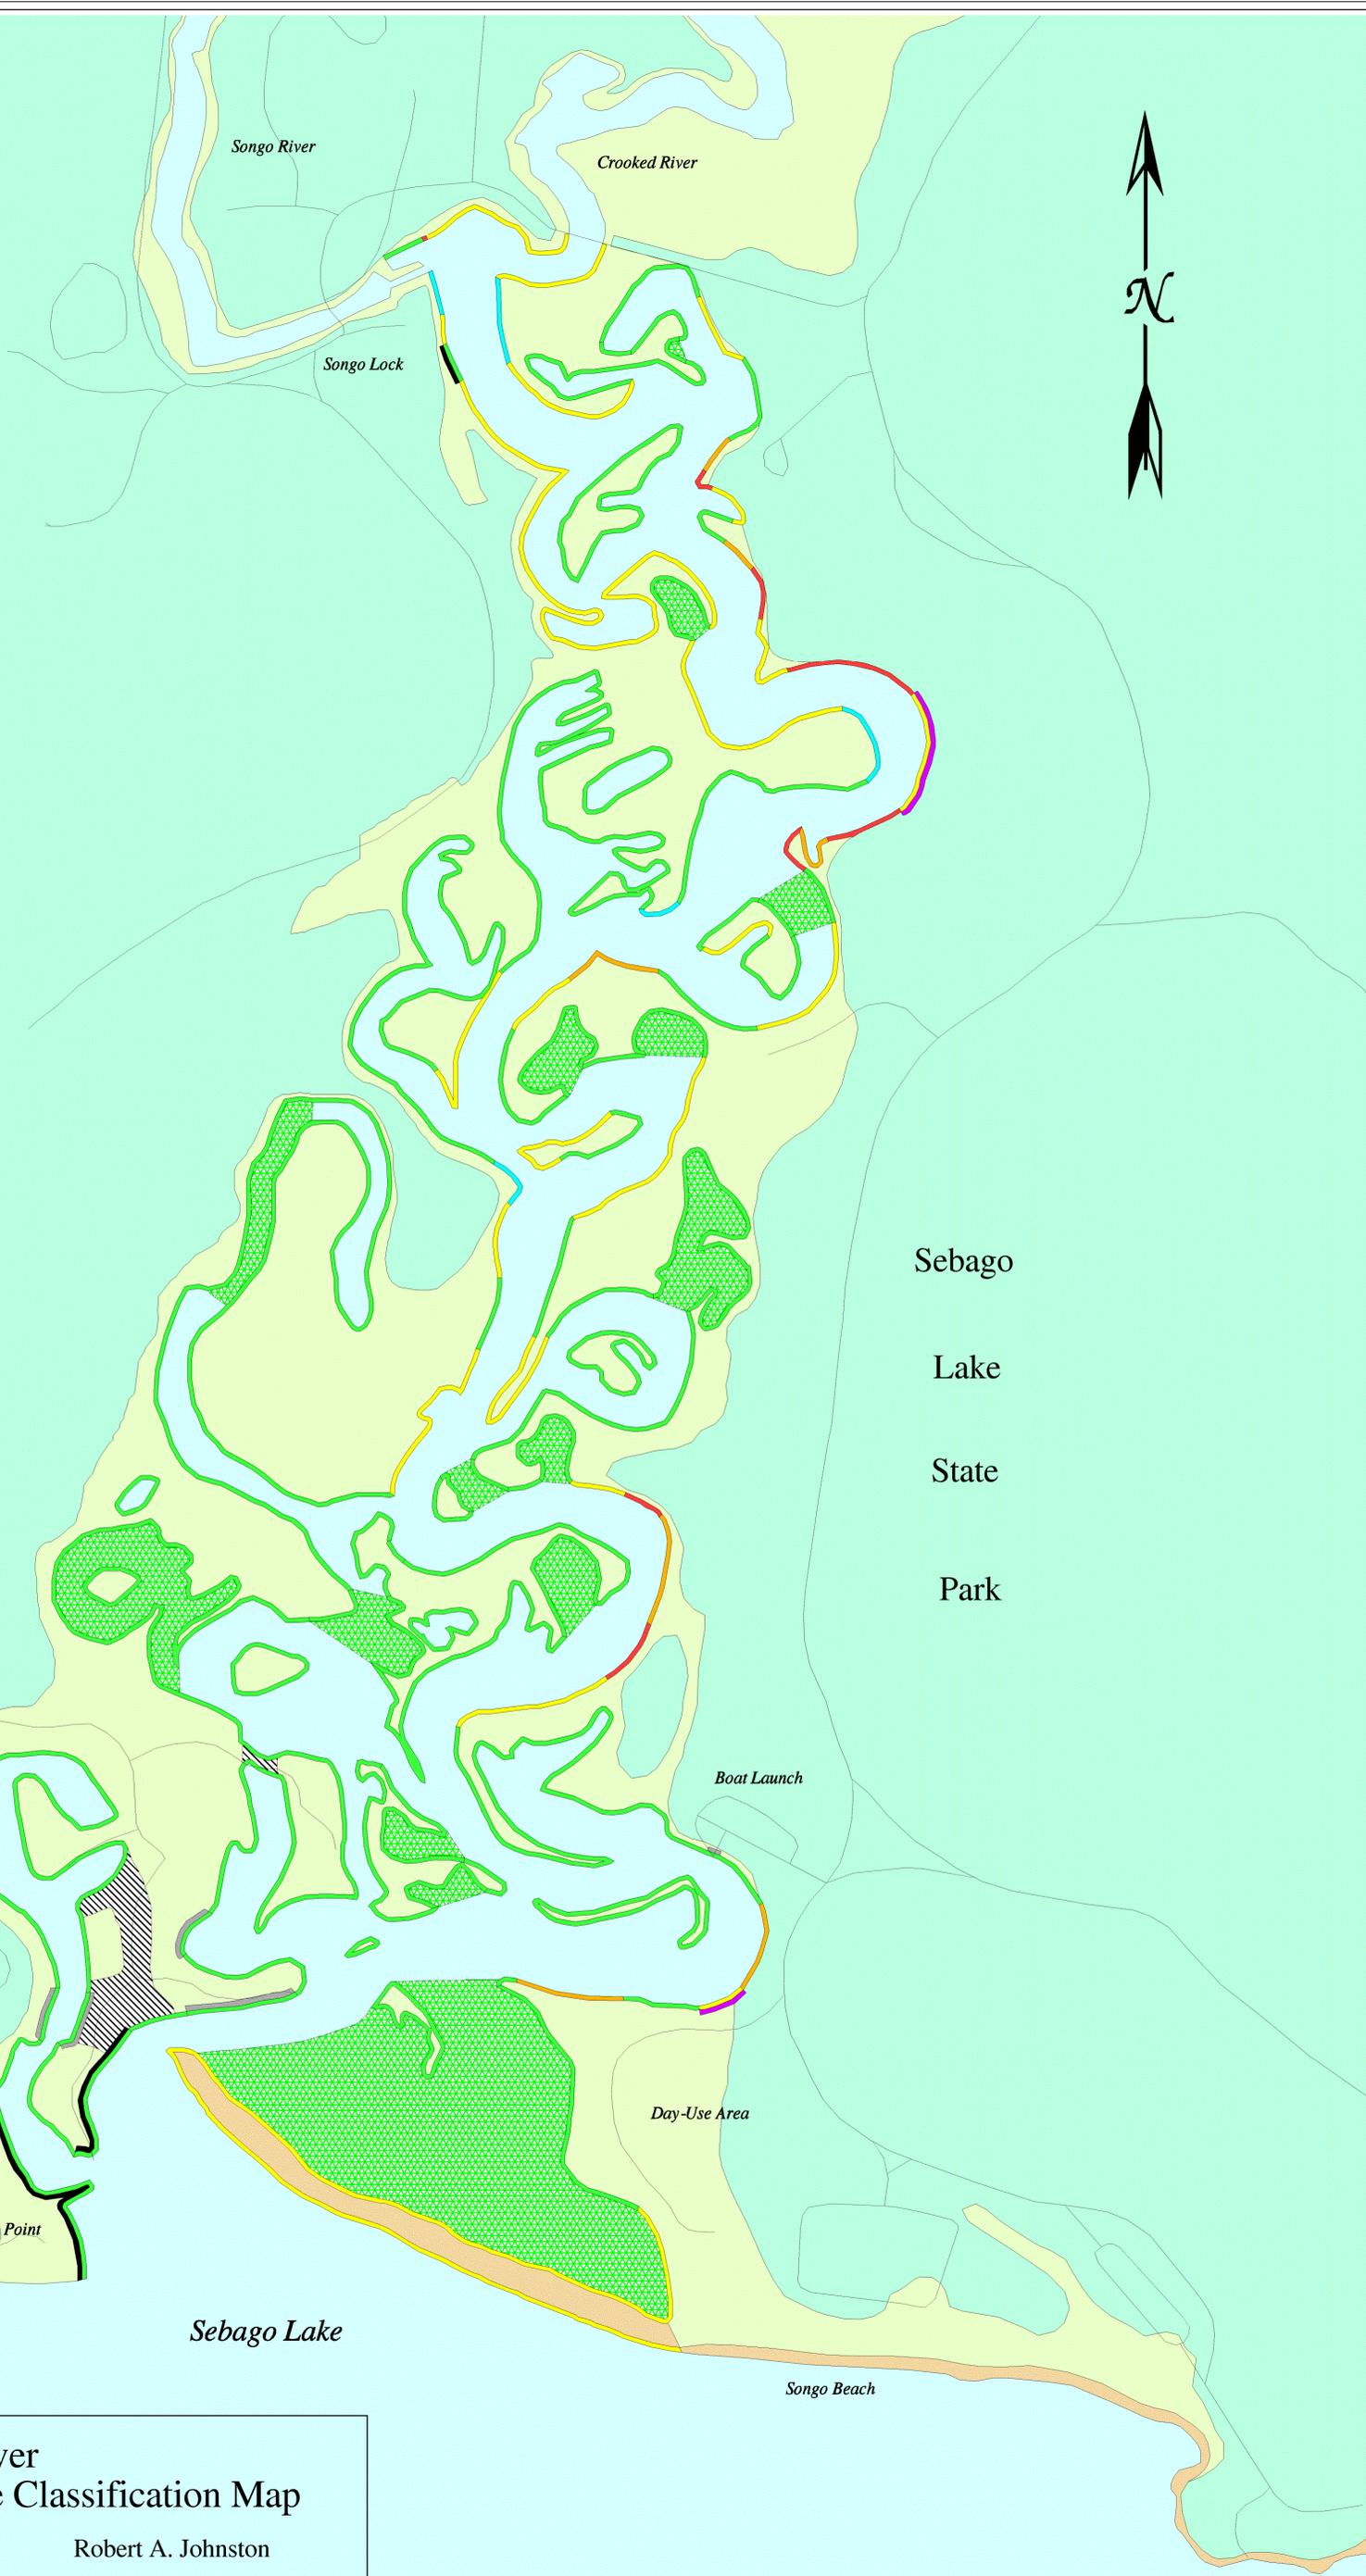
- Notes:
1. Boundaries of zones are accurate to within five (5) meters. Area of fill estimated from changes observed in historical aerial photographs.
 2. Base map is from the U.S.G.S. 1983 7.5-minute Naples quadrangle.
 3. Mapped in July, 1996.
