Figure 1: Site Map Farwell Mill 244 Lisbon St., Lisbon

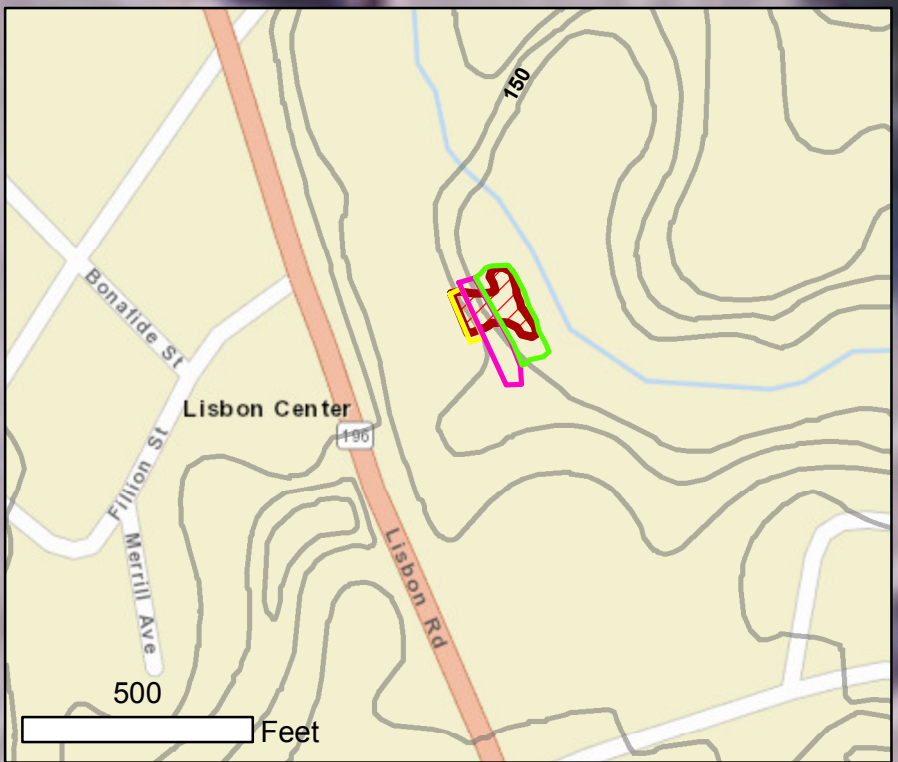
Geoprobe Points

- ▲ No Signs of Oil
- ▲ Oil Indicator but Not Saturated
- ▲ Oil-Saturated Soils Encountered

Hand-Tool Points Along Stream

- Some Oil Present
- Saturated Sediment
- Heavily Saturated Sediment
- Hand Auger (AOC 1)

Areas of Concern

- AOC-1
- AOC-2
- AOC-3
- ▨ Inferred Oil-Saturated Soils Area
