**PRELIMINARY ASSESSMENT REPORT
FOR
HILLSIDE CLEANERS (REM#01886)
148 FRENCH STREET
BANGOR, MAINE**

EPA ID NO. MEN000153605

PRELIMINARY ASSESSMENT

U.S. Environmental Protection Agency
Region I
Superfund and Emergency Management Division
Boston, MA 02109-3912

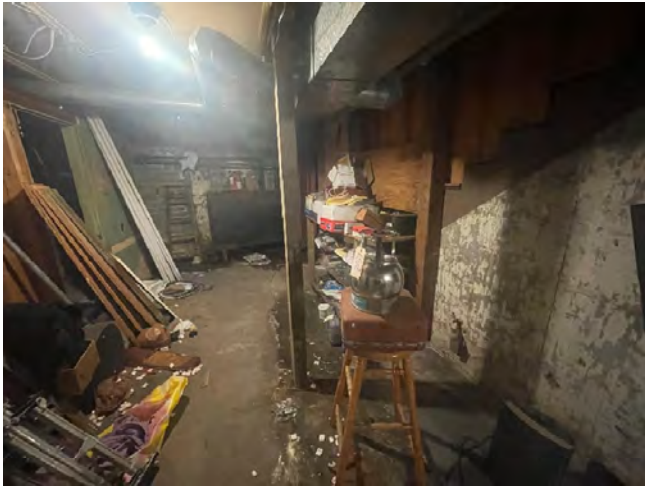
Photo No. 1	Date: 3/27/2023
-----------------------	---------------------------

Description: Pawn Shop Basement (55 State St.),
Sample AS-2 location

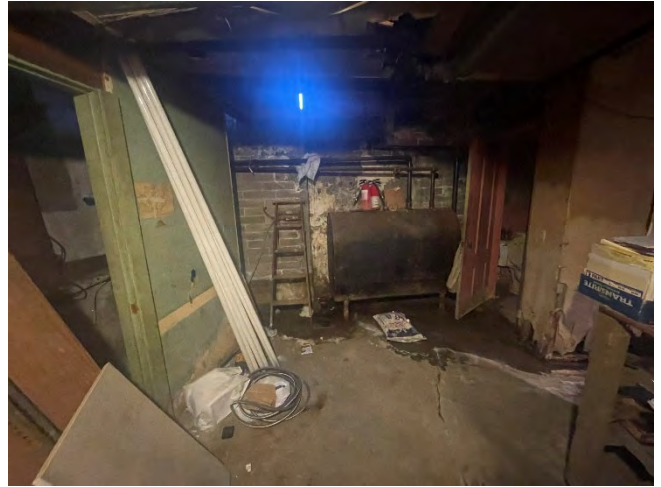
Photo No. 2	Date: 3/27/2023
-----------------------	---------------------------

Description: Pawn Shop Basement, Sample AS-2
location

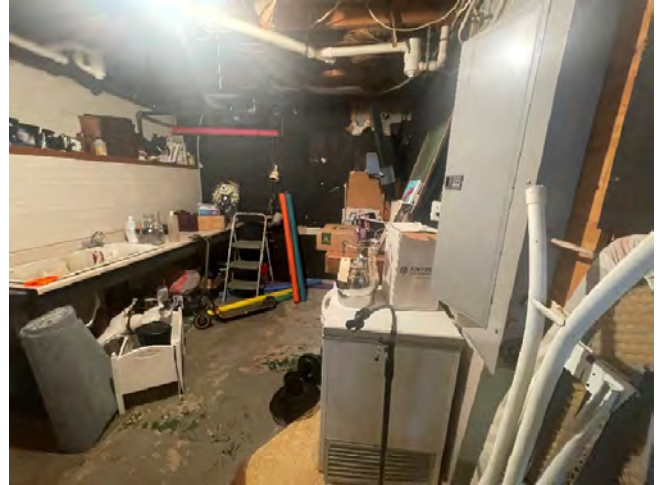
Photo No. 6	Date: 3/27/2023
-----------------------	---------------------------

Description: Residential Dwelling Basement (61 State St.), AS-1 sample location

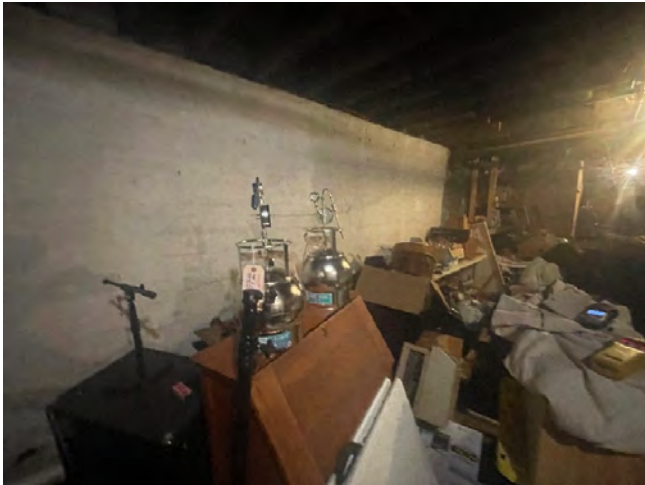
Photo No. 9	Date: 3/27/2023
-----------------------	---------------------------

Description: Photo Studio Basement (148 French Street), AS-3 and Duplicate sample location.

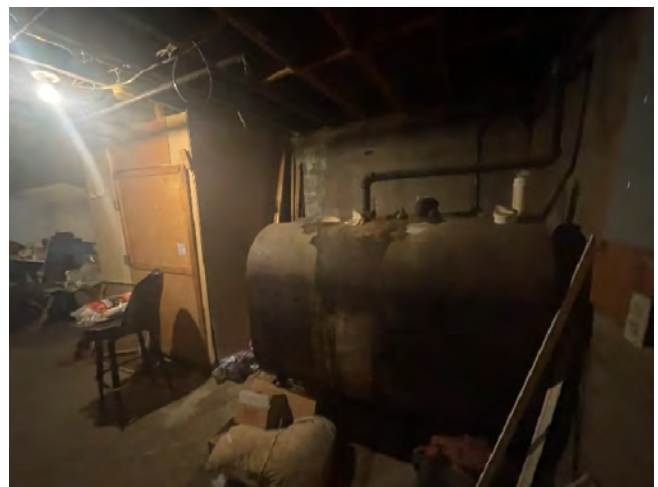
Photo No. 12	Date: 3/27/2023
------------------------	---------------------------

Description: Photo Studio Basement, AST location.

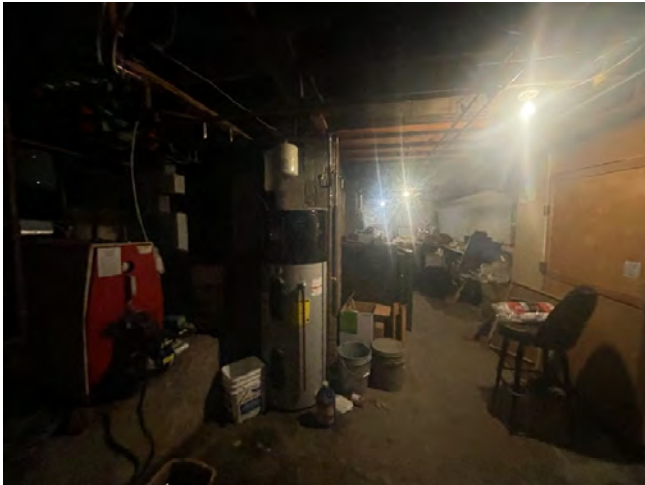
Photo No. 13	Date: 3/27/2023
------------------------	---------------------------

Description: Photo Studio Basement, water heater.

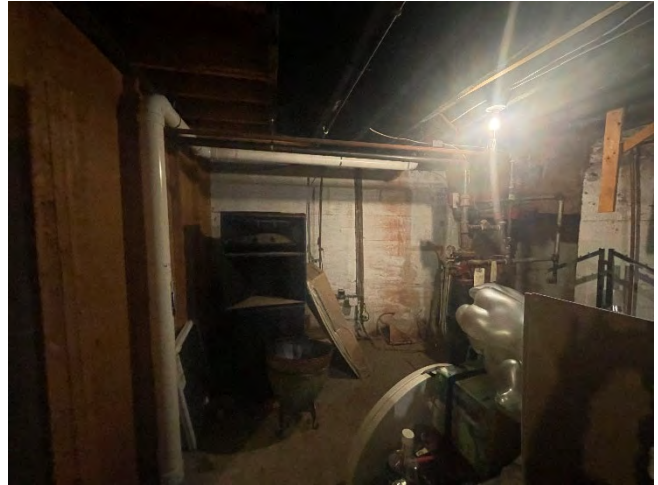
Photo No. 14	Date: 3/27/2023
------------------------	---------------------------

Description: Photo Studio Basement, Vapor Mitigation suction point.

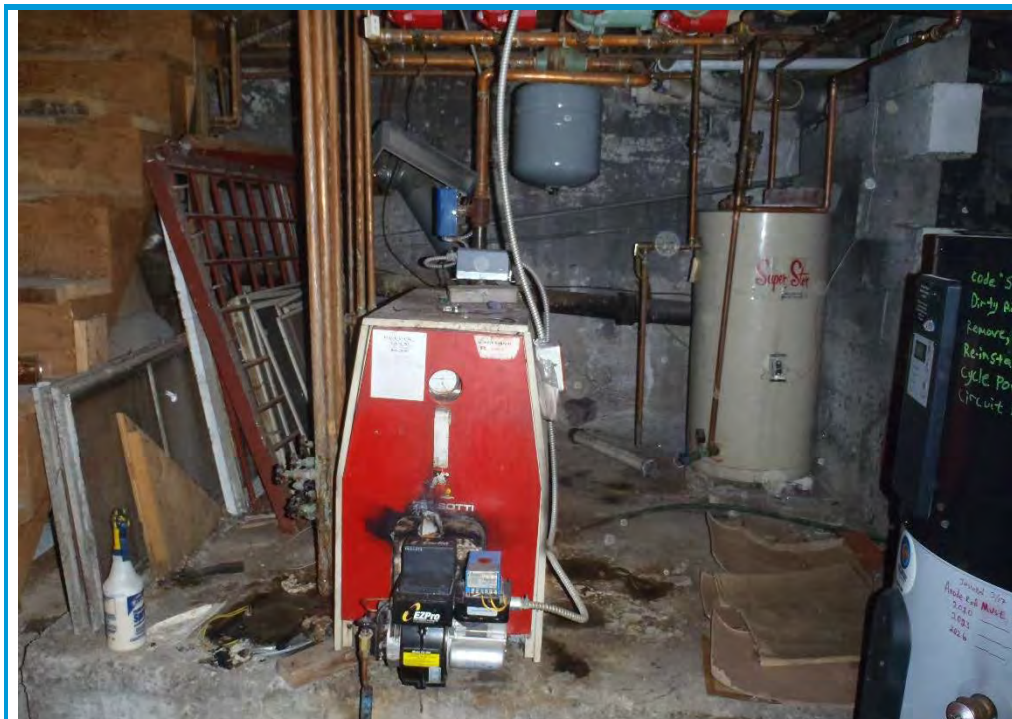
Photo No. 4
Photo Date: June 19, 2019
Site Location: 148 French Street, Bangor, Maine
Description: View of the boiler within the structure basement.
Photo By: BDS

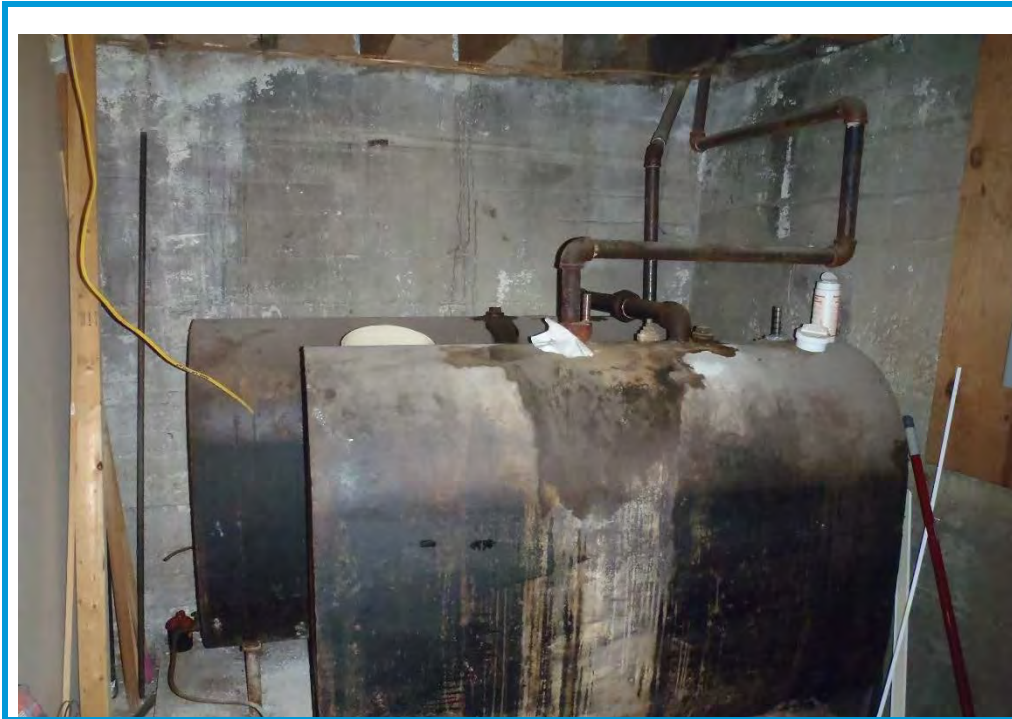
Photo No. 5
Photo Date: June 19, 2019
Site Location: 148 French Street, Bangor, Maine
Description: View of the #2 fuel oil ASTs.
Photo By: BDS

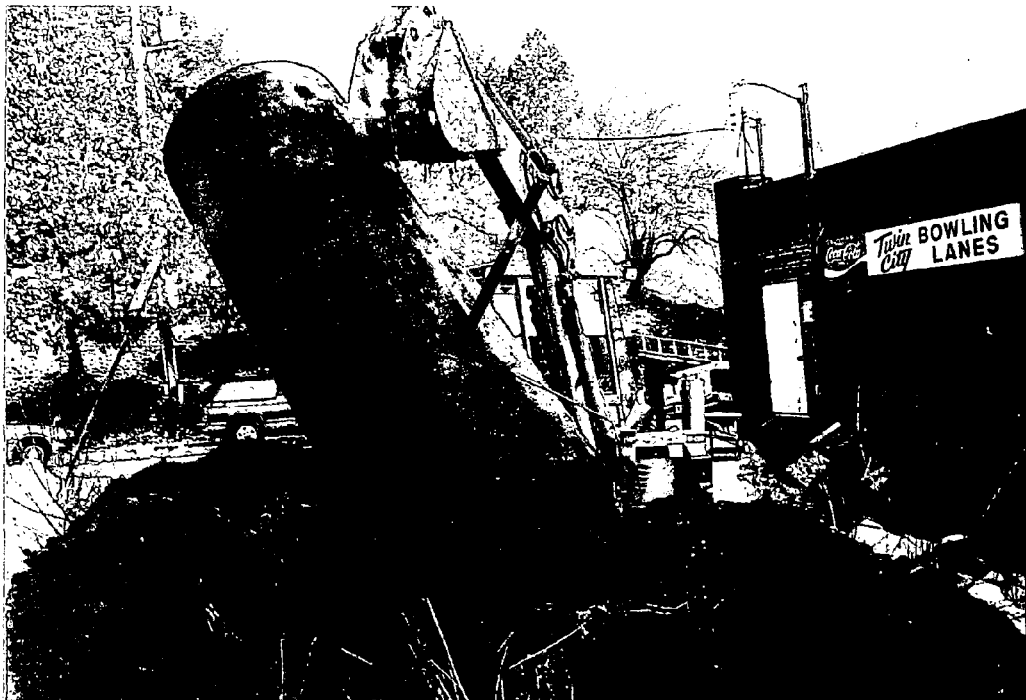
TANK #1

TOP PHOTO: 1,000-GAL # 2 FUEL OIL TANK PRIOR TO REMOVAL
BOTTOM PHOTO: # 2 FUEL OIL TANK DURING REMOVAL

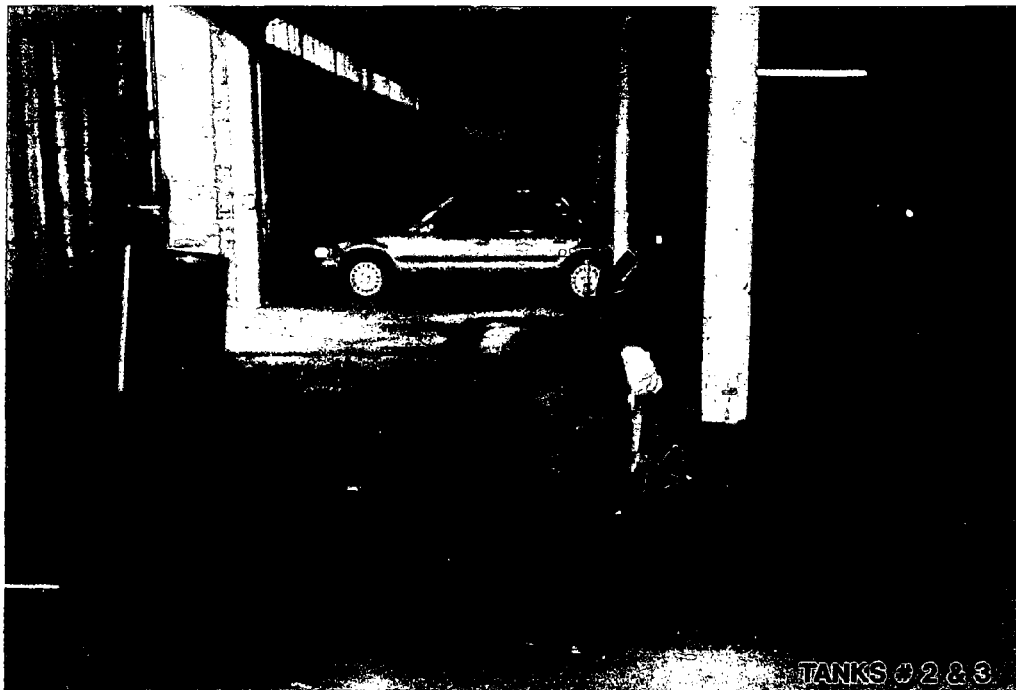
TANK #3

TOP PHOTO: 1,000-GAL GASOLINE TANK INTERIOR PRIOR TO REMOVAL
BOTTOM PHOTO: 1,000-GAL GASOLINE TANK INTERIOR AFTER CLEANING BY TWM

**1,000-GAL GASOLINE TANK
LOCATIONS PRIOR TO
ABANDONMENT IN PLACE**

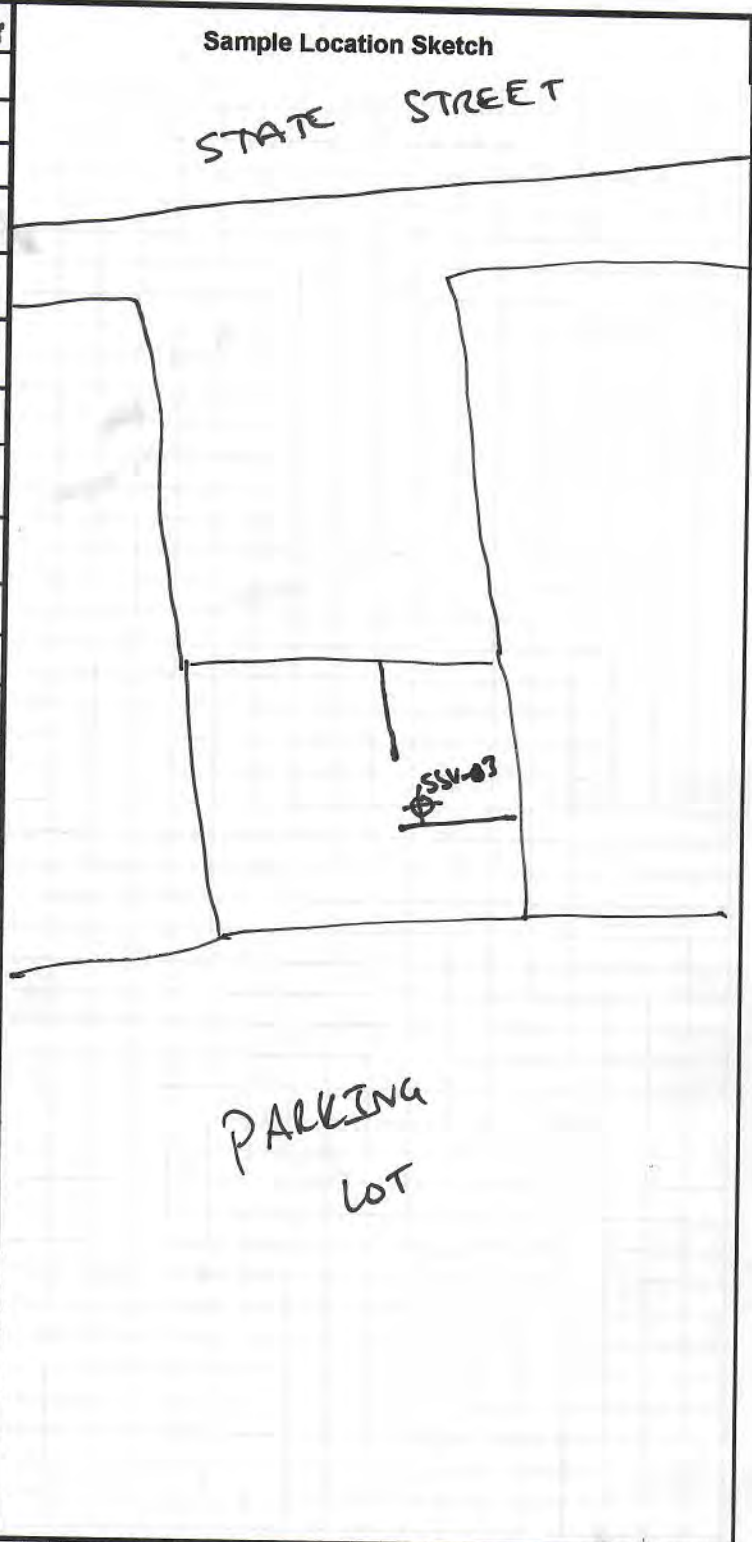
Site Name:	HILLSIDE CLEANERS
Town:	BANGOR
Date:	4-4-2022
Sample I.D.:	SSV-03
Sampling Purpose	(Source) (Utility) (Mitigation) (Receptor) (Other)
Sampling Personnel:	CRESSEY
Project Manager	REDMOND
Collection Device:	(Summa Can) (Pedlar Bag)
Sample Penetration Location:	(Asphalt) (Concrete) (Soil)
Soil Type:	(Fill) (Till) (Sand & Gravel) (Glacial Marine)
Sample Depth:	8"
Depth to Water:	~ 6'
Suspected COCs:	(Petroleum) (Solvents)
Canister I.D.:	2555
Flow Control I.D.:	02144
Flow control rate:	72 mL/min
O ₂ Ambient	20.9%
CO ₂ Ambient	540 PPM
subsurface pressure/vacuum	(+/- inches of water column)
Pre-Sample O ₂	20.1%
Pre-Sample CO ₂	480 PPM
Pre-Sample PID:	310 PPM
Pre-Sample CH ₄ :	NA (% Volume, %LEL, PPM)
Sample Initiation Time:	925
Initial Vacuum:	-29.48
Sample End Time:	953
Final Vacuum:	-7.55
Post Sample O ₂	20.0%
Post Sample CO ₂ :	480 PPM
Post Sample PID	315 PPM

Notes/Observations: If subslab sample collected and no indoor air samples collect: note foundation type, slab type, floor penetrations, and wall penetrations. If subslab sample and indoor air sample collected, note co-located indoor air sample ID.

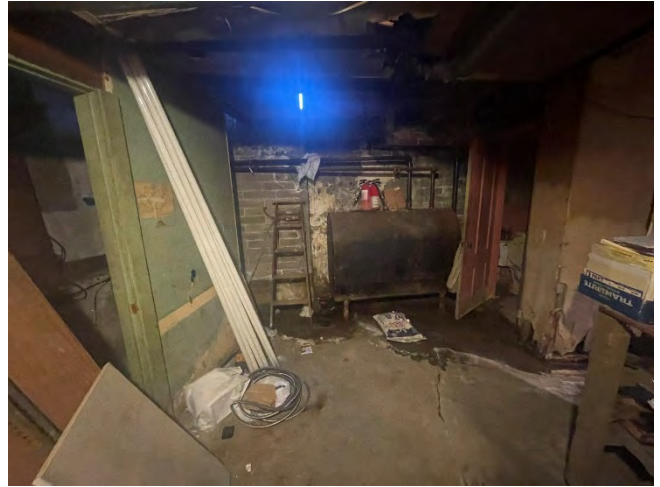
Photo No. 2	Date: 3/27/2023
-----------------------	---------------------------

Description: Pawn Shop Basement, Sample AS-2
location
