Exhibit 5: Visual Simulation and Post-Construction Photos

(Sheet 1 of 2)

April 18, 2013

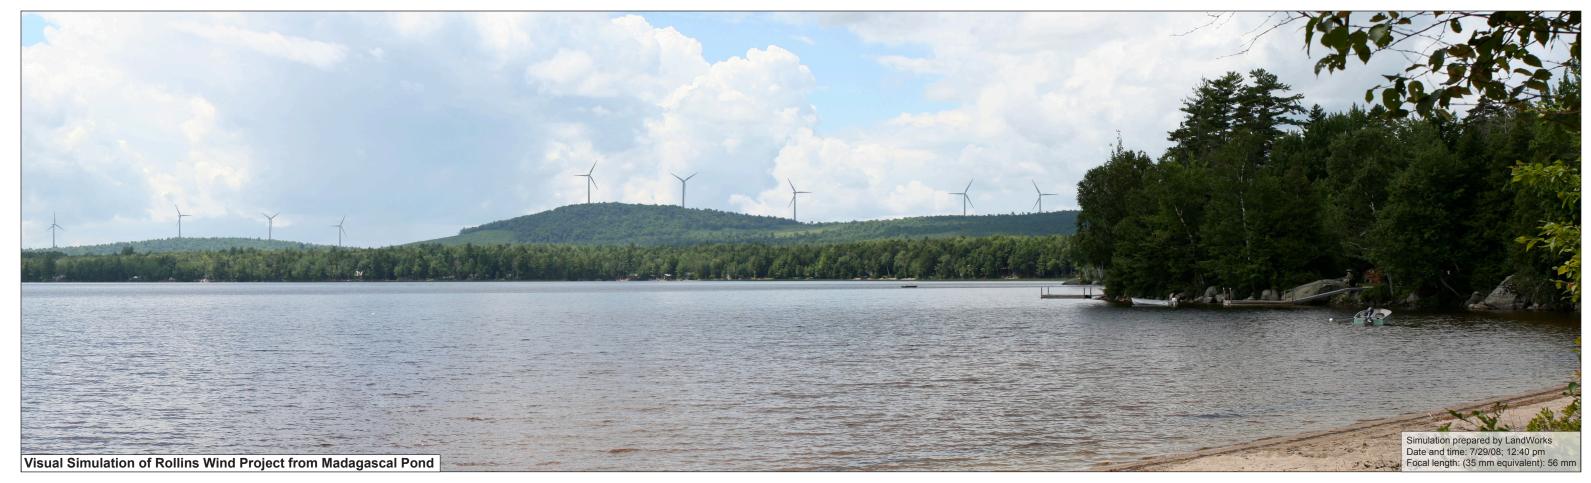
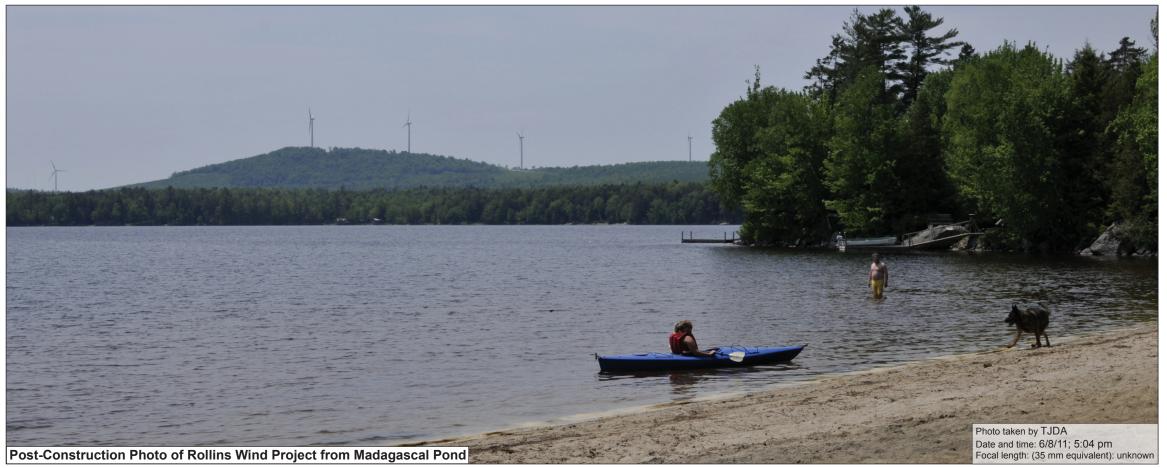
Note: View location is slightly different for post-construction photo

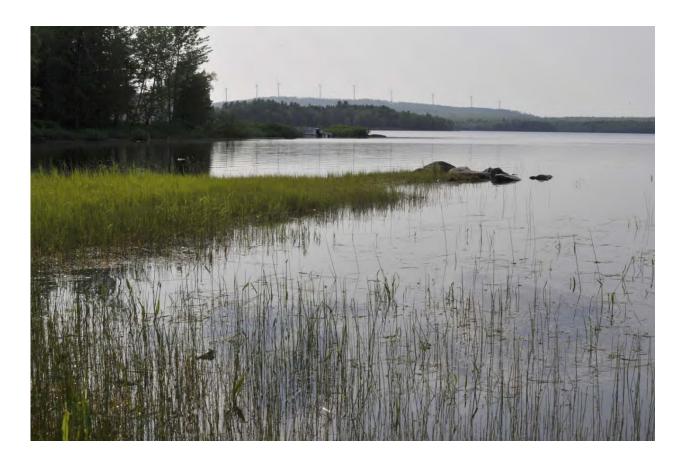
Rollins from Upper Hot Brook Lake.

From this location, the closest turbine at Rollins is approximately 2.5 miles away. Note that the rotors are difficult to discern from this distance, despite the silhouette effect present with these light conditions. Photo taken by TJDA, June 6-7, 2011.

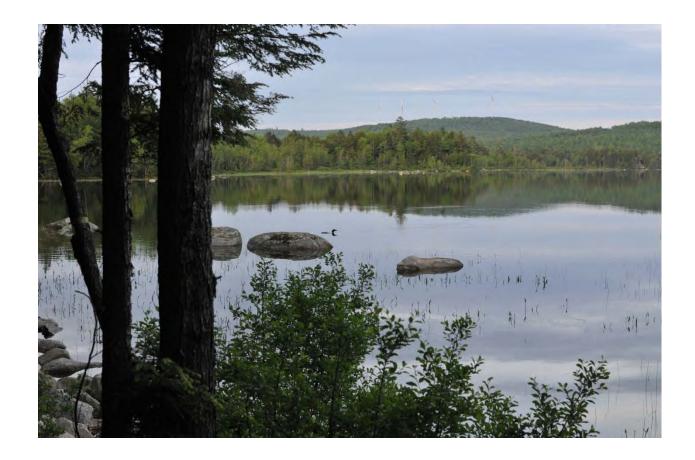
Rollins from Upper Pond.

From this location, the closest turbine at Rollins is approximately 2.5 miles away. Note that even with a blue sky, the turbines do not stand out in this photo. Photo taken by TJDA, June 6-7, 2011.
