*The Androscoggin River is the fourth largest river in Maine, draining 3,450 square miles or about 10% of the state. In comparison to the other three rivers, available dilution on the Androscoggin mainstem is fairly low.*

## Introduction

## **CASE STUDY 6**

## **CASE STUDY 7**

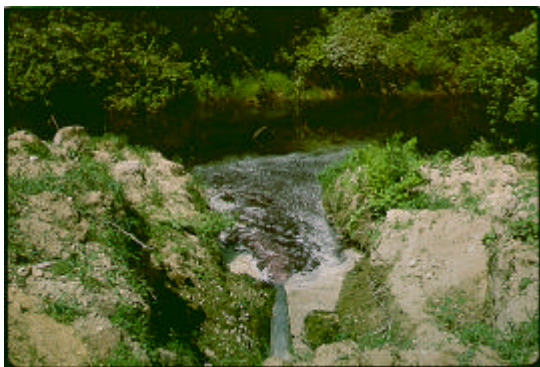
Robinson MFG. Co. discharge to Thompson Lake Outlet Stream, circa 1984

Management intervention at the Robinson Manufacturing Company occurring in the late 1980s and early 1990s has addressed wastewater treatment, manufacturing processes and general mill practices. Treatment changes include the construction of an equalization system to prevent large slugs of effluent from overwhelming the plant. The aeration capacity was also greatly increased. The industry hired a well-qualified, full time, treatment plant operator to run the upgraded plant, and also hired general environmental staff to holistically address environmental concerns at the mill. Within the textile mill, chemical process substitutions were initiated in an effort to reduce effluent toxicity through the use of less hazardous materials, and waste handling changes were instituted to decrease the incidence of spills and dumping.

All remedial actions combined have resulted in the discharge of a much higher quality effluent to Thompson Lake Outlet Stream. The incidence of violations of licensing limits has decreased to a fraction of violations that were recorded in the 1980s and no recent violations have occurred as a result of lack of treatment capacity. Remaining problems have tended to be associated with spills and mill operations, rather than treatment problems. Unfortunately, the stream itself has been slower to respond to cleanup efforts. As noted, the stream consistently failed to attain the minimum aquatic life characteristics for Class C standards between 1984 and 1992. Yet a closer look at the community characteristics reveals a classic trend of improving response, with recruitment of increasingly sensitive organisms. The 22 organisms in 1984 were nearly all snails (Physa). The dramatically increased numbers in the 1985 samples were comprised of over 90% worms, leeches and midge larvae (Chironomidae), with the pollution-tolerant midge larvae considered to be a favorable trend as compared to the extremely pollution-tolerant non-insects. In 1988 the very first observation of a few mayflies (7 individuals) was recorded in the downstream station (78). The 1992 samples revealed an average of 45 mayflies per sampler and filter-feeding caddisflies and black flies made up 93% of the total number of organisms (1576) colonizing the samplers. Conditions were next evaluated in 1996, following completion of the above-mentioned improvements. For the first time in the period of record, both the upstream and the downstream stations attained Class C aquatic life standards. Because 1996 was an extremely high-flow year, allowing for higher than normal dilution ratios, optimism about the long-term health of the stream must be somewhat guarded. But field observations of samples collected in 1998 suggest that standards may have once again been attained. It is clear that major improvements in water quality have been accomplished and there is justifiable hope for the future.

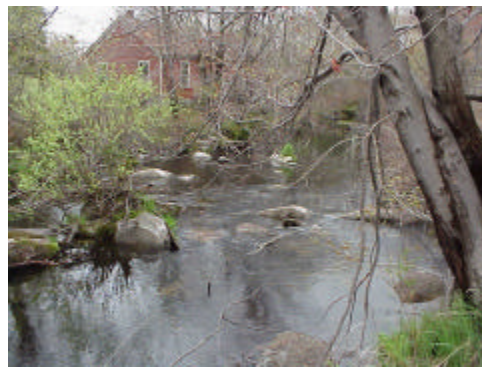
Thompson Lake Outlet Stream, below Robinson MFG Co., April 1999

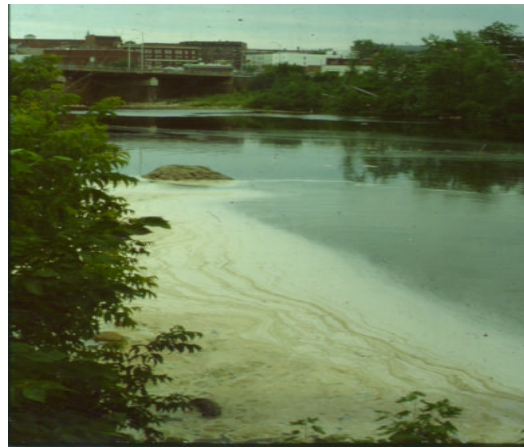
*Combined Sewer Overflow discharging to the Androscoggin River in Auburn (1984, approx.)*
