BEAVER TAIL POND

T14 R9, T14 R10, Aroostook County
U.S.G.S. Gardner Pond, Maine (7 1/2')

Surveyed - August, 1961

Maine Department of Inland Fisheries and Wildlife

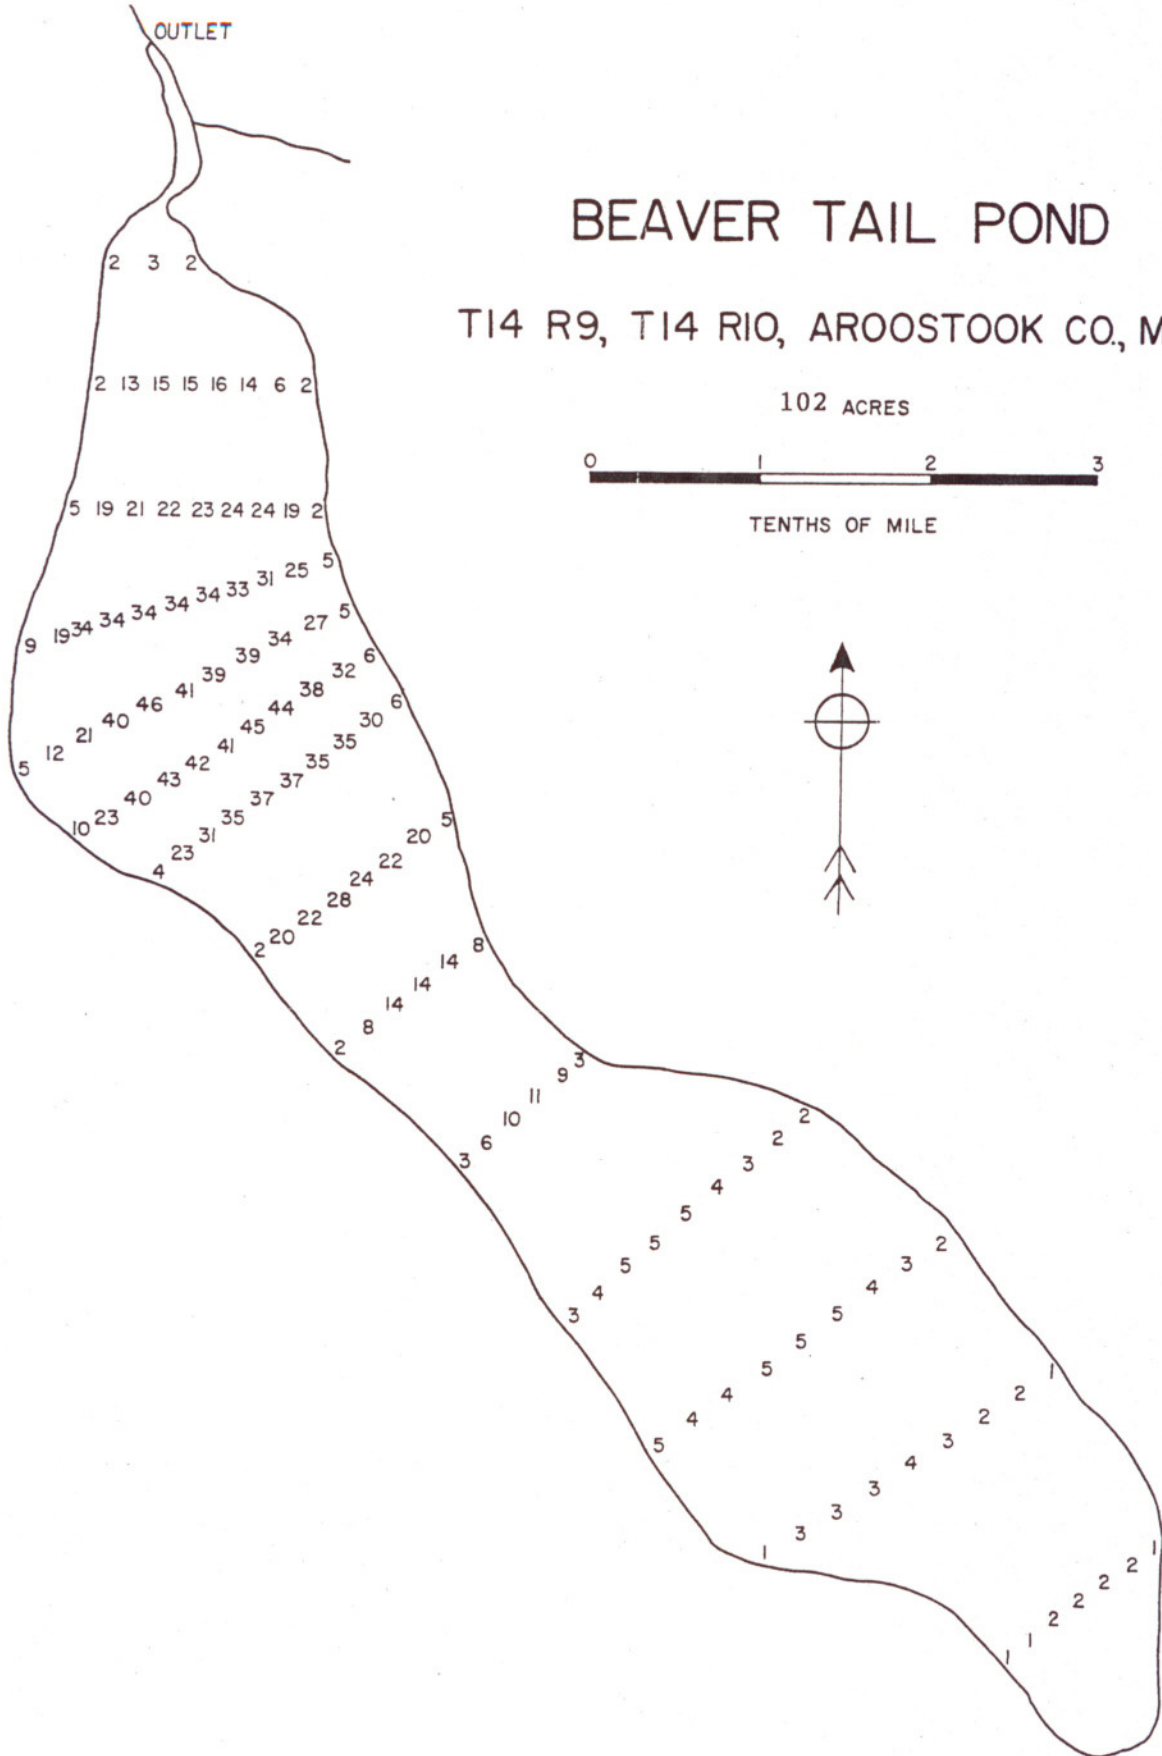
BEAVER TAIL POND

Area - 102 acres	Temperatures
	Surface - 71°F
Maximum depth - 51 feet	45 feet - 45°F

The upper one-third of the pond is shallow with a soft mud bottom. The rest of the pond drops off quickly from shore into deep water which stratifies into warm and cold layers during the summer. Dissolved oxygen is adequate except near bottom in the deepest water during late summer.

There are no true inlets but some spring seepage areas are in evidence along the shore. Trout are often able to utilize such areas and spawn successfully when there are no suitable tributaries.

The outlet, at least for one-half mile below the pond, is considered poor as trout spawning and nursery area. A series of old beaver dams prevents free migration for trout at most water levels and has caused the channel to divide into several smaller, exposed channels.
