ROCKY POND

T3 R11 WELS, Piscataquis Co., U.S.G.S. Rainbow Lake West, Me (7 ½')

Surveyed - August 2000 Maine Department of Inland Fisheries and Wildlife Funded in part by the Federal Aid in Restoration Act under Federal Project F-28-P

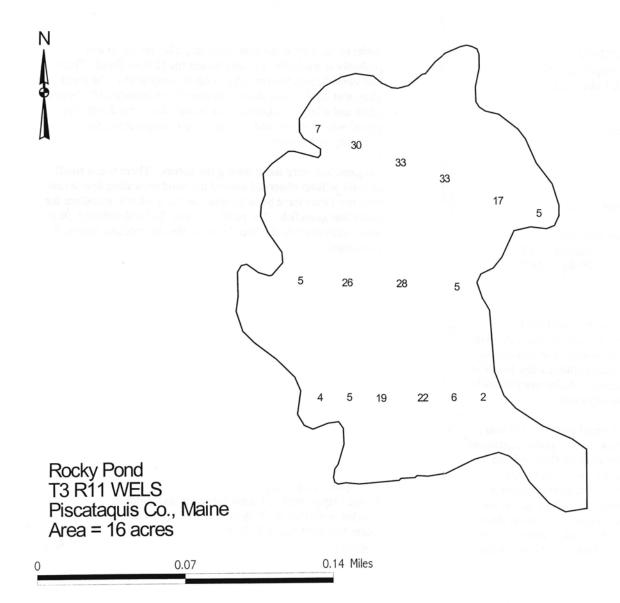
Area - 16 acres Temperatures:

Surface - 72°F 30 feet - 44°F

Maximum depth - 33 feet

The pond is quite deep with just a small area of water less than 10 feet deep. There are small areas of aquatic vegetation primarily near the outlet and in the cove on the southeast shore. There are ledges along the east shore and large granite boulders are scattered around the entire shoreline. The surrounding forest is predominantly softwood. At the time of the survey, the outlet was choked with beaver dams and there was no outflow. The outlet is silty with rocks and scattered boulders. No gravel was observed. Although the outlet is not very steep near the pond, it is very steep and probably impassable as it approaches the Golden Road. There was considerable beaver activity on the only inlet to the pond. This inlet on the west shore was completely inundated by beaver dams and a large backwater area existed above the dams. No gravel was observed and this inlet offers no potential for spawning at this time.
