MISERY POND
T2 R7, Somerset Co.
U.S.G.S. Brassua Lake, Me.

Surveyed - August 1964

MISERY POND

T2 R7, SOMERSET CO., MAINE

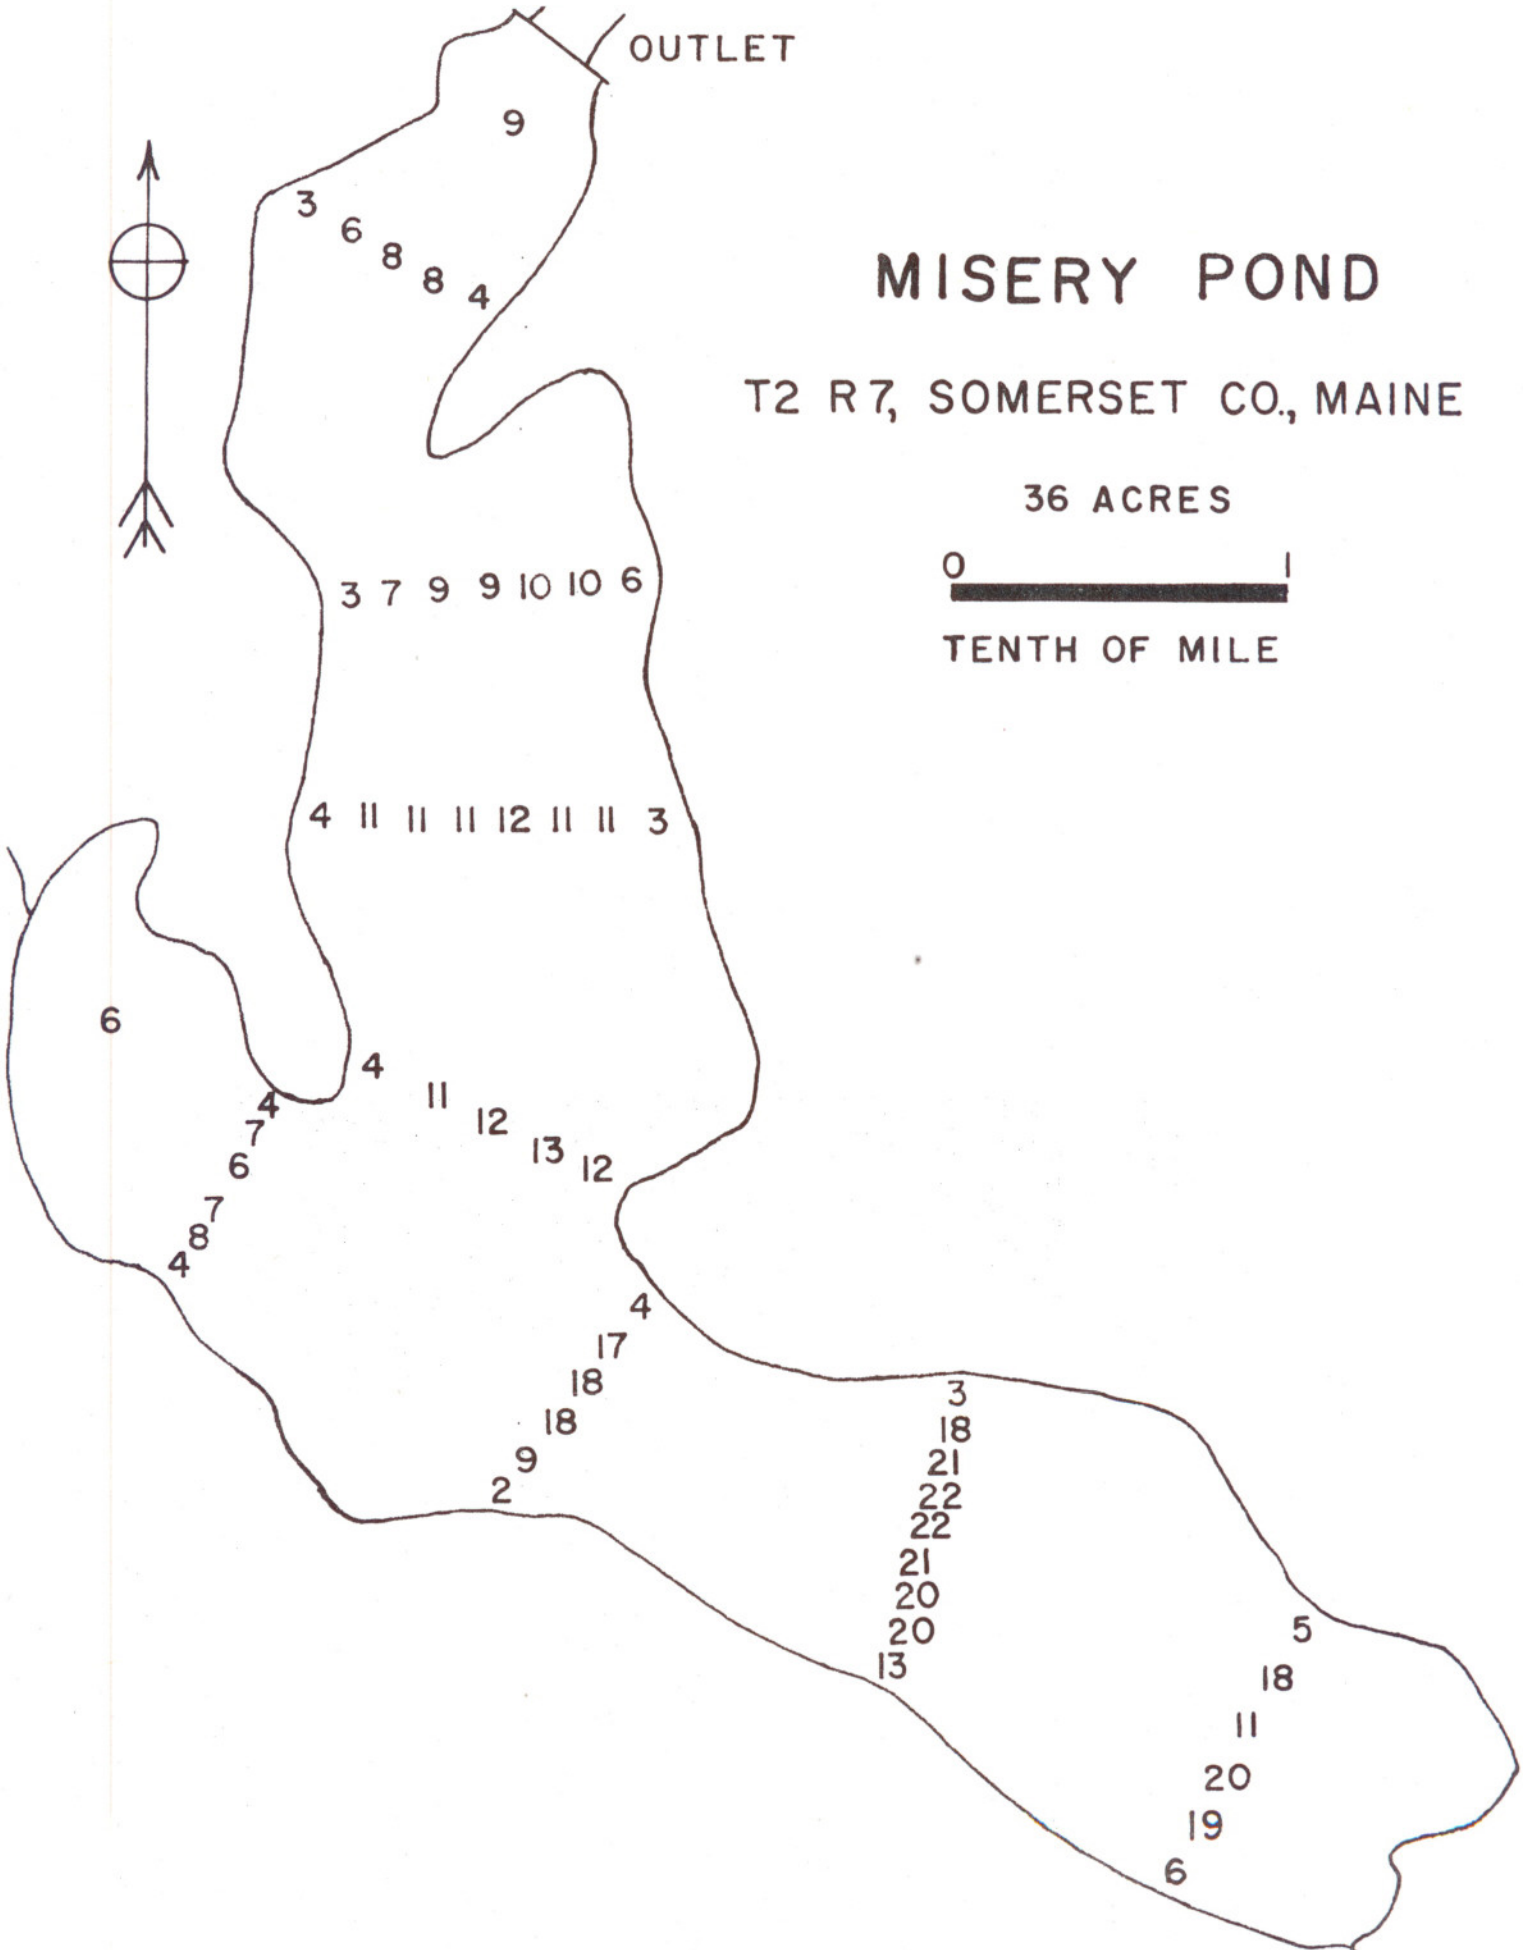
OUTLET

36 ACRES

Area - 36 acres

Maximum depth - 22 feet
