# PHOTOSIMULATION 13: MOXIE POND - North, East Moxie Twp

**PHOTOSIMULATION 13A: MOXIE POND - North, East Moxie Twp**

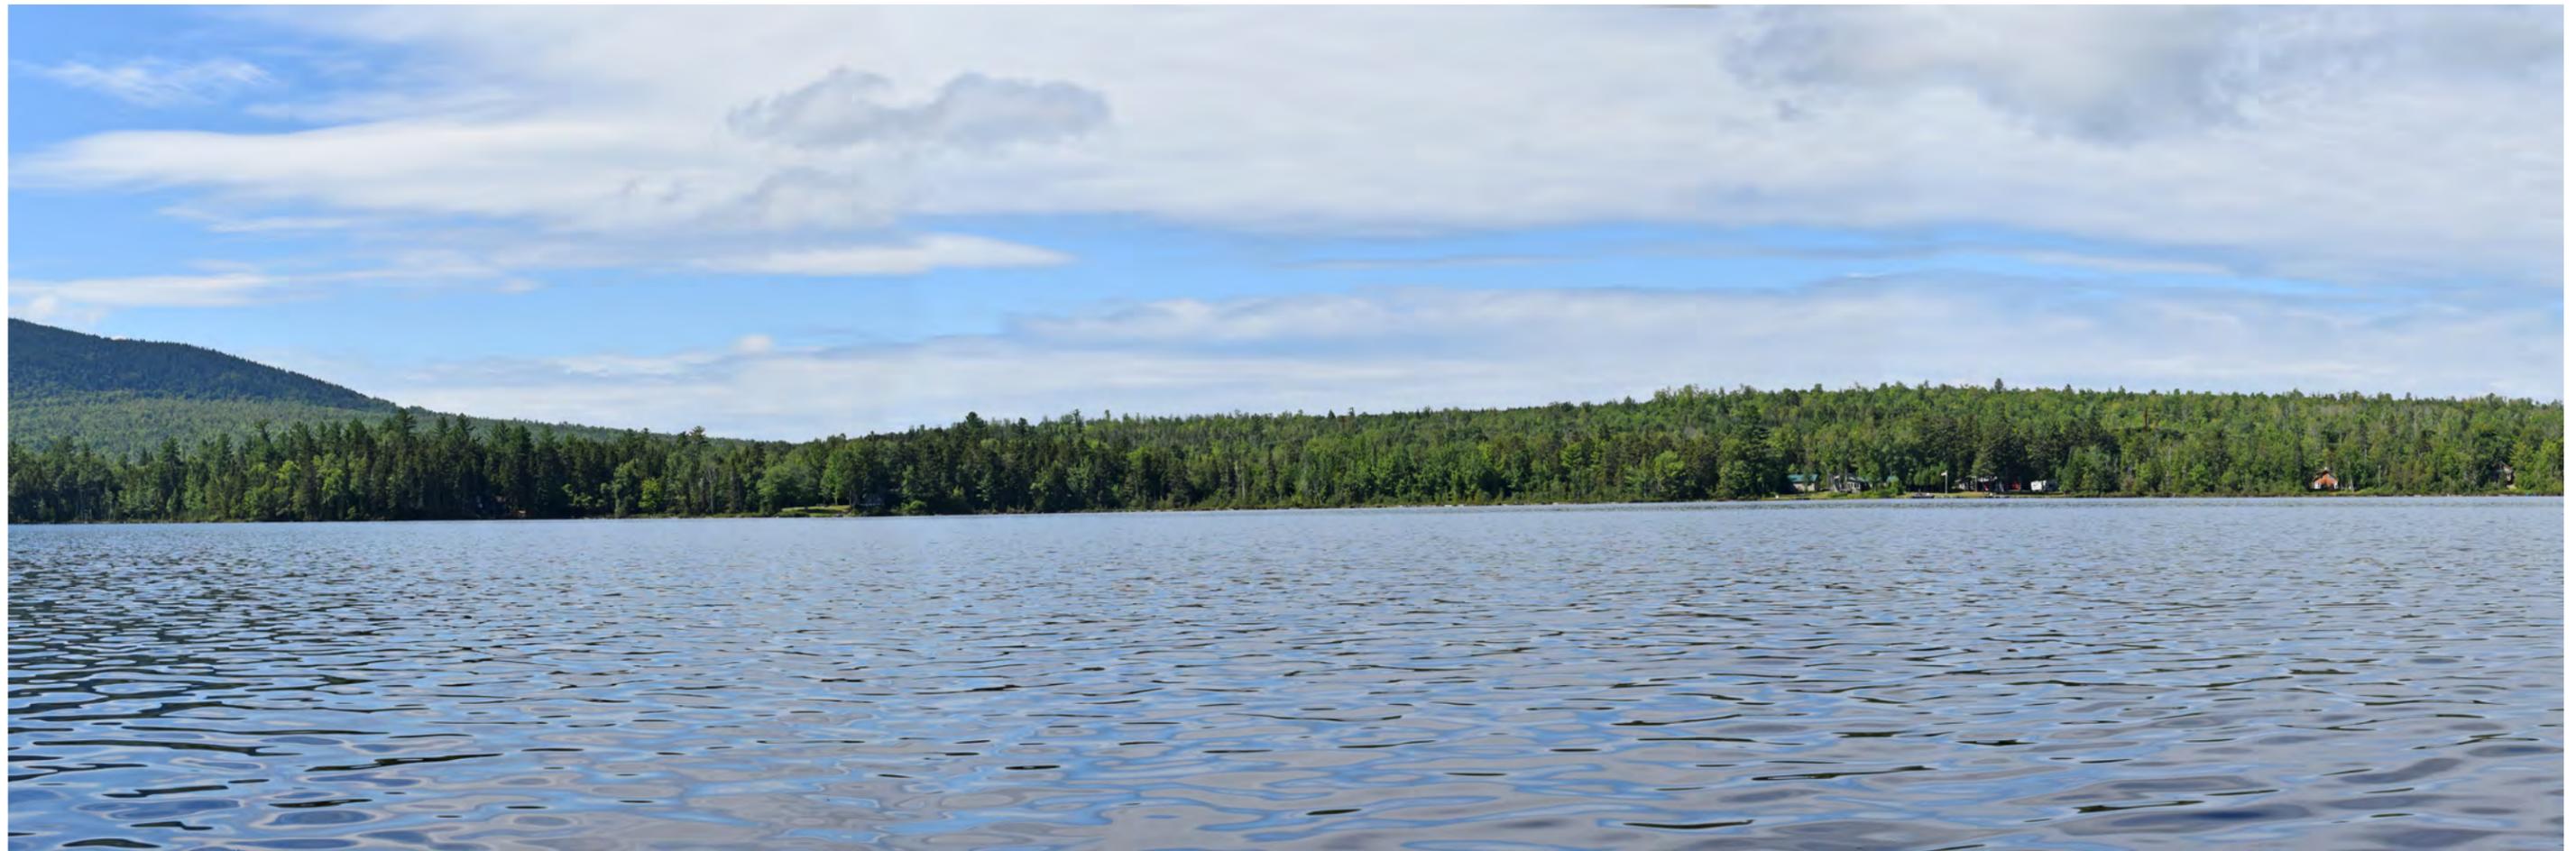
**Proposed Conditions:** Panoramic view looking southwest to west from the northern end of Moxie Pond toward the proposed co-located HVDC transmission line. The existing 150' wide corridor clearing will be widened by 75' on the western side to accommodate the new transmission line. Three structures and conductors will be visible at distances of 2,400 to 2,900 feet from this viewpoint. Moxie Pond is a designated scenic resource with a 'Outstanding' rating in the [Maine Wildlands Lake Assessment](#). See Appendix B: Study Area Photographs for images.

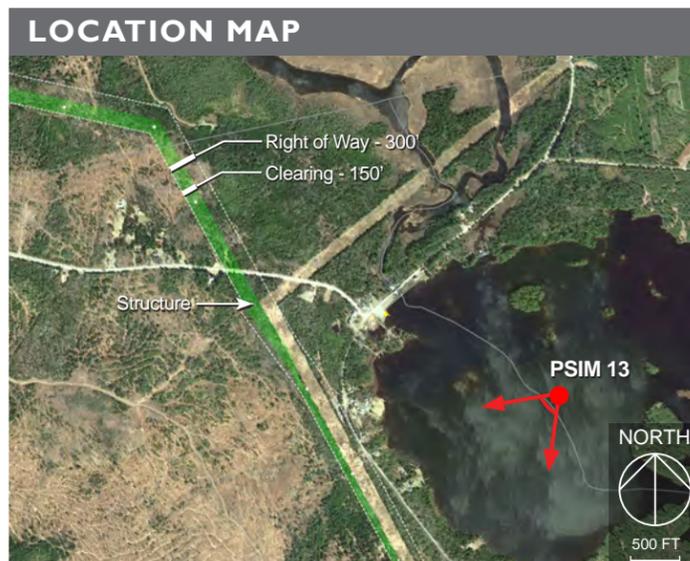
Typical Cross Section	Photograph / Photosimulation Information
	Location
	Viewing Direction
	Horizontal Angle of View
	Date and Time
	Camera Focal Length
	Camera Make/Model
	Photo Source
	Proposed Structures Visible
	Approximate Distance to Nearest Visible Structure

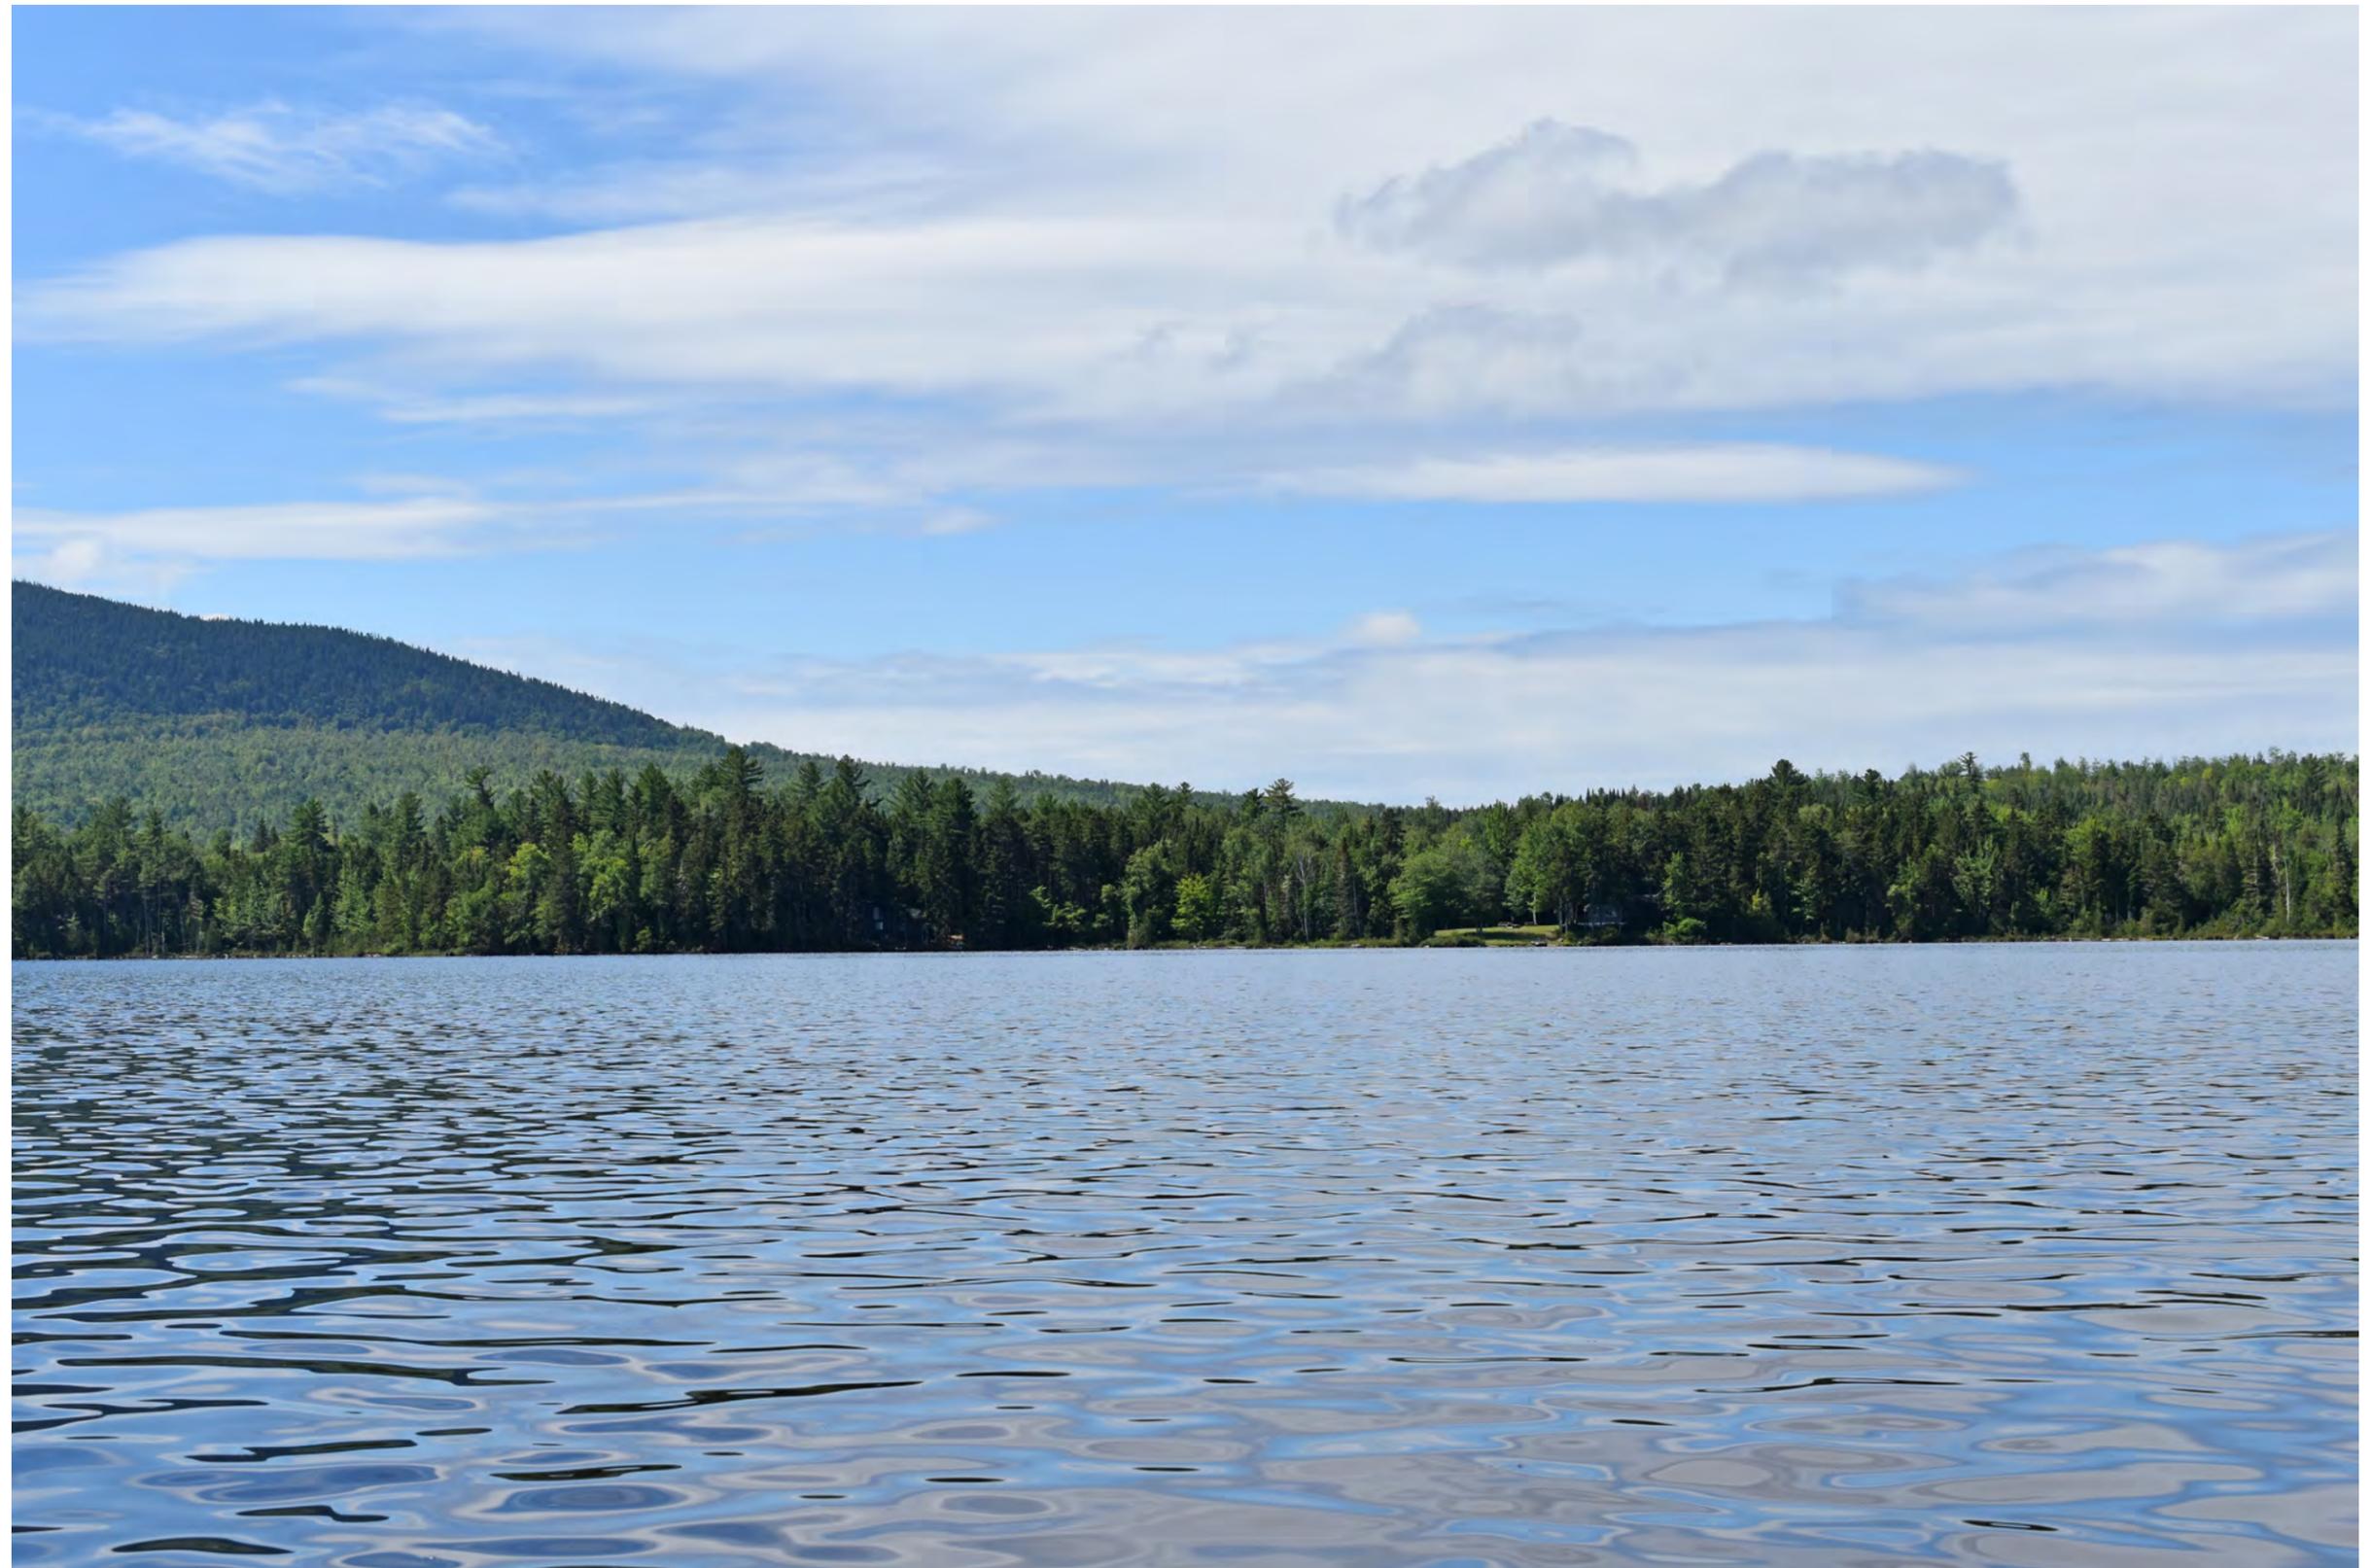
**Existing Conditions:** Normal view looking southwest from the northern area of Moxie Pond toward existing 115 kV transmission line. Mosquito Mountain is visible on the left side of the image.

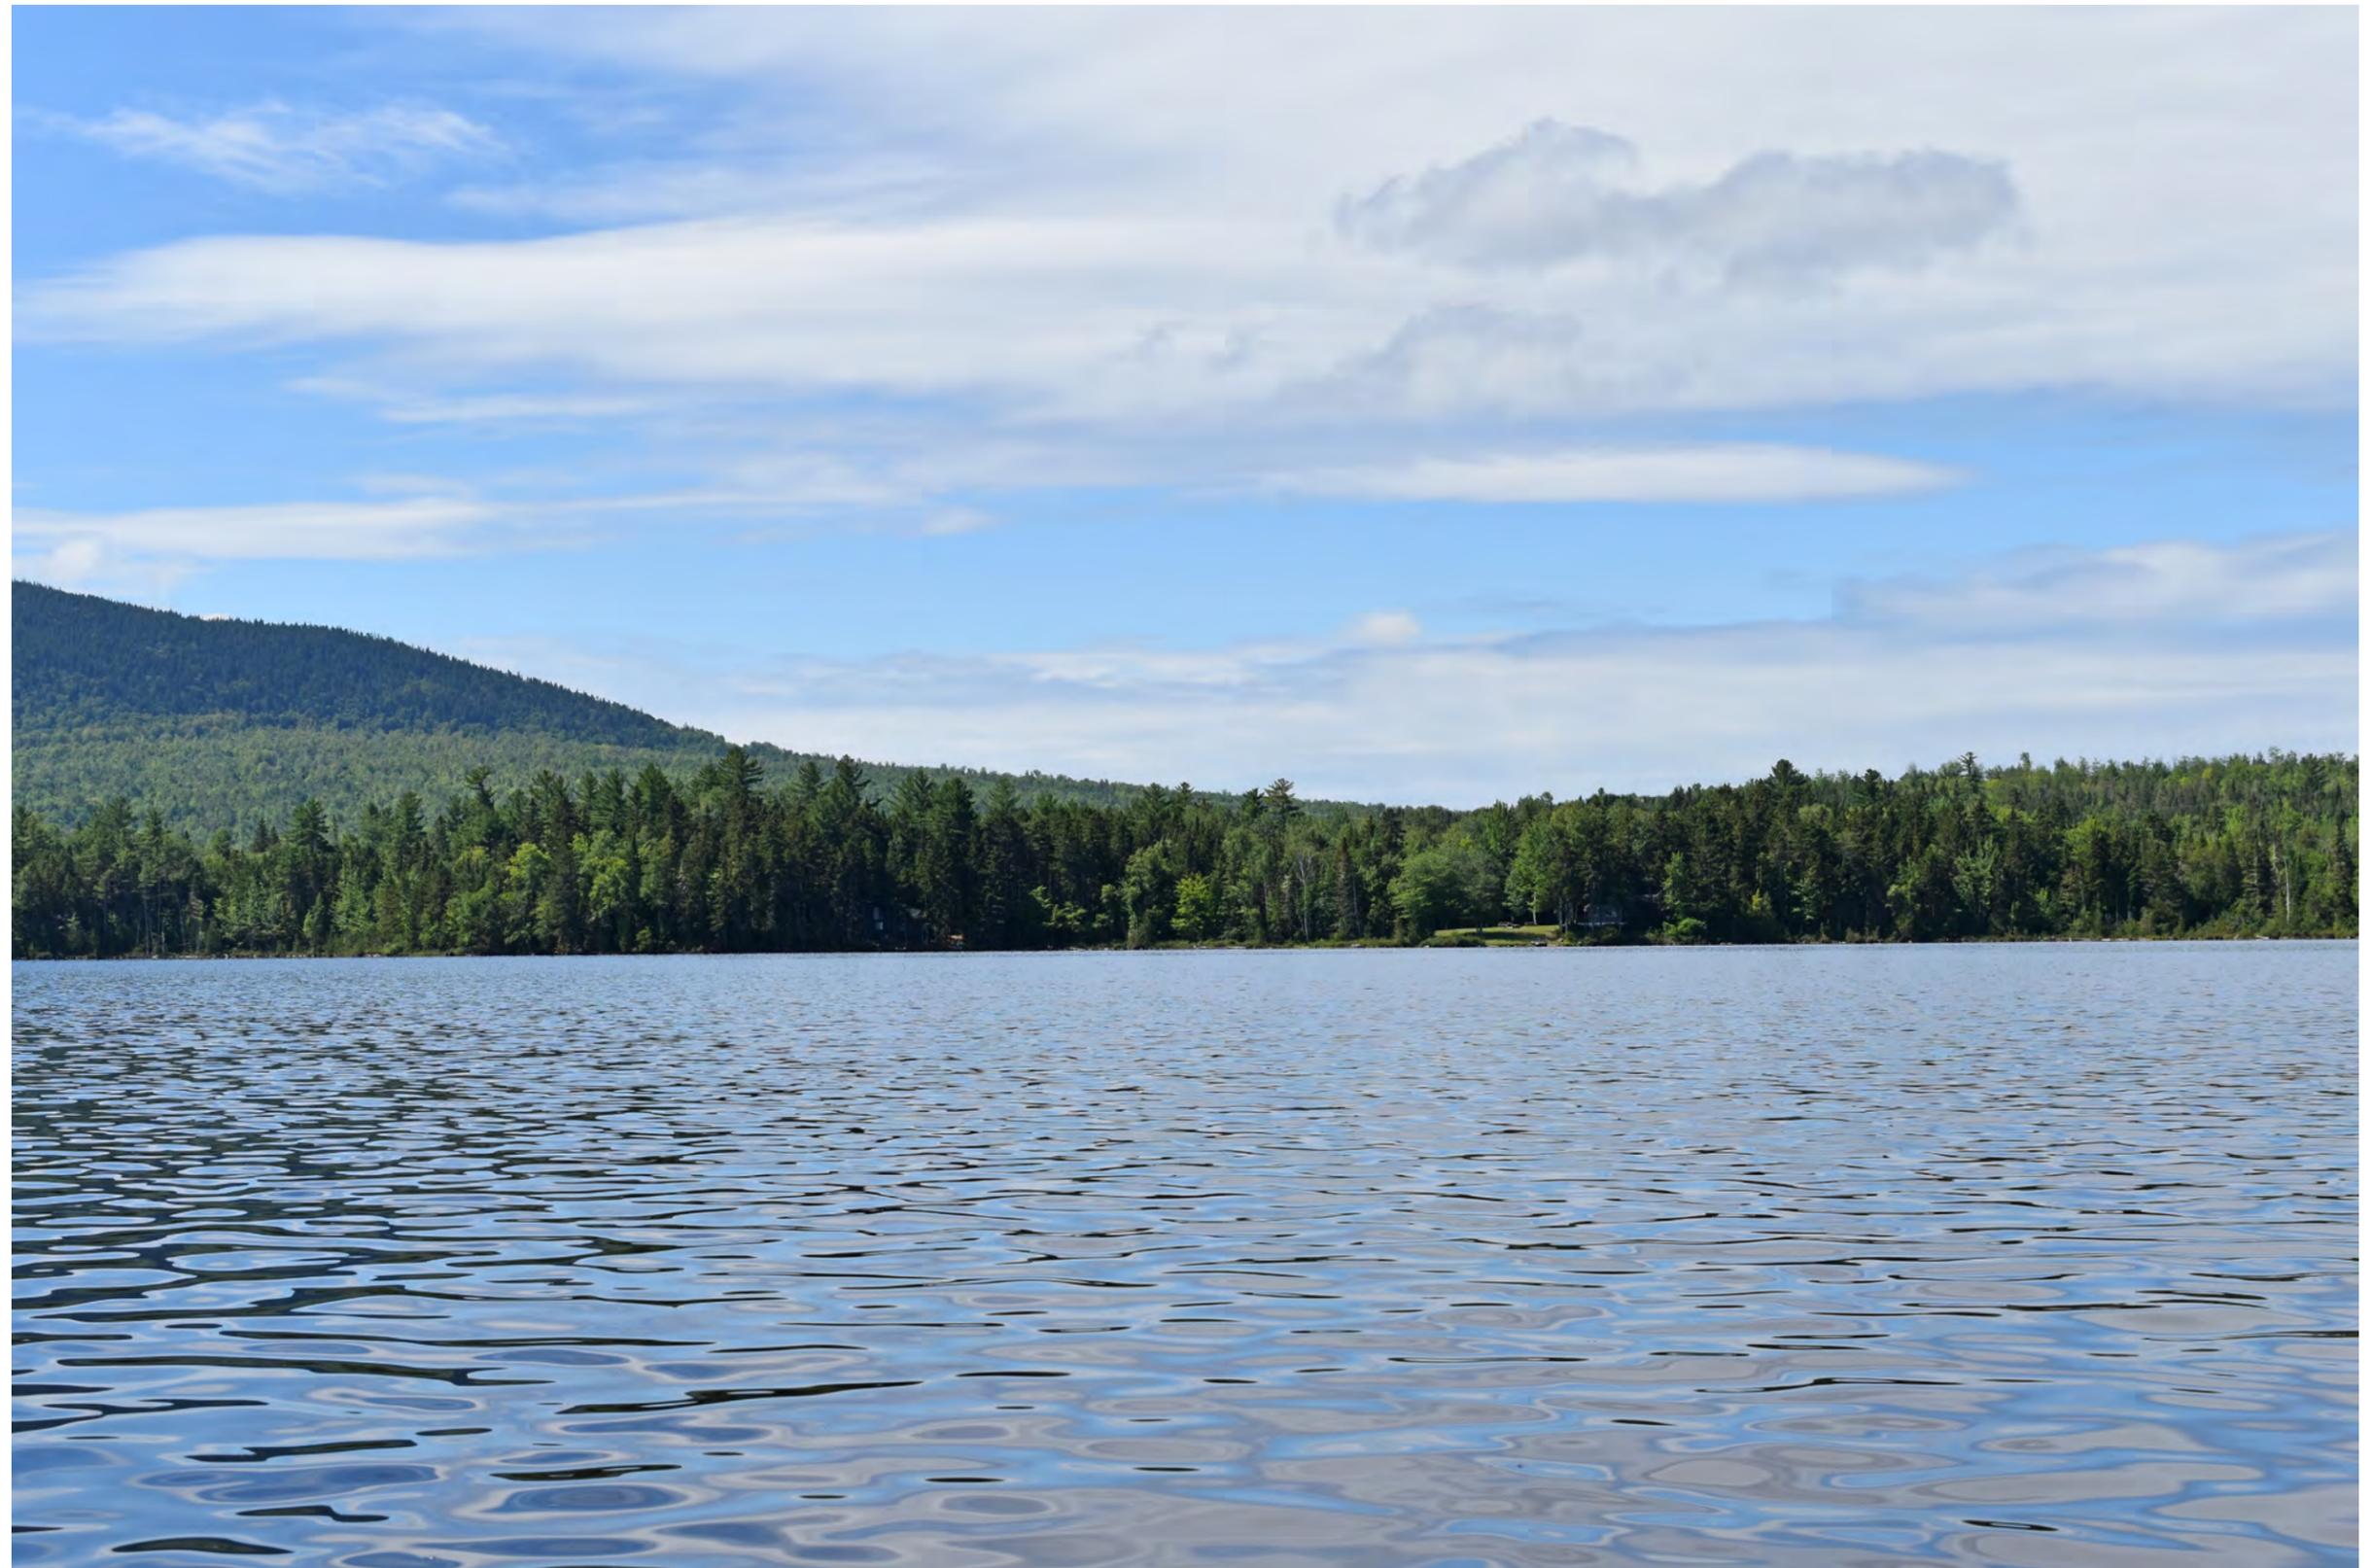
**PHOTOSIMULATION 13A: MOXIE POND - North, East Moxie Twp**

**Proposed Conditions:** Normal view looking southwest from the northern area of Moxie Pond toward the proposed co-located HVDC transmission line. One structure and conductors will be visible from this viewpoint at a distance of 2,900 feet. The existing 150' wide corridor clearing will be widened by 75' on the western side to accommodate the new transmission line.

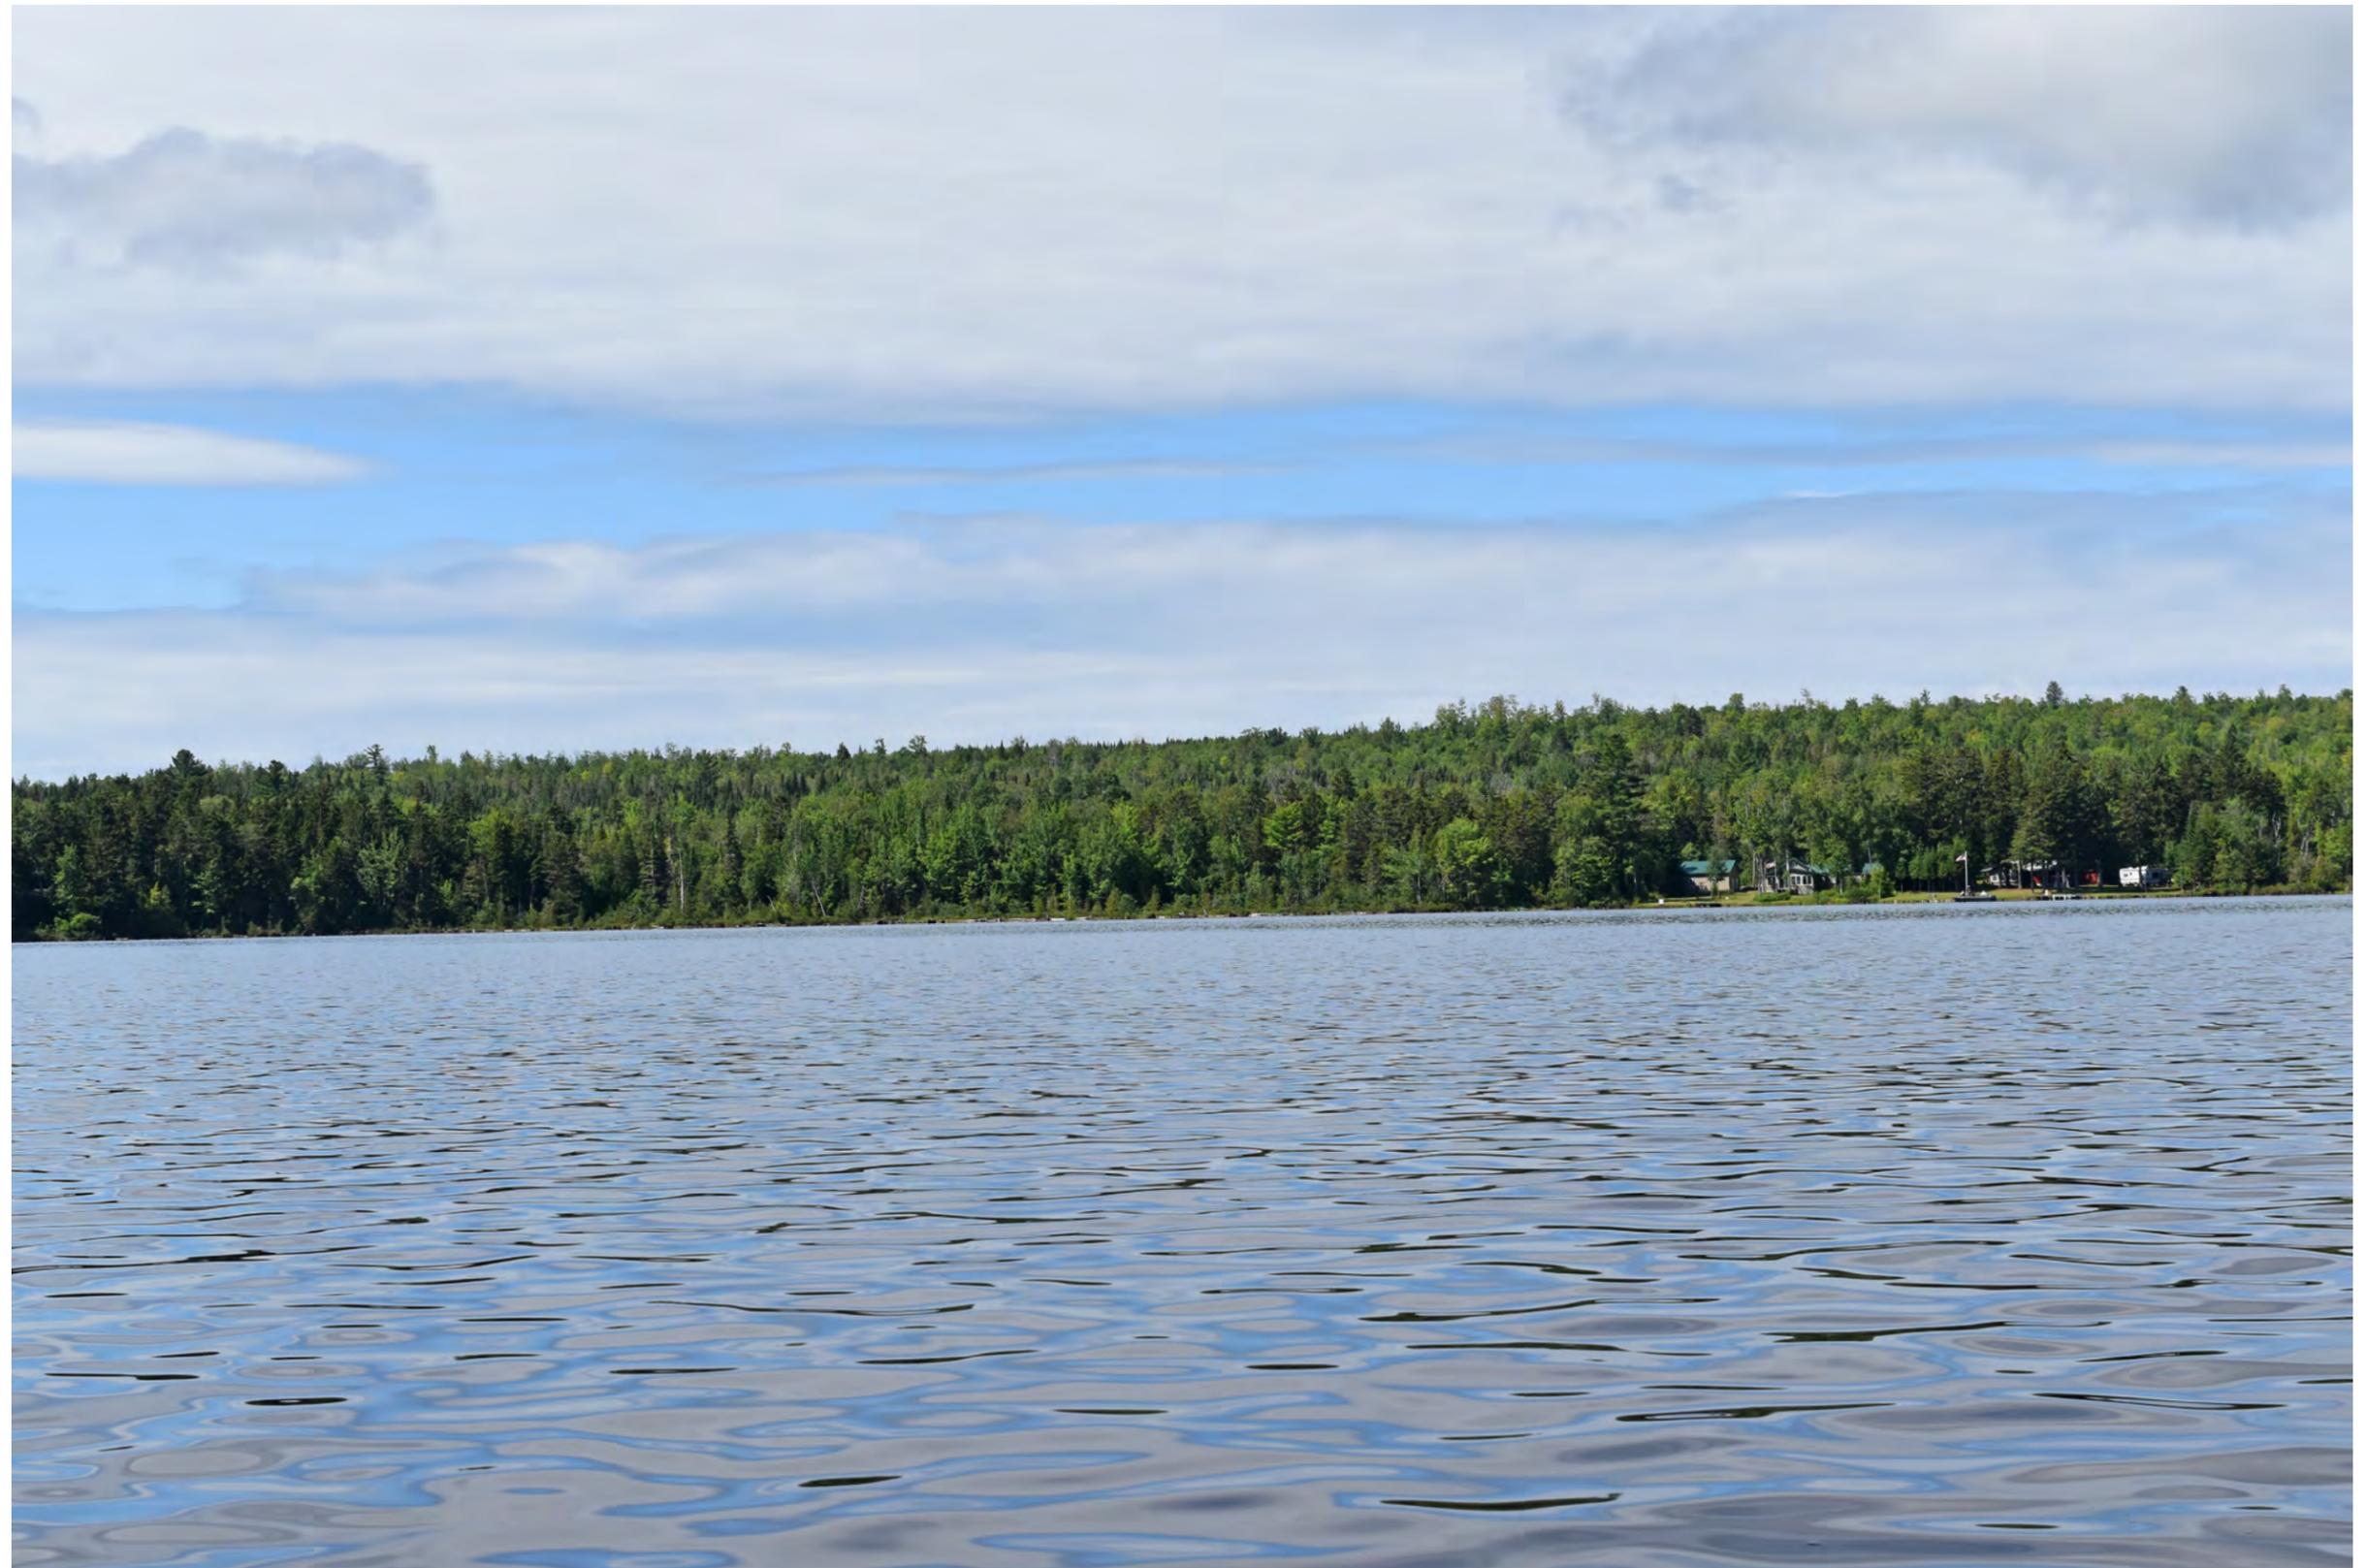
**PHOTOSIMULATION 13B: MOXIE POND - North, East Moxie Twp**

**Existing Conditions:** Normal view looking southwest from the northern area of Moxie Pond toward existing 115 kV transmission line.

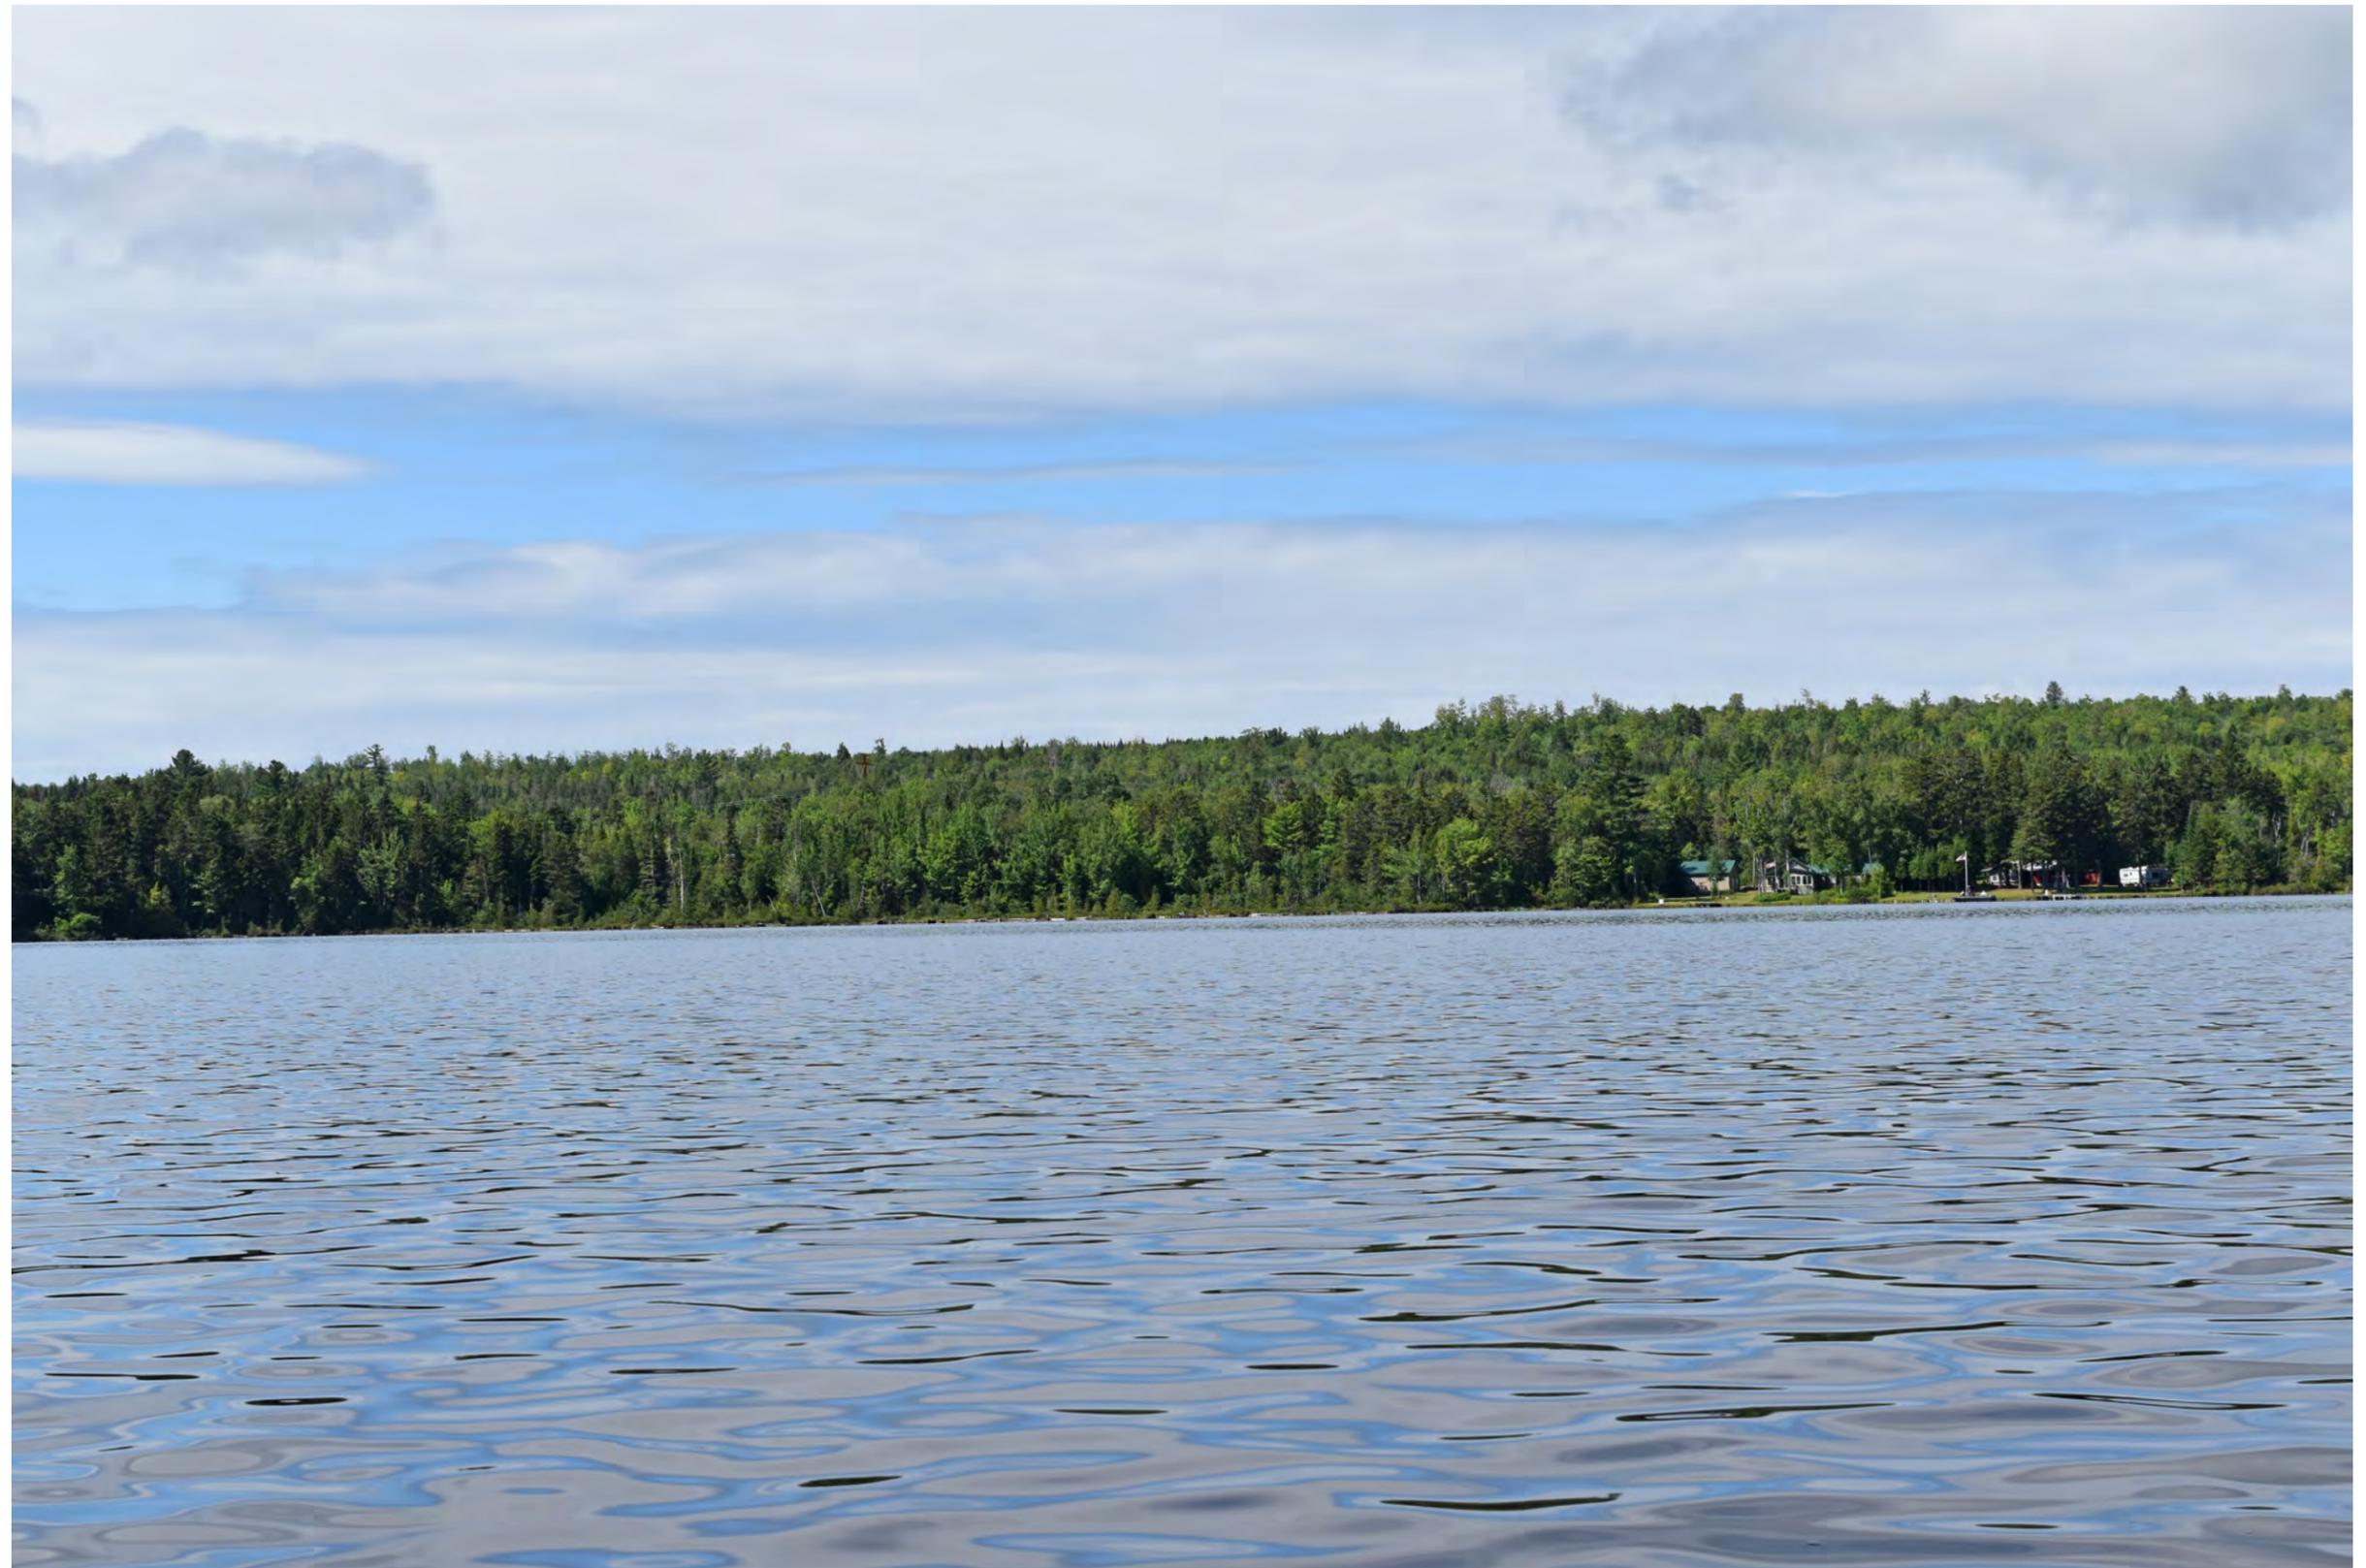
**PHOTOSIMULATION 13B: MOXIE POND - North, East Moxie Twp**

**Proposed Conditions:** Normal view looking southwest from the northern area of Moxie Pond toward the proposed co-located HVDC transmission line. One structure and conductors will be visible from this viewpoint at a distance of 2,400 feet. The existing 150' wide corridor clearing will be widened by 75' on the western side to accommodate the new transmission line.

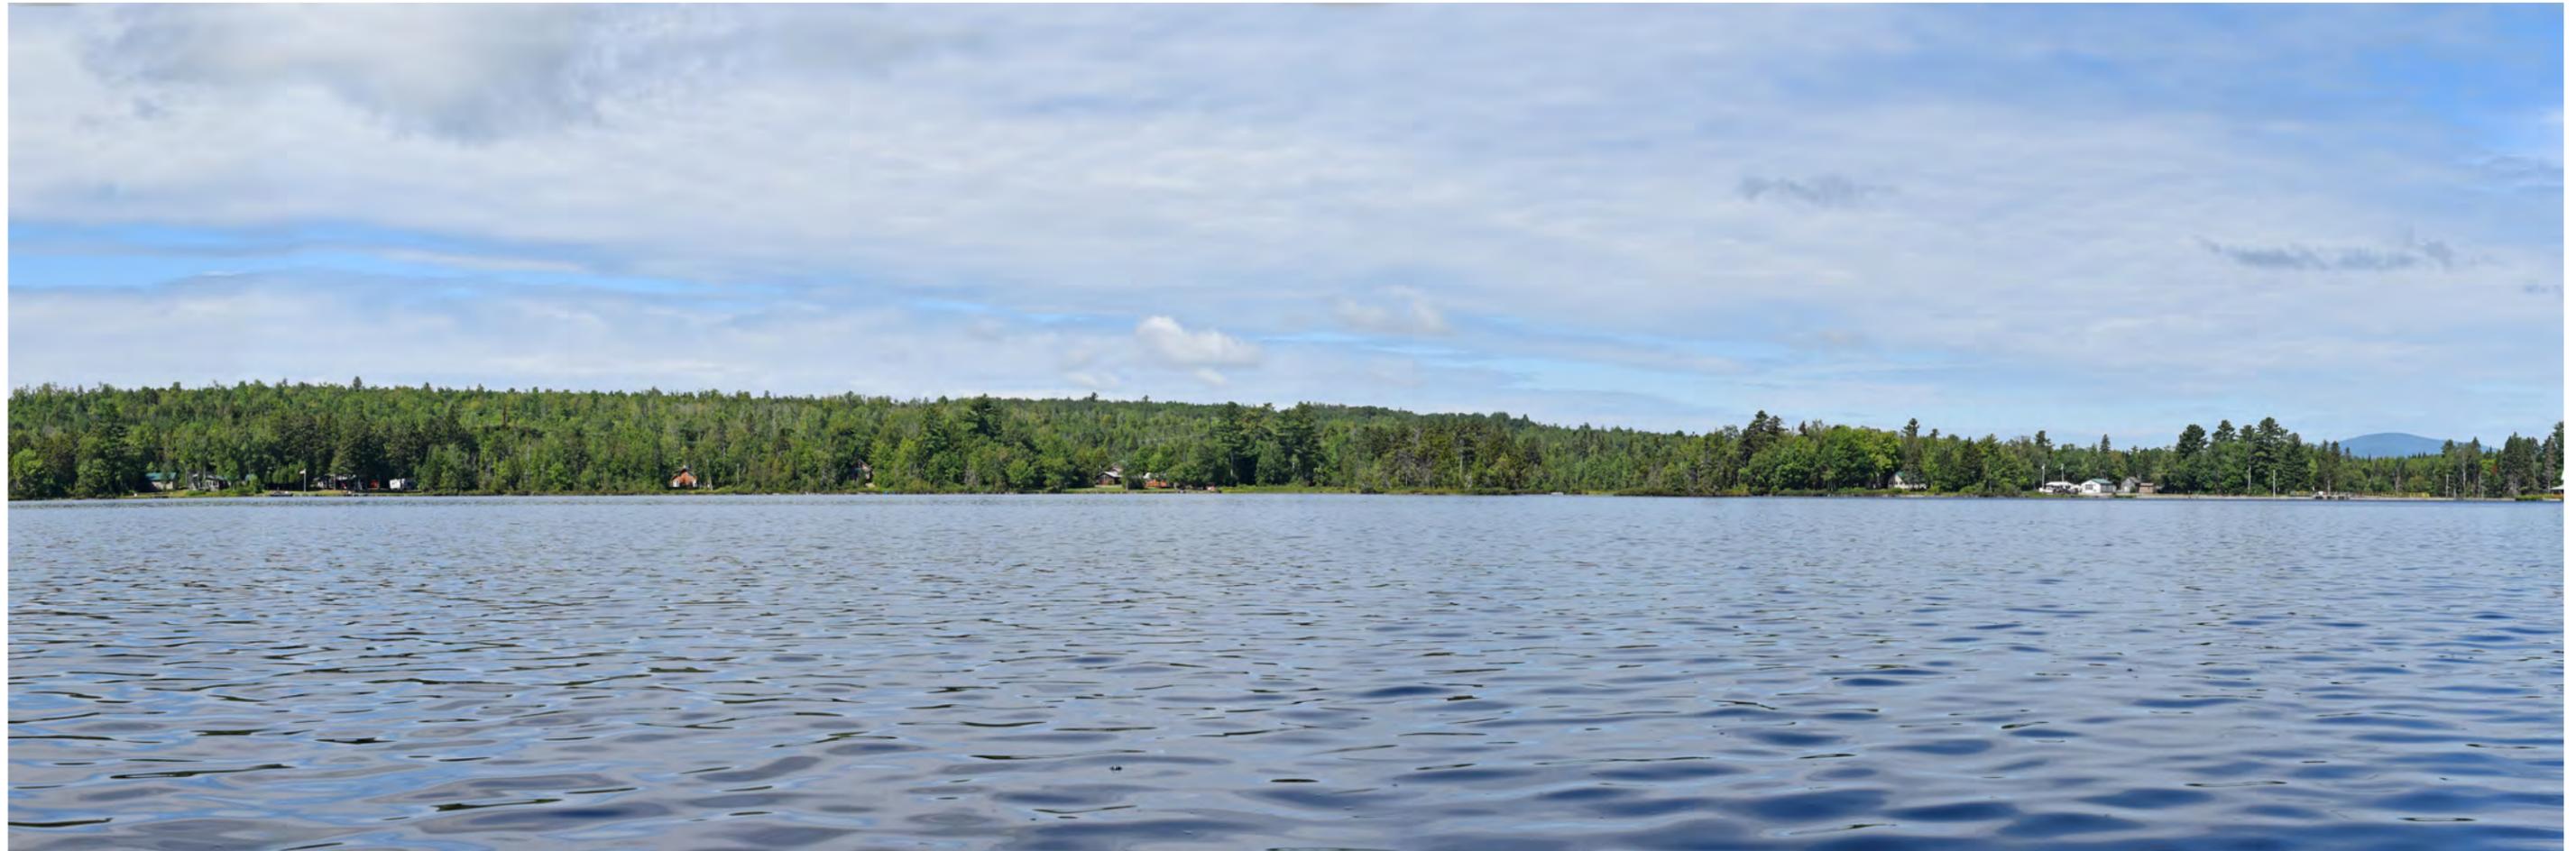
# PHOTOSIMULATION 14: MOXIE POND - North, East Moxie Twp

**Proposed Conditions:** Panoramic view looking west to northwest from the northern end of Moxie Pond toward the proposed co-located HVDC transmission line. The existing 150' wide corridor clearing will be widened by 75' on the western side to accommodate the new transmission line. Three structures and conductors will be visible at distances of 2,400 to 4,200 feet from this viewpoint. Moxie Pond is a designated scenic resource with a 'Outstanding' rating in the [Maine Wildlands Lake Assessment](#). See Appendix B: Study Area Photographs for images.

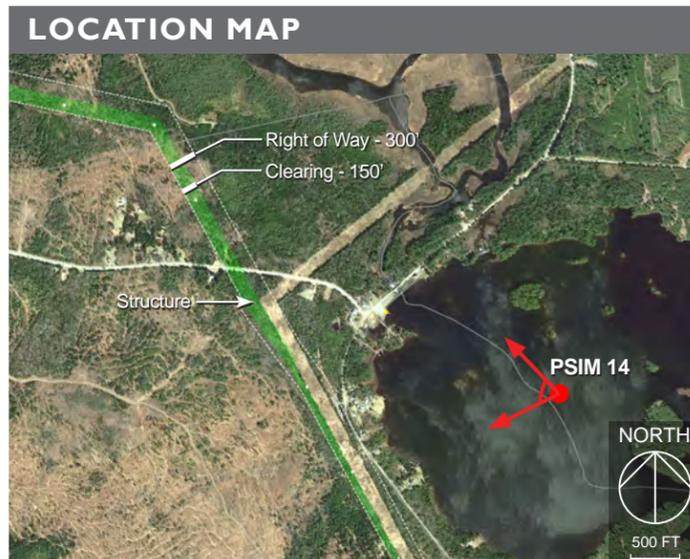
TECHNICAL INFORMATION																			
<b>Typical Cross Section</b>	<b>Photograph / Photosimulation Information</b>																		
<p>EXISTING 115 kV TYP. 45'</p> <p>PROPOSED HVDC TYP. 100'</p> <p>75' 75' 75' CLEARED 150'</p> <p>300'</p> <p>LIMIT R.O.W. TYPICAL VIEW LOOKING SOUTH LIMIT R.O.W.</p>
