# PHOTOSIMULATION 13: MOXIE POND - North, East Moxie Twp

**PHOTOSIMULATION 13A: MOXIE POND - North, East Moxie Twp**

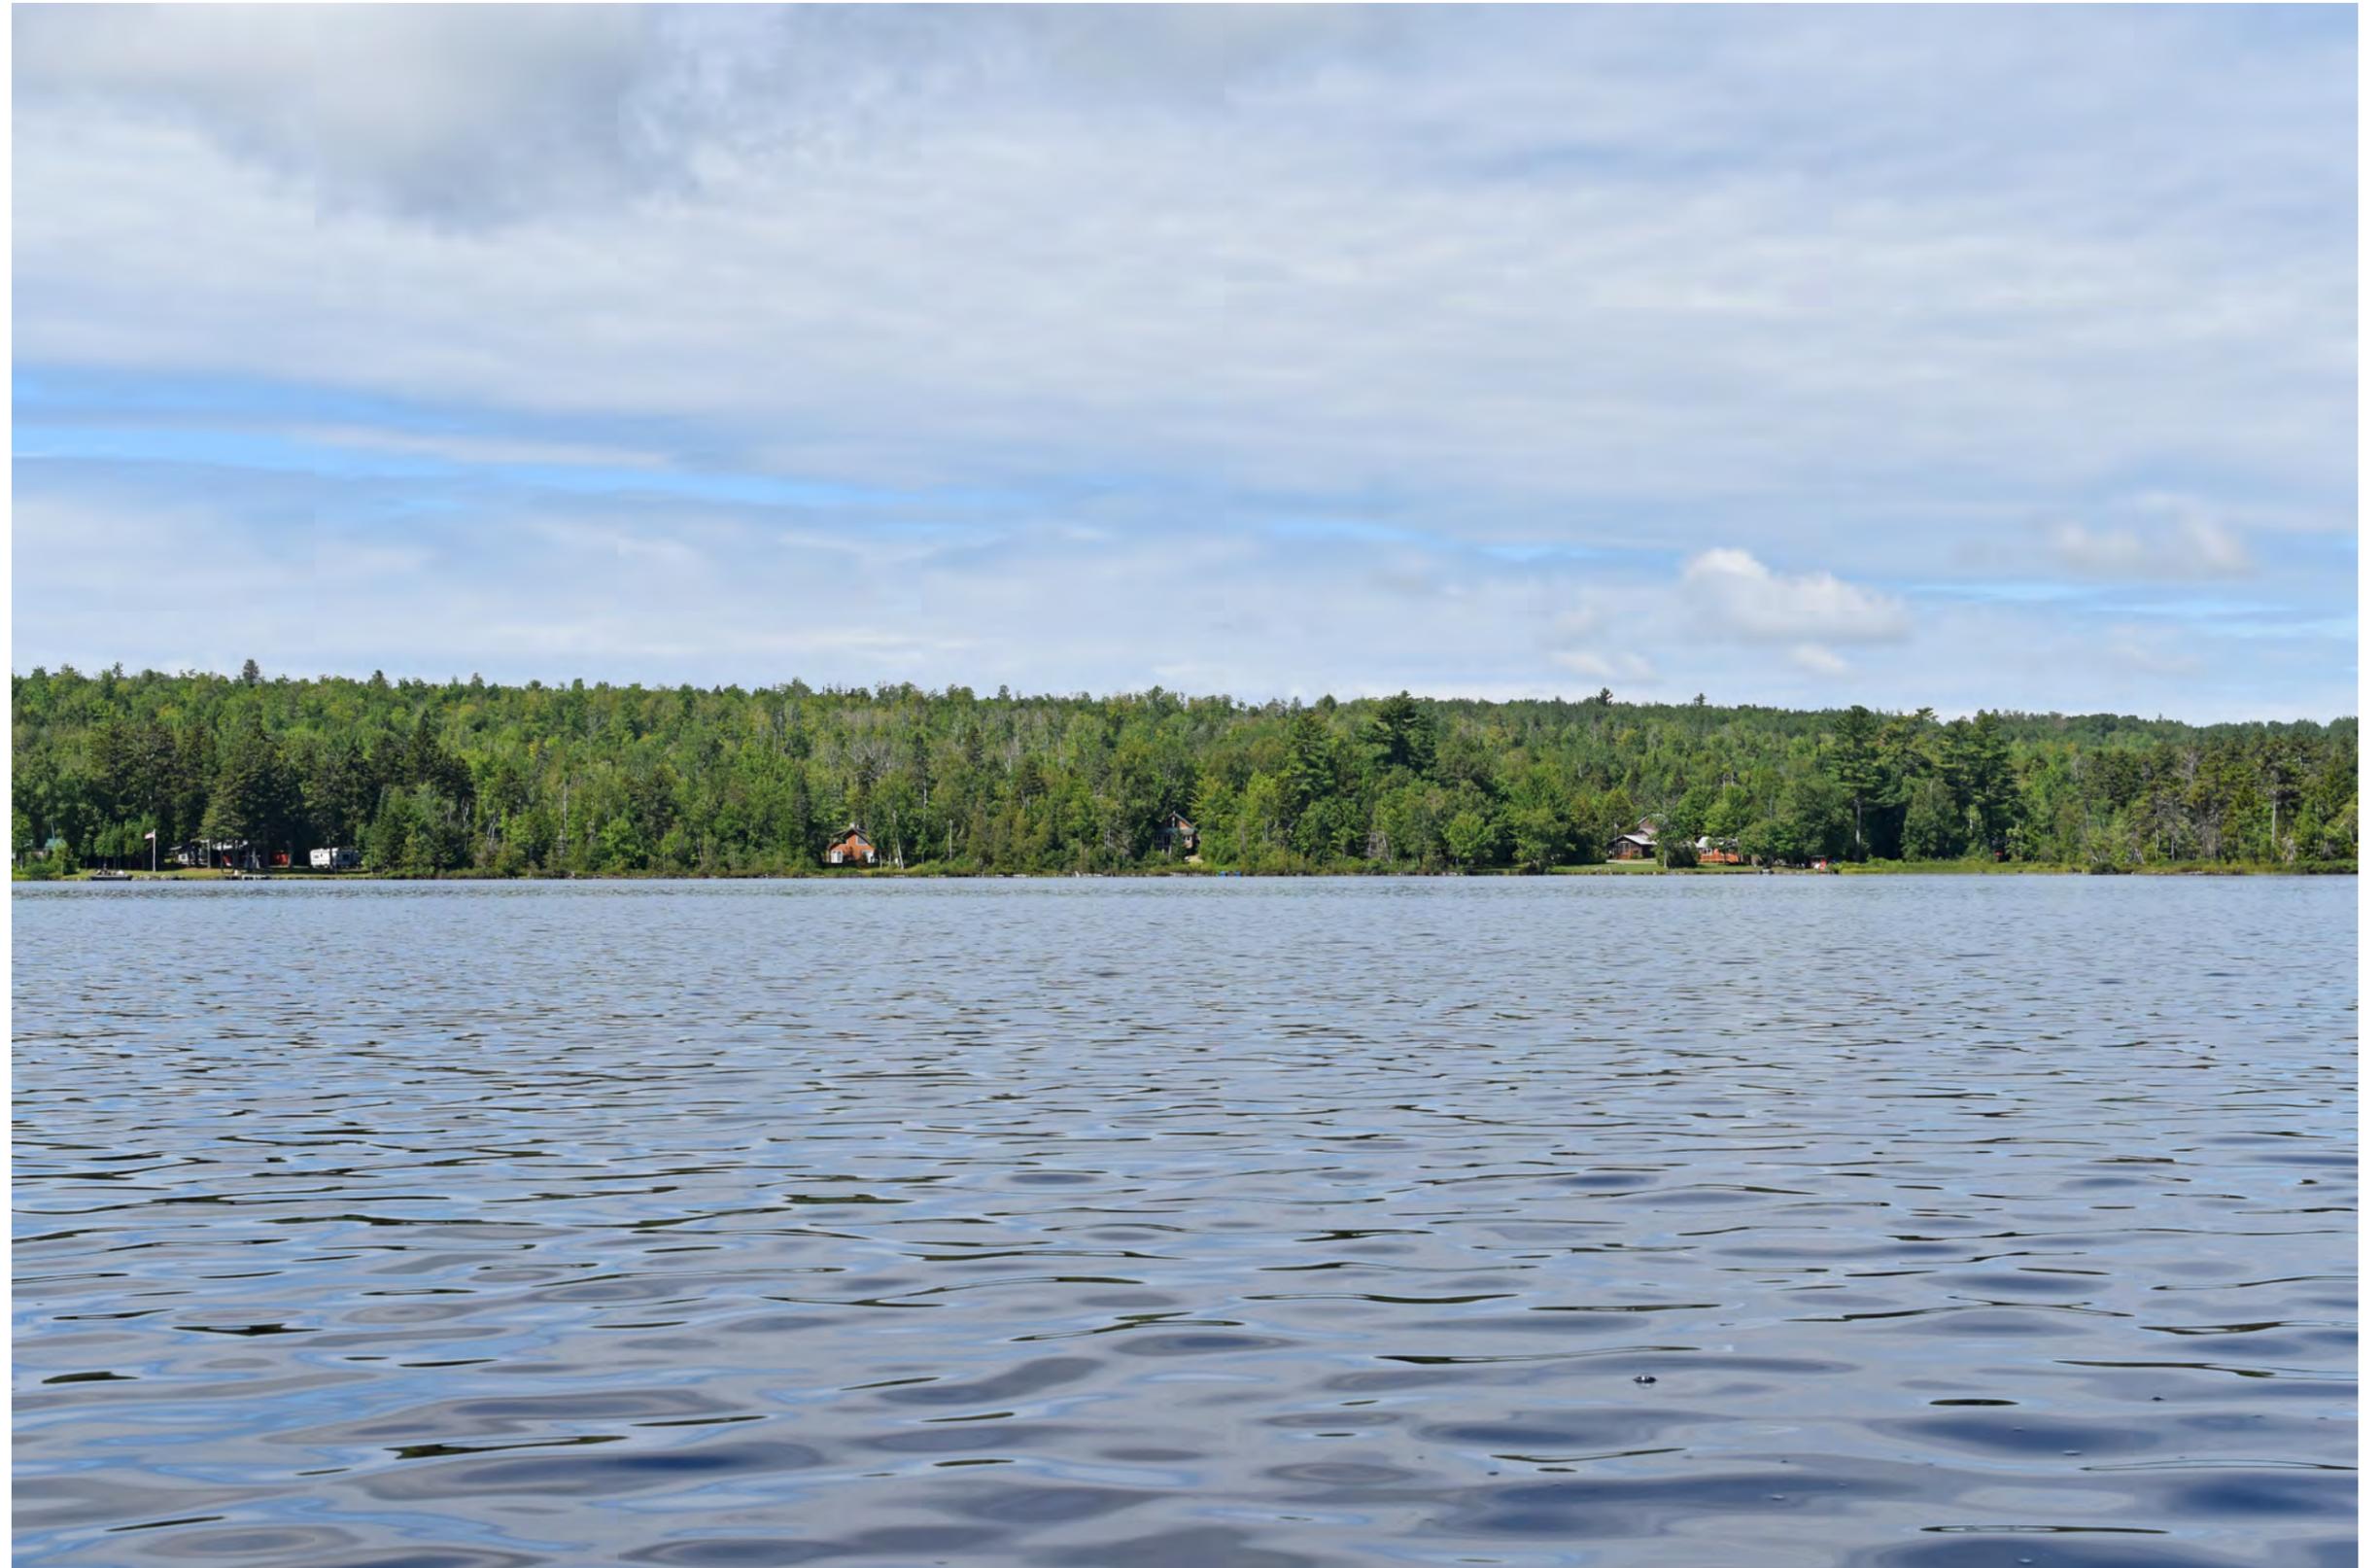
**PHOTOSIMULATION I 4A: MOXIE POND - North, East Moxie Twp**

**Existing Conditions:** Normal view looking west from the northern area of Moxie Pond. The existing 115 kV transmission line is screened by vegetation.

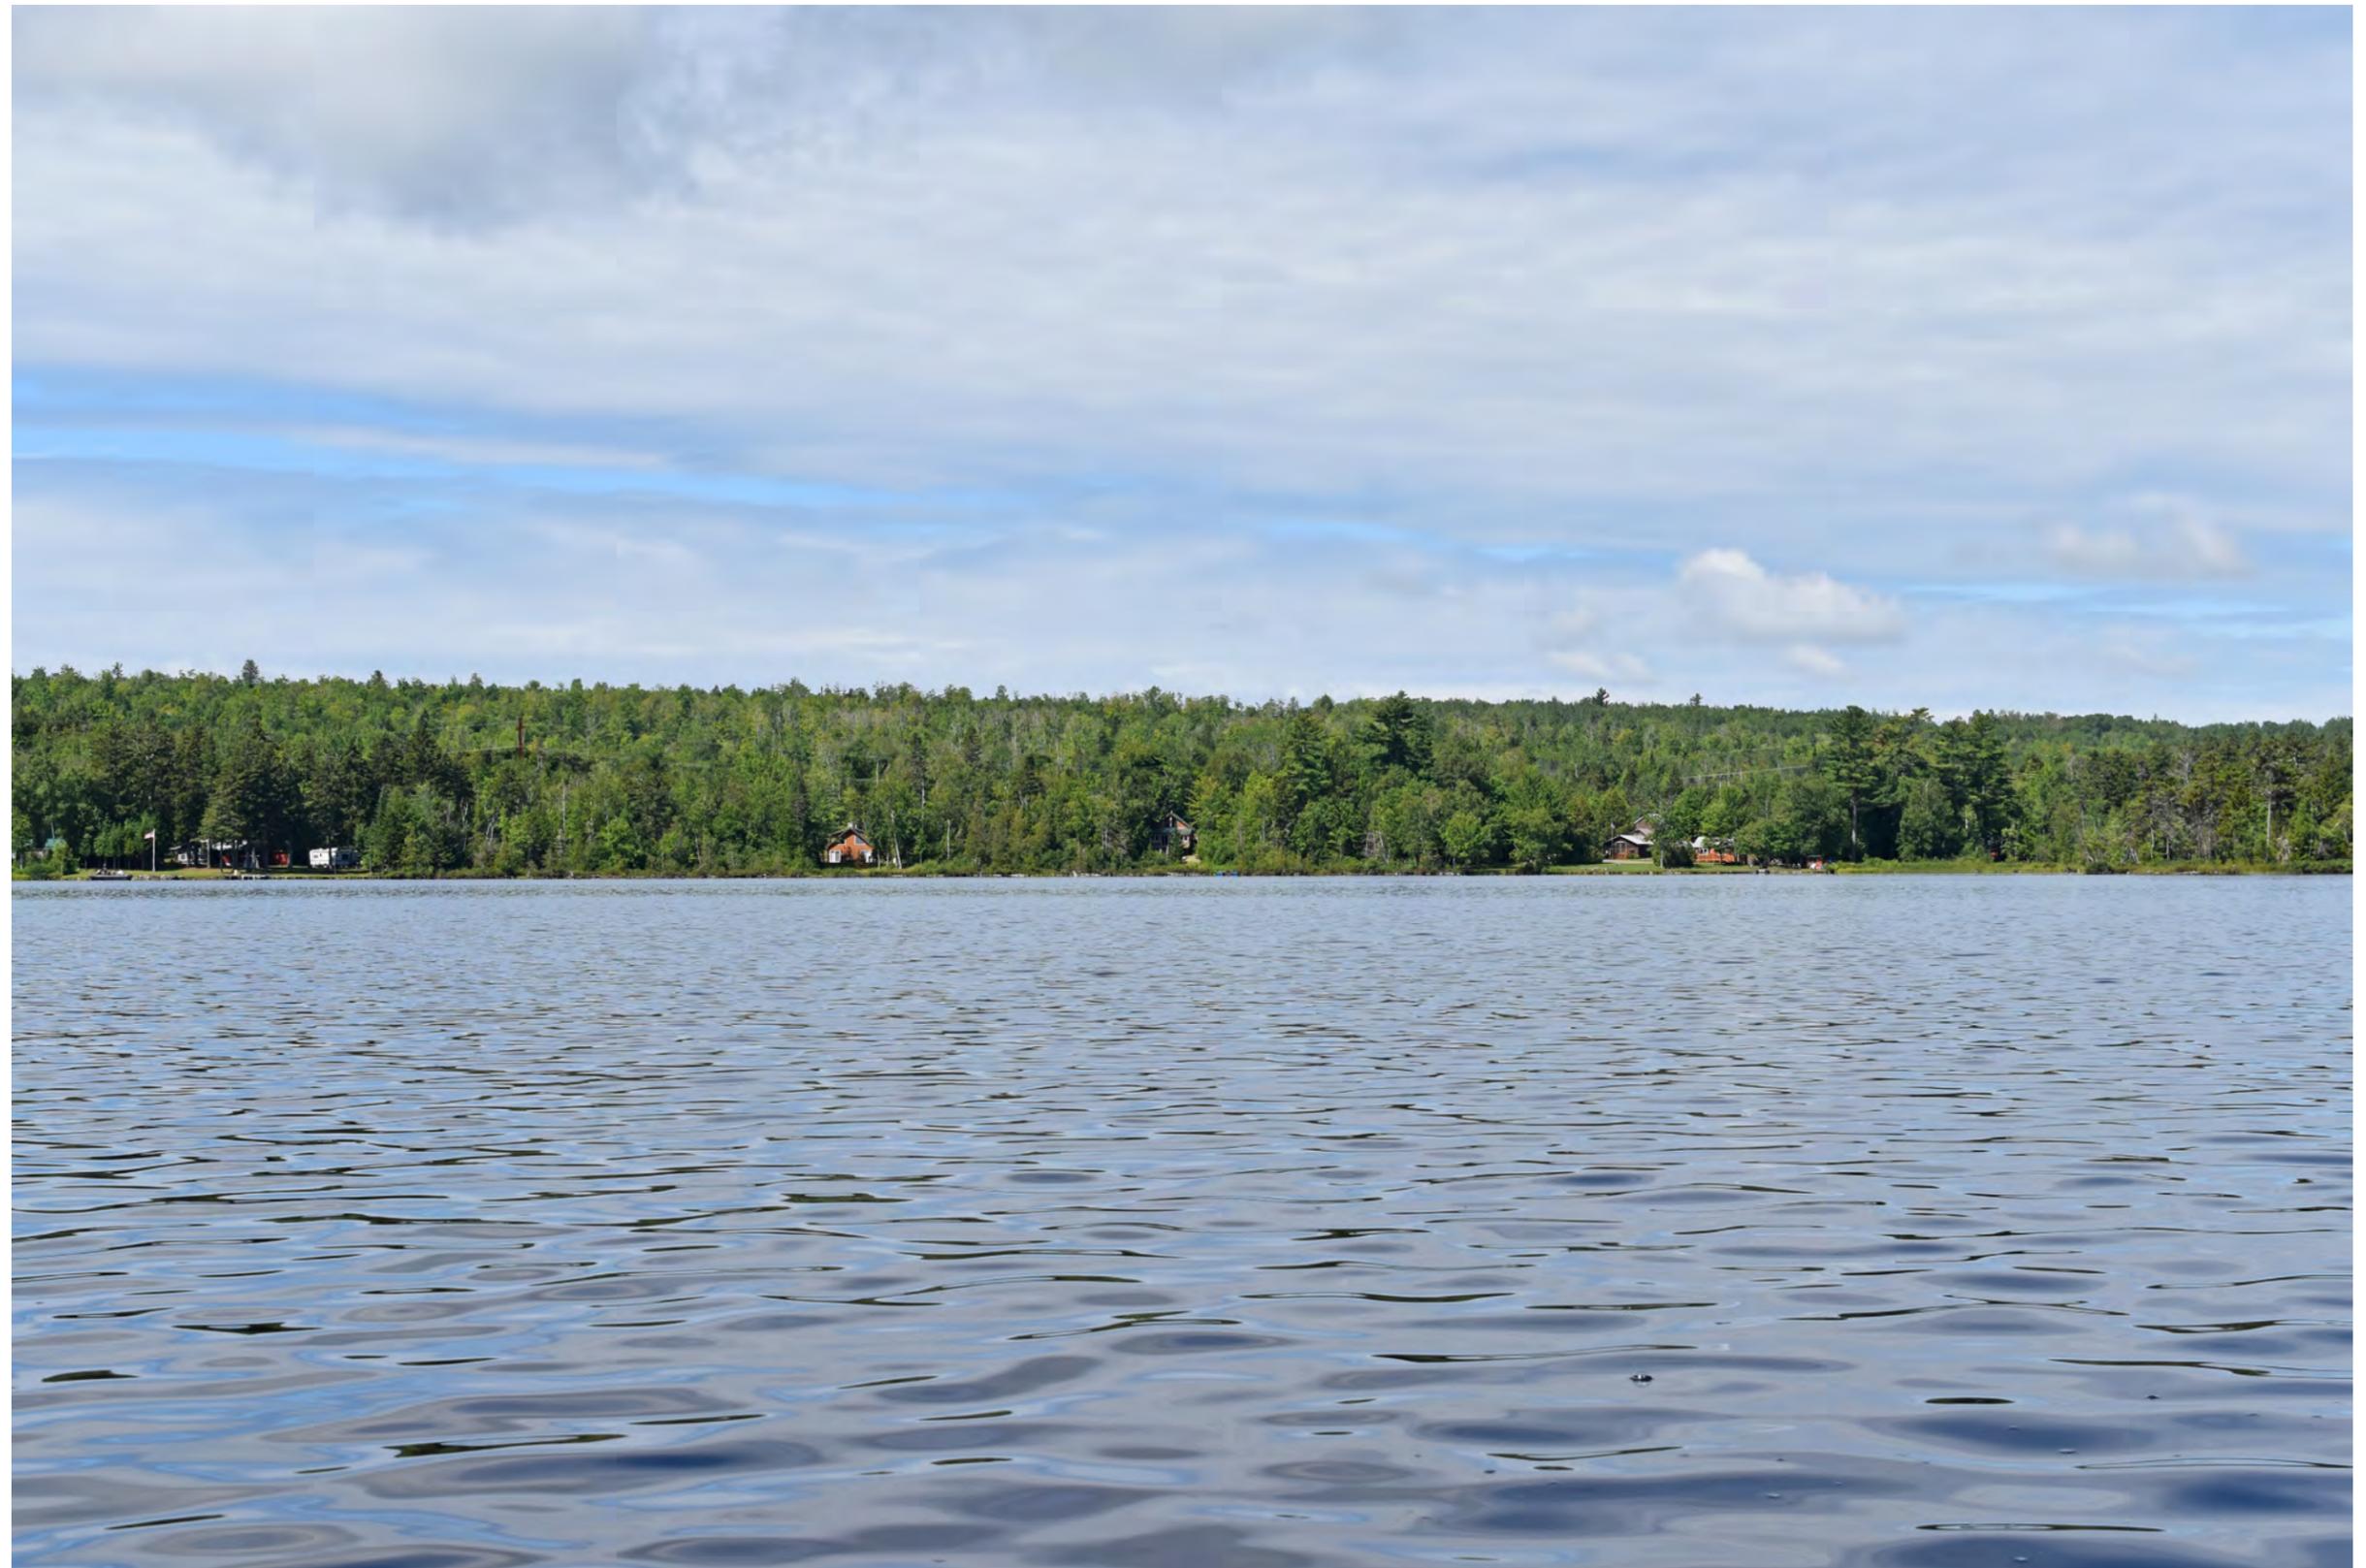
**PHOTOSIMULATION 14A: MOXIE POND - North, East Moxie Twp**

**Proposed Conditions:** Normal view looking west from the northern area of Moxie Pond toward the proposed co-located HVDC transmission line. Two structures and conductors will be visible from this viewpoint at a distance of 2,400 feet. The existing 150' wide corridor clearing will be widened by 75' on the western side to accommodate the new transmission line.

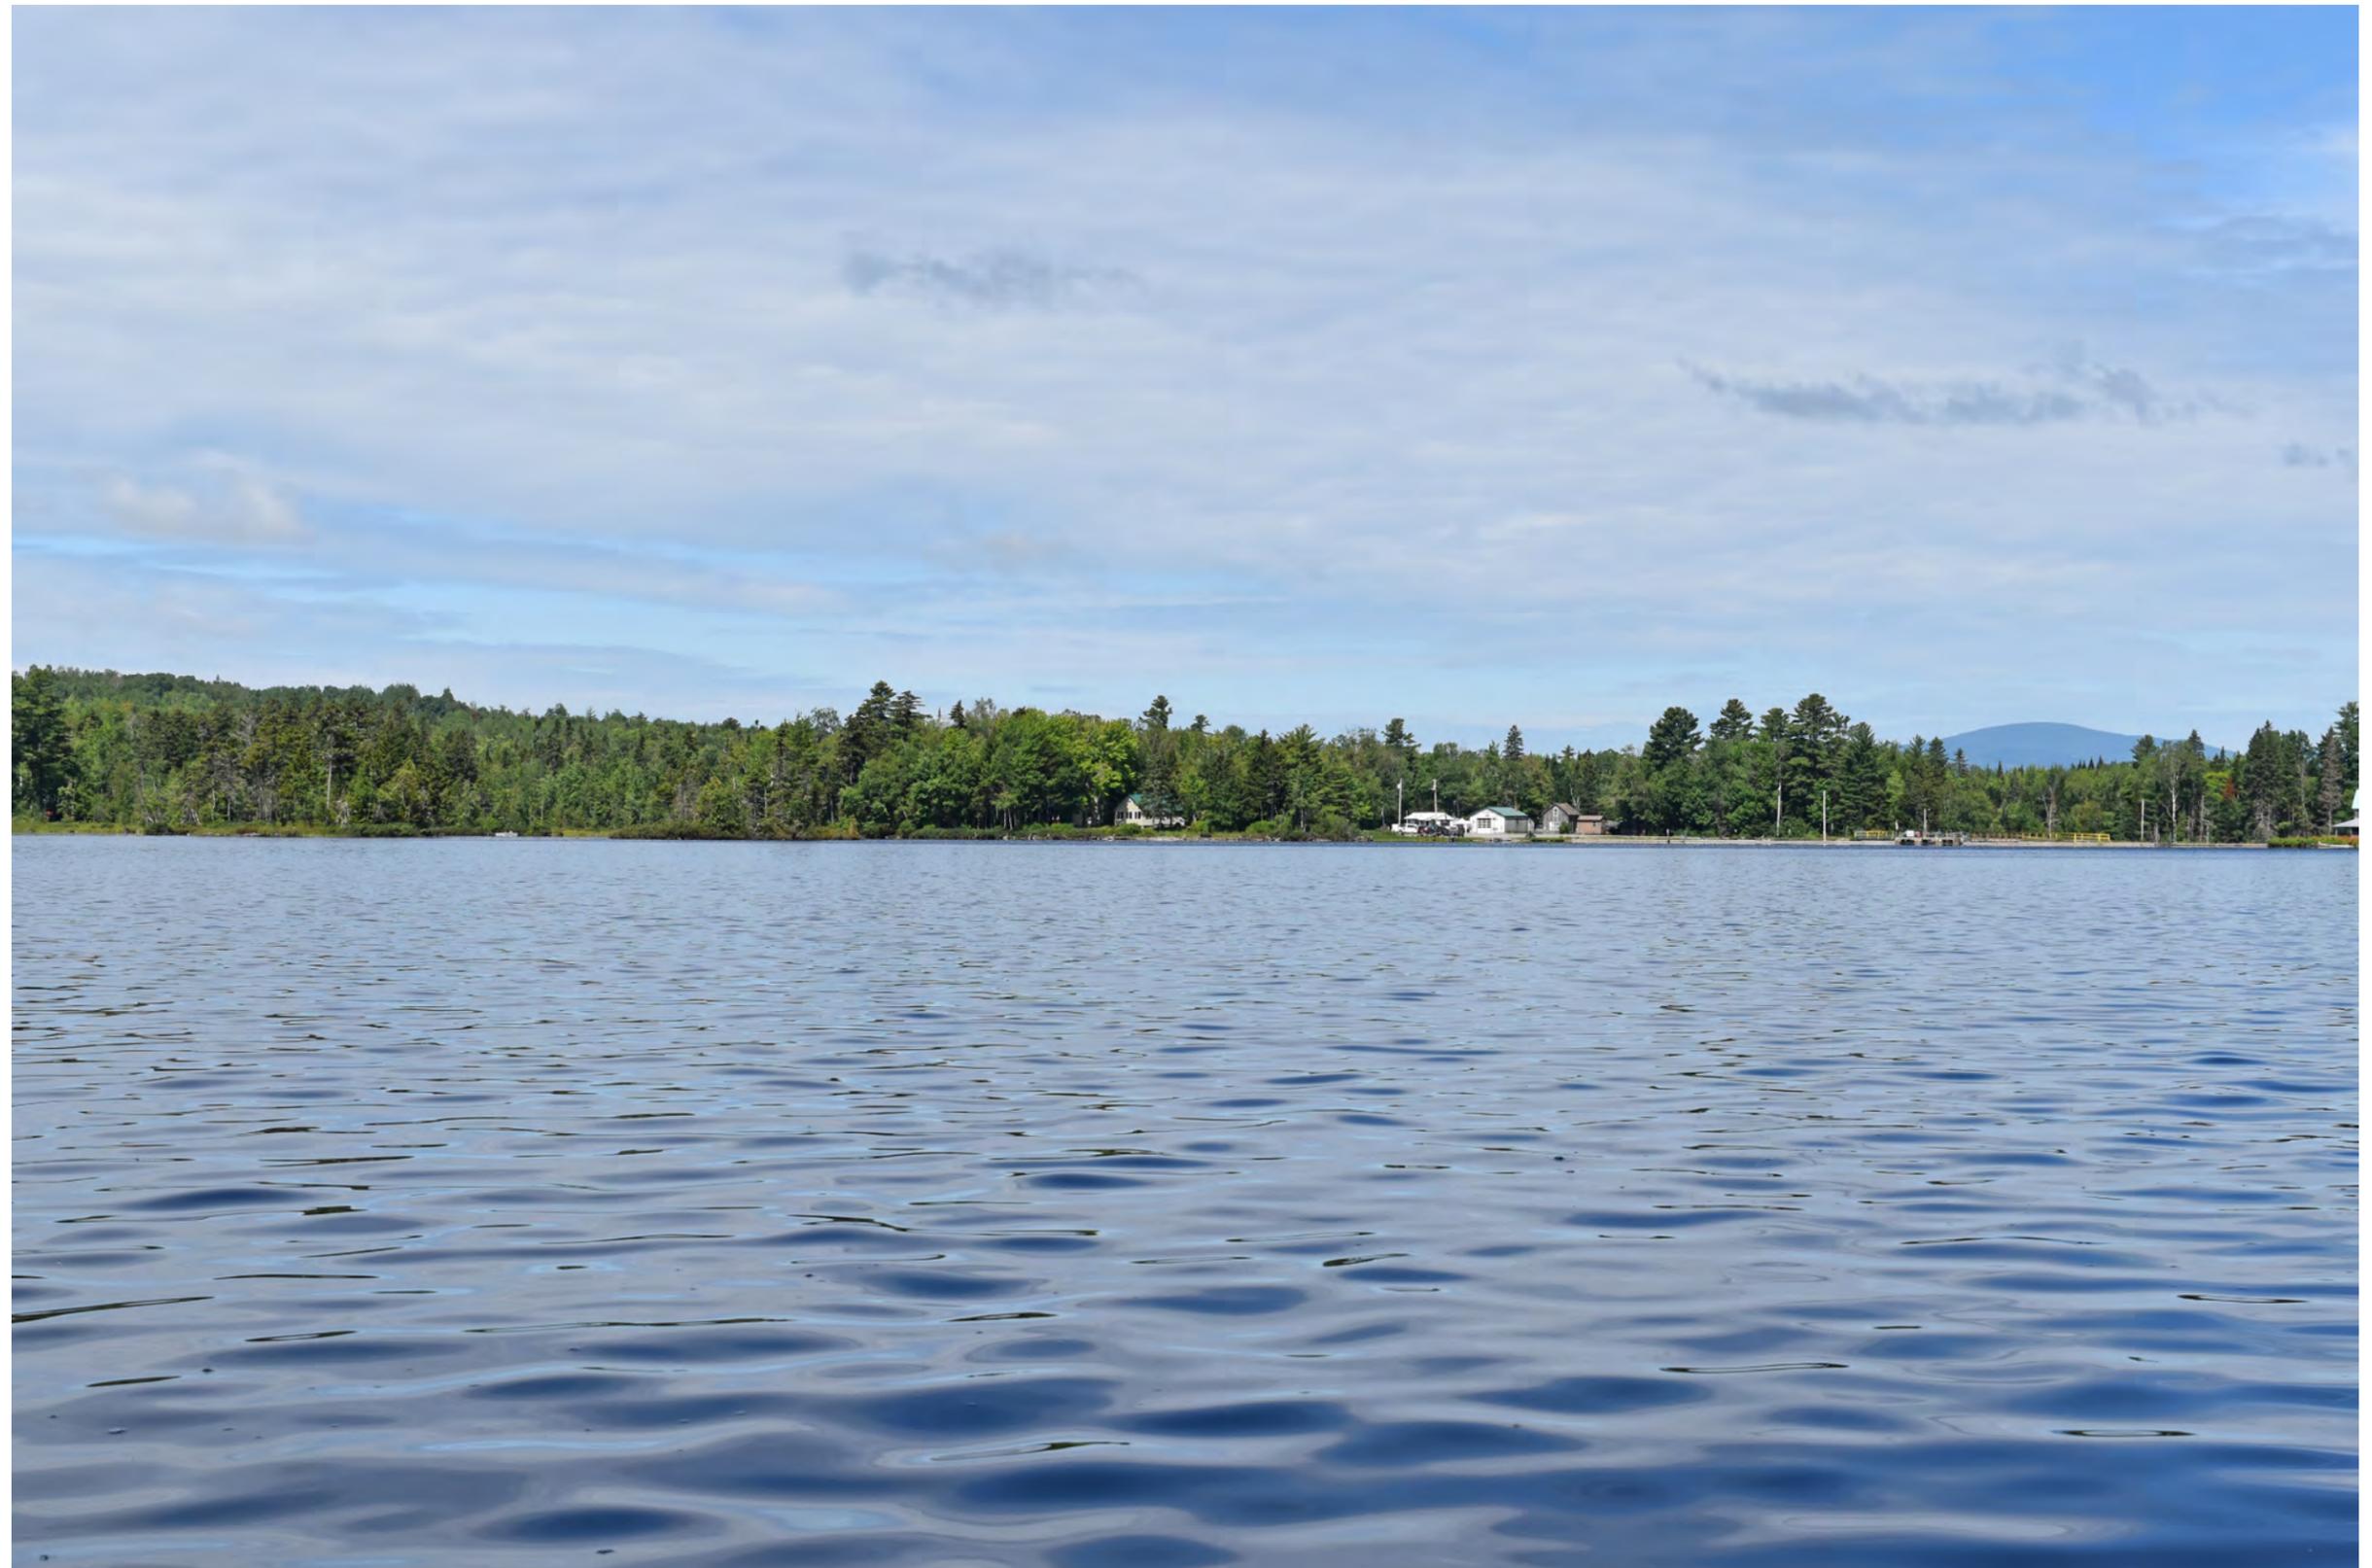
**PHOTOSIMULATION I4B: MOXIE POND - North, East Moxie Twp**

**Existing Conditions:** Normal view looking northwest from the northern area of Moxie Pond toward existing 115 kV transmission line. The boat launch at the north end of Moxie Pond and Coburn Mountain are visible on the right side of the image.

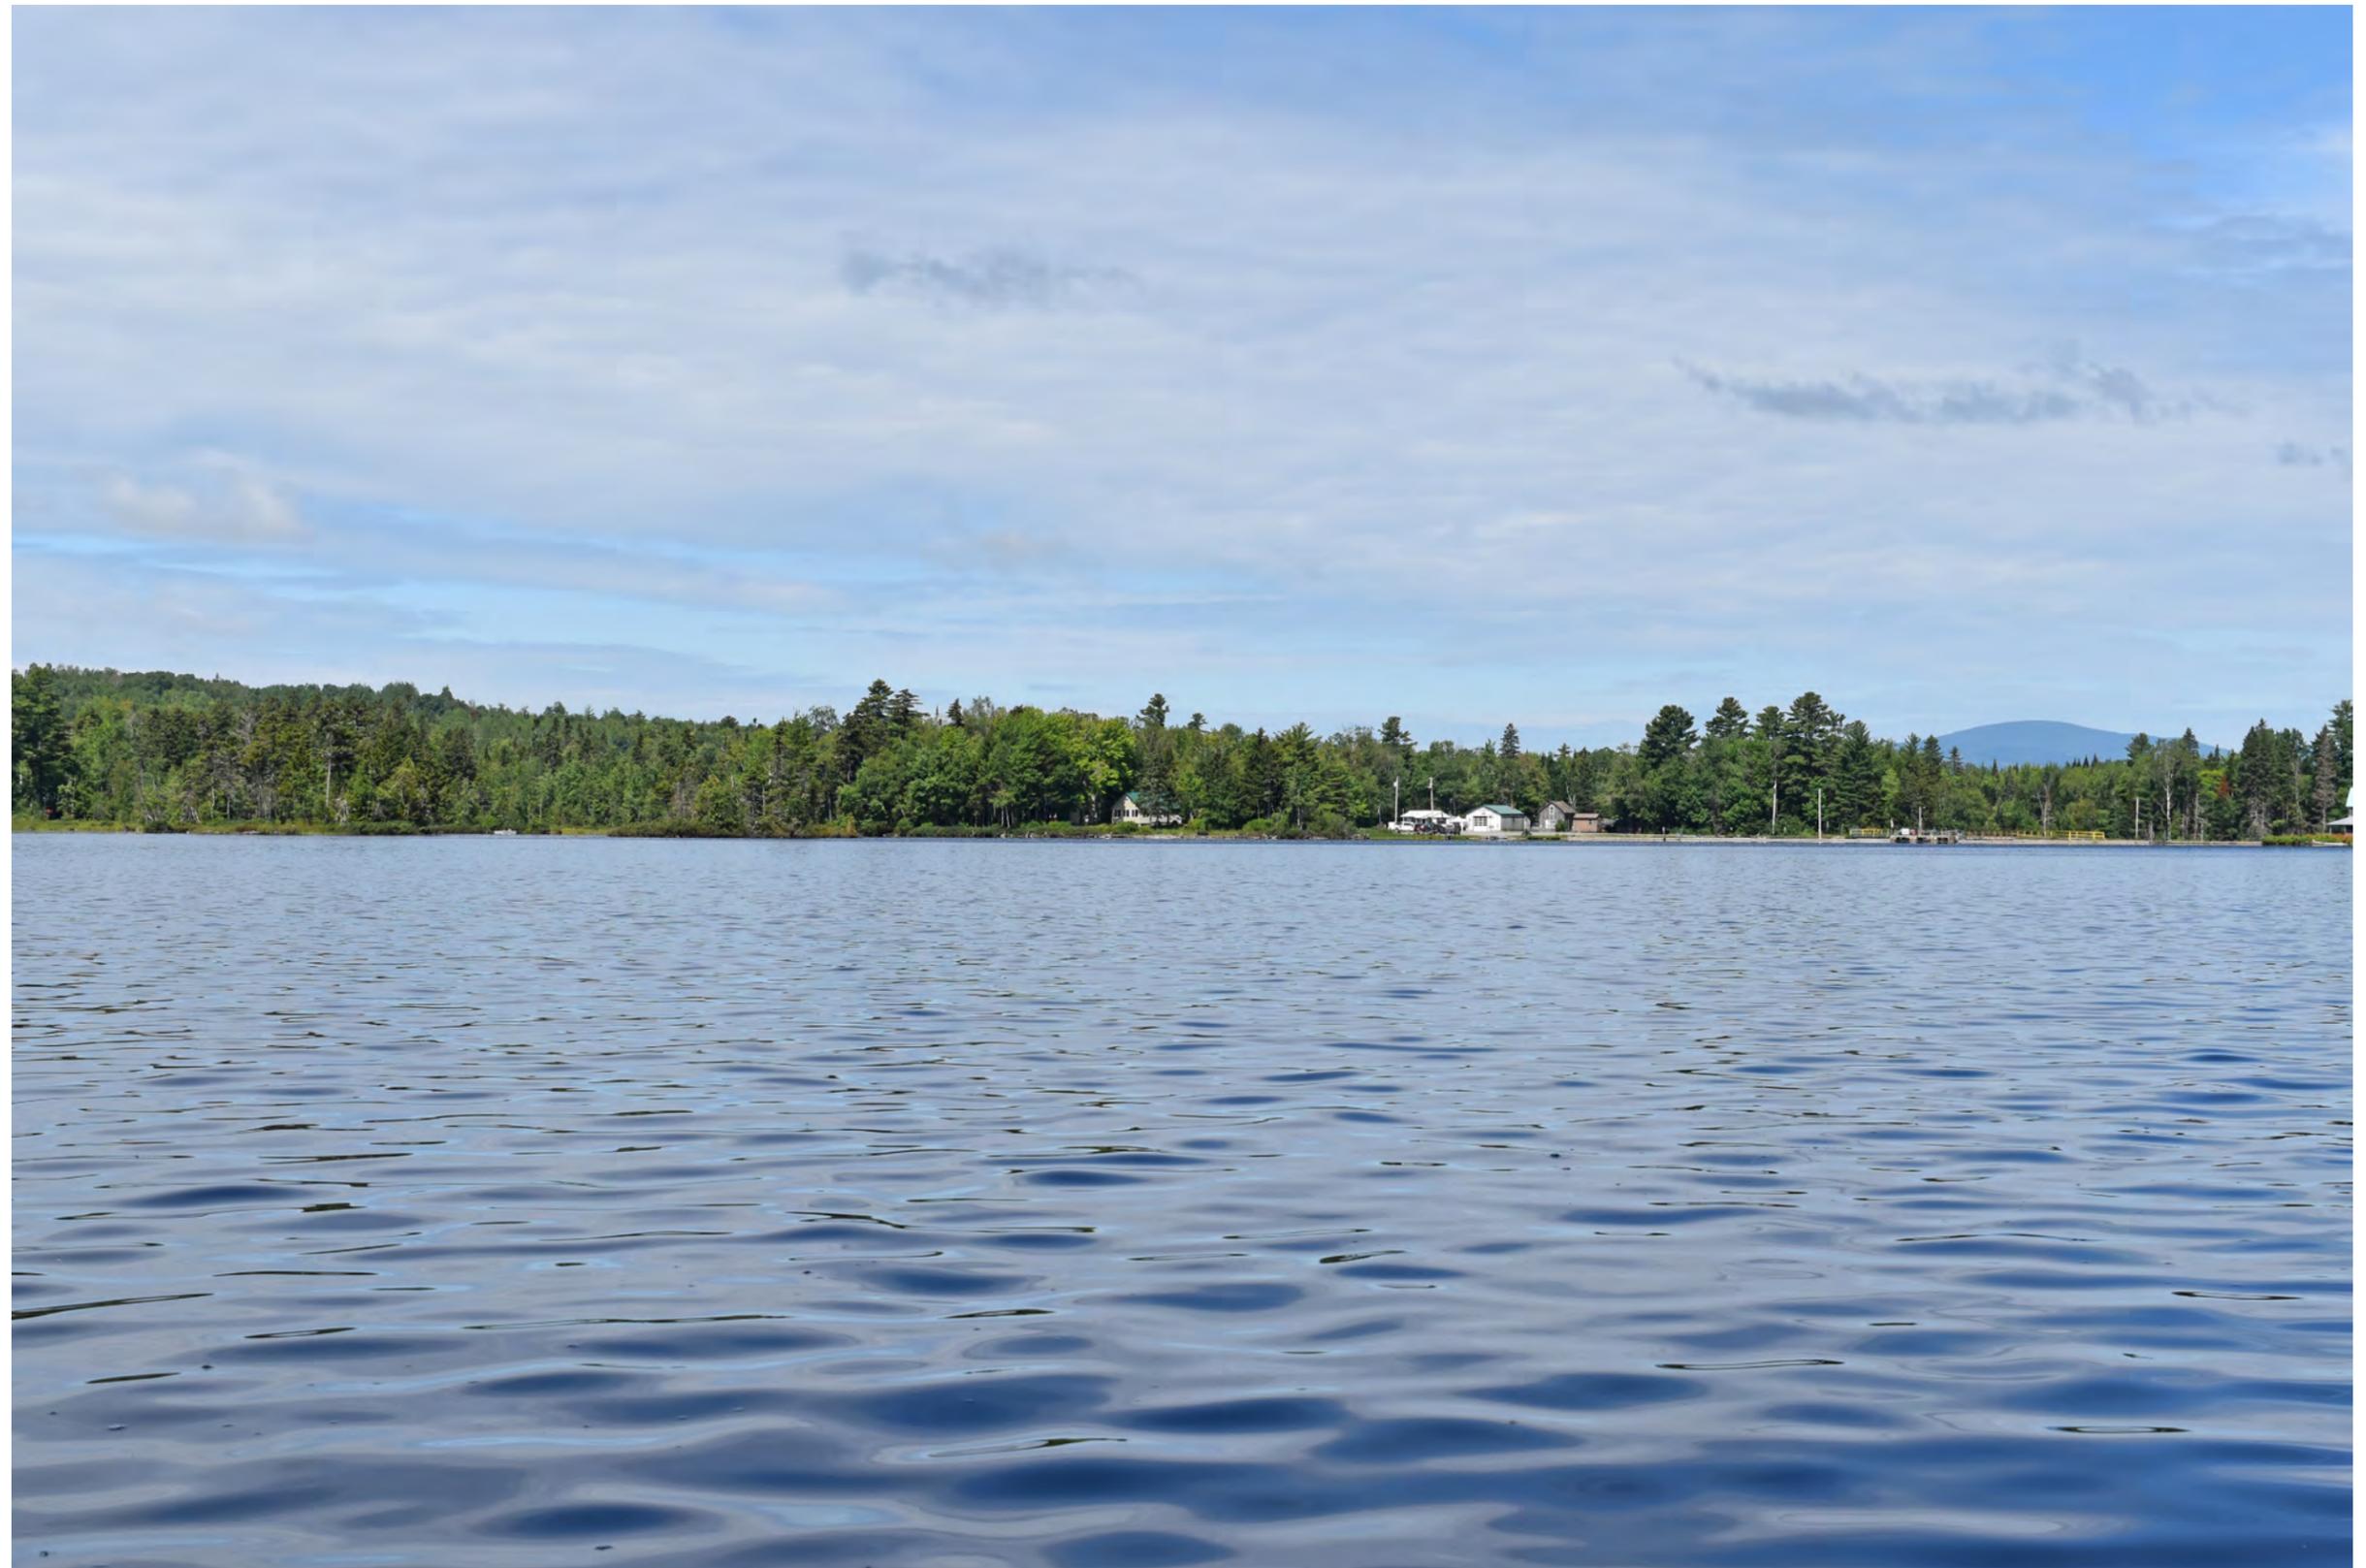
**PHOTOSIMULATION I4B: MOXIE POND - North, East Moxie Twp**

**Proposed Conditions:** Normal view looking southwest from the northern area of Moxie Pond toward the proposed co-located HVDC transmission line. One structure and conductors will be visible from this viewpoint at a distance of 4,200'. The existing 150' wide corridor clearing will be widened by 75' on the western side to accommodate the new transmission line.

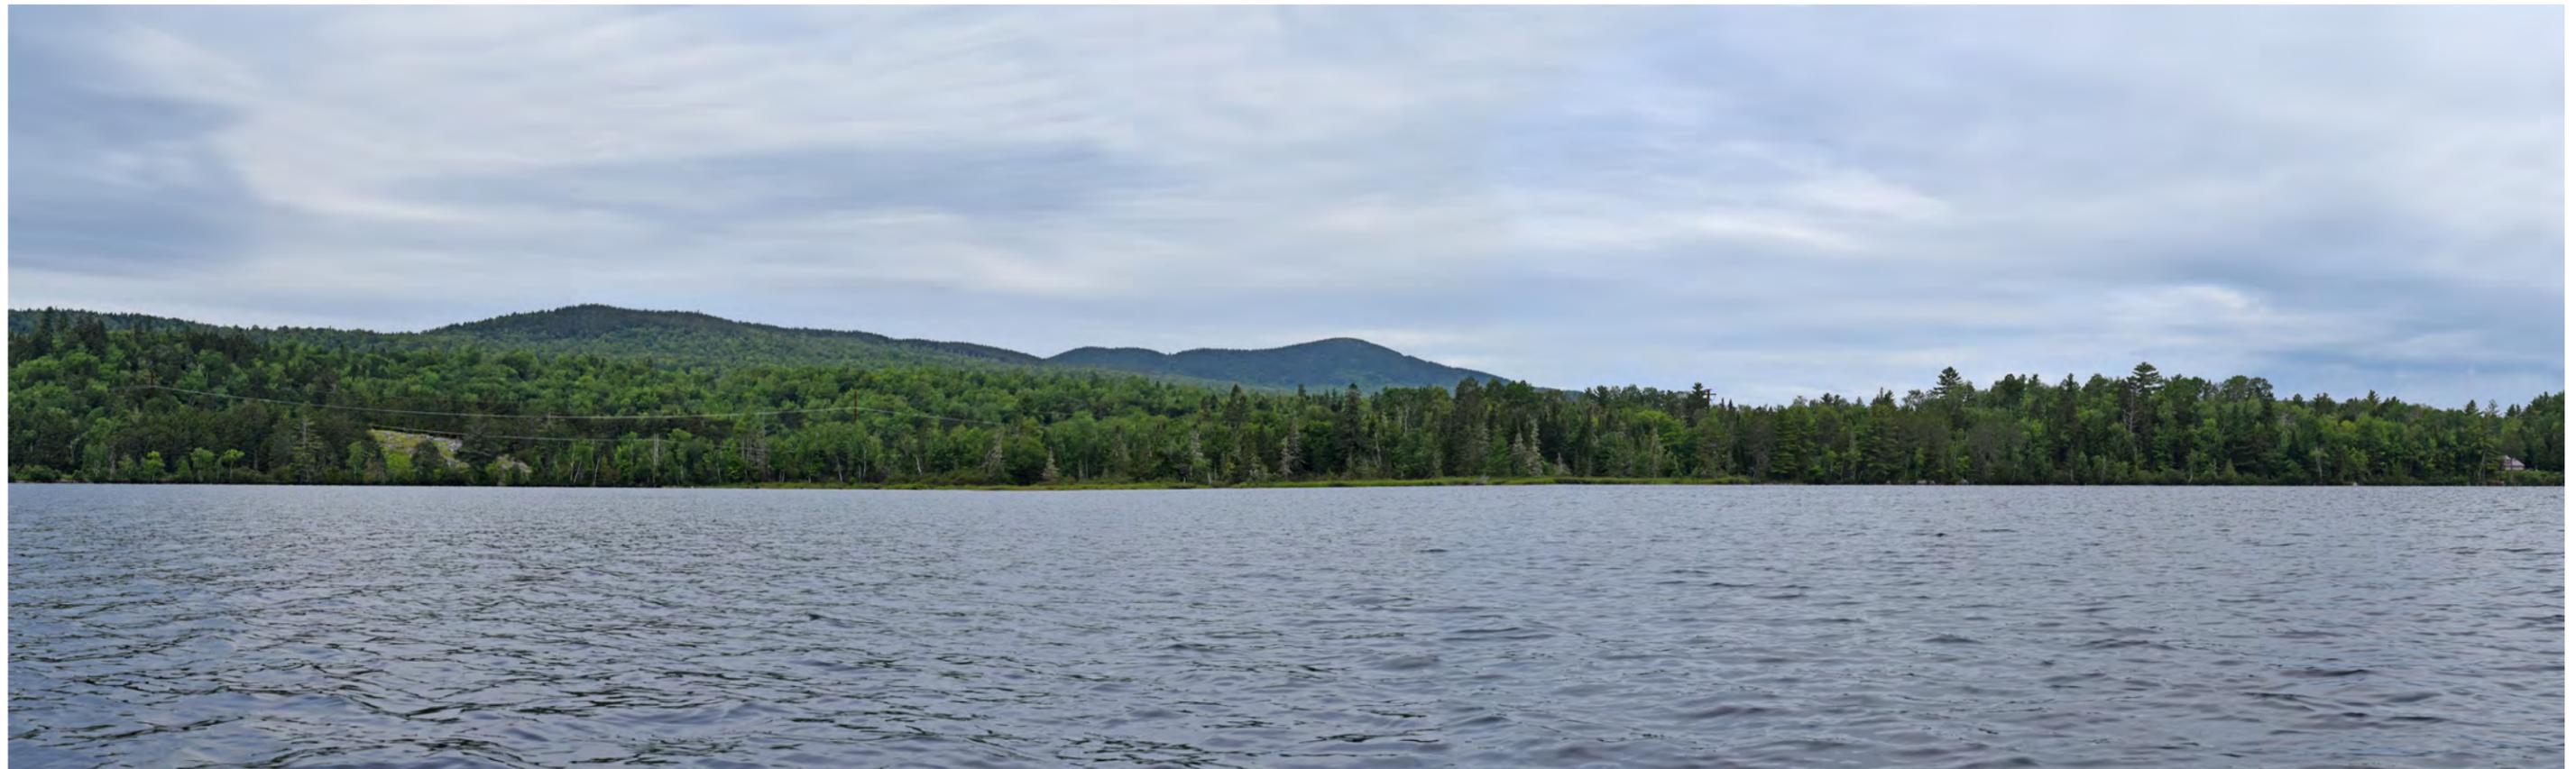
# PHOTOSIMULATION 15: MOXIE POND - South, Bald Mountain Twp T2 R3

**Proposed Conditions:** Panoramic view looking from southwest to northwest from the southern area of Moxie Pond toward the proposed co-located HVDC transmission line. The clearing will be widened by 75' on the western side of the existing 150' wide 115 kV transmission line corridor to accommodate the new transmission line. Portions of the widened corridor will be visible in two areas of the pond where the existing corridor is already visible; at the southern end north of Joes Hole as shown in this image and near Black Narrows. The tops of up to three HVDC transmission line structures will be visible above the tree line from this viewpoint. The majority of the structures and conductors will be screened by shoreline vegetation. Moxie Pond is a designated scenic resource with an 'Outstanding' rating in the [Maine Wildlands Lake Assessment](#). See Appendix B: Study Area Photographs for additional images.

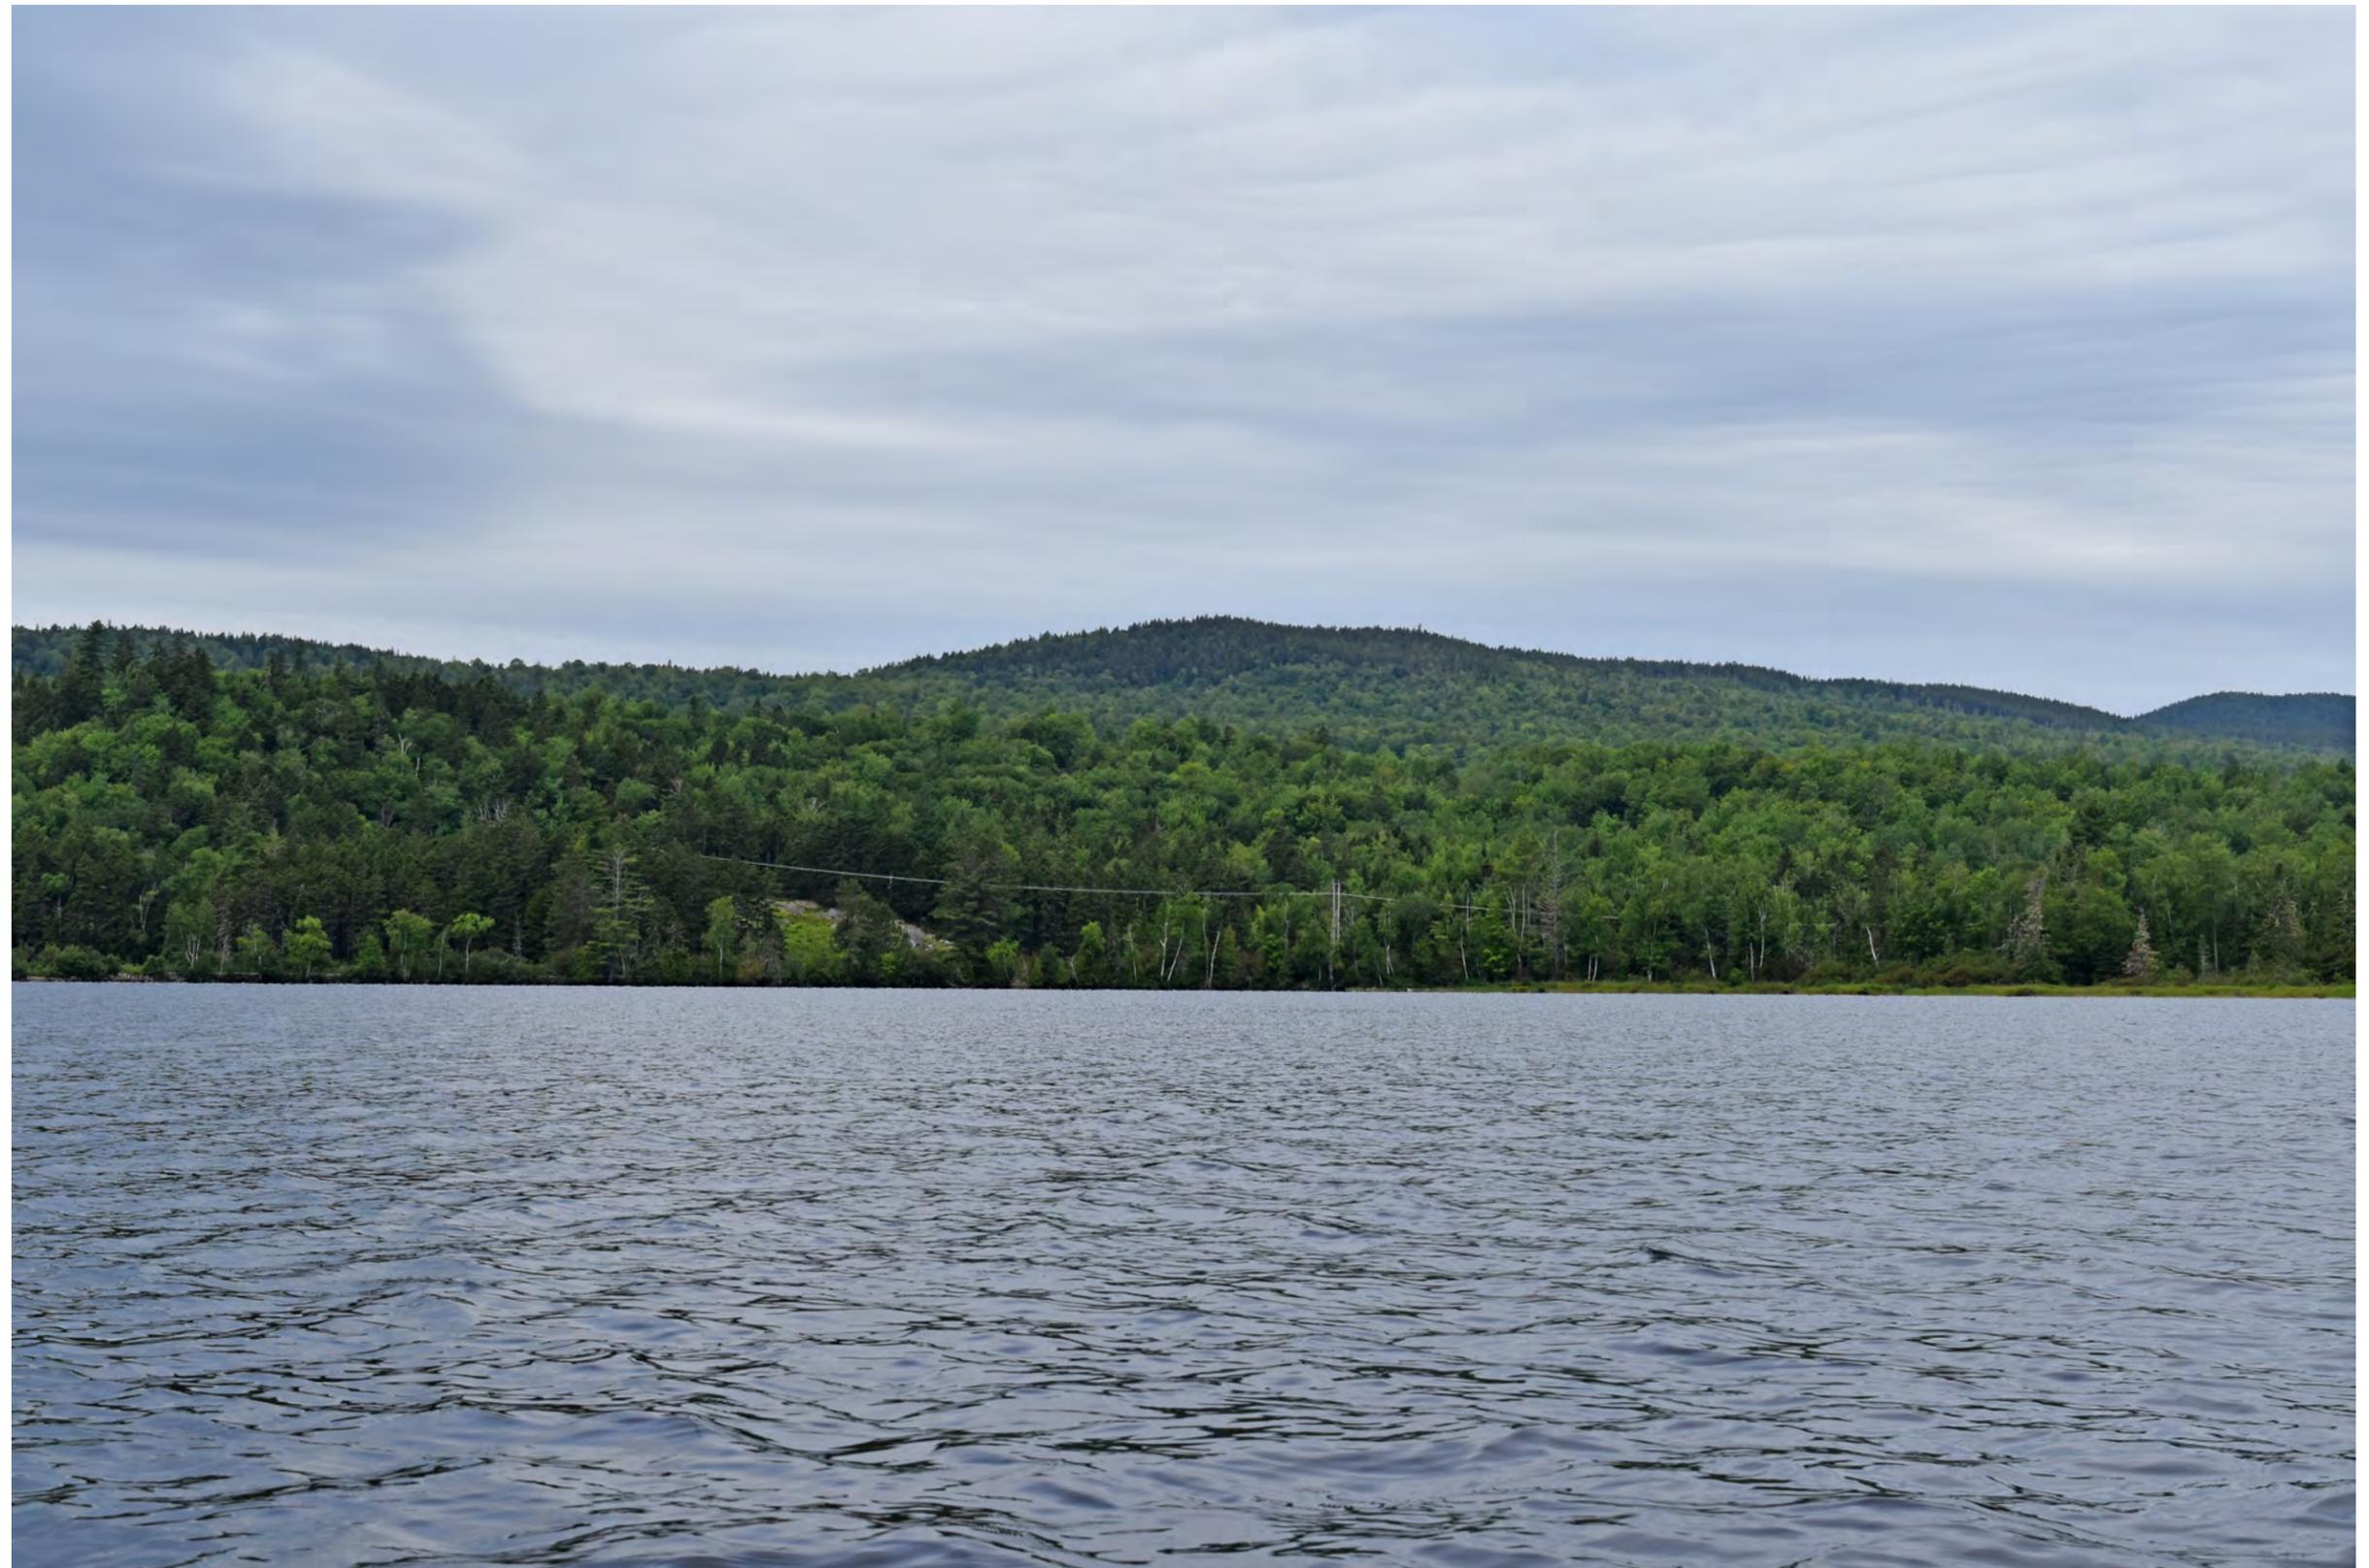
**PHOTOSIMULATION 15A: MOXIE POND - South, Bald Mountain Twp T2 R3**

**Existing Conditions:** Normal view looking west from the southern area of Moxie Pond towards the existing 115 kV transmission line.
