# PHOTOSIMULATION 13: MOXIE POND - North, East Moxie Twp

**PHOTOSIMULATION 13A: MOXIE POND - North, East Moxie Twp**

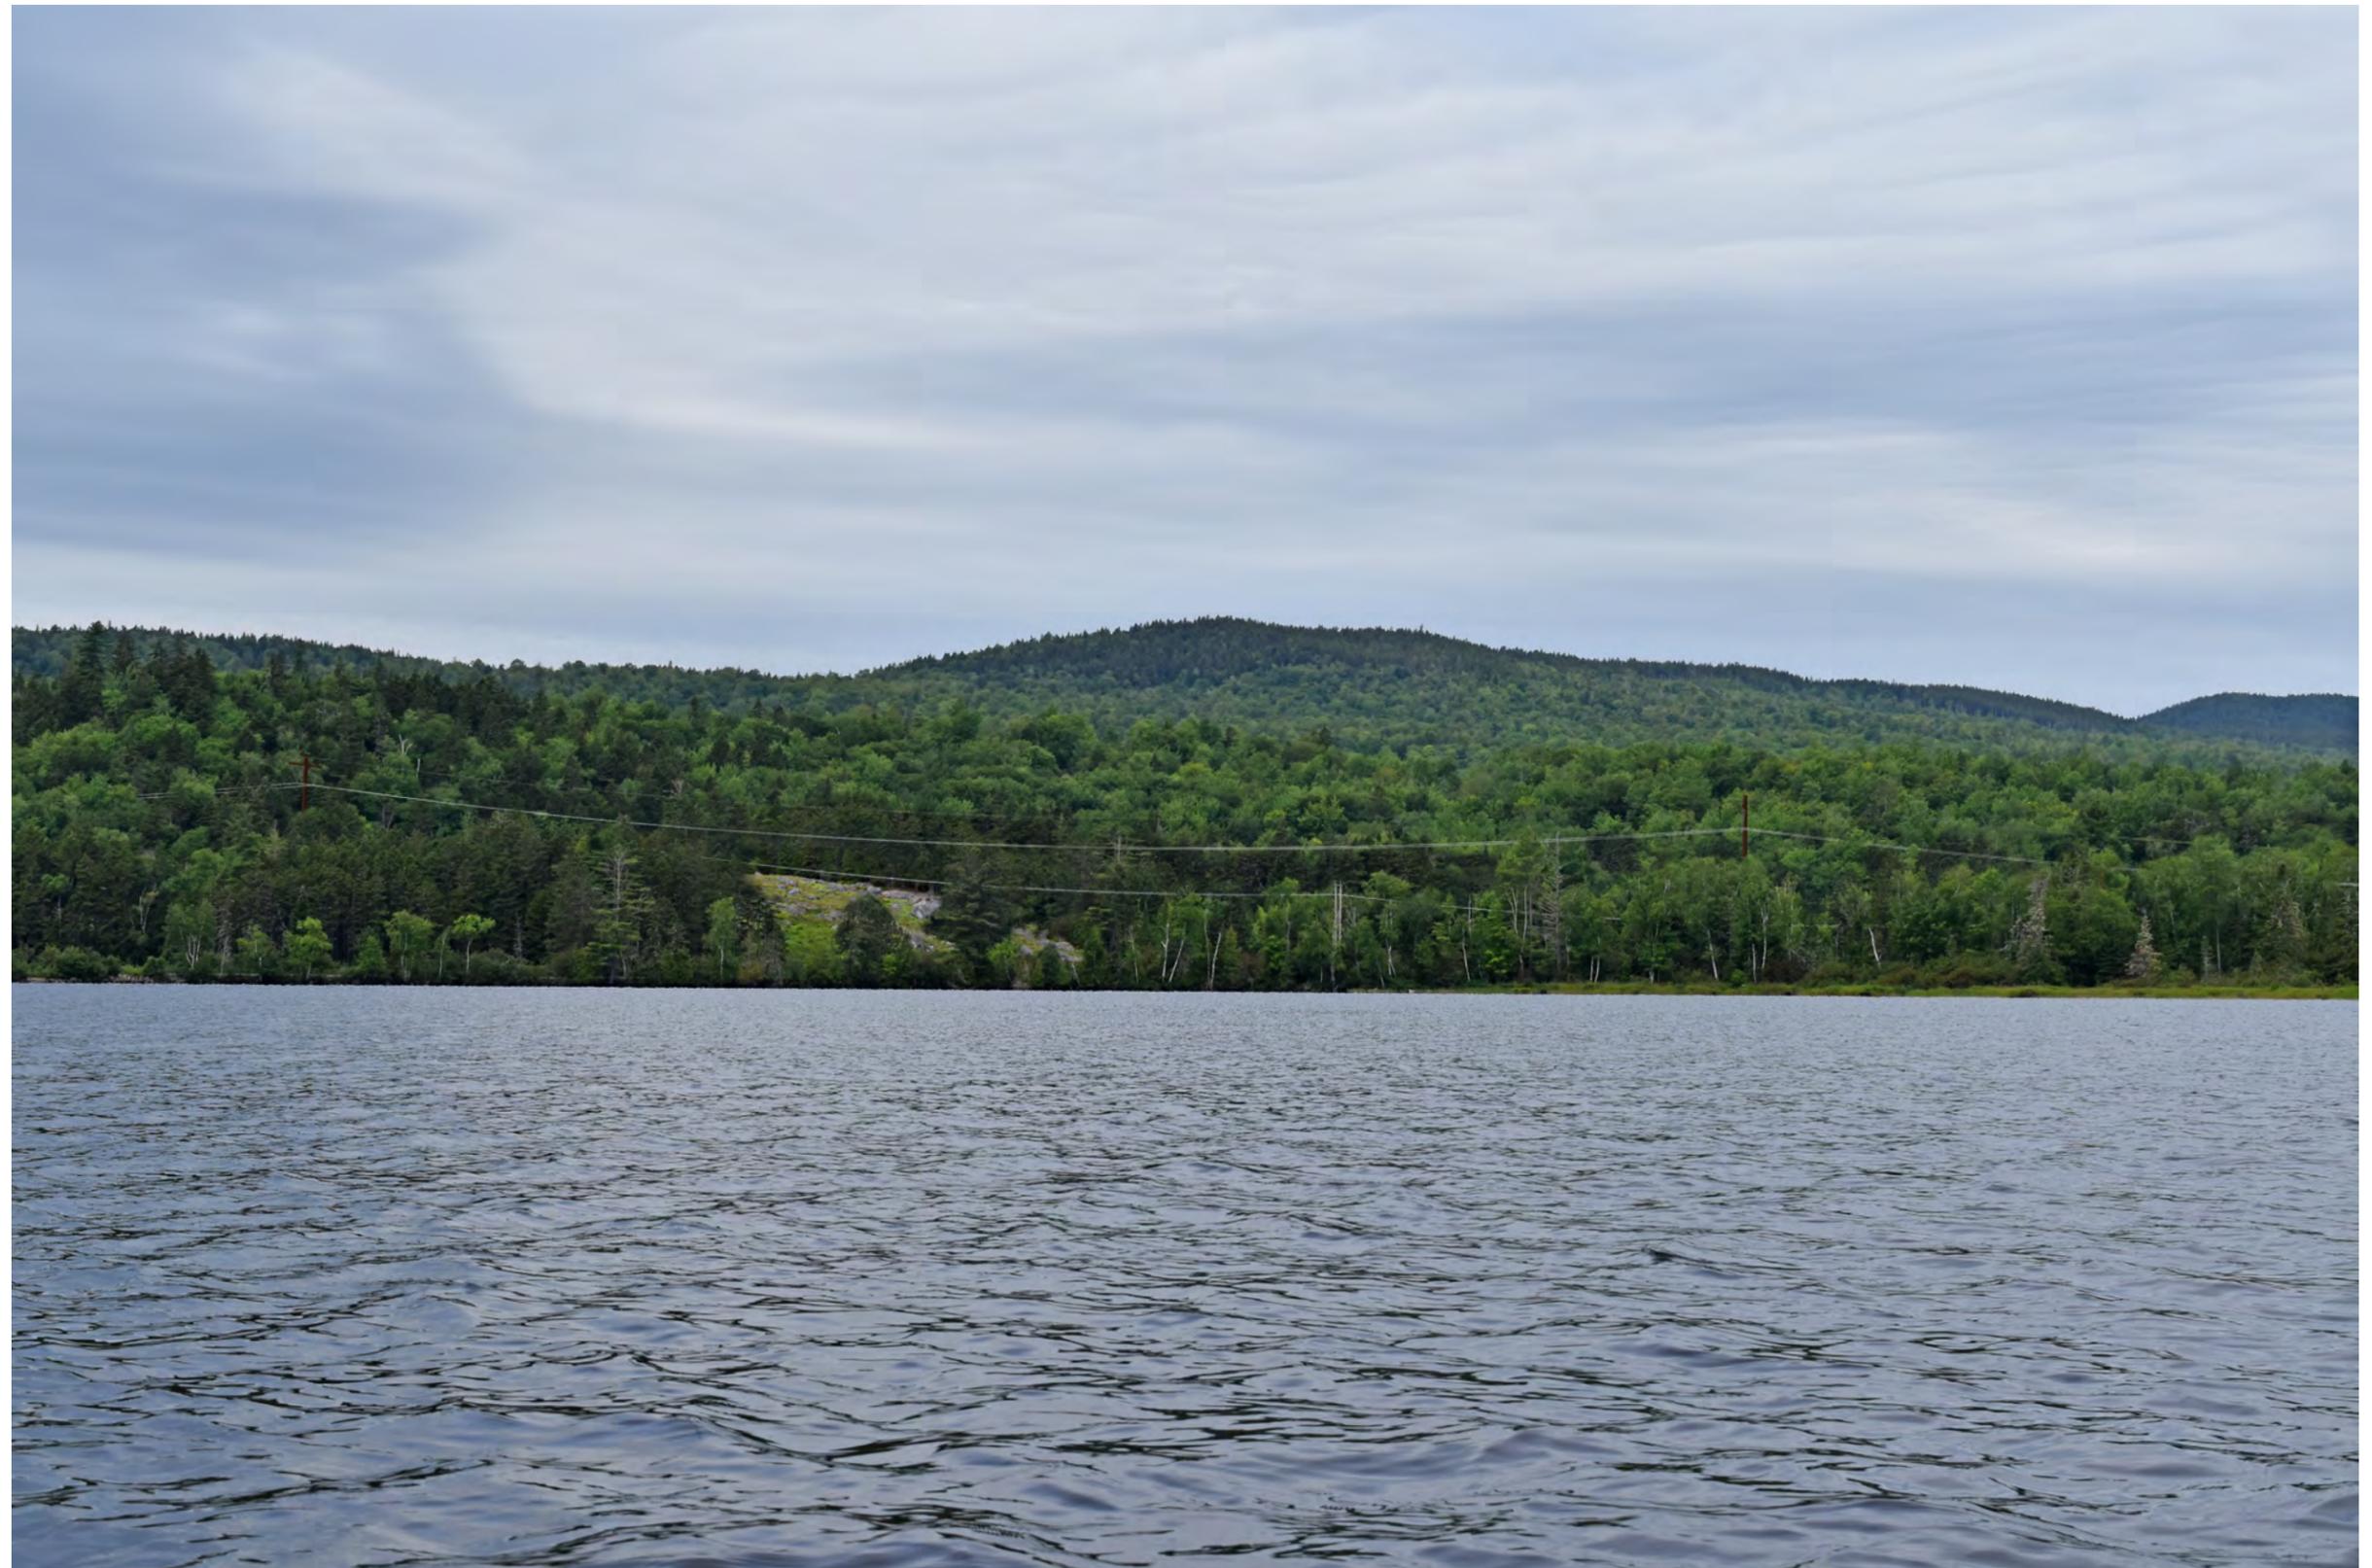
**PHOTOSIMULATION 15A: MOXIE POND - South, Bald Mountain Twp T2 R3**

**Proposed Conditions:** Normal view looking west from the southern area of Moxie Pond toward the proposed co-located HVDC transmission line. The clearing will be widened by 75' on the western side of the existing 150' wide 115 kv transmission line corridor to accommodate the new HVDC transmission line. The top portion of three structures and the conductors will be visible above the existing transmission line structures & conductors.

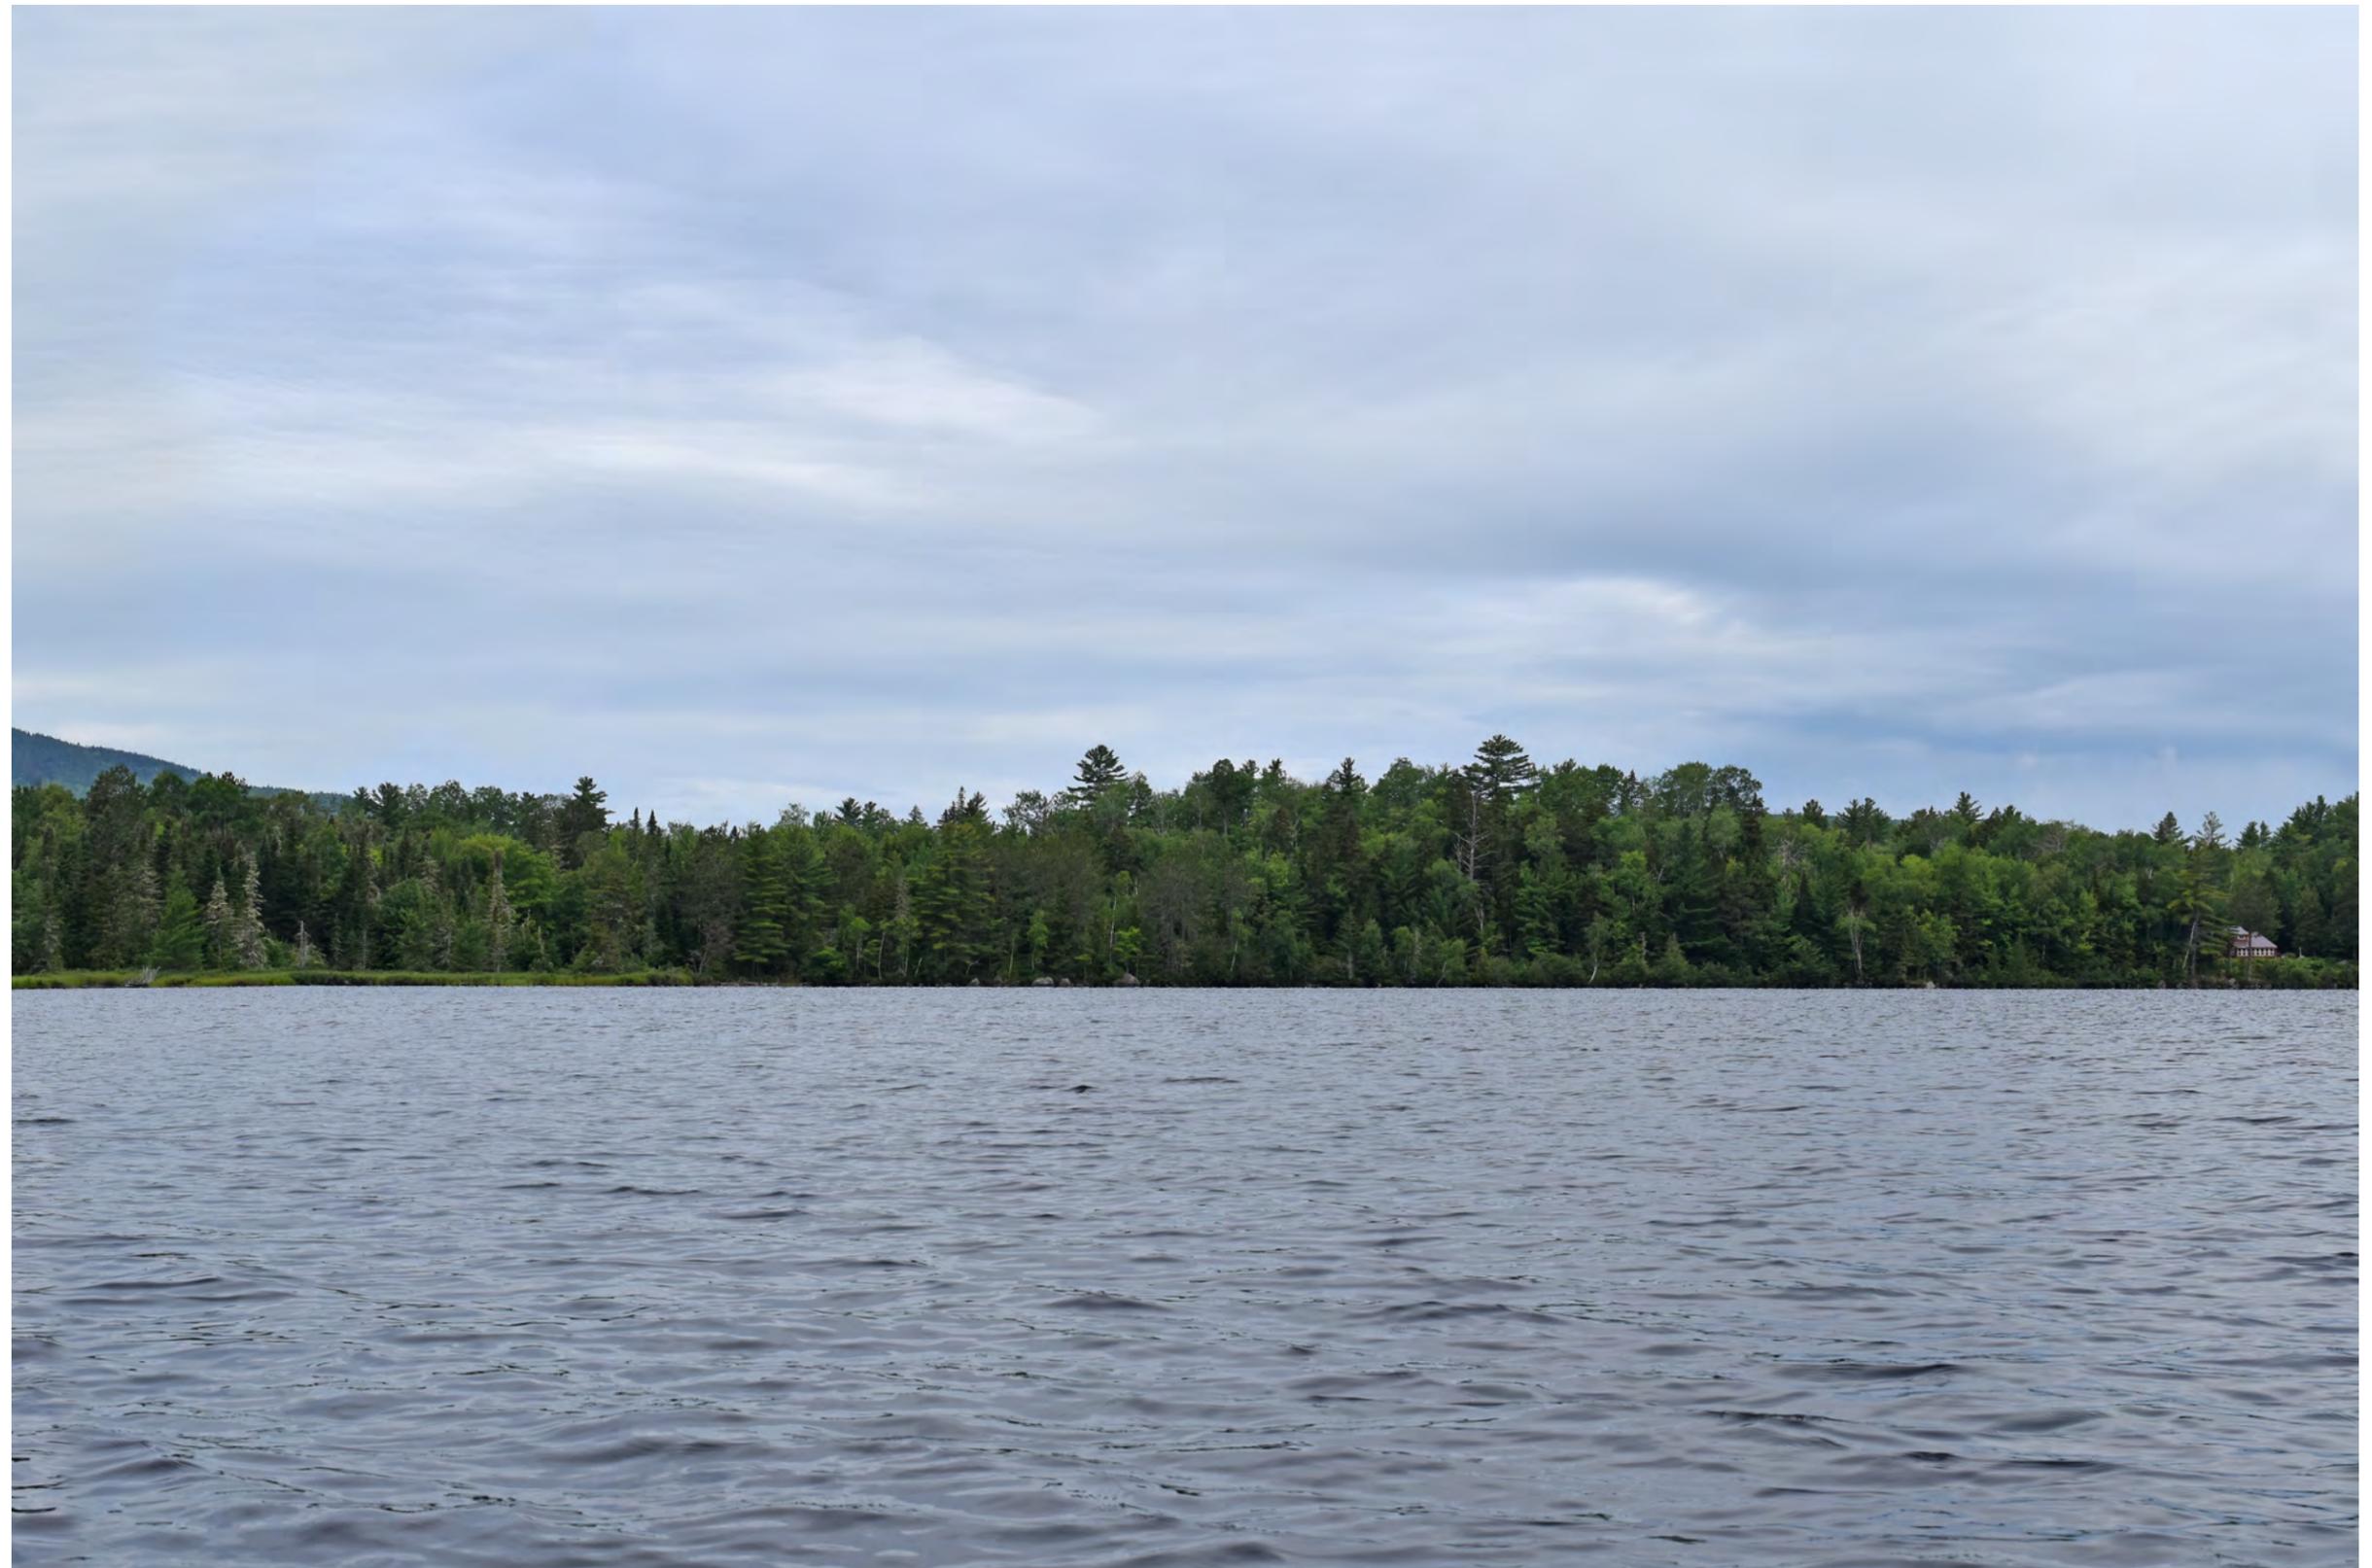
**Existing Conditions:** Normal view looking northwest from the southern area of Moxie Pond.

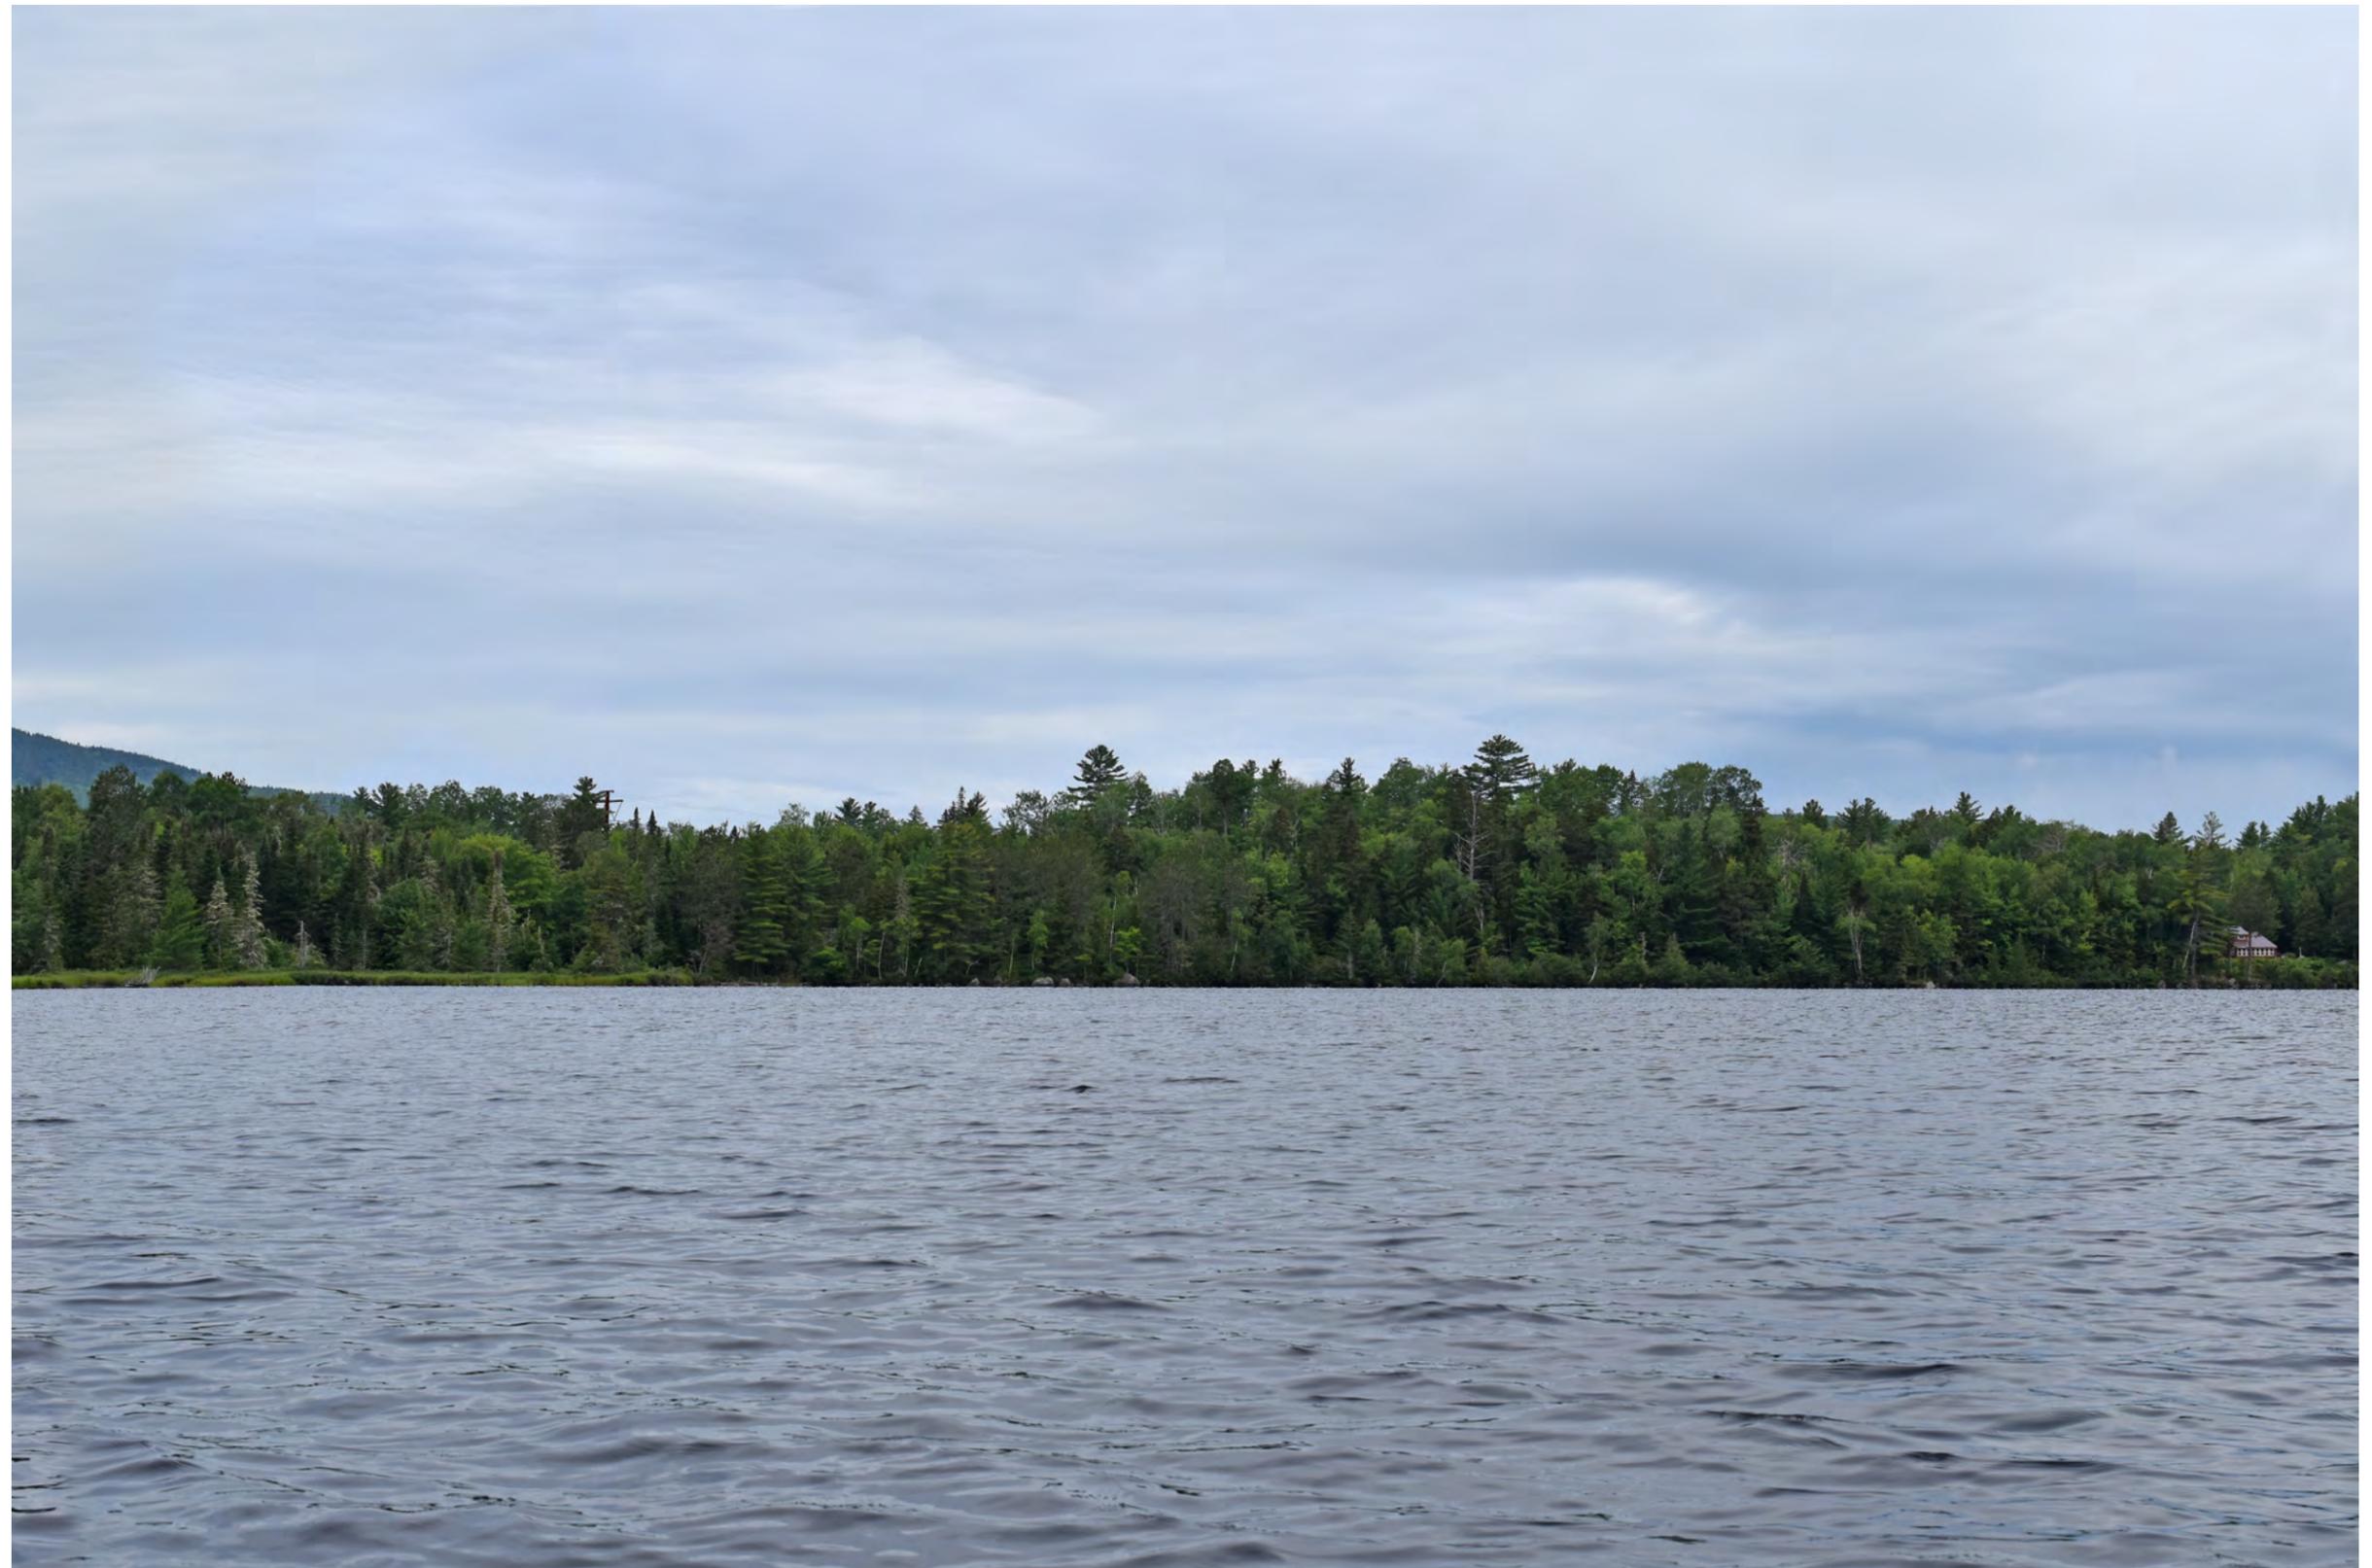
**PHOTOSIMULATION 15B: MOXIE POND - South, Bald Mountain Twp T2 R3**

**Proposed Conditions:** Normal view looking northwest from the southern area of Moxie Pond toward the proposed co-located transmission line. The change in vegetation due to the widening of the cleared corridor will not be noticeable looking in this direction. One structure and portions of conductors will be visible, but mostly screened by vegetation.

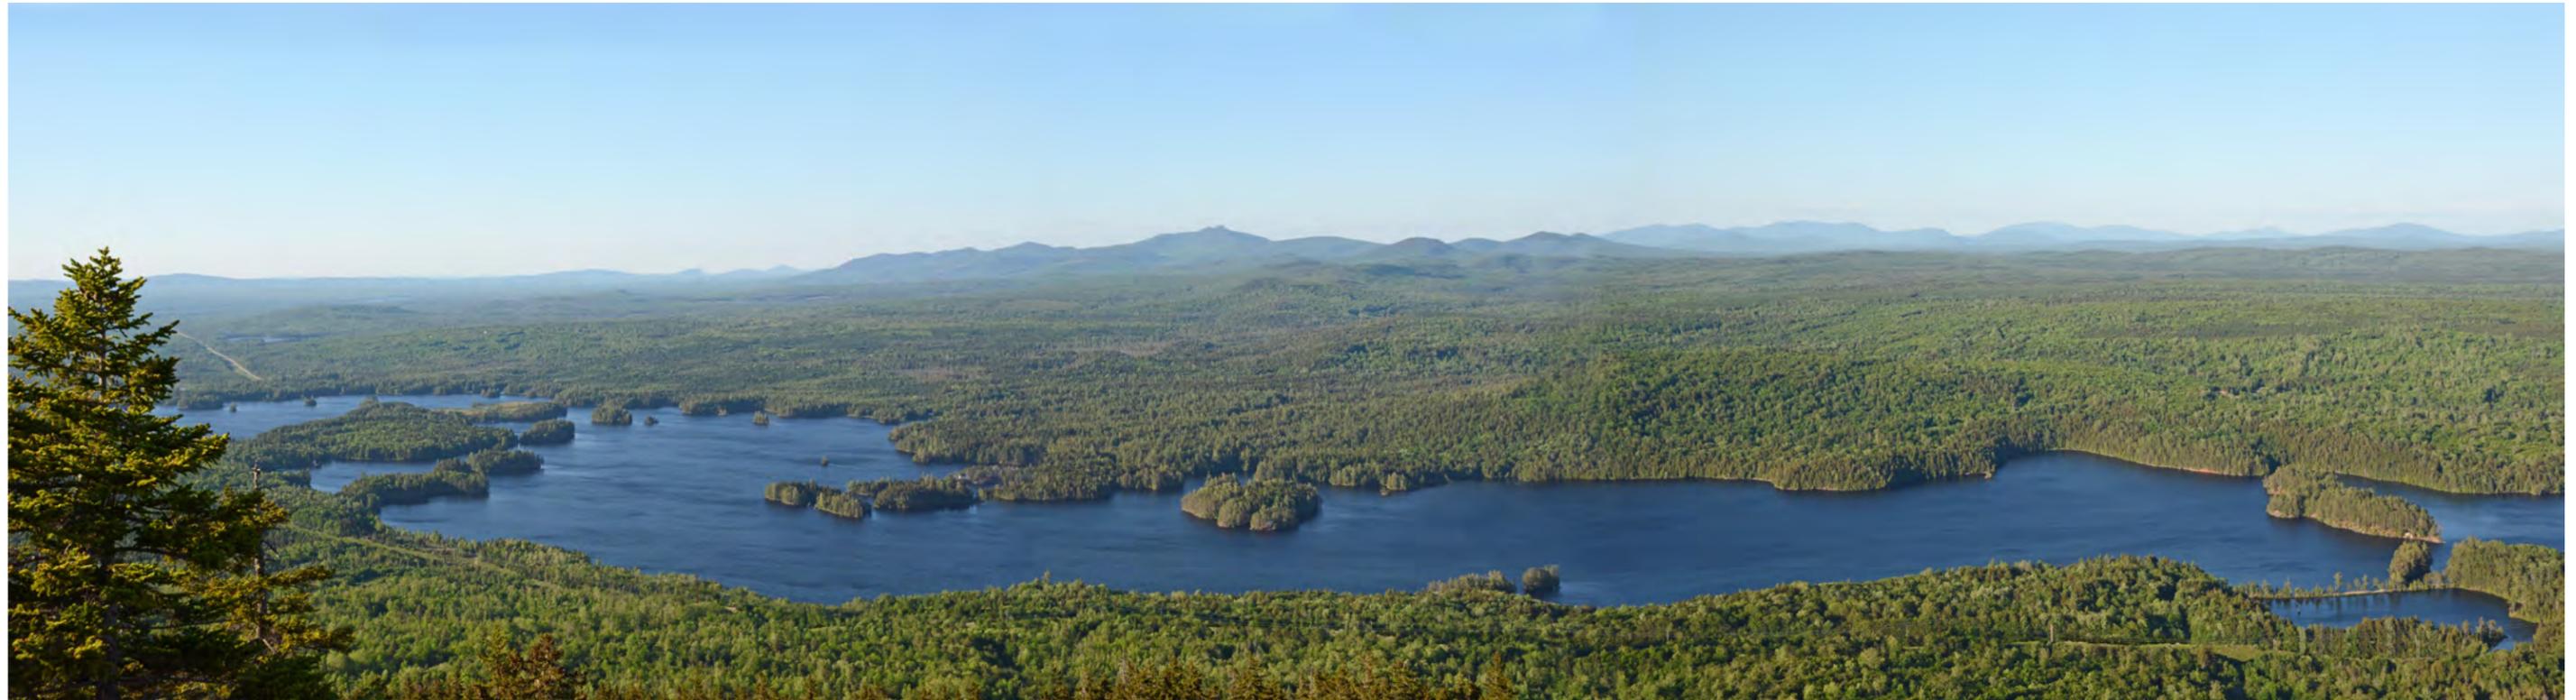
# PHOTOSIMULATION 16: MOSQUITO MOUNTAIN - Overlook Looking Northeast, The Forks PLT

**Proposed Conditions:** Panoramic view looking north to east from the eastern overlook on Mosquito Mountain toward the proposed co-located HVDC transmission line. The existing 150' wide transmission line corridor clearing will be widened by 75' on the western side to accommodate the proposed HVDC transmission line. Seven structures and conductors will be visible within three miles of this viewpoint. Big Moose Mountain is visible in the center of the image with Black Narrows on the right side of the image. Moxie Pond is visible across the entire image. See Appendix B: Study Area Photographs for additional images.

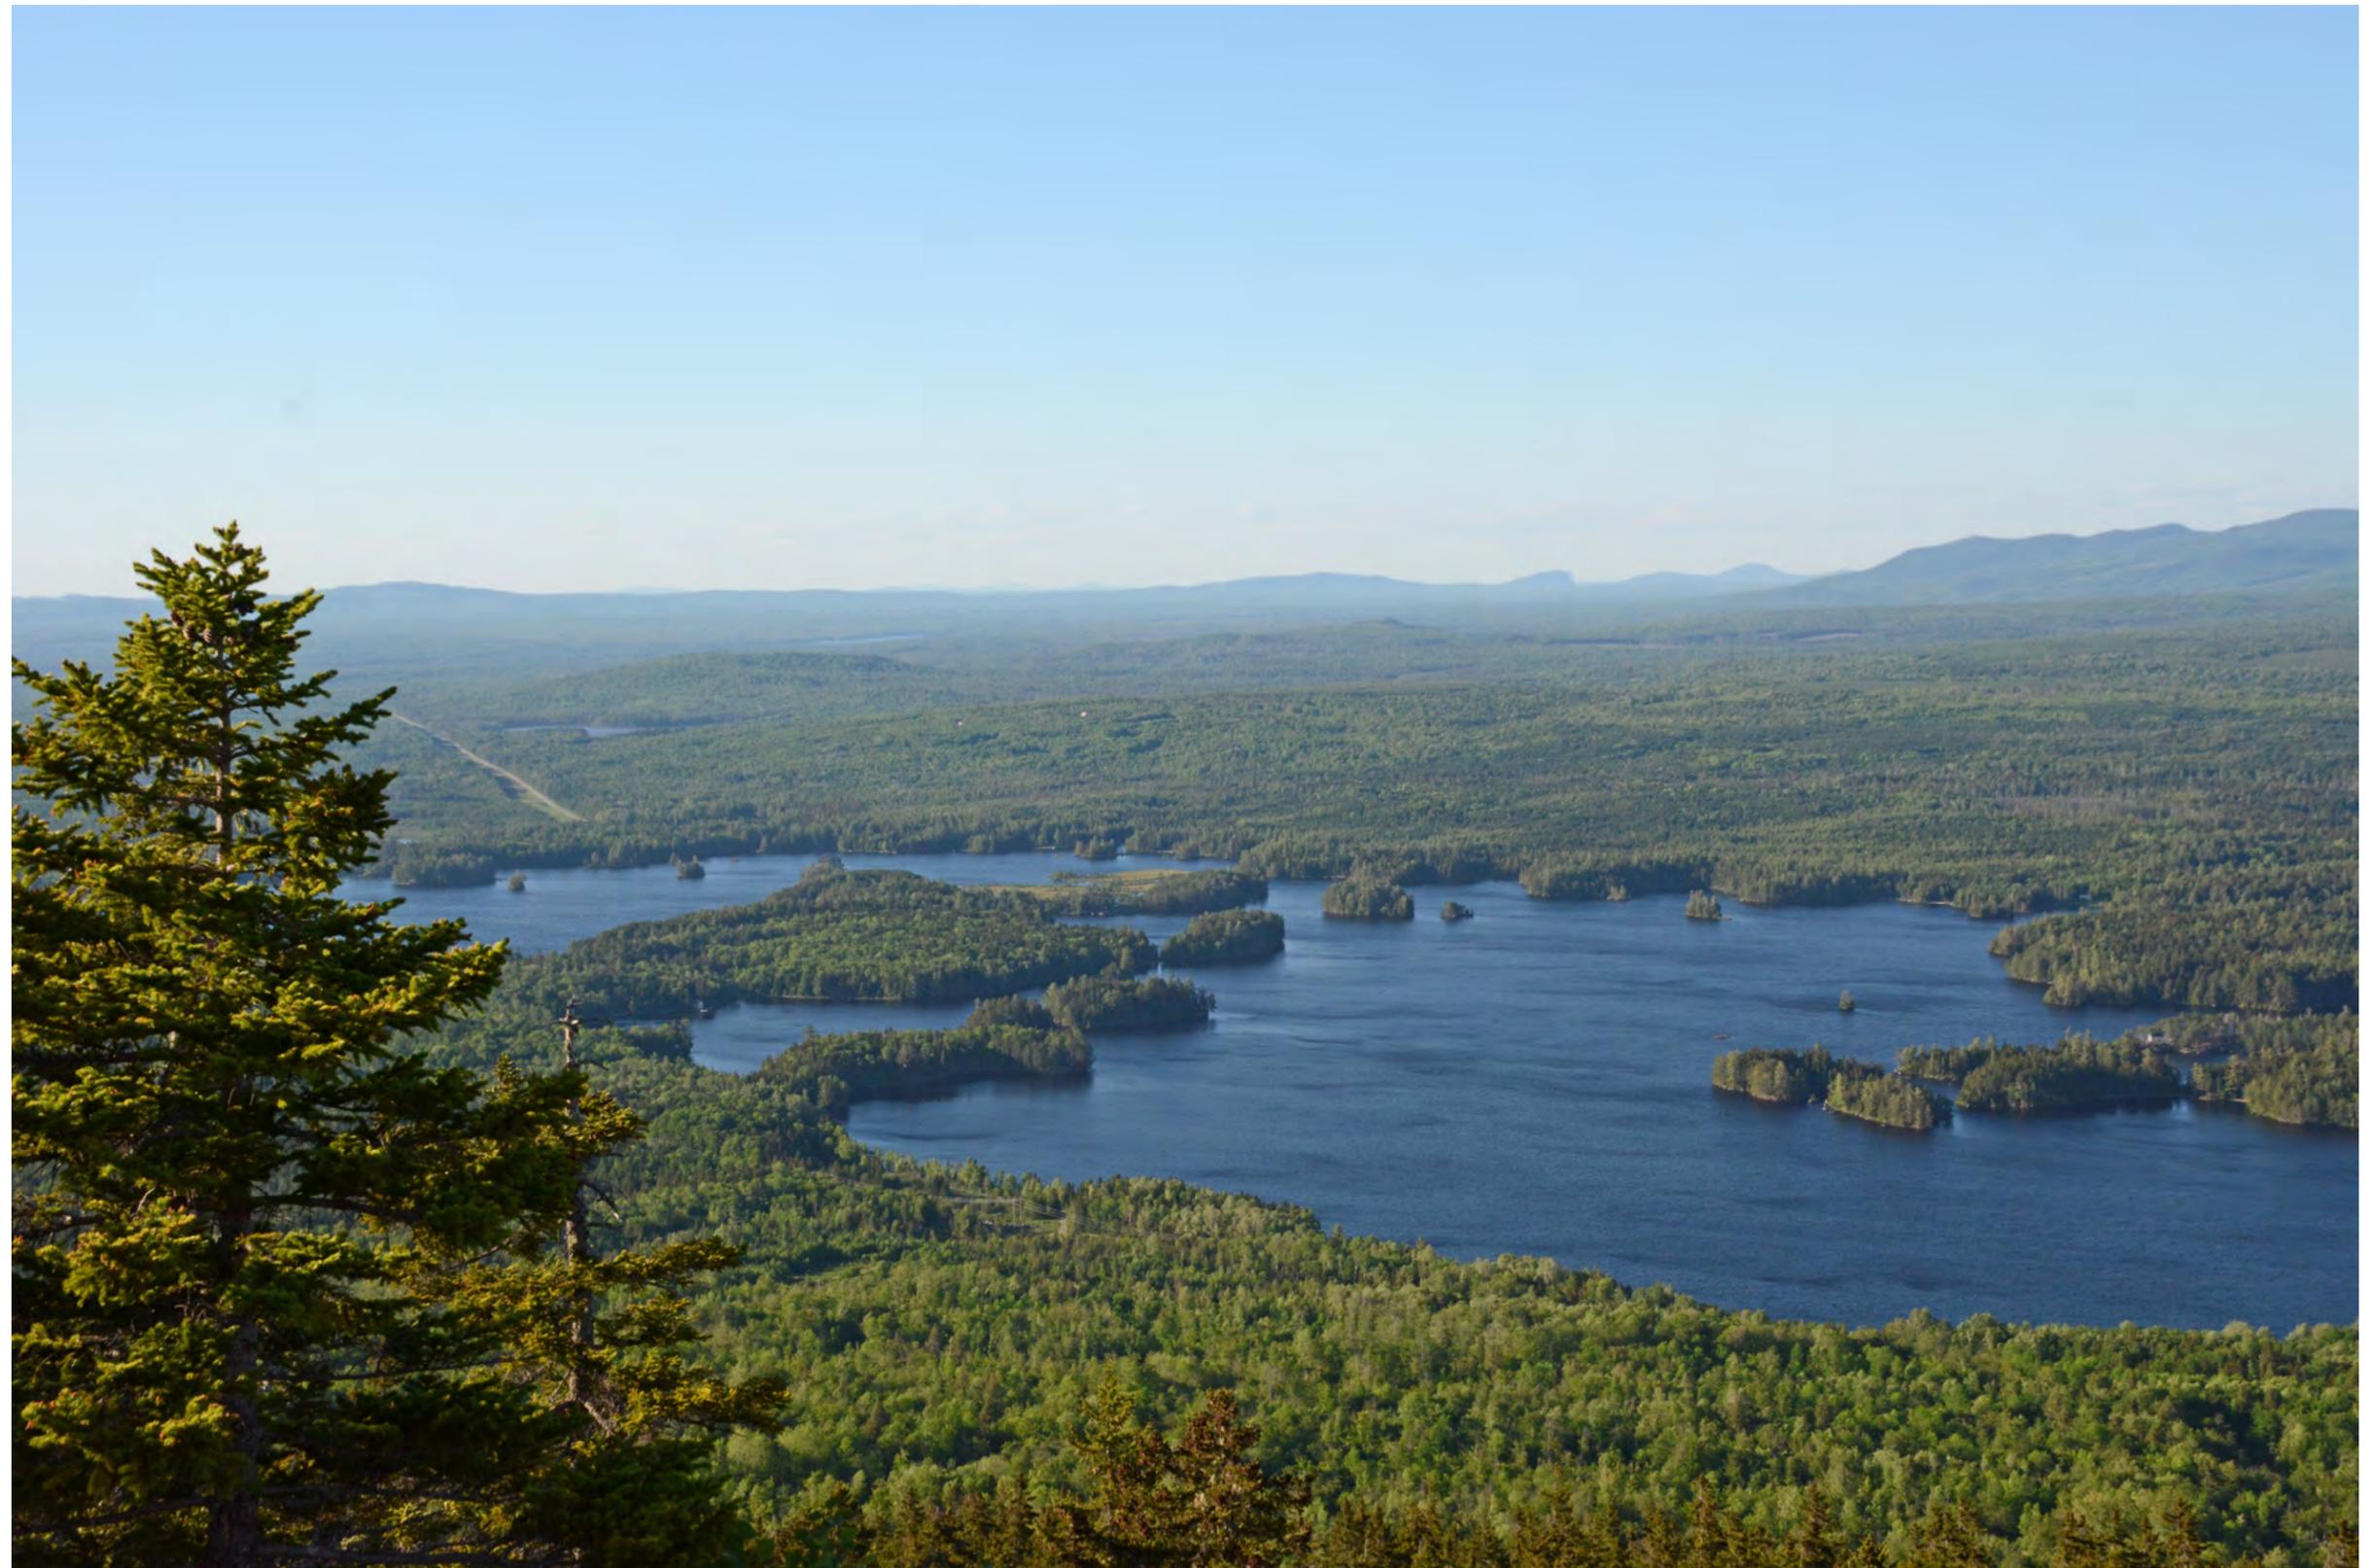
**PHOTOSIMULATION 16A: MOSQUITO MOUNTAIN - Overlook Looking Northeast, The Forks PLT**

**Existing Conditions:** Normal view looking north from Mosquito Mountain towards the existing 115 kV transmission line and the northern end of Moxie Pond. The existing transmission line corridor and Indian Pond Road to Harris Dam are visible on the left side of the image, north of Moxie Pond.

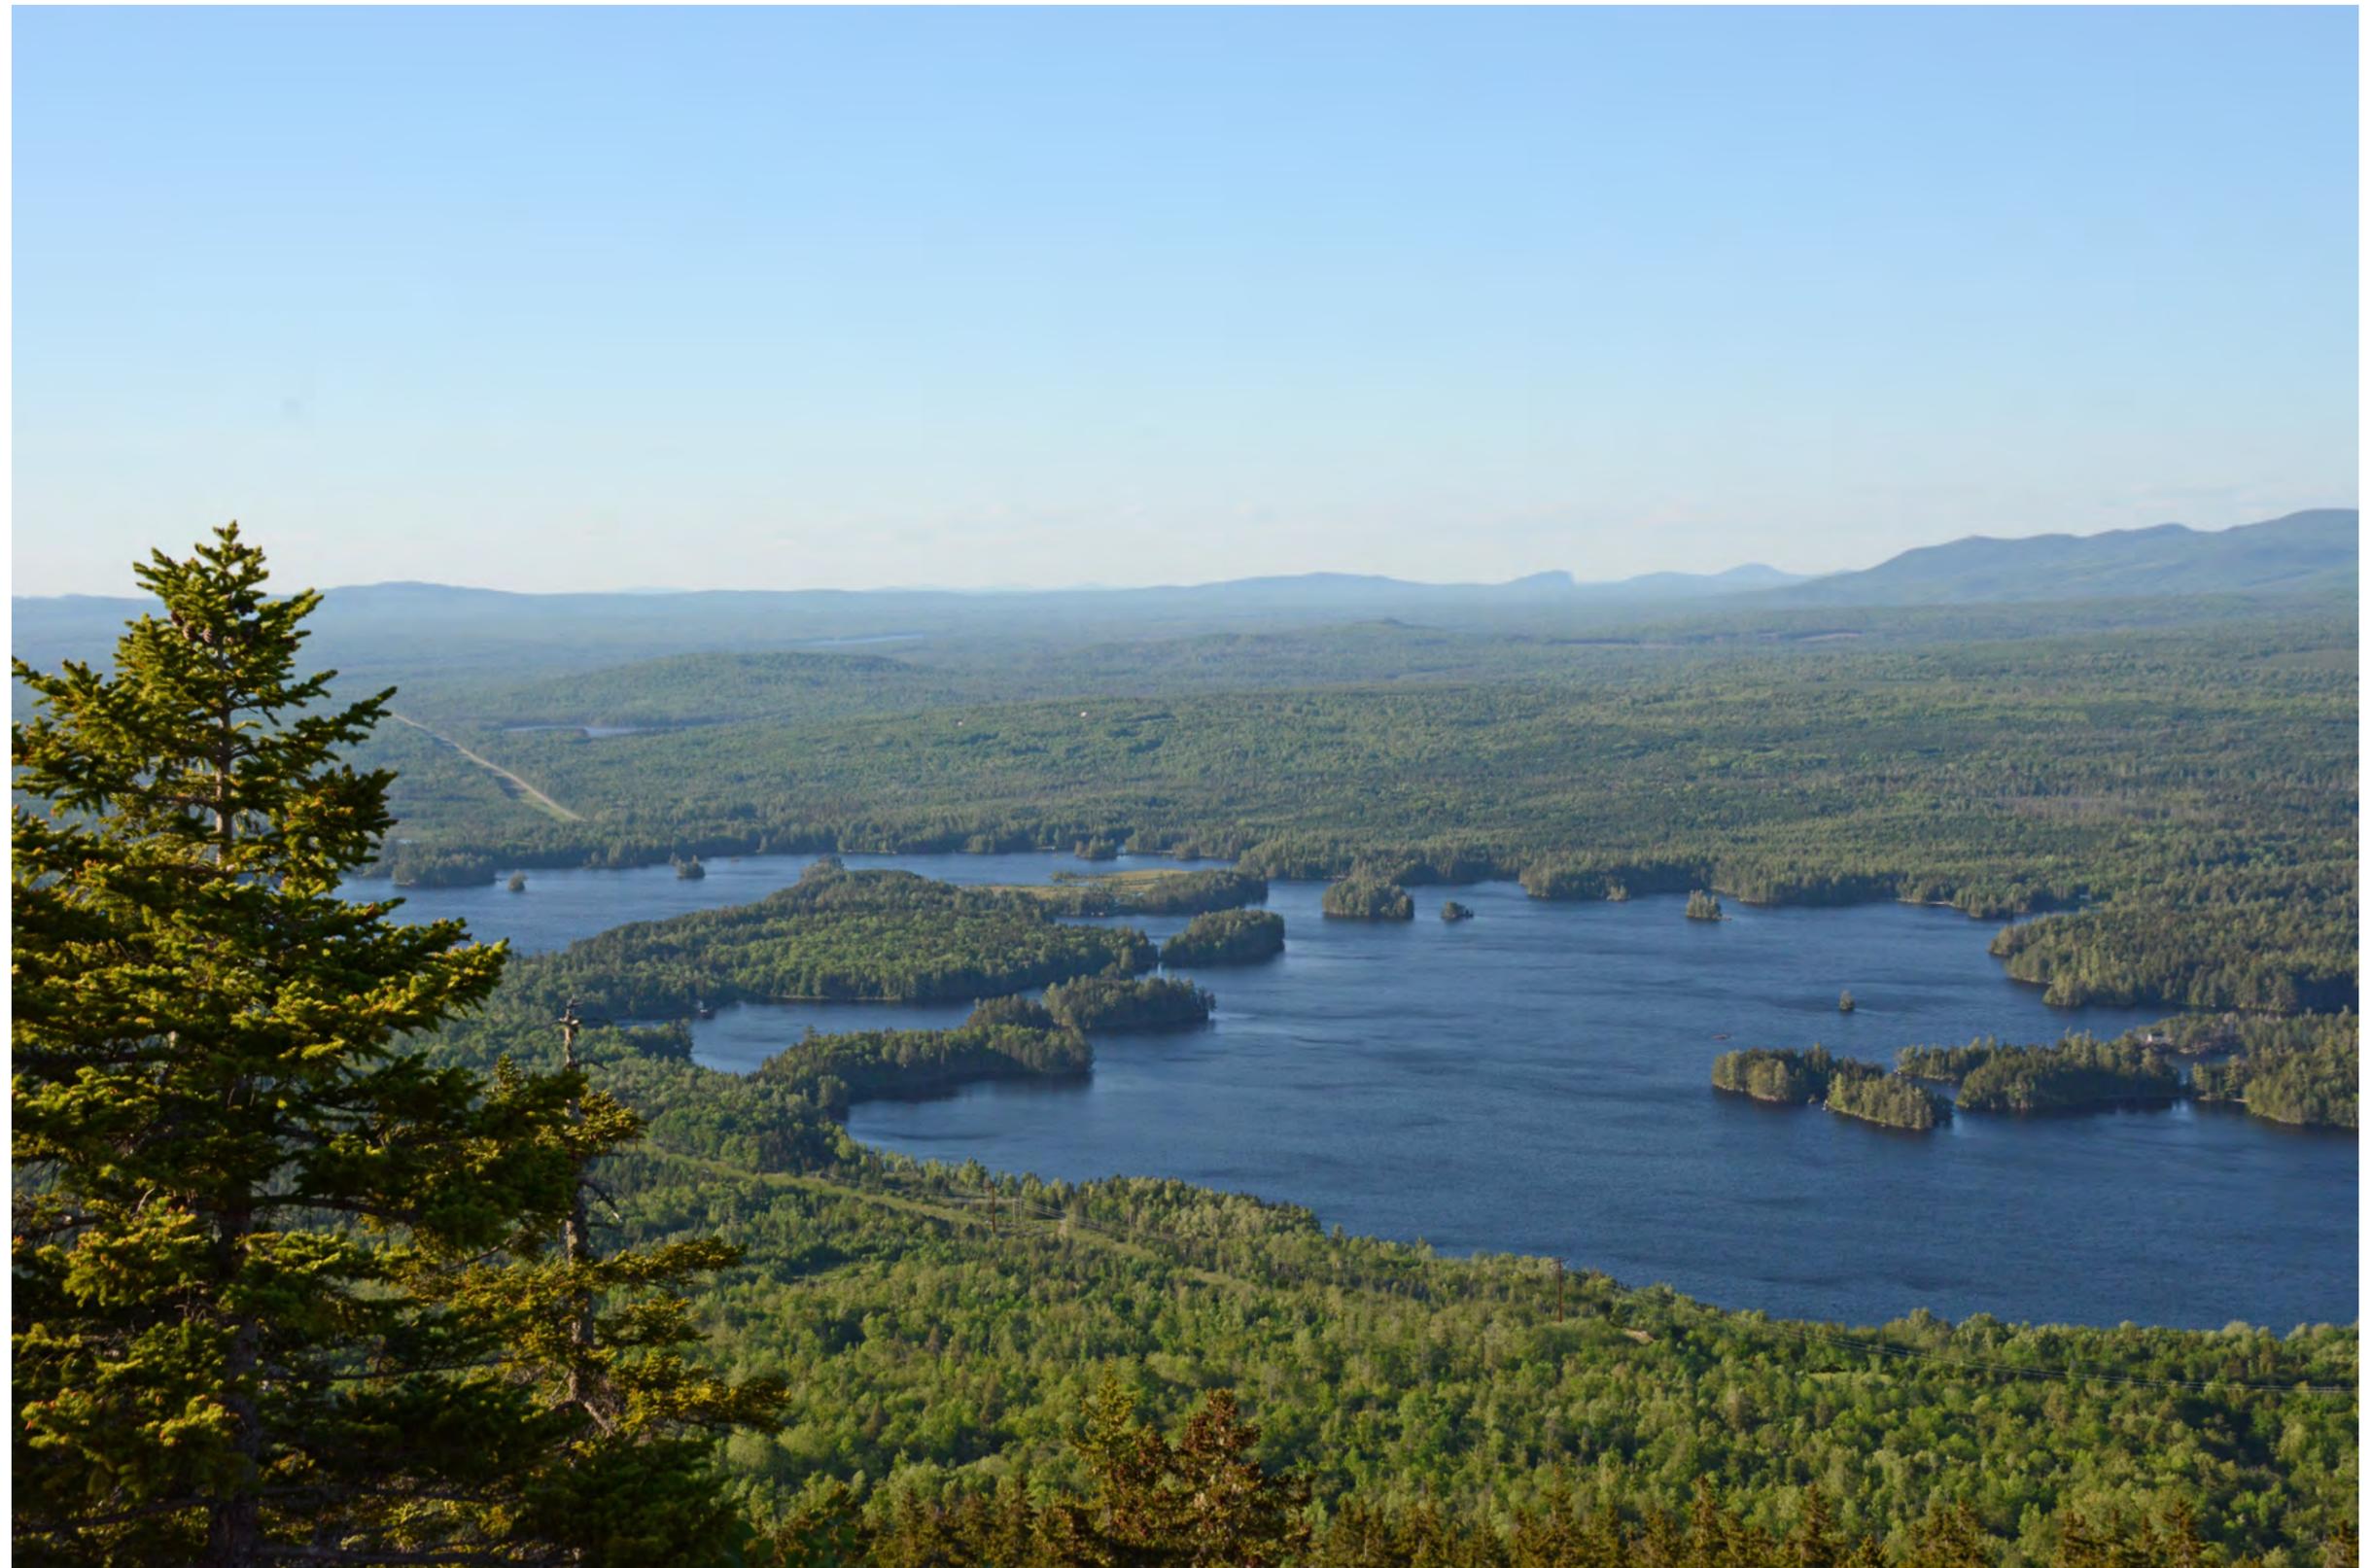
**PHOTOSIMULATION 16A: MOSQUITO MOUNTAIN - Overlook Looking Northeast, The Forks PLT**

**Proposed Conditions:** Normal view looking north from Mosquito Mountain toward the proposed co-located HVDC transmission line. The existing 150' wide transmission line corridor clearing will be widened by 75' on the western side to accommodate the proposed co-located HVDC transmission line. Three structures and conductors will be visible from this viewpoint at distances of 0.9 to 1.3 miles.
