# PHOTOSIMULATION 13: MOXIE POND - North, East Moxie Twp

**PHOTOSIMULATION 13A: MOXIE POND - North, East Moxie Twp**

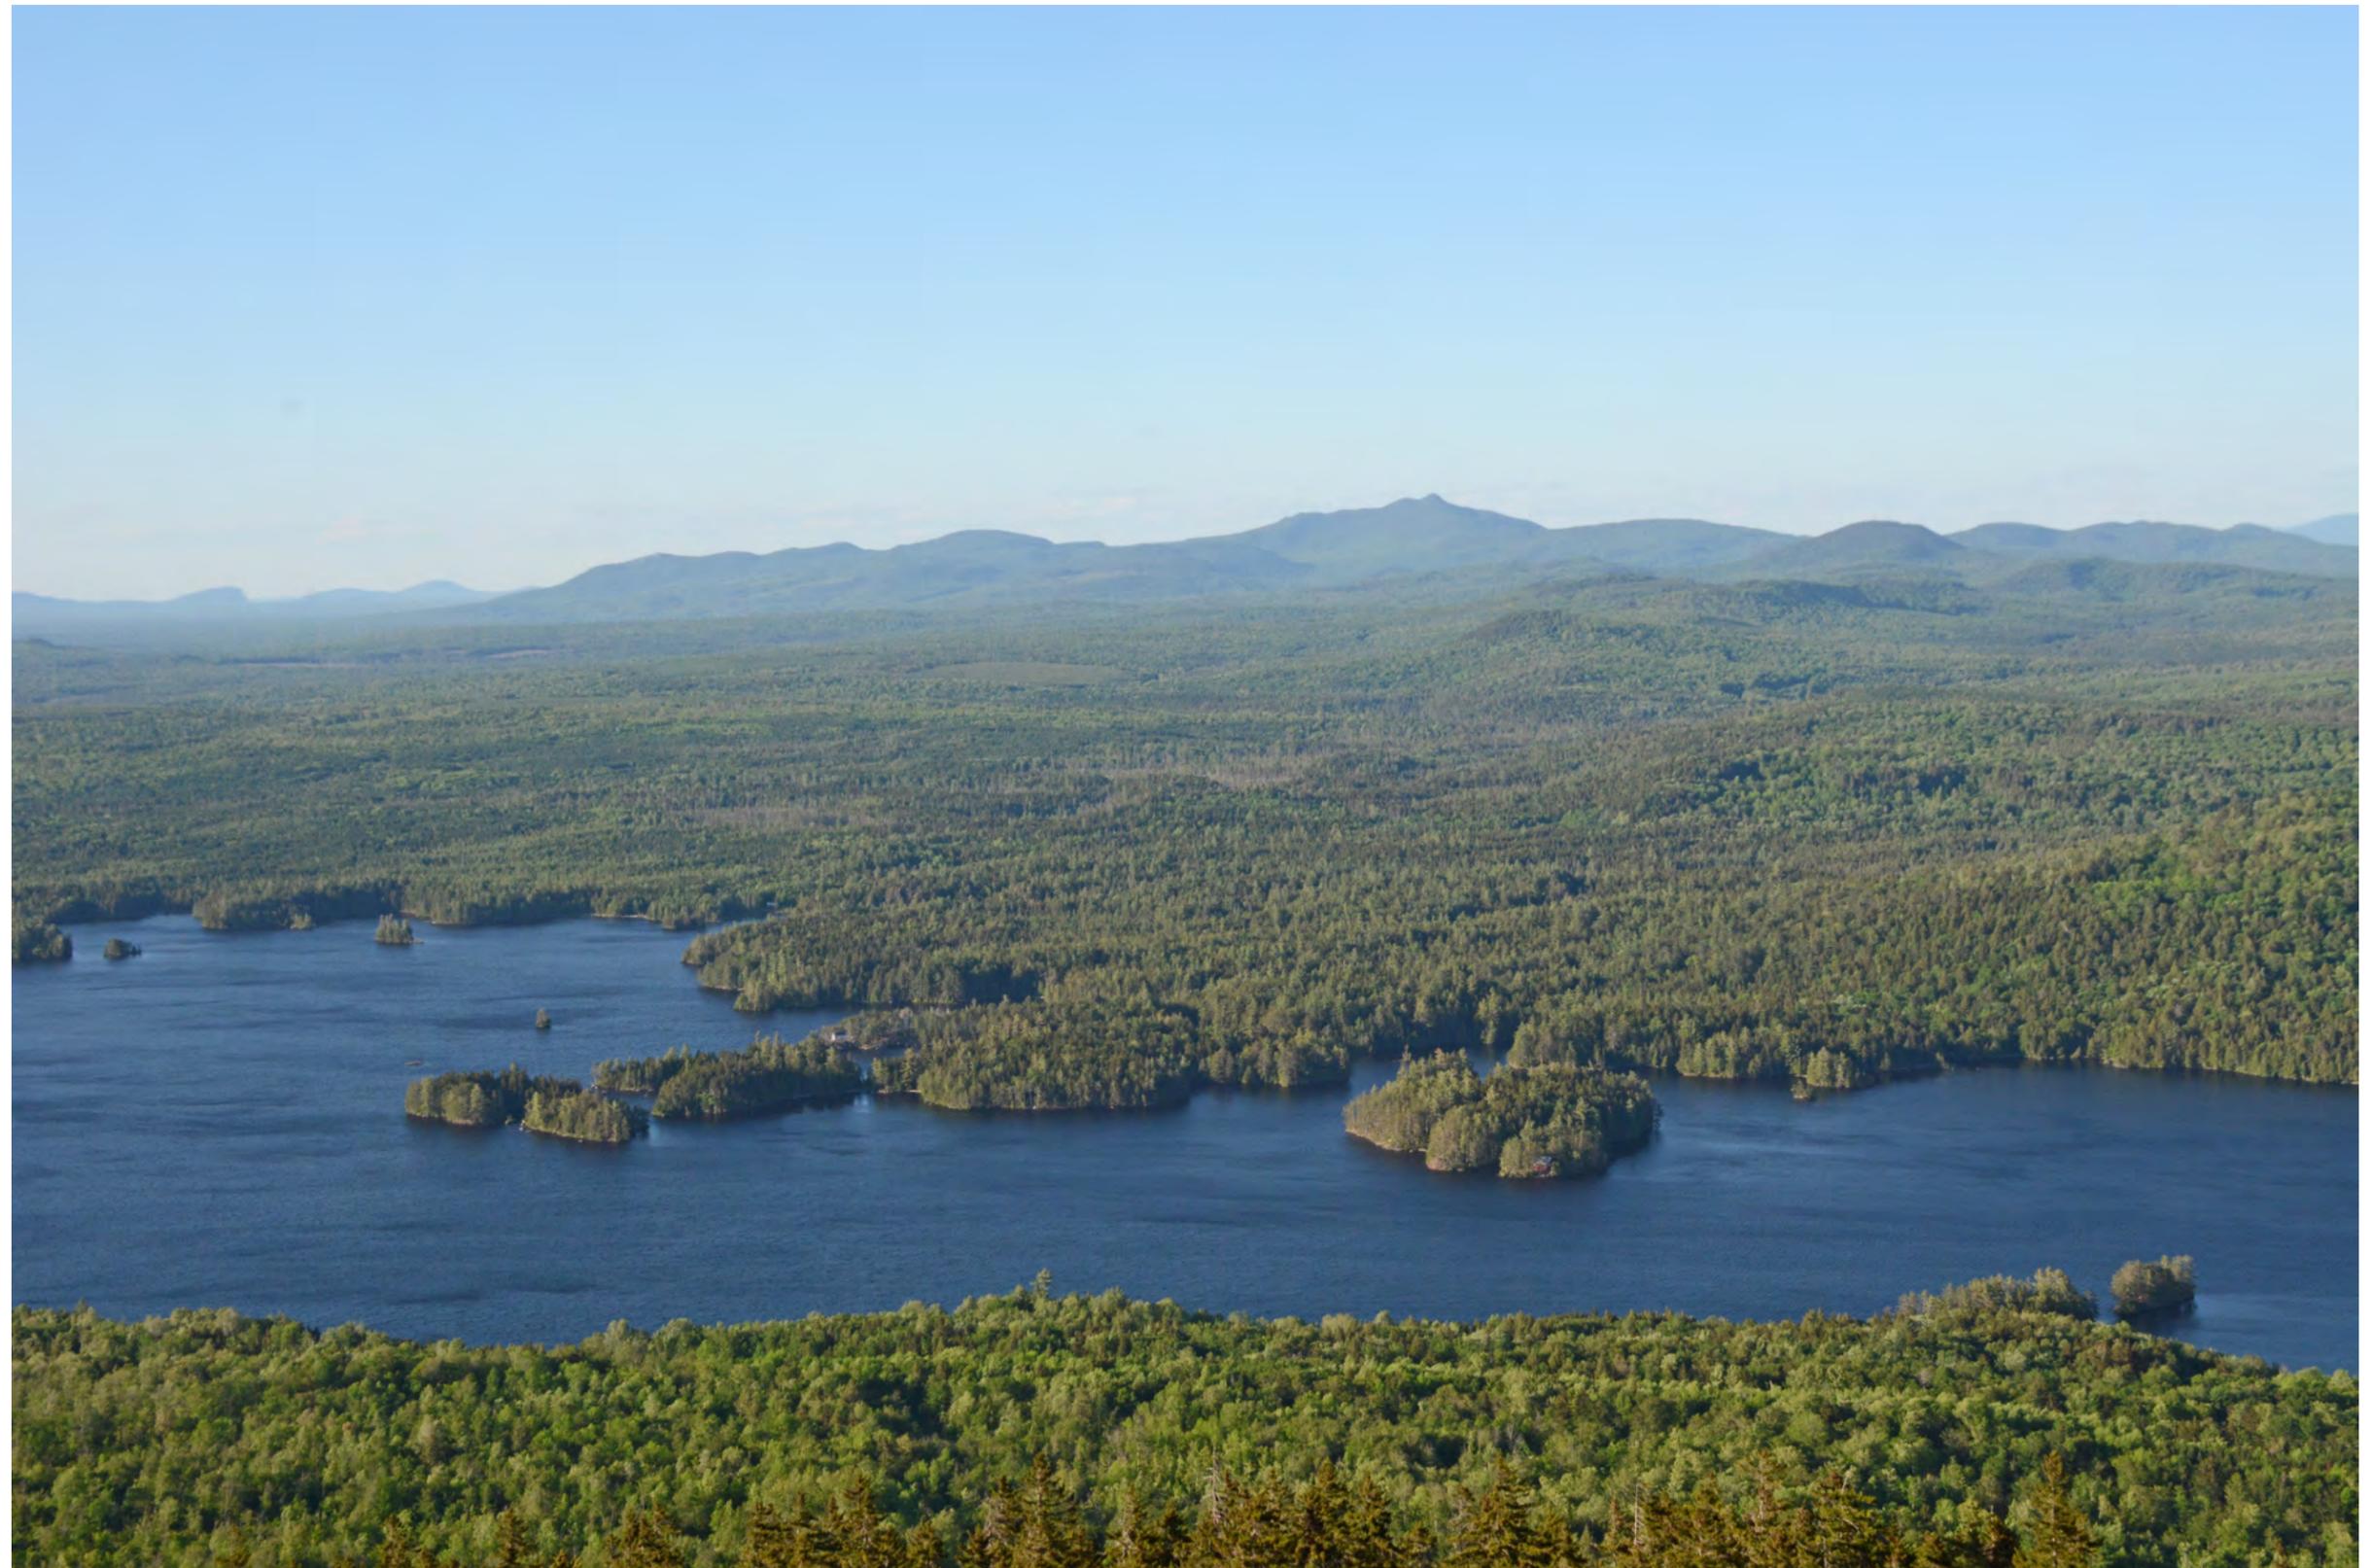
**PHOTOSIMULATION I6B: MOSQUITO MOUNTAIN - Overlook Looking Northeast, The Forks PLT**

**Existing Conditions:** Normal view looking northeast from Mosquito Mountain. Burnt Jacket Island in Moxie Pond is visible right of center in image. The existing 115 kV transmission line is mostly screened by vegetation in this view.

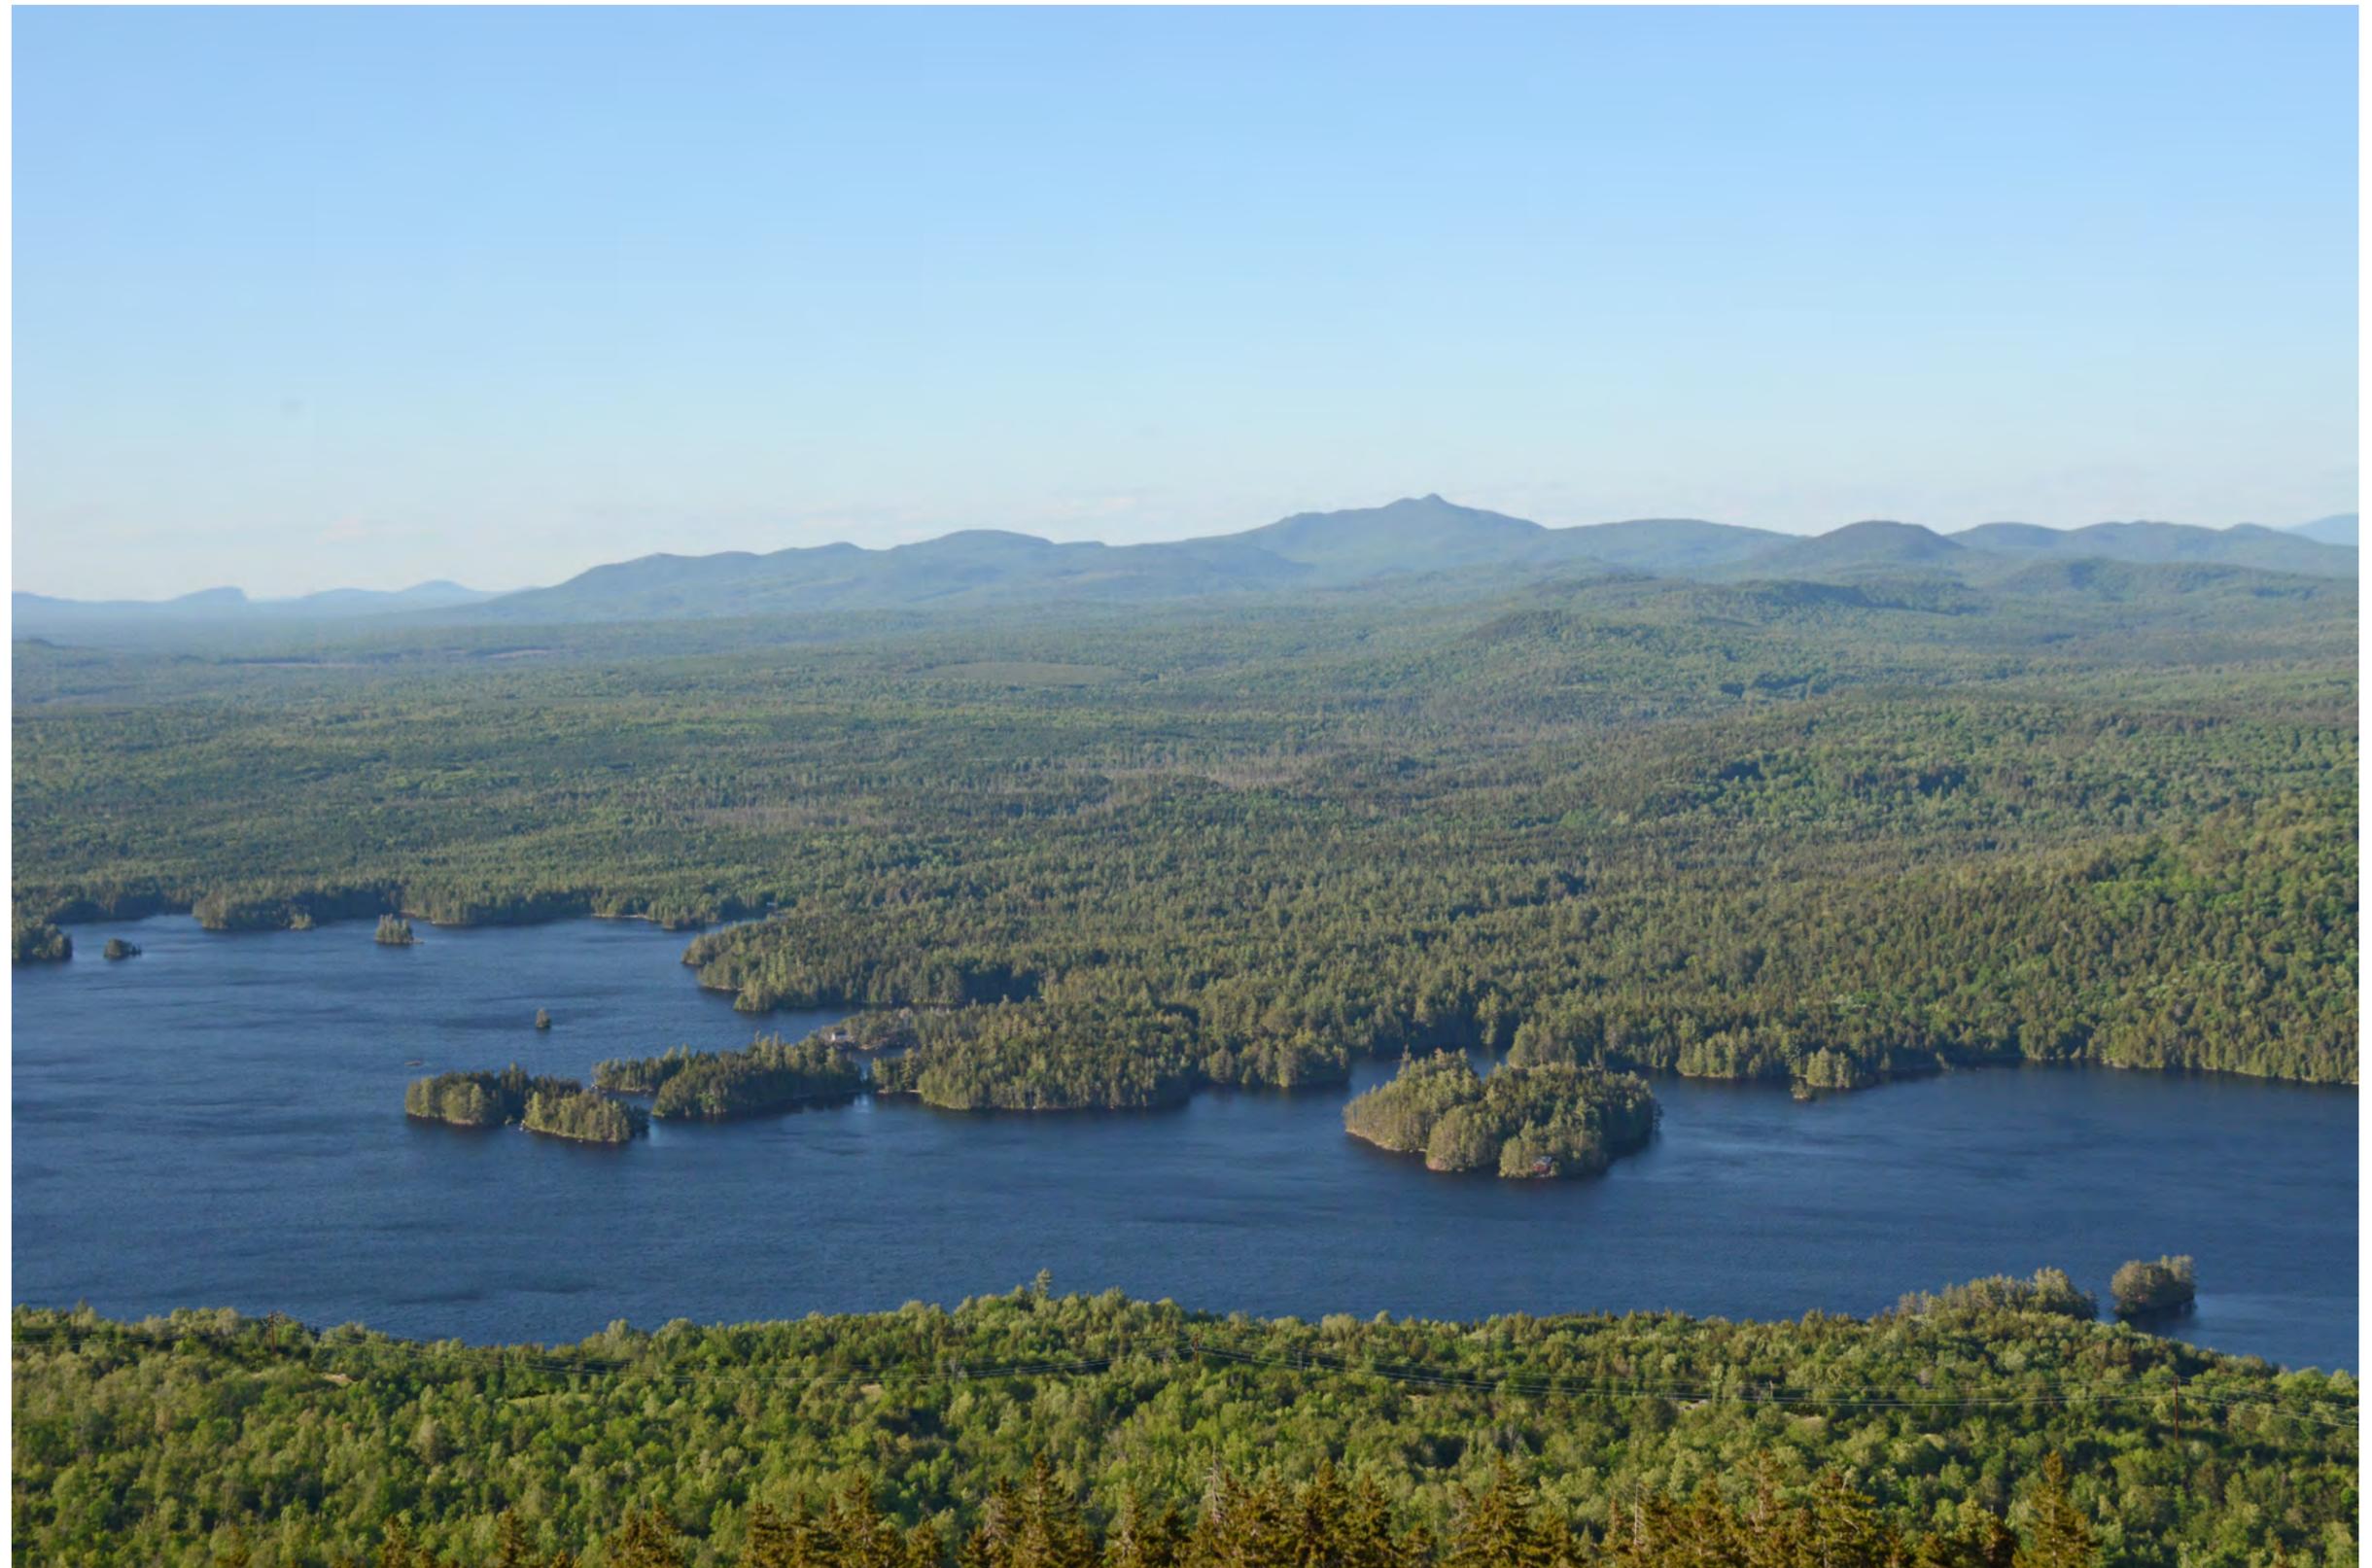
**PHOTOSIMULATION 16B: MOSQUITO MOUNTAIN - Overlook Looking Northeast, The Forks PLT**

**Proposed Conditions:** Normal view looking northeast from Mosquito Mountain toward the proposed co-located HVDC transmission line. The existing 150' wide transmission line corridor clearing will be widened by 75' on the western side to accommodate the proposed Co-located HVDC transmission line. Three structures and conductors will be visible from this viewpoint at distances of 0.7 to 0.9 miles.

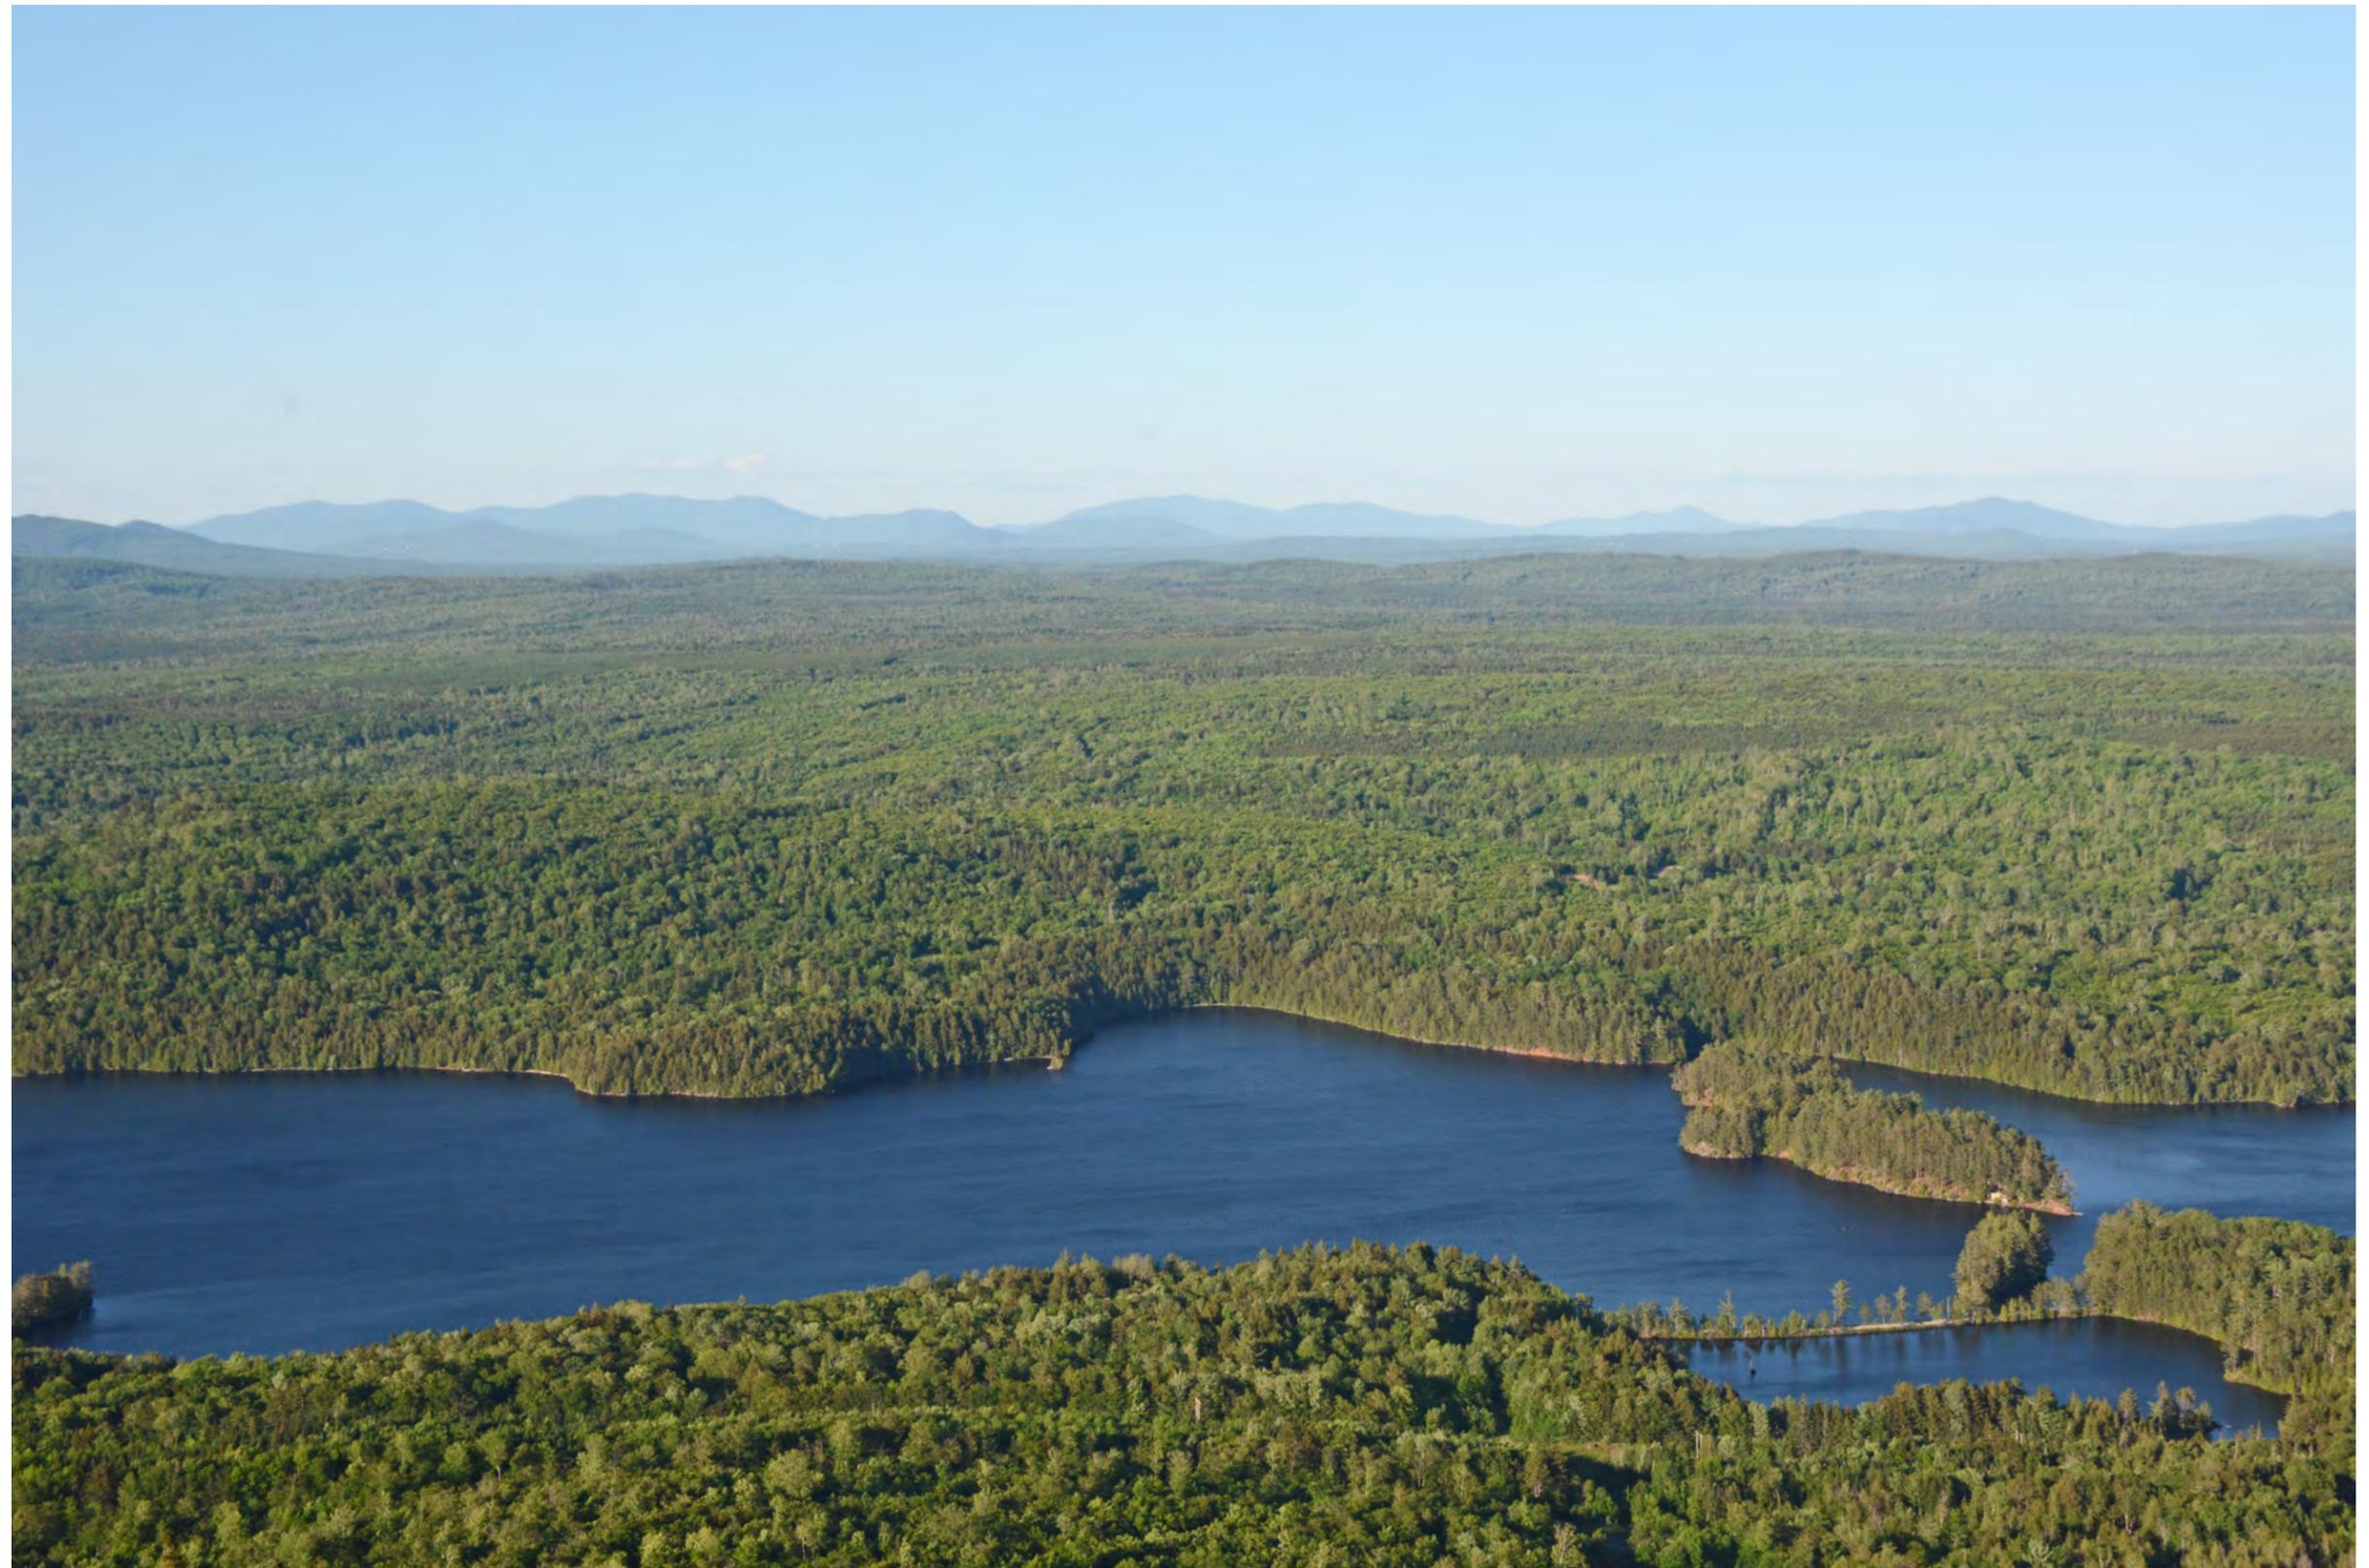
**PHOTOSIMULATION I6C: MOSQUITO MOUNTAIN - Overlook Looking Northeast, The Forks PLT**

**Existing Conditions:** Normal view looking east from Mosquito Mountain. Moxie Pond is visible across the entire image with Black Narrows on right in image. The existing 115 kV transmission line and Troutdale Road are visible

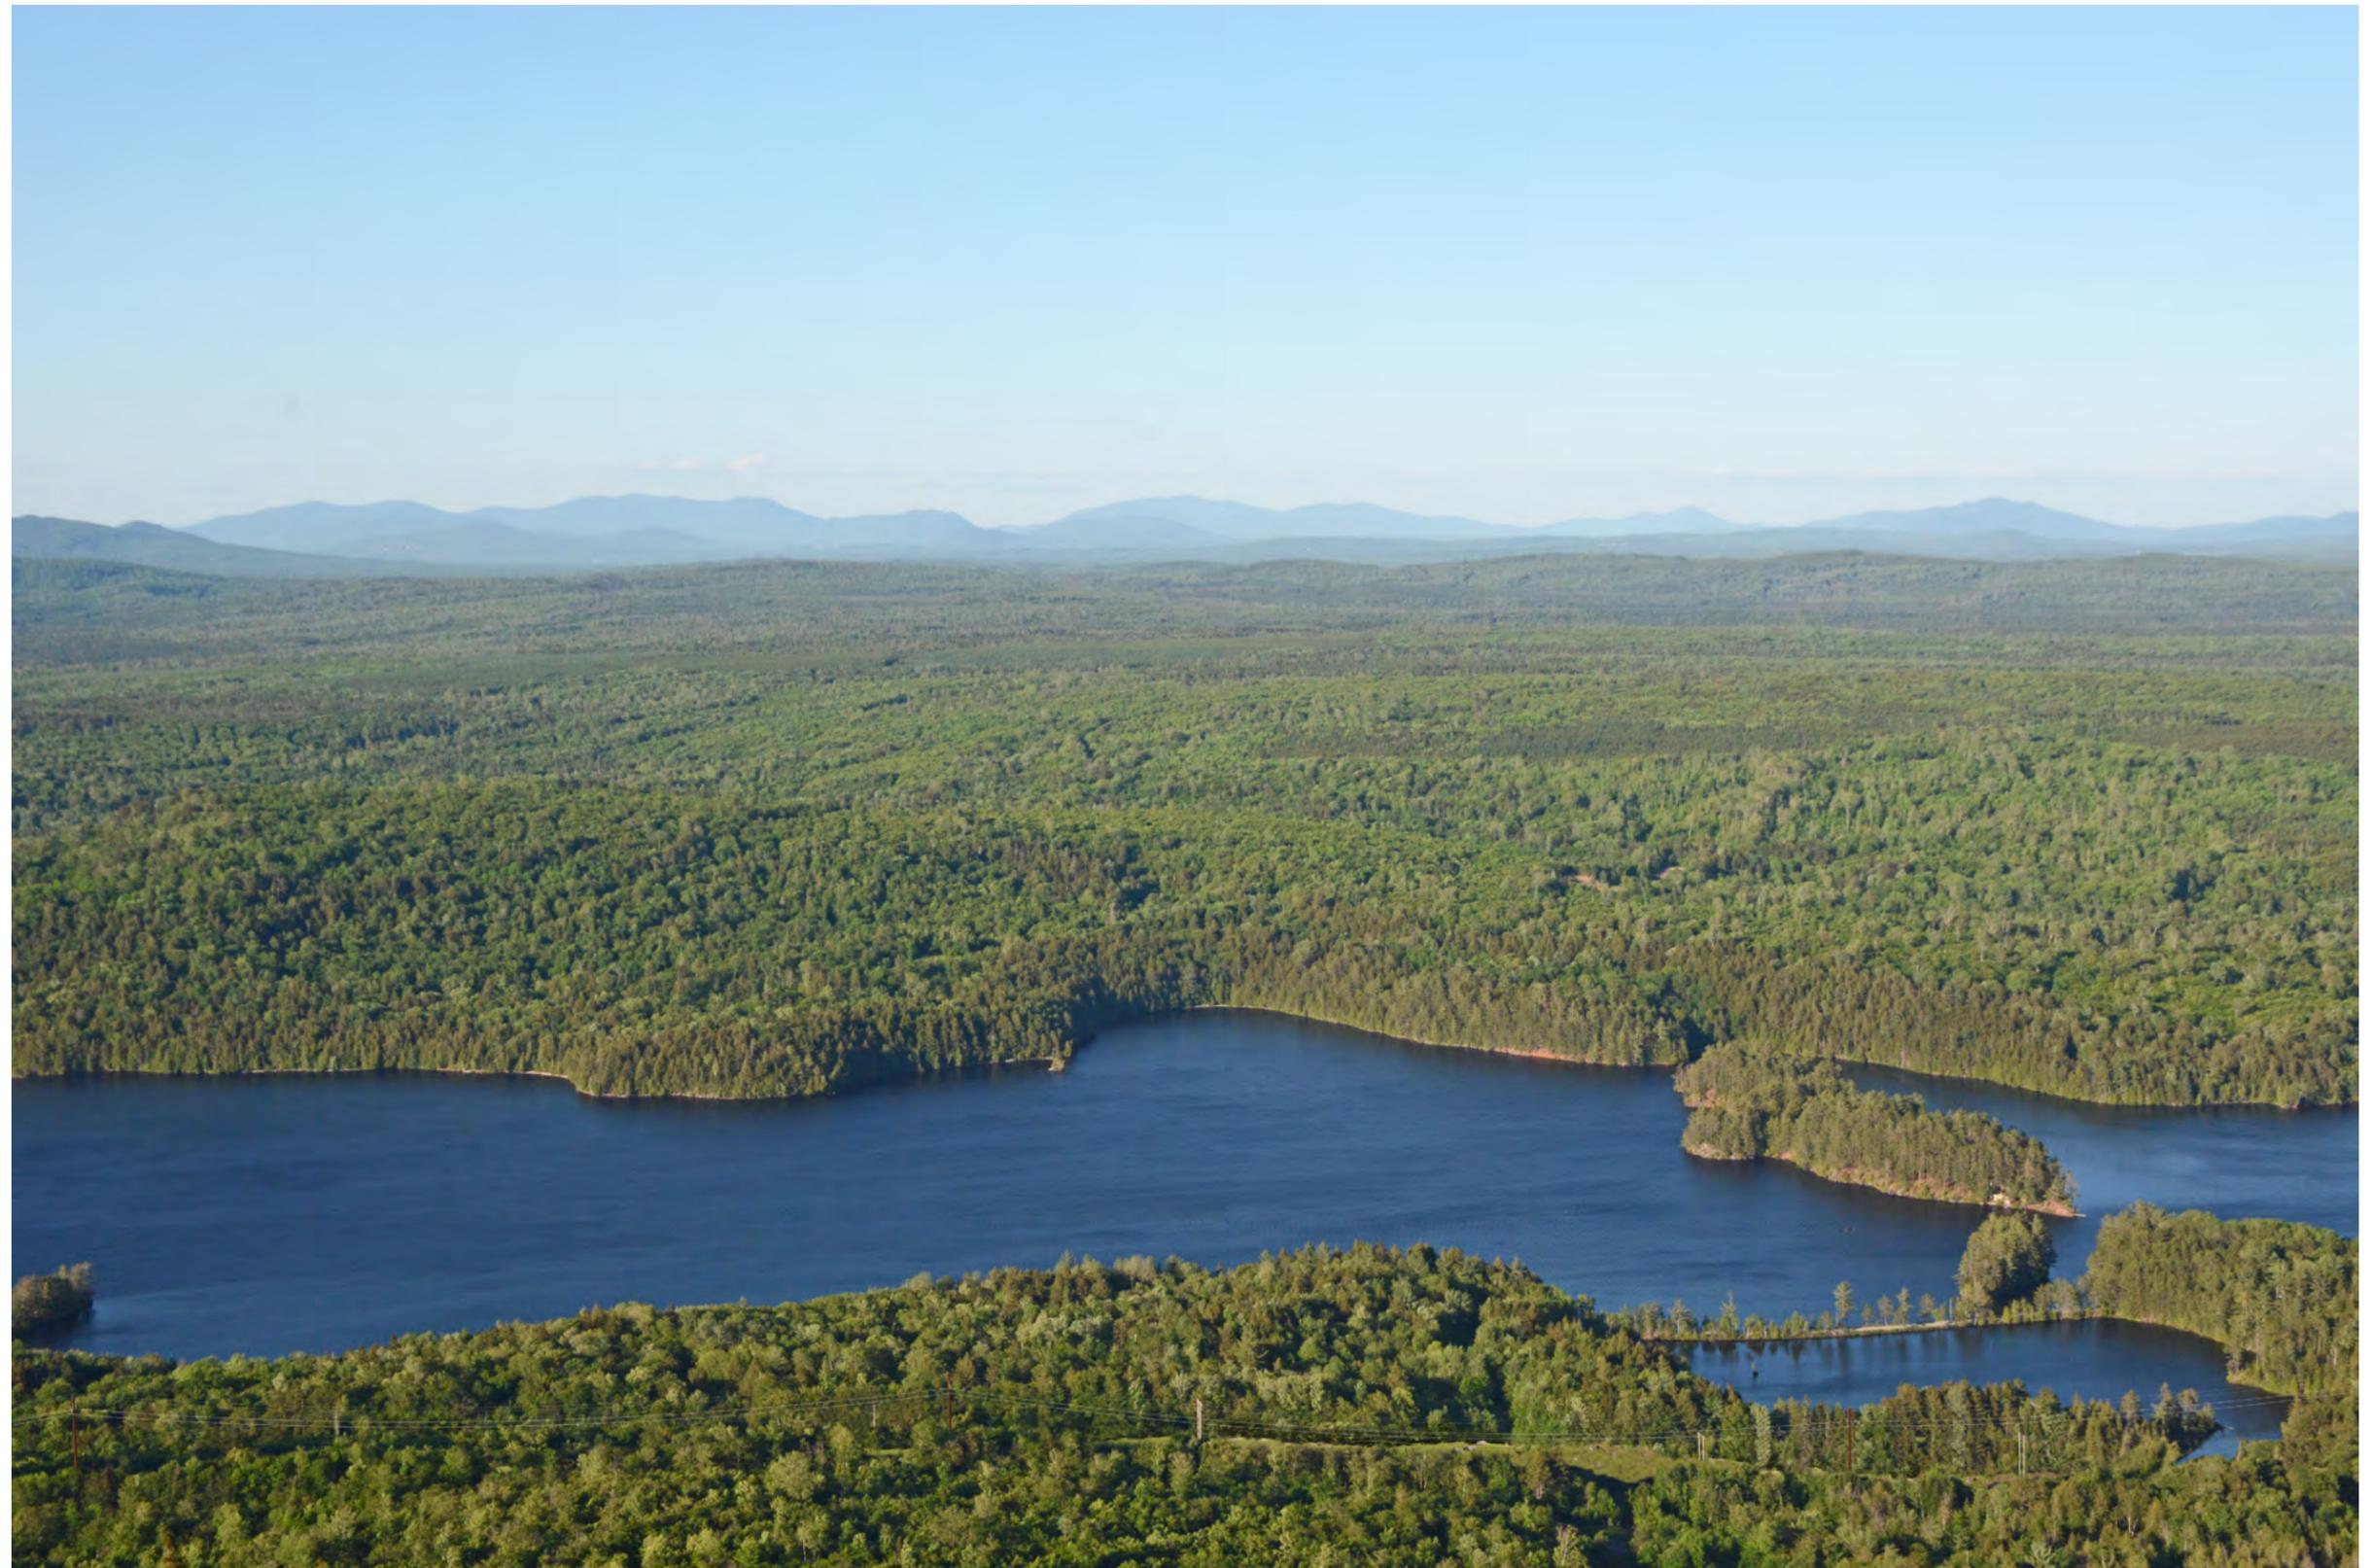
**PHOTOSIMULATION 16C: MOSQUITO MOUNTAIN - Overlook Looking Northeast, The Forks PLT**

**Proposed Conditions:** Normal view looking east from Mosquito Mountain toward the proposed co-located HVDC transmission line. The existing 150' wide transmission line corridor clearing will be widened by 75' on the western side to accommodate the proposed co-located HVDC transmission line. Three structures and conductors will be visible from this viewpoint at distances of 0.7 to 0.75 miles.

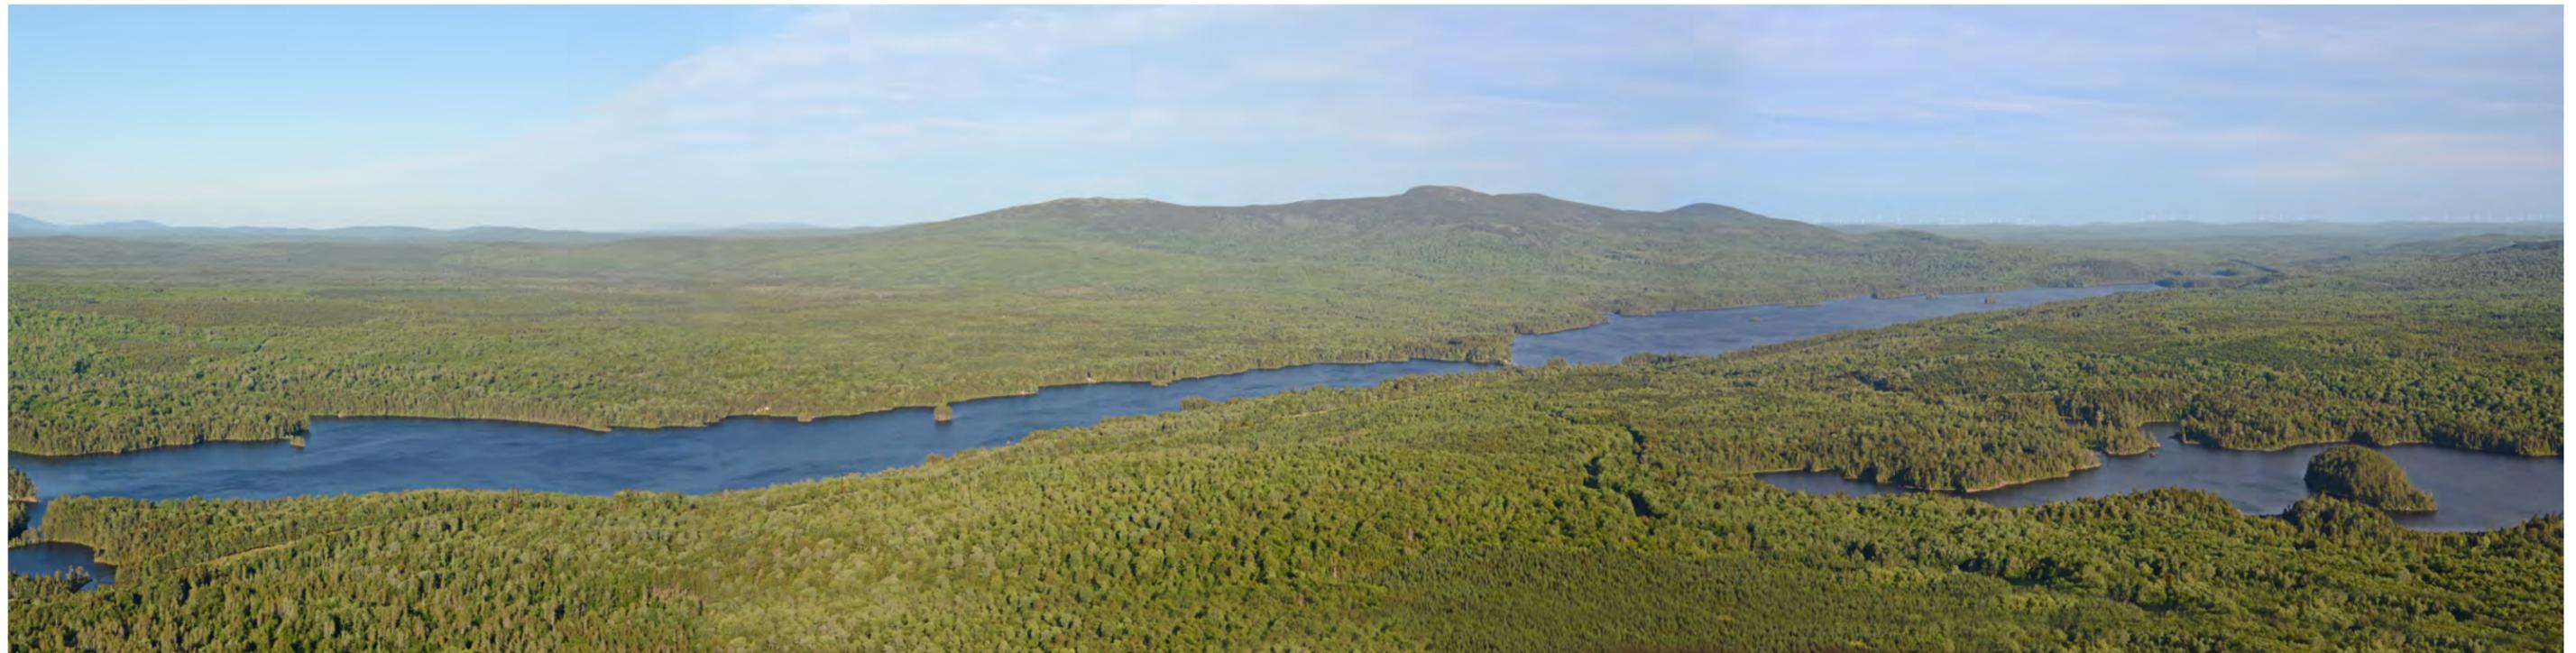
# PHOTOSIMULATION 17: MOSQUITO MOUNTAIN - Looking Southeast, The Forks Plt

**Proposed Conditions:** Continued panoramic view looking from east to south from the eastern overlook of Mosquito Mountain toward the proposed co-located HVDC transmission line (see Photosimulation 17 for view to northeast). The existing 150' wide transmission line corridor clearing will be widened by 75' on the western side to accommodate the proposed HVDC transmission line. Bald Mountain is visible in the center of the image. Mosquito Pond is visible on the right side of the image. Moxie Pond, from Black Narrows to the Southern end, is visible across the entire image. The Bingham Wind Project is visible to the east at 14.5 miles. Up to 13 structures, conductors, and portions of the cleared corridor will be visible from within 3 miles from this viewpoint. See Appendix B: Study Area Photographs for additional images.

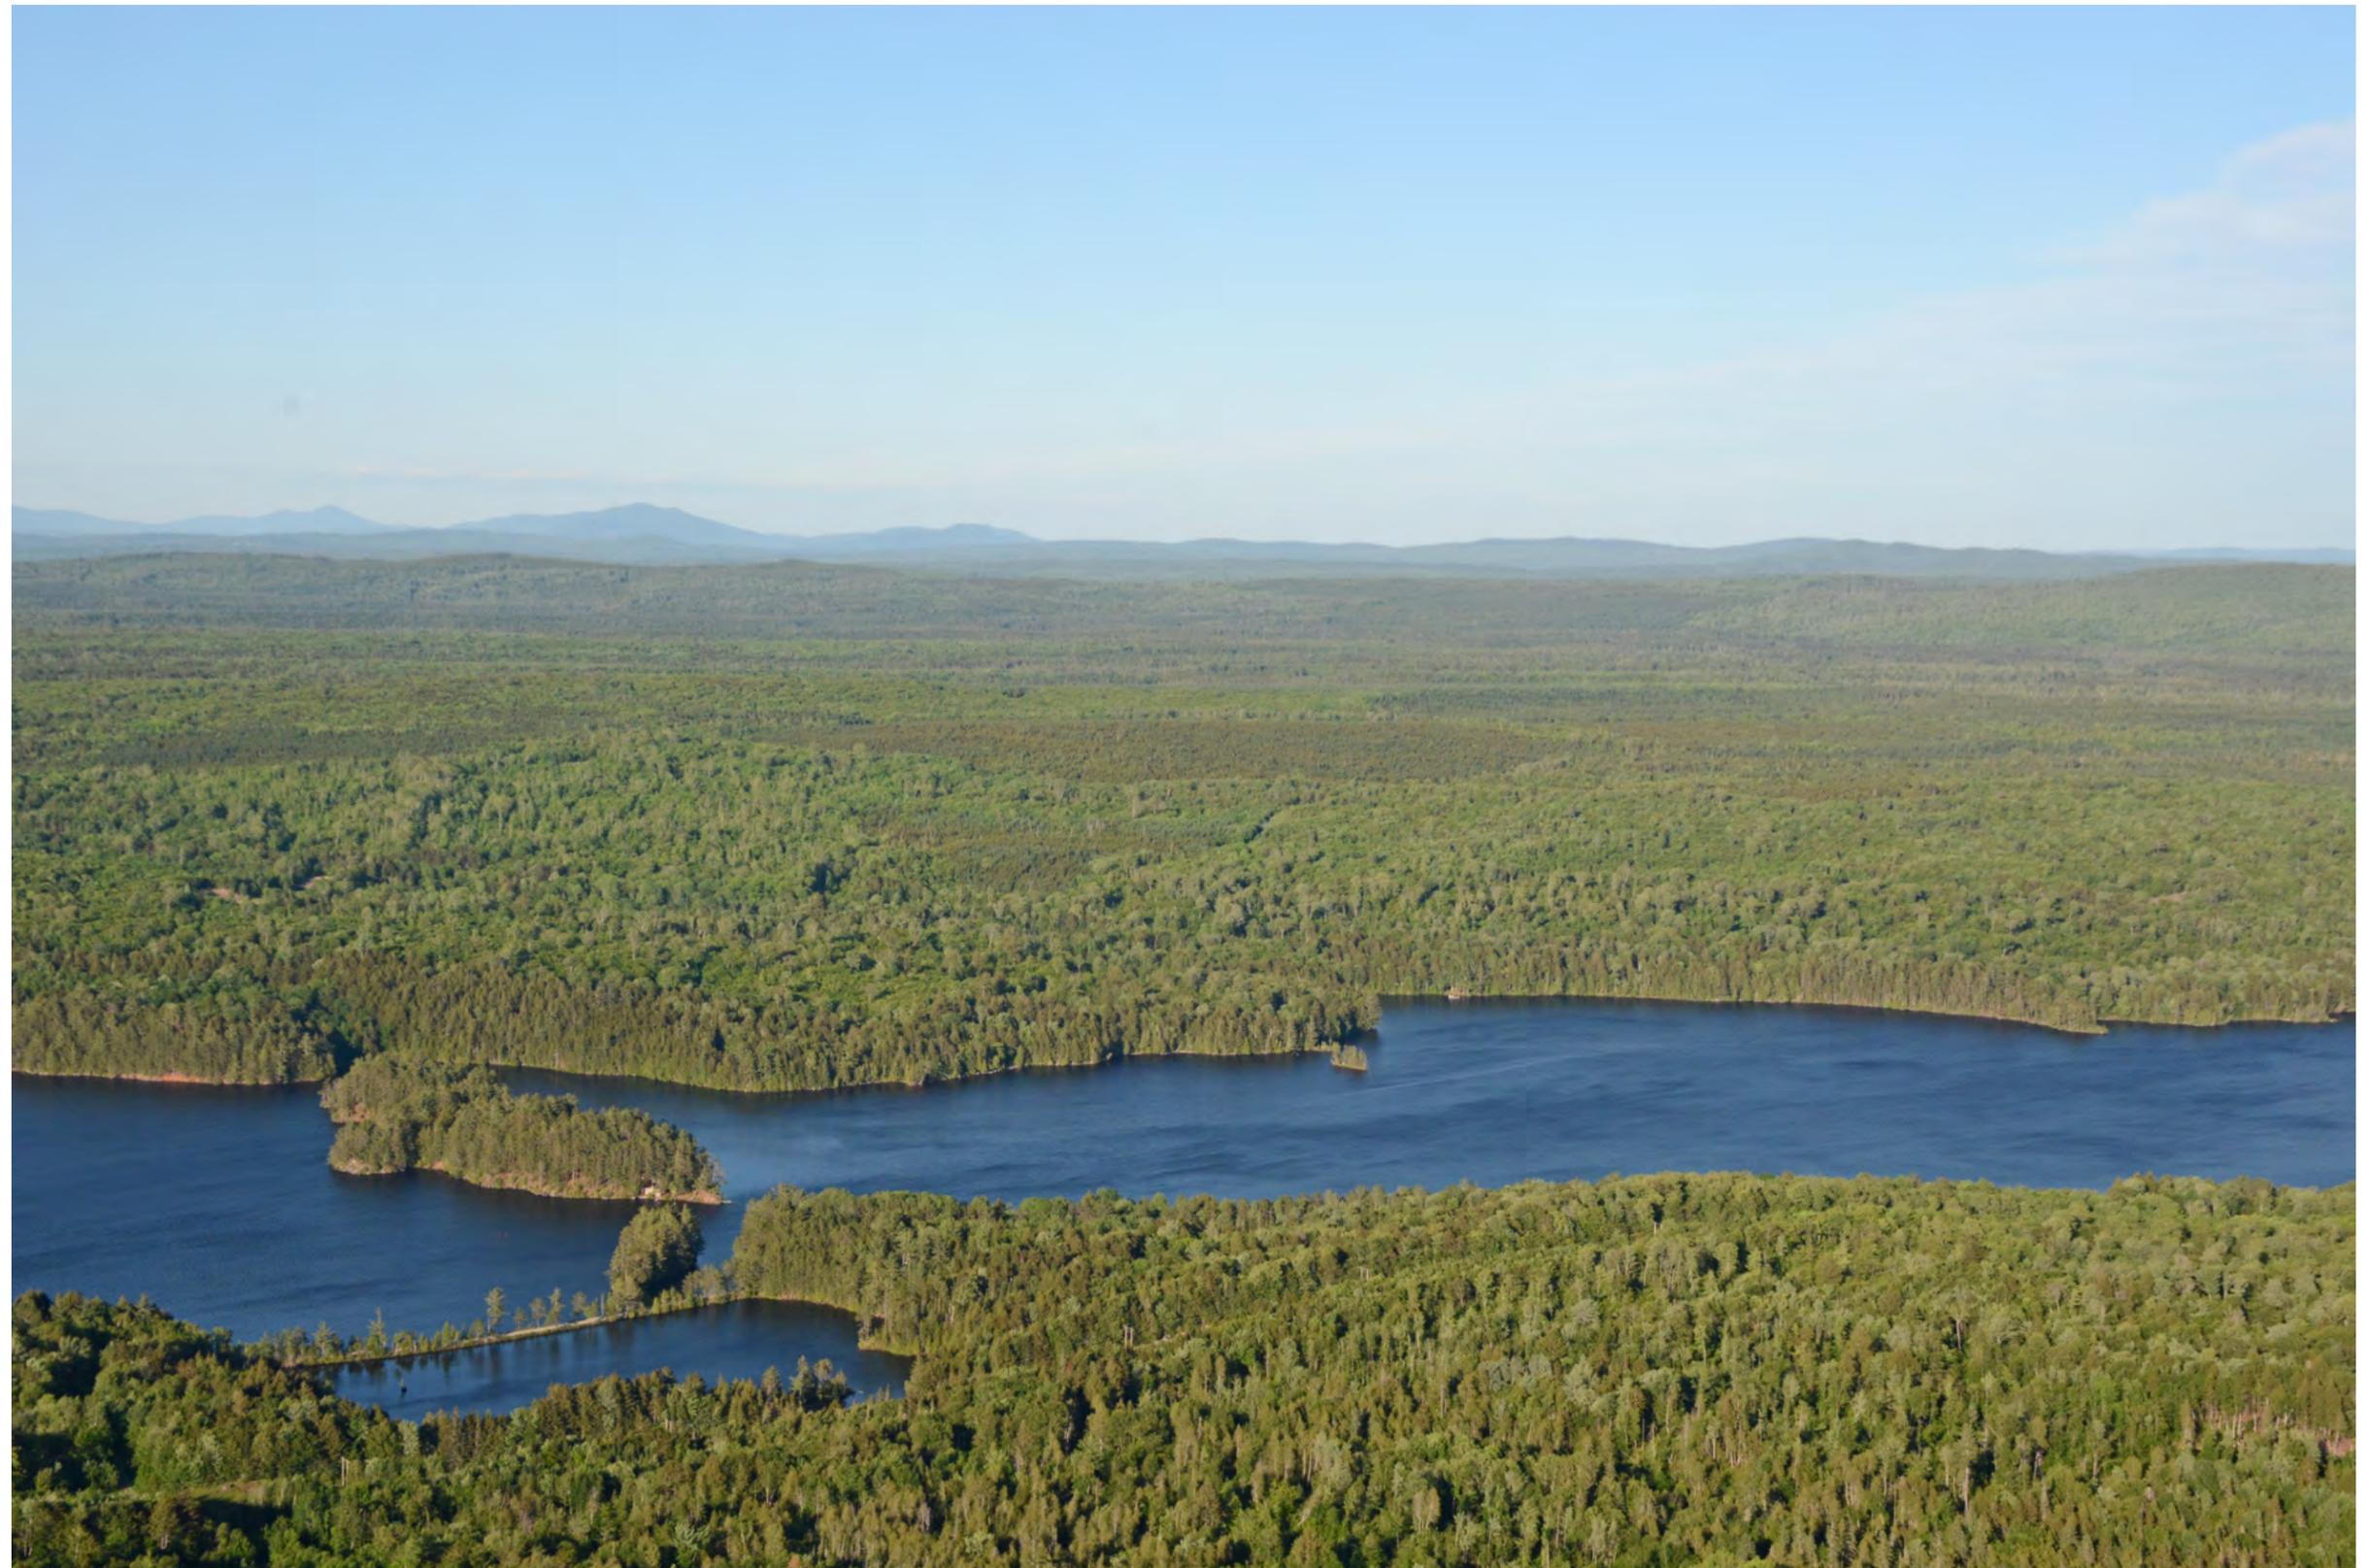
**PHOTOSIMULATION 17A: MOSQUITO MOUNTAIN - Looking Southeast , The Forks Pt**

**Existing Conditions:** Normal view looking east from Mosquito Mountain. Black Narrows in Moxie Pond is visible on the left side of the image. The existing 115 kV transmission line and Troutdale Road are visible.
