# PHOTOSIMULATION 13: MOXIE POND - North, East Moxie Twp

**PHOTOSIMULATION 13A: MOXIE POND - North, East Moxie Twp**

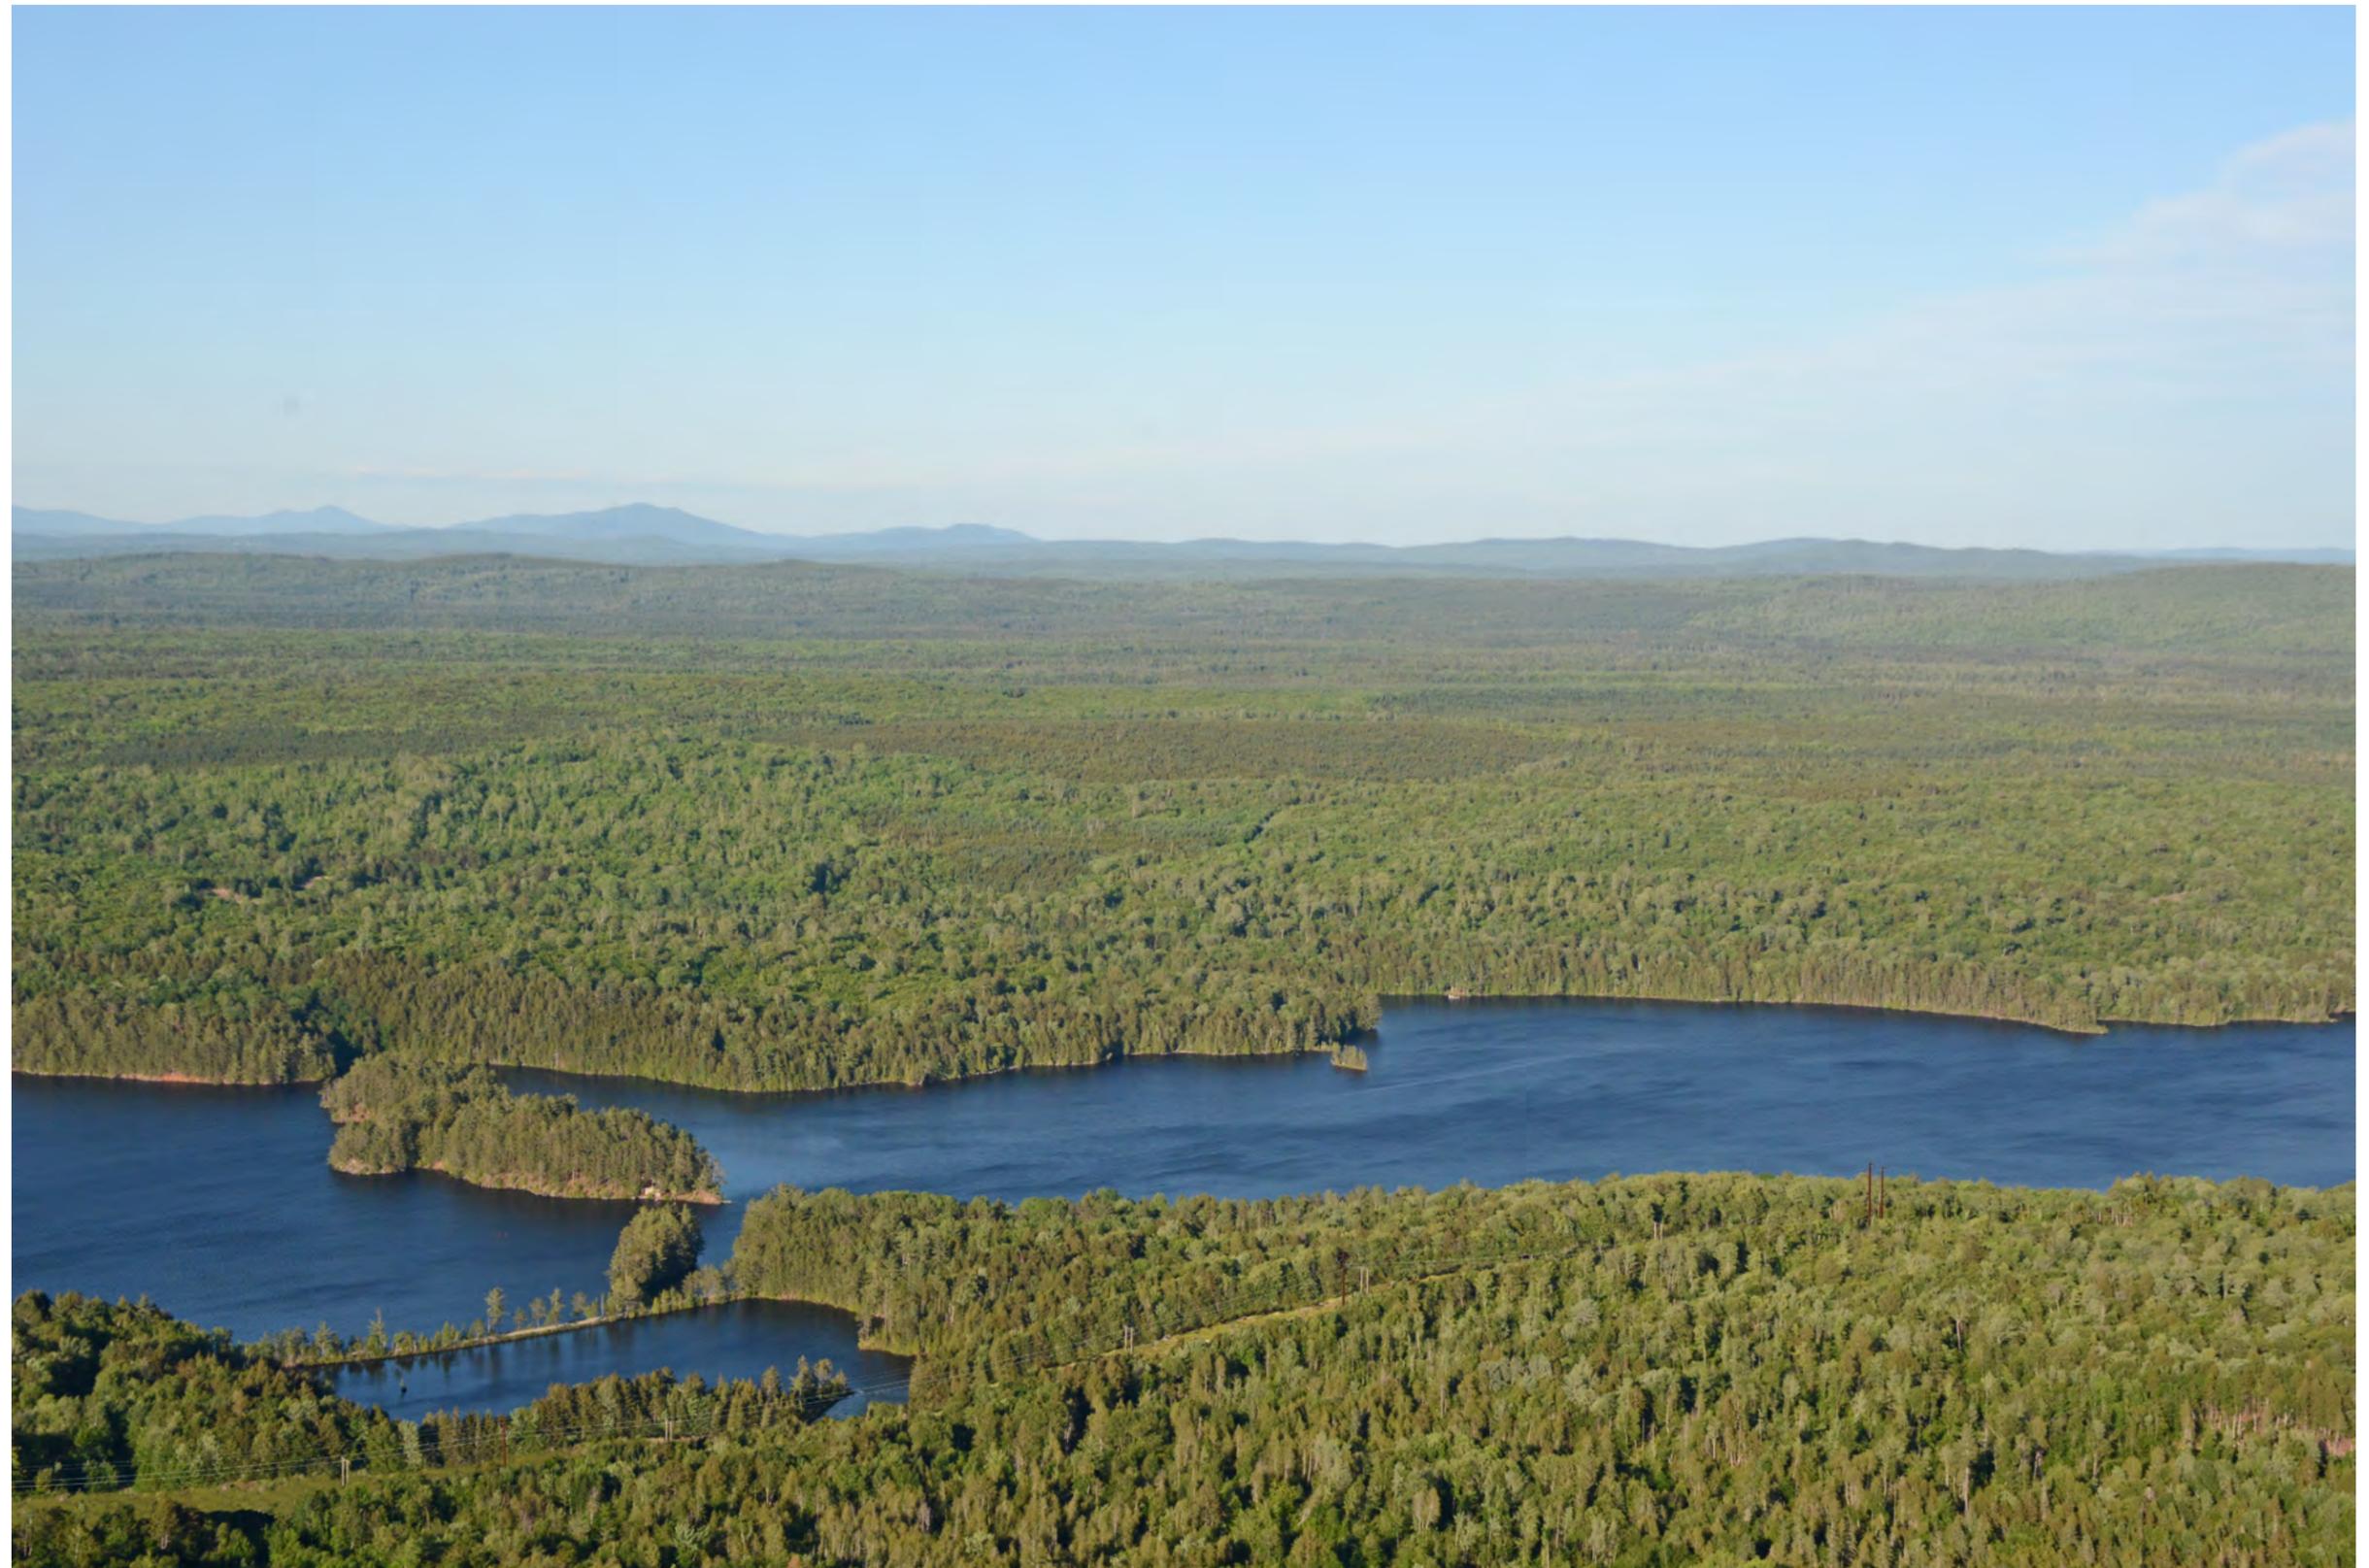
**PHOTOSIMULATION 17A: MOSQUITO MOUNTAIN - Looking Southeast, The Forks Plt**

**Proposed Conditions:** Normal view looking south from Mosquito Mountain toward the proposed co-located HVDC transmission line. The existing 150' wide transmission line corridor clearing will be widened by 75' on the western side to accommodate the proposed HVDC transmission line. Bald Mountain is visible in the center of the image. Mosquito Pond is visible on the right side of the image. Moxie Pond is visible across the entire image. The Bingham Wind Project is visible to the east. Three proposed structures and conductors will be visible at distances of 0.75 - 1.0 miles from this viewpoint.

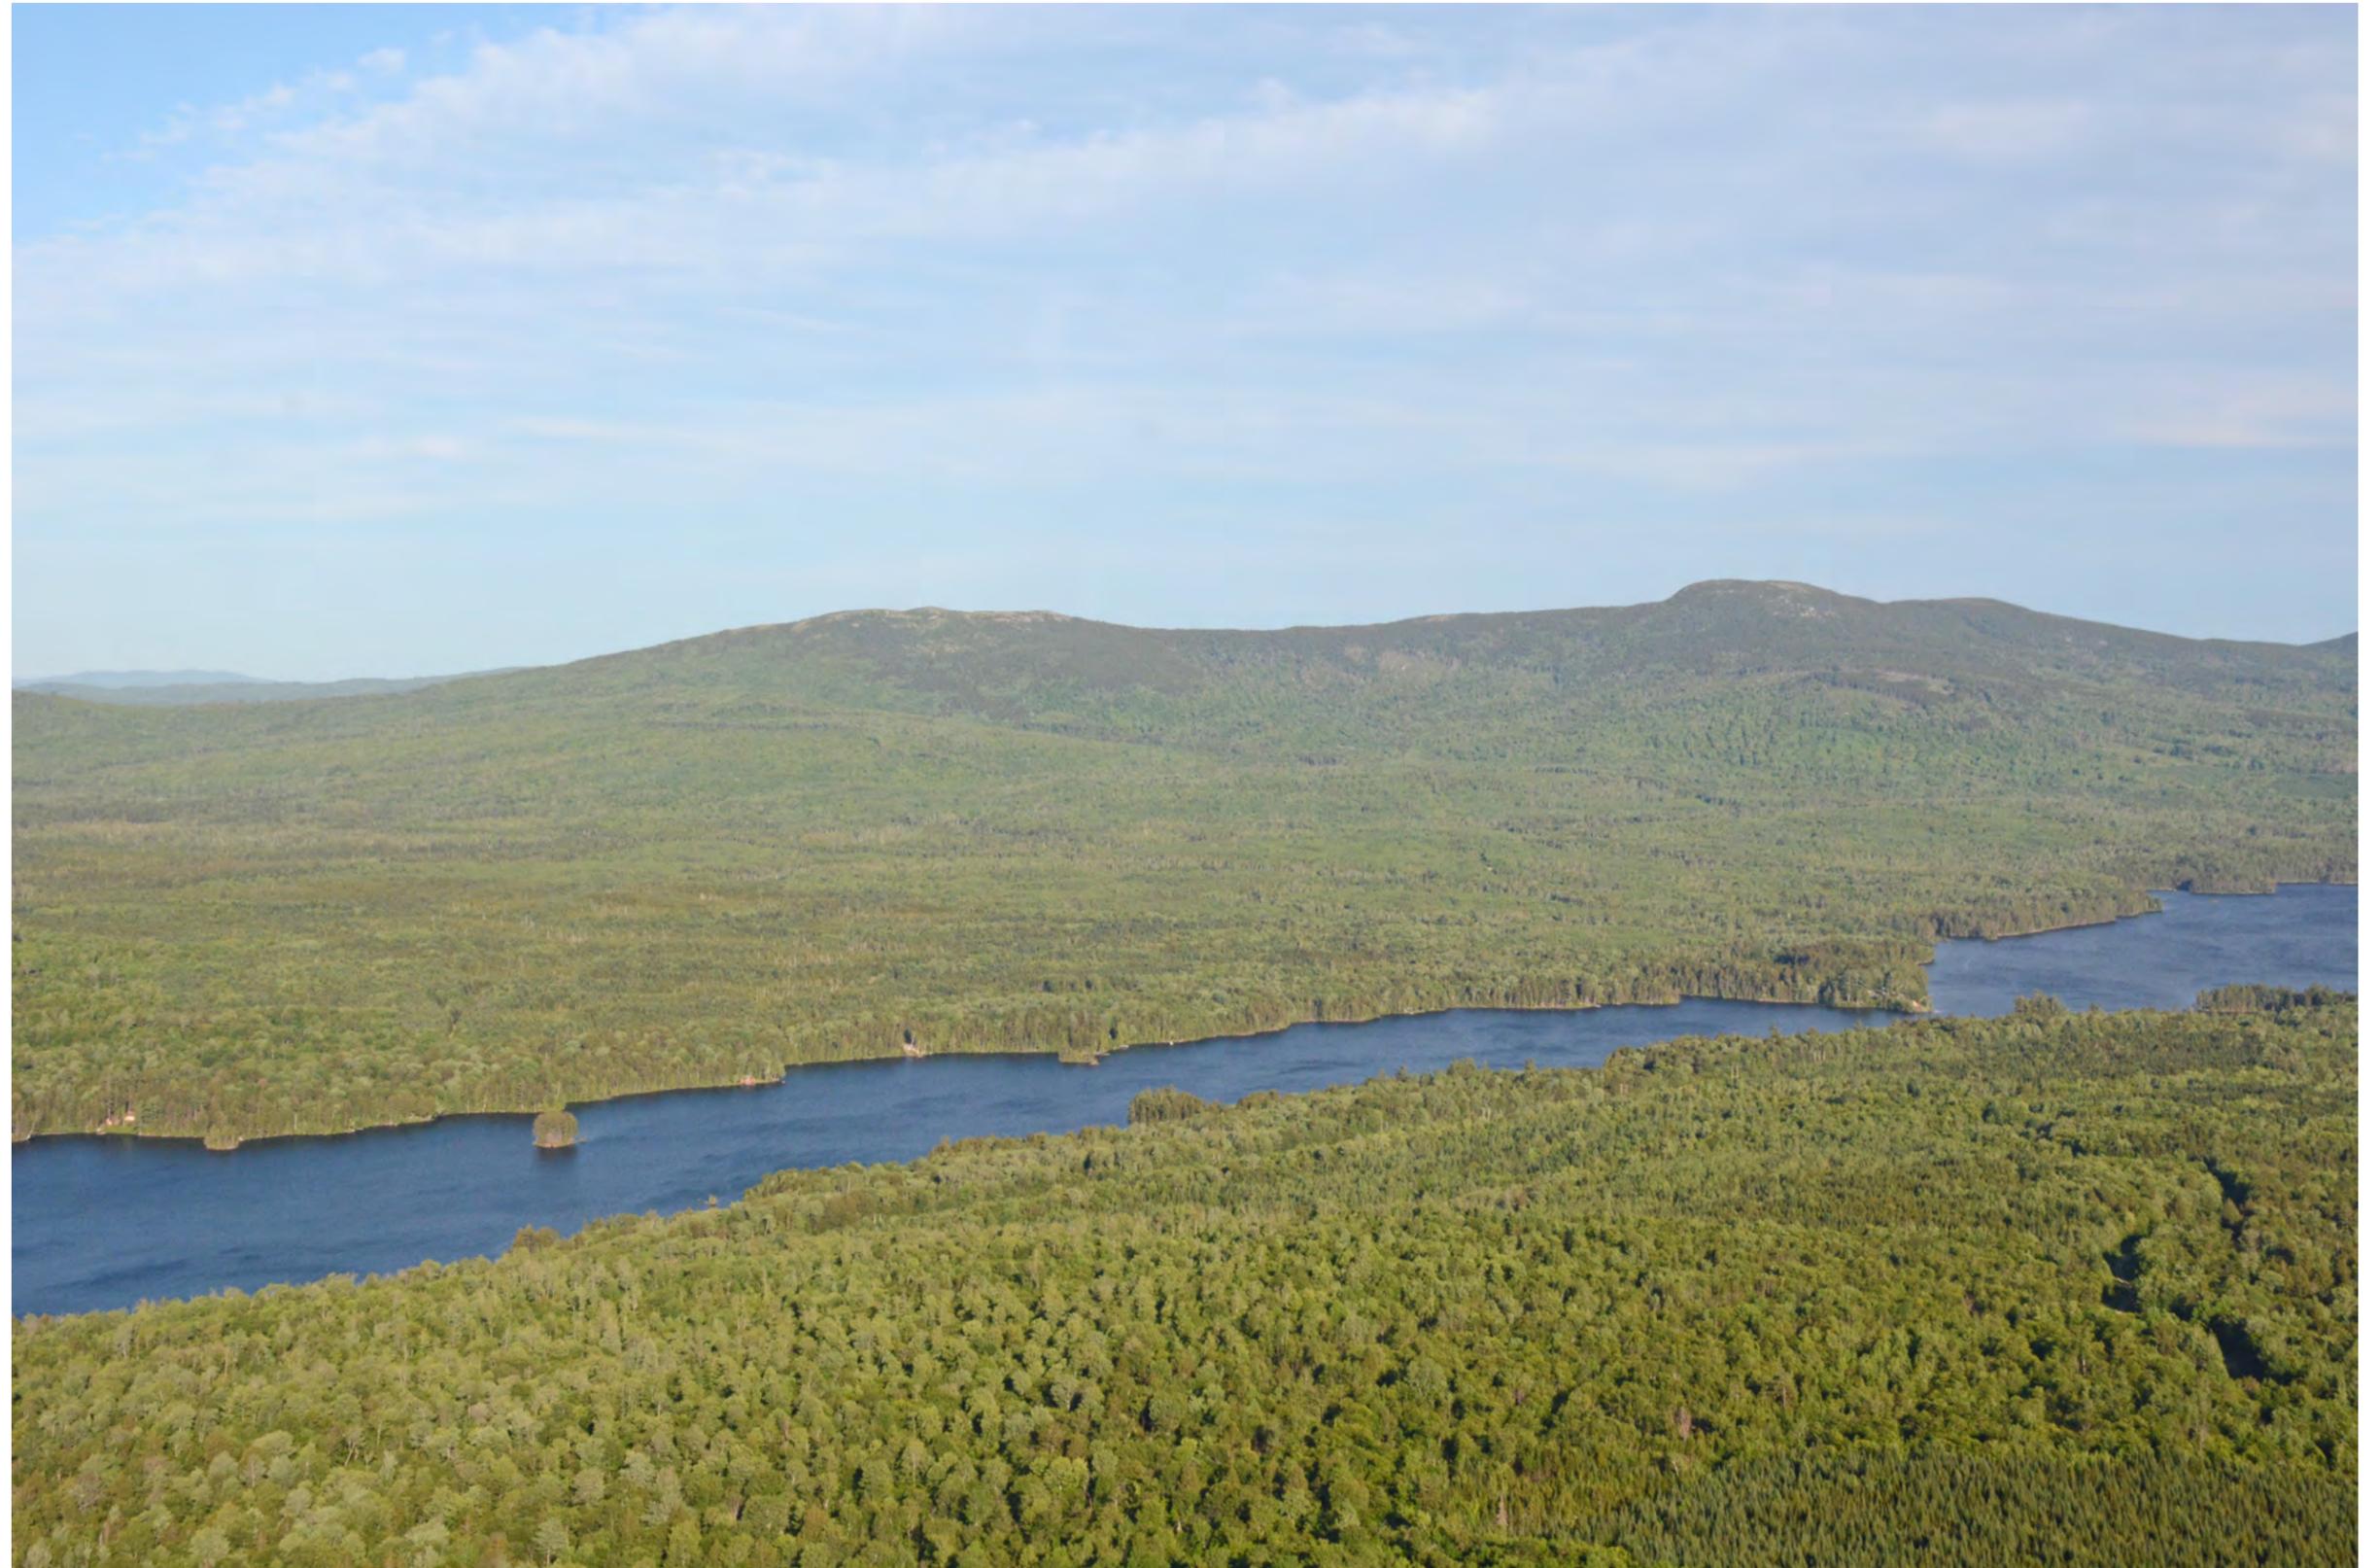
**PHOTOSIMULATION I7B: MOSQUITO MOUNTAIN - Looking Southeast, The Forks Plt**

**Existing Conditions:** Normal view looking east from Mosquito Mountain. Bald Mountain North Peak is visible on the left side of the image, and Bald Mountain is visible on the right side of the image. Moxie Pond is visible across the entire image, with Mosquito Narrows on right in image.

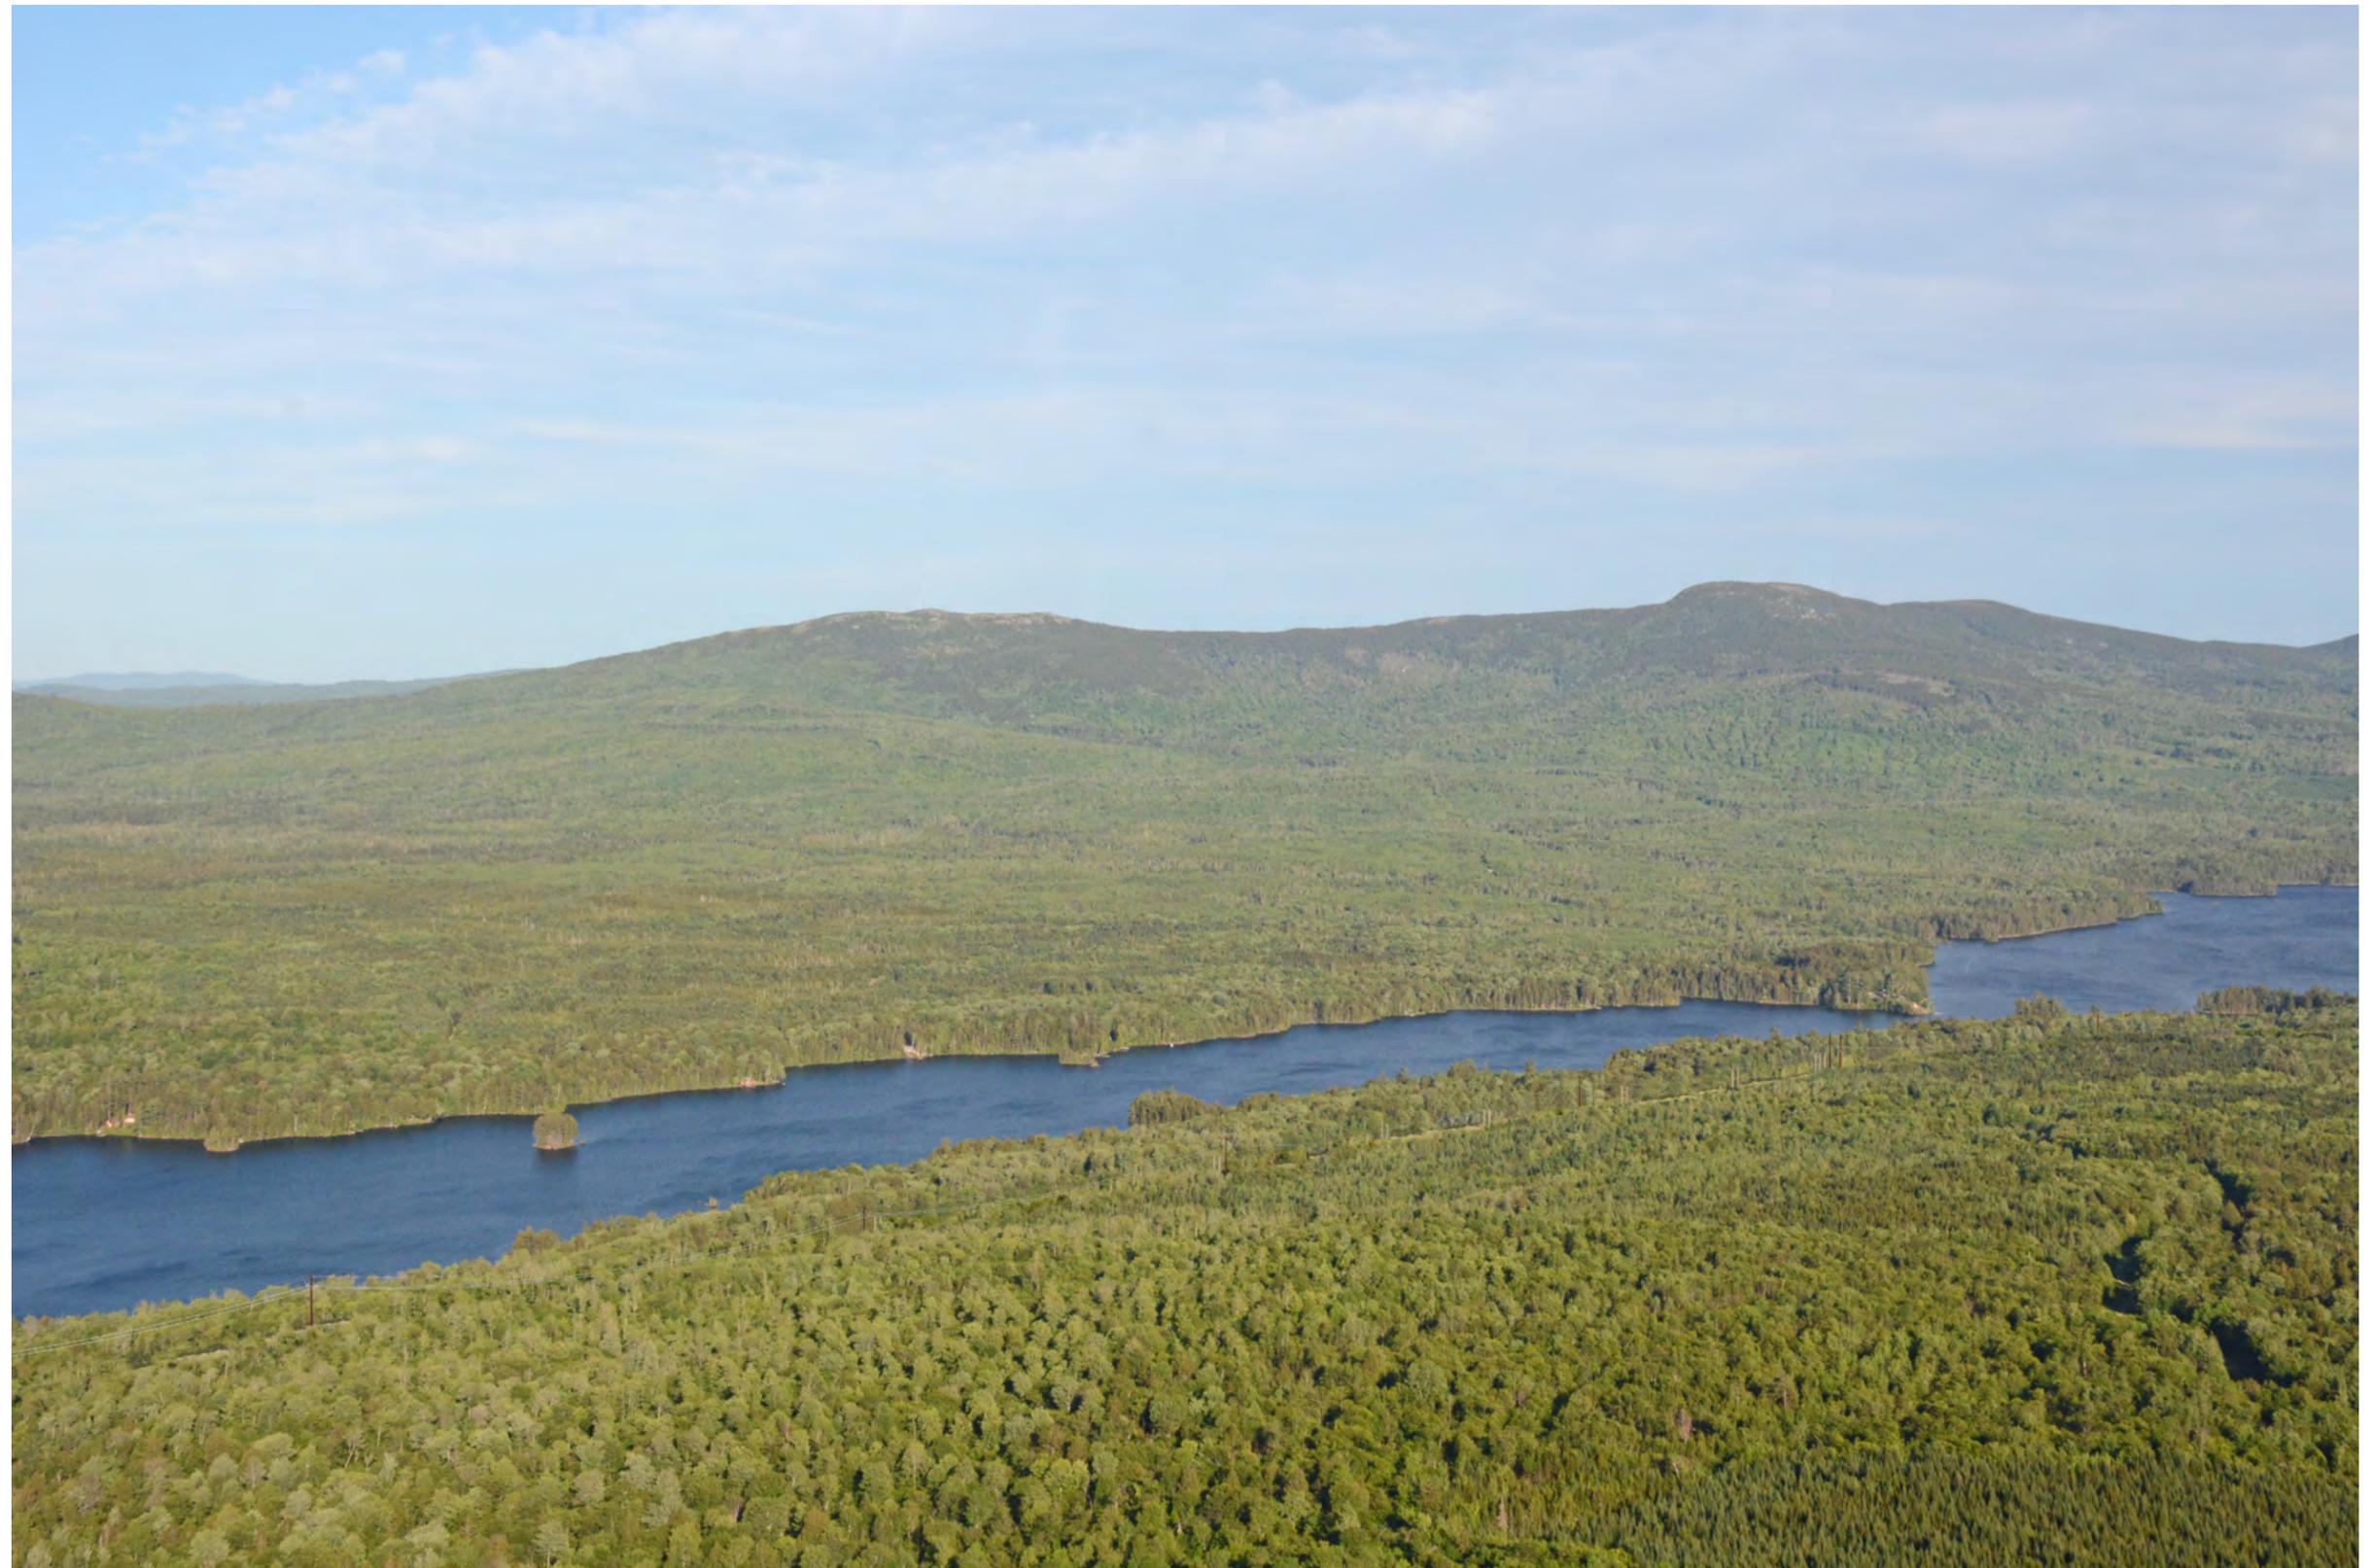
**PHOTOSIMULATION 17B: MOSQUITO MOUNTAIN - Overlook Looking Southeast, The Forks Plt**

**Proposed Conditions:** Normal view looking southeast from Mosquito Mountain toward the proposed co-located HVDC transmission line. The existing 150' wide transmission line corridor clearing will be widened by 75' on the western side to accommodate the proposed HVDC transmission line. Six structures, conductors and portions of the cleared corridor will be visible at distances of 1.1 to 1.8 miles.

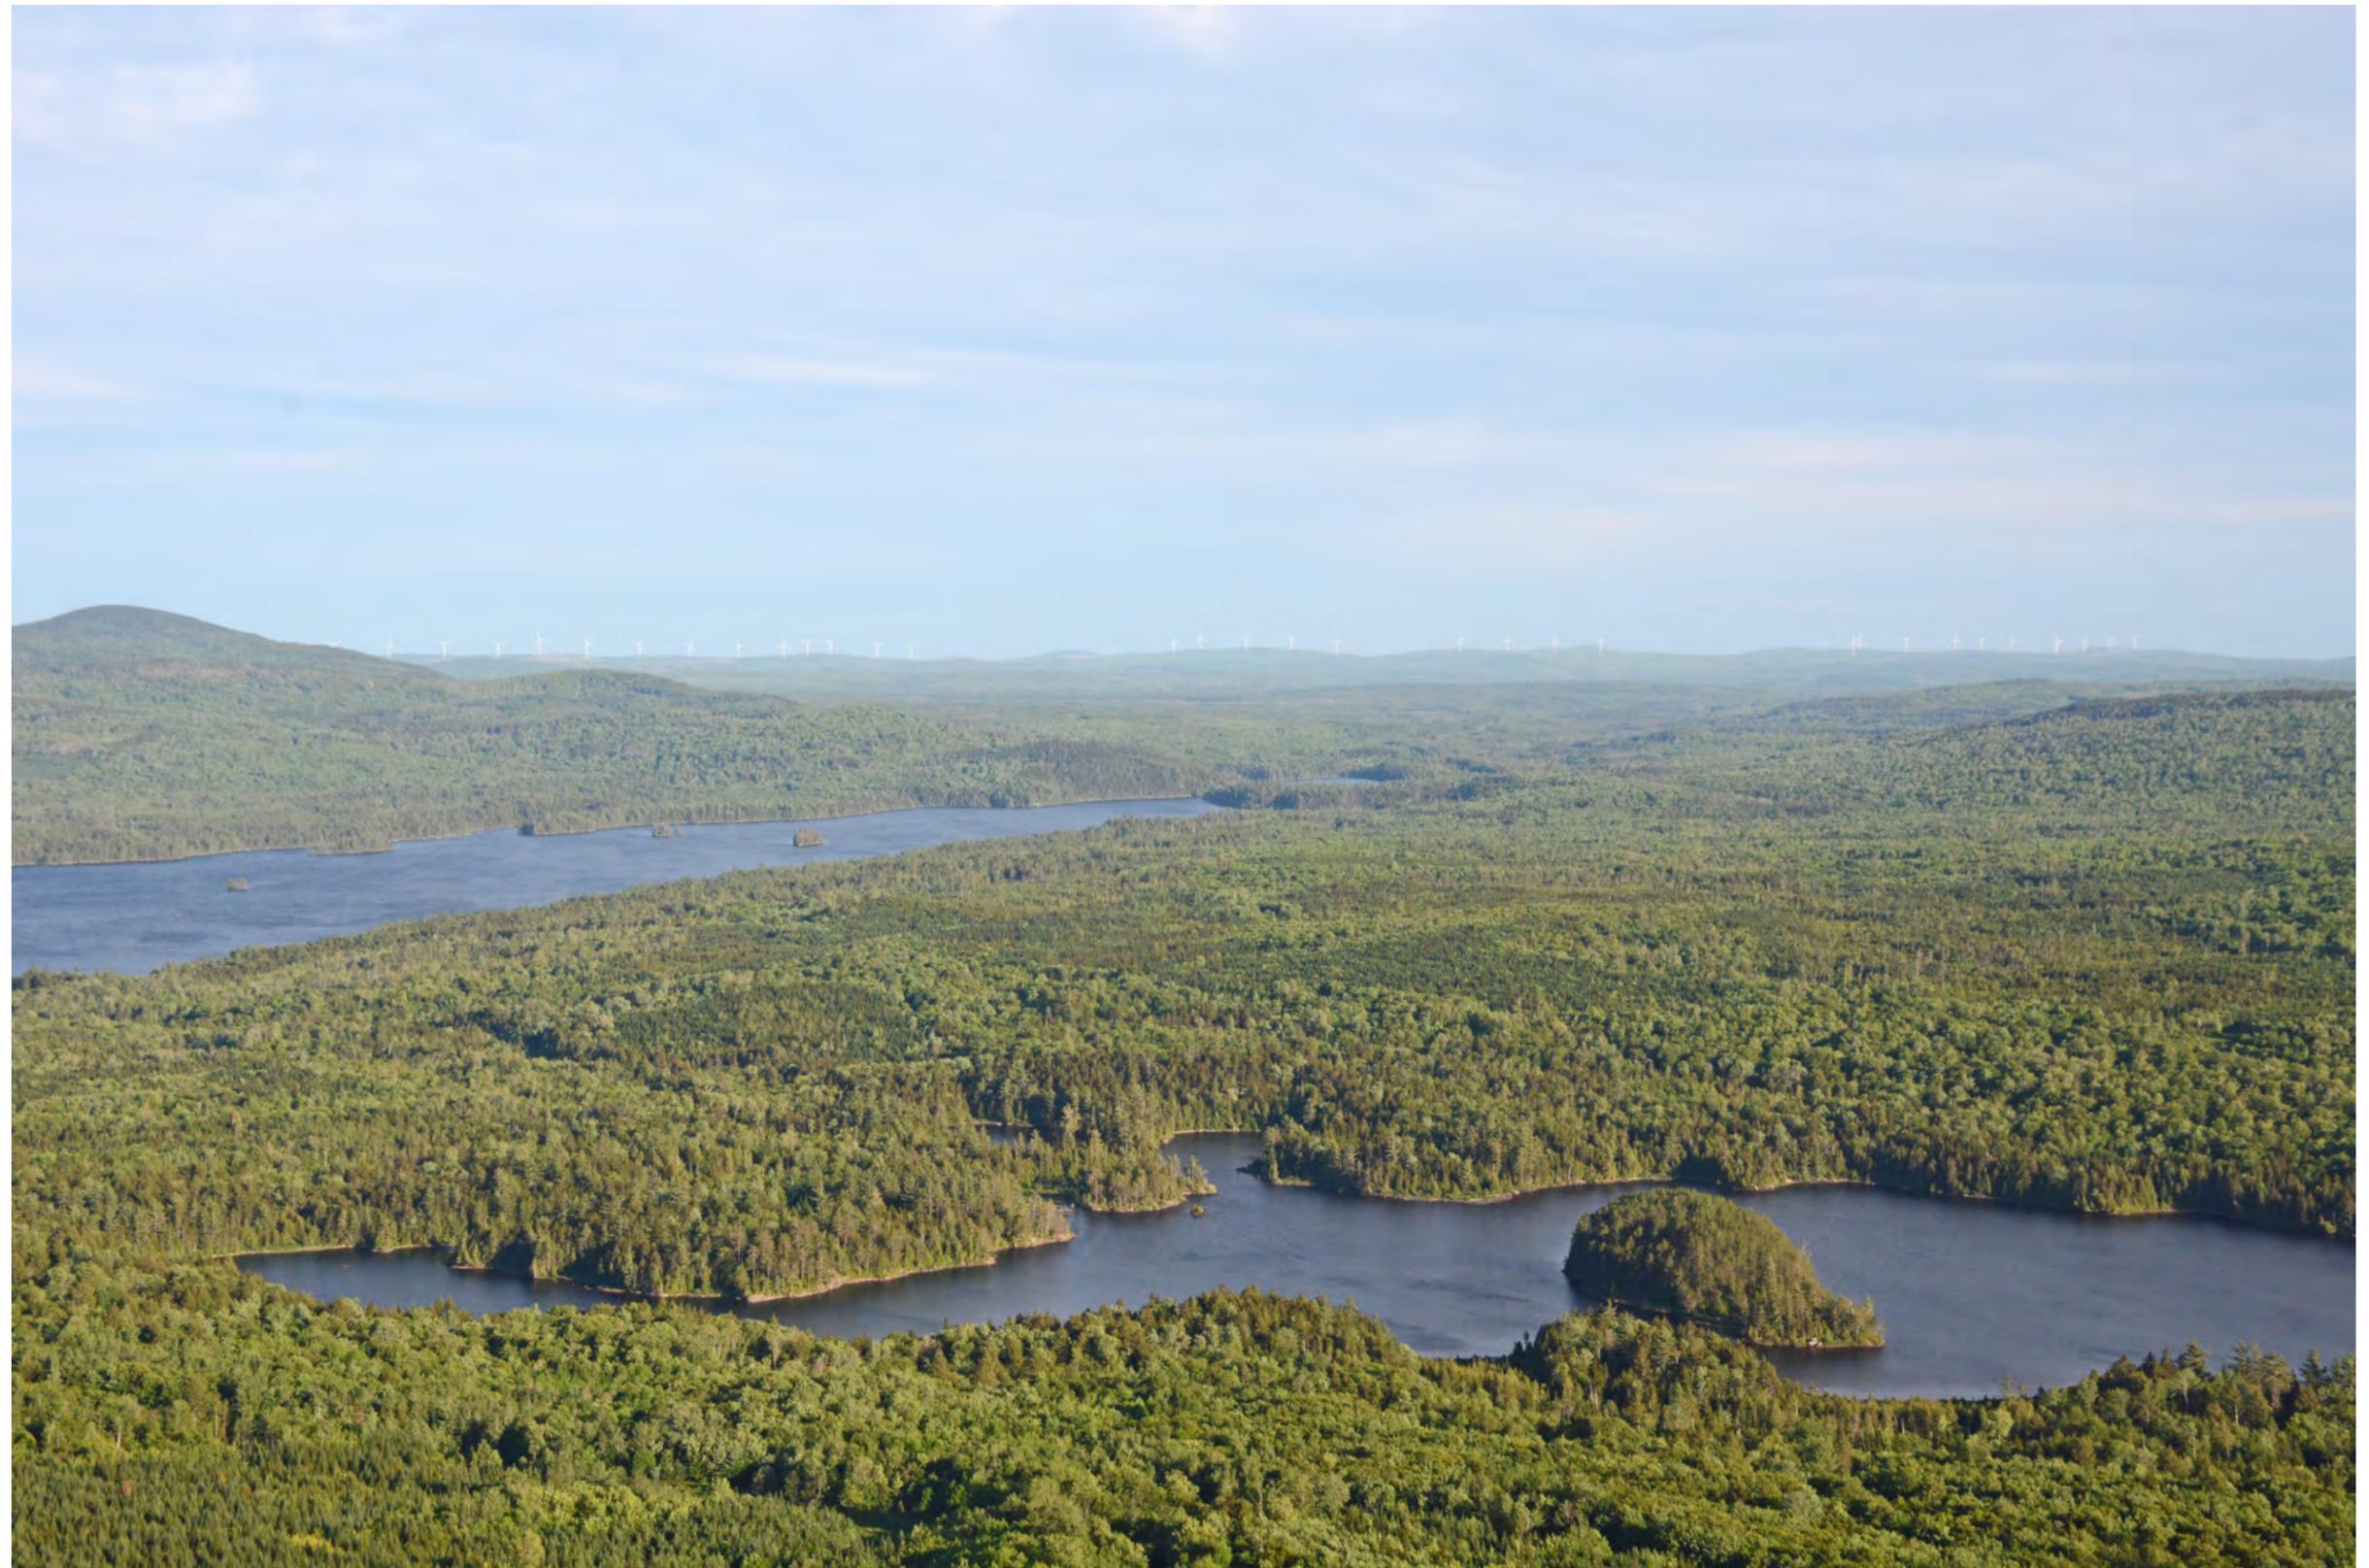
**PHOTOSIMULATION 17C: MOSQUITO MOUNTAIN - Looking Southeast, The Forks Plt**

**Existing Conditions:** Normal view looking southeast from Mosquito Mountain . Bald Mountain is visible on the left side of the image. The southern Moxie Pond is visible across the middle of image and Mosquito Pond is visible below in foreground. The Bingham Wind Project is visible 14.5 to 16.6 miles to the southeast.

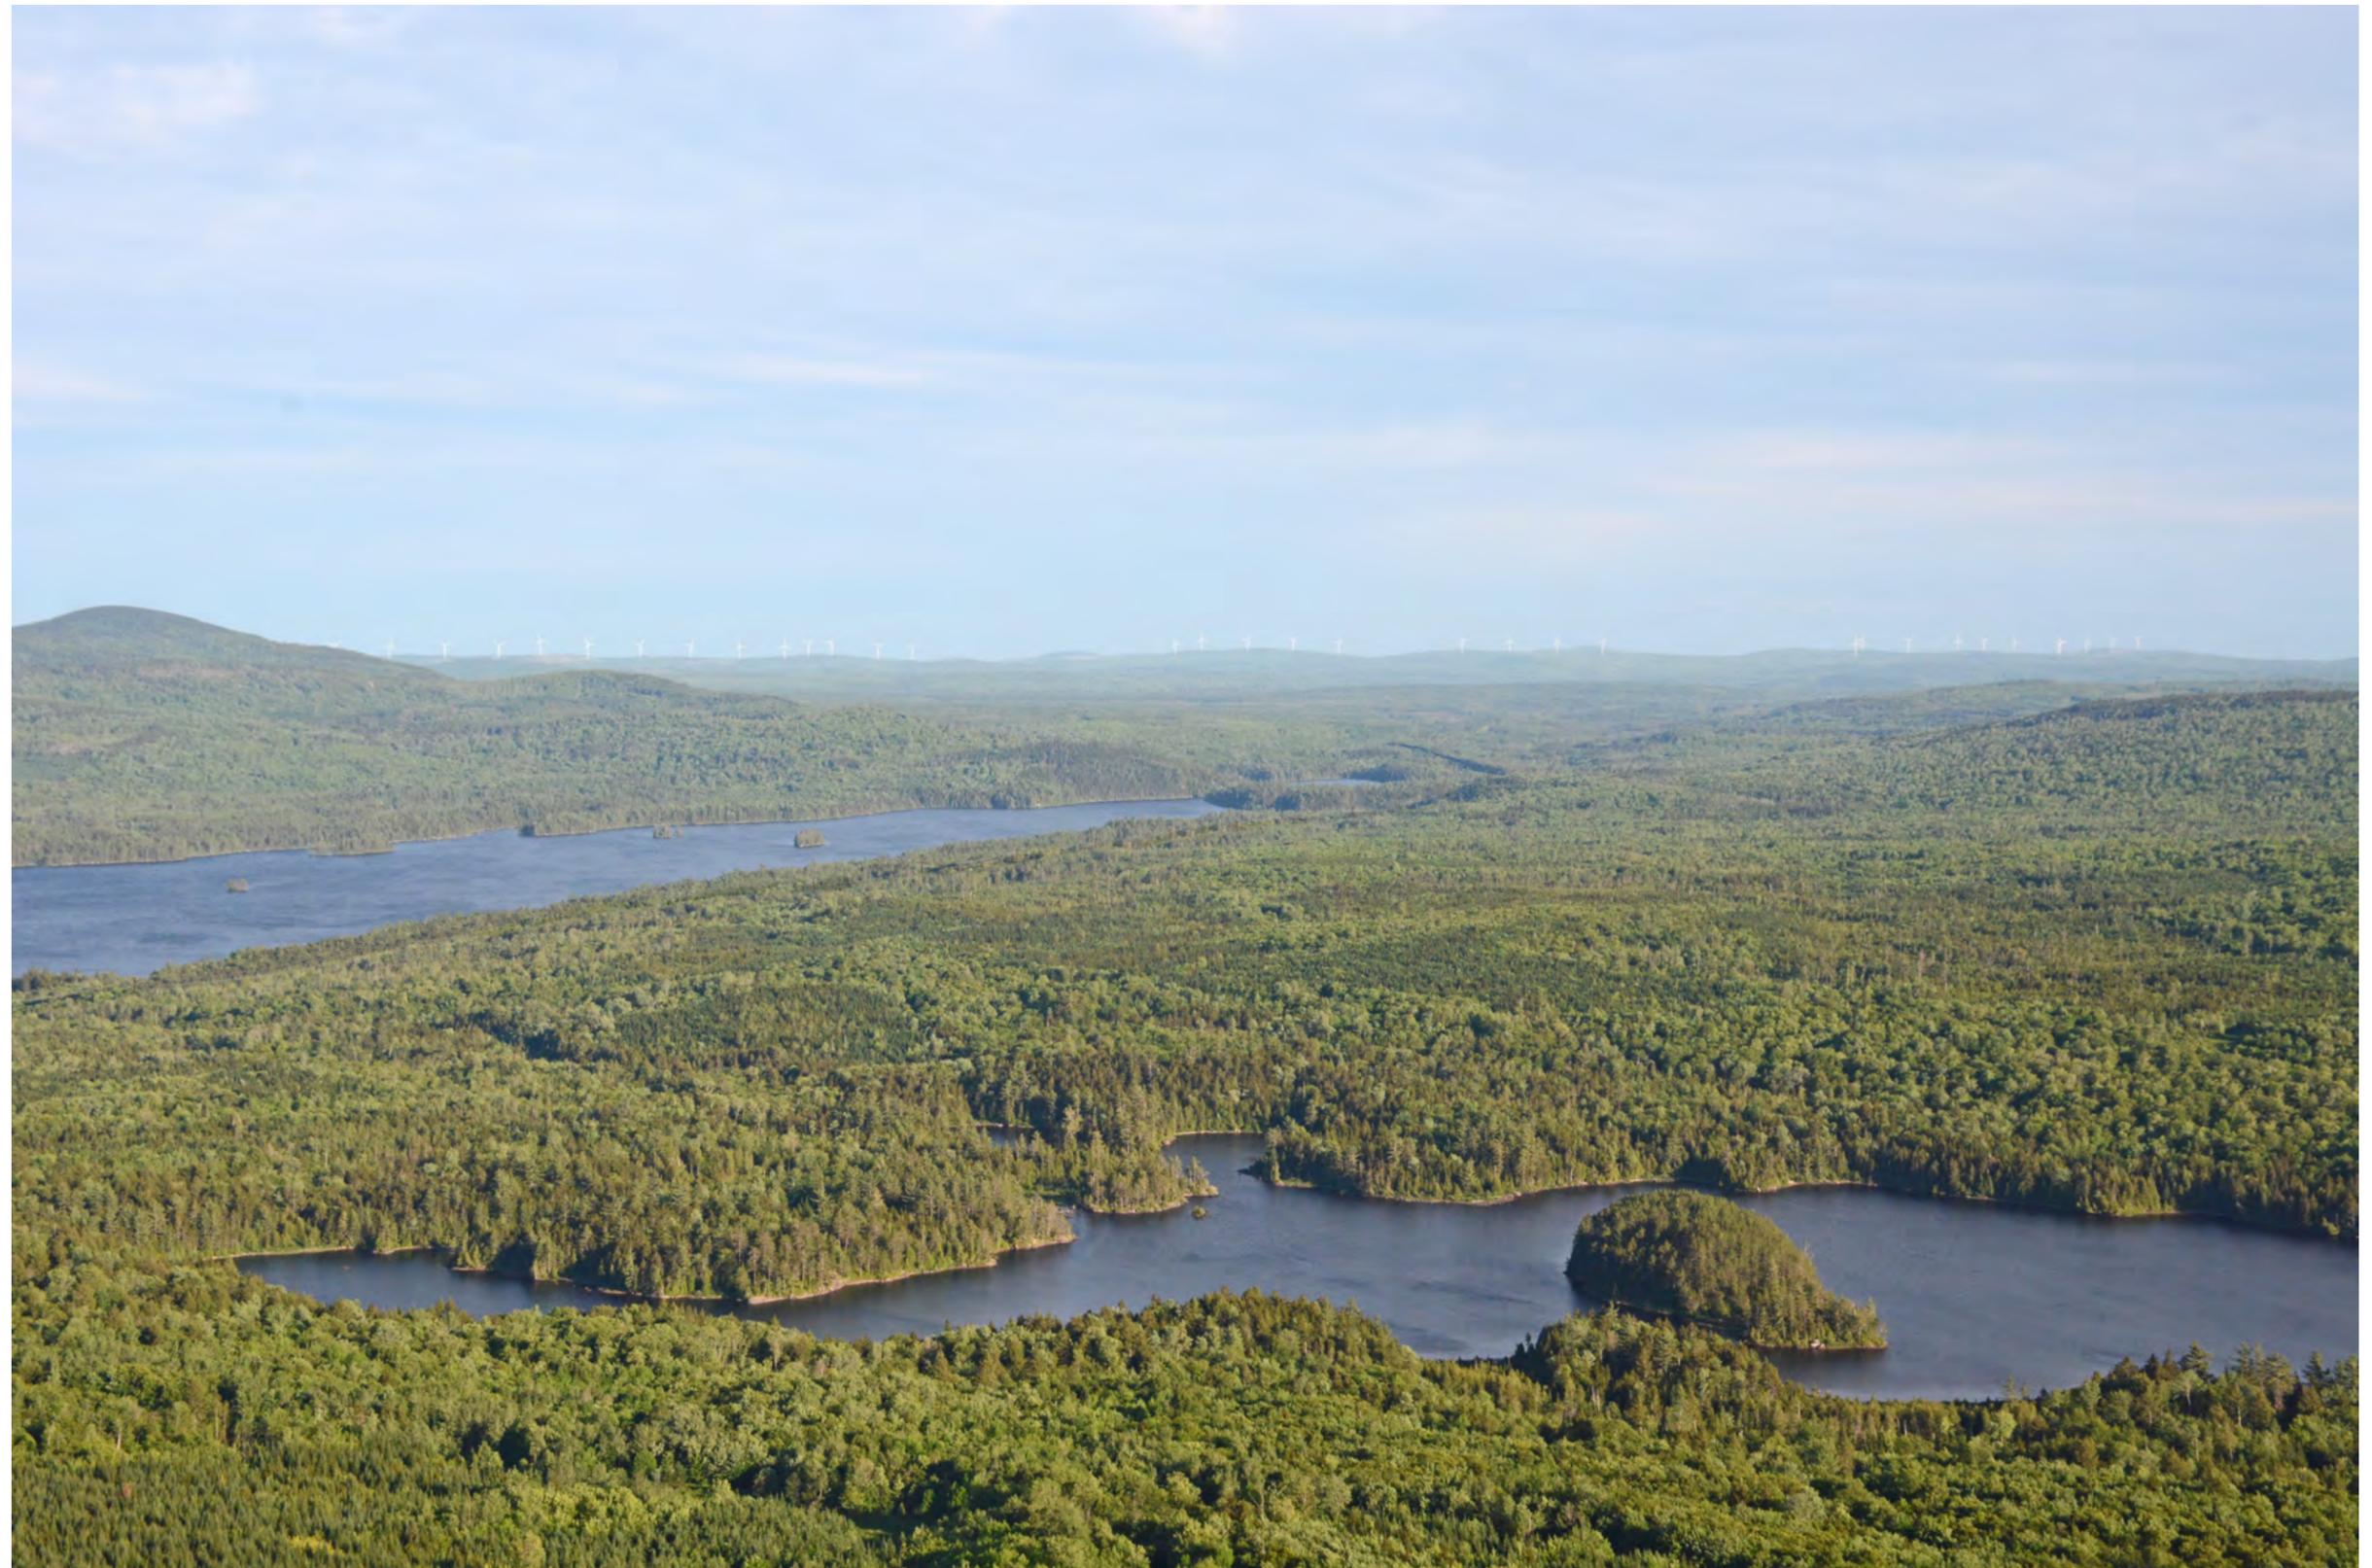
**PHOTOSIMULATION 17C: MOSQUITO MOUNTAIN - Looking Southeast, The Forks Pt**

**Proposed Conditions:** Normal view looking southeast from Mosquito Mountain toward the proposed transmission line. The existing 150' wide transmission line corridor clearing will be widened by 75' on the western side to accommodate the proposed HVDC transmission line. Six structures and conductors and portions of the cleared corridor will be visible within three miles.

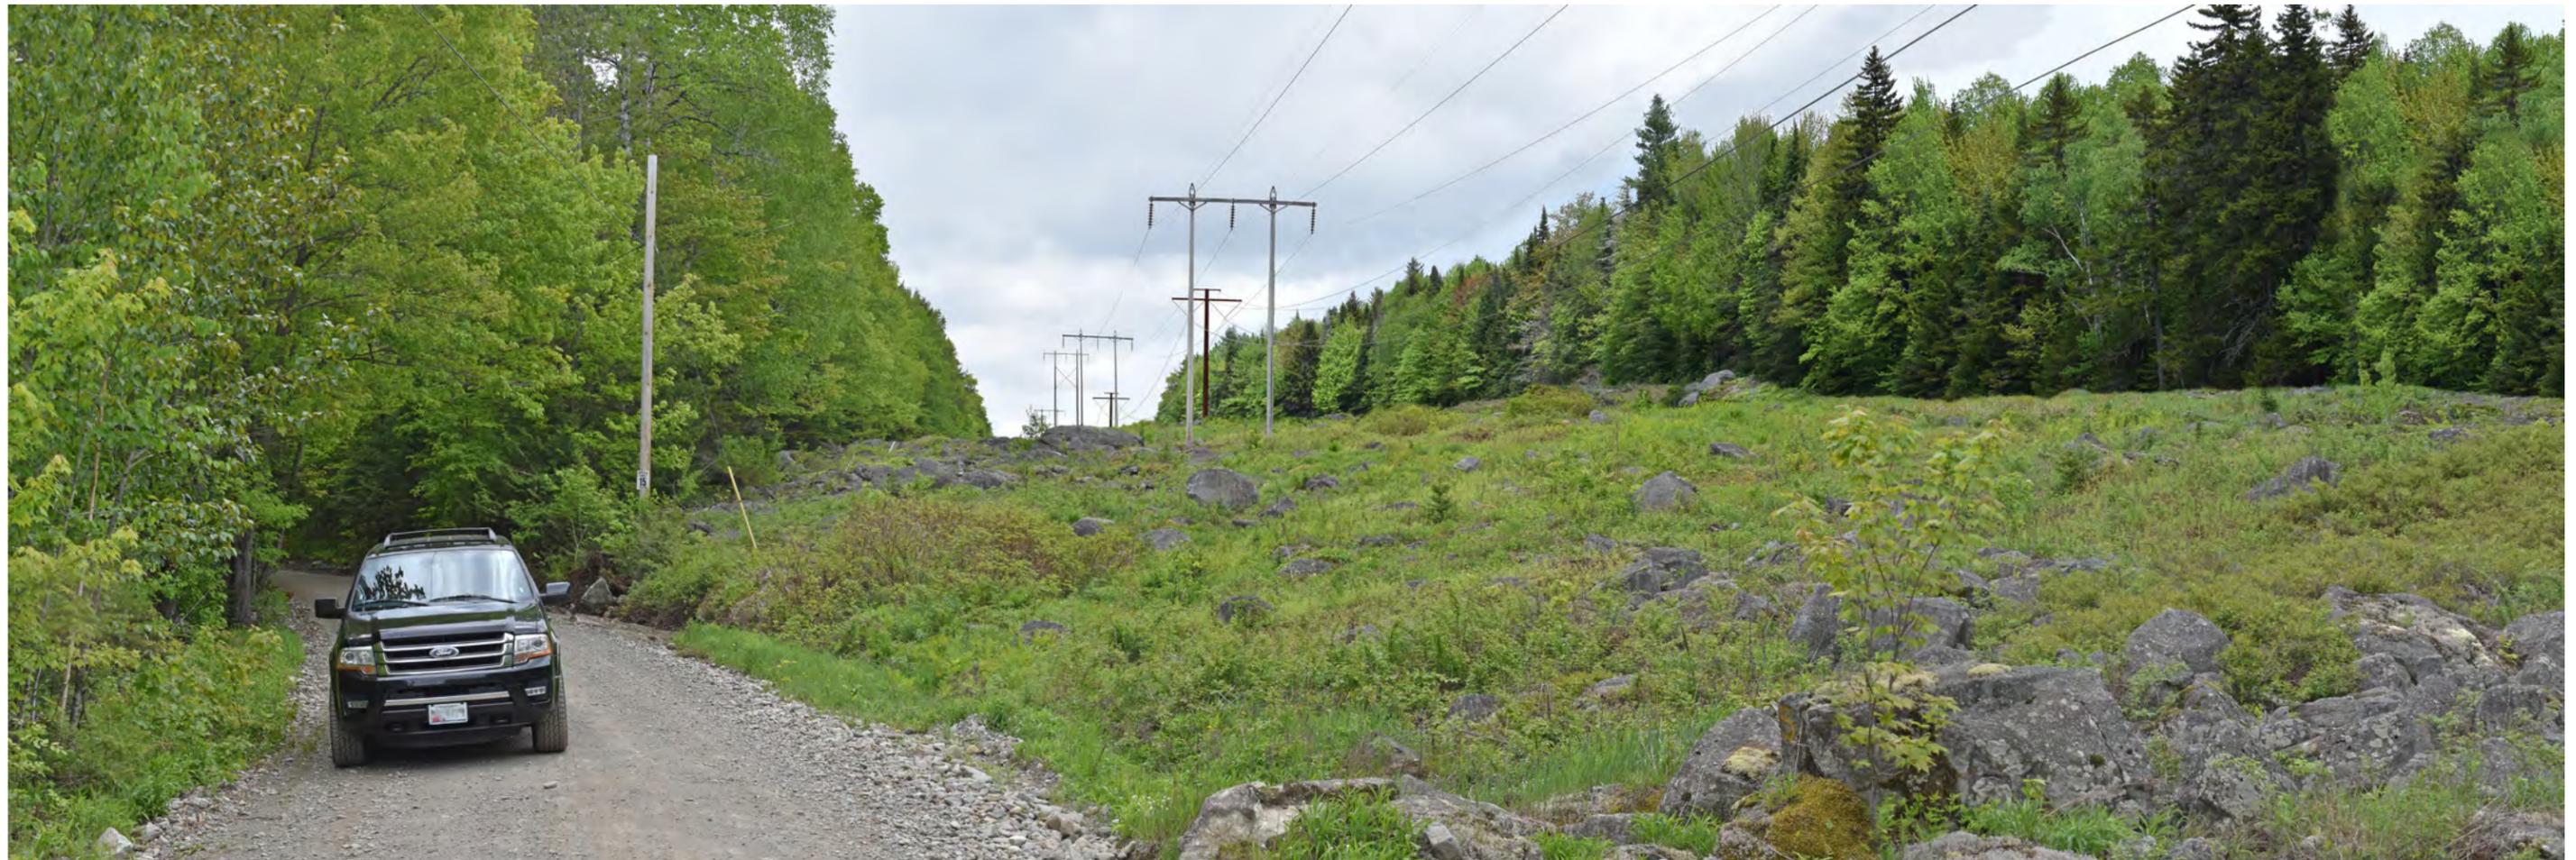
### PHOTOSIMULATION 18:TROUTDALE ROAD, The Forks Plt.

**Proposed Conditions:** Panoramic view looking southeast to south from Troutdale Road in The Forks Plt. toward the proposed co-located HVDC transmission line. Troutdale Road is located within the existing 115 kV transmission line corridor for approximately 1,000 feet. The existing 150' wide corridor clearing will be widened by 75' on the western side to accommodate the new transmission line. Two HVDC transmission structures will be visible looking to the southeast, and four looking to the northwest. See Appendix B: Study Area Photographs for additional images.
