# PHOTOSIMULATION 13: MOXIE POND - North, East Moxie Twp

**PHOTOSIMULATION 13A: MOXIE POND - North, East Moxie Twp**

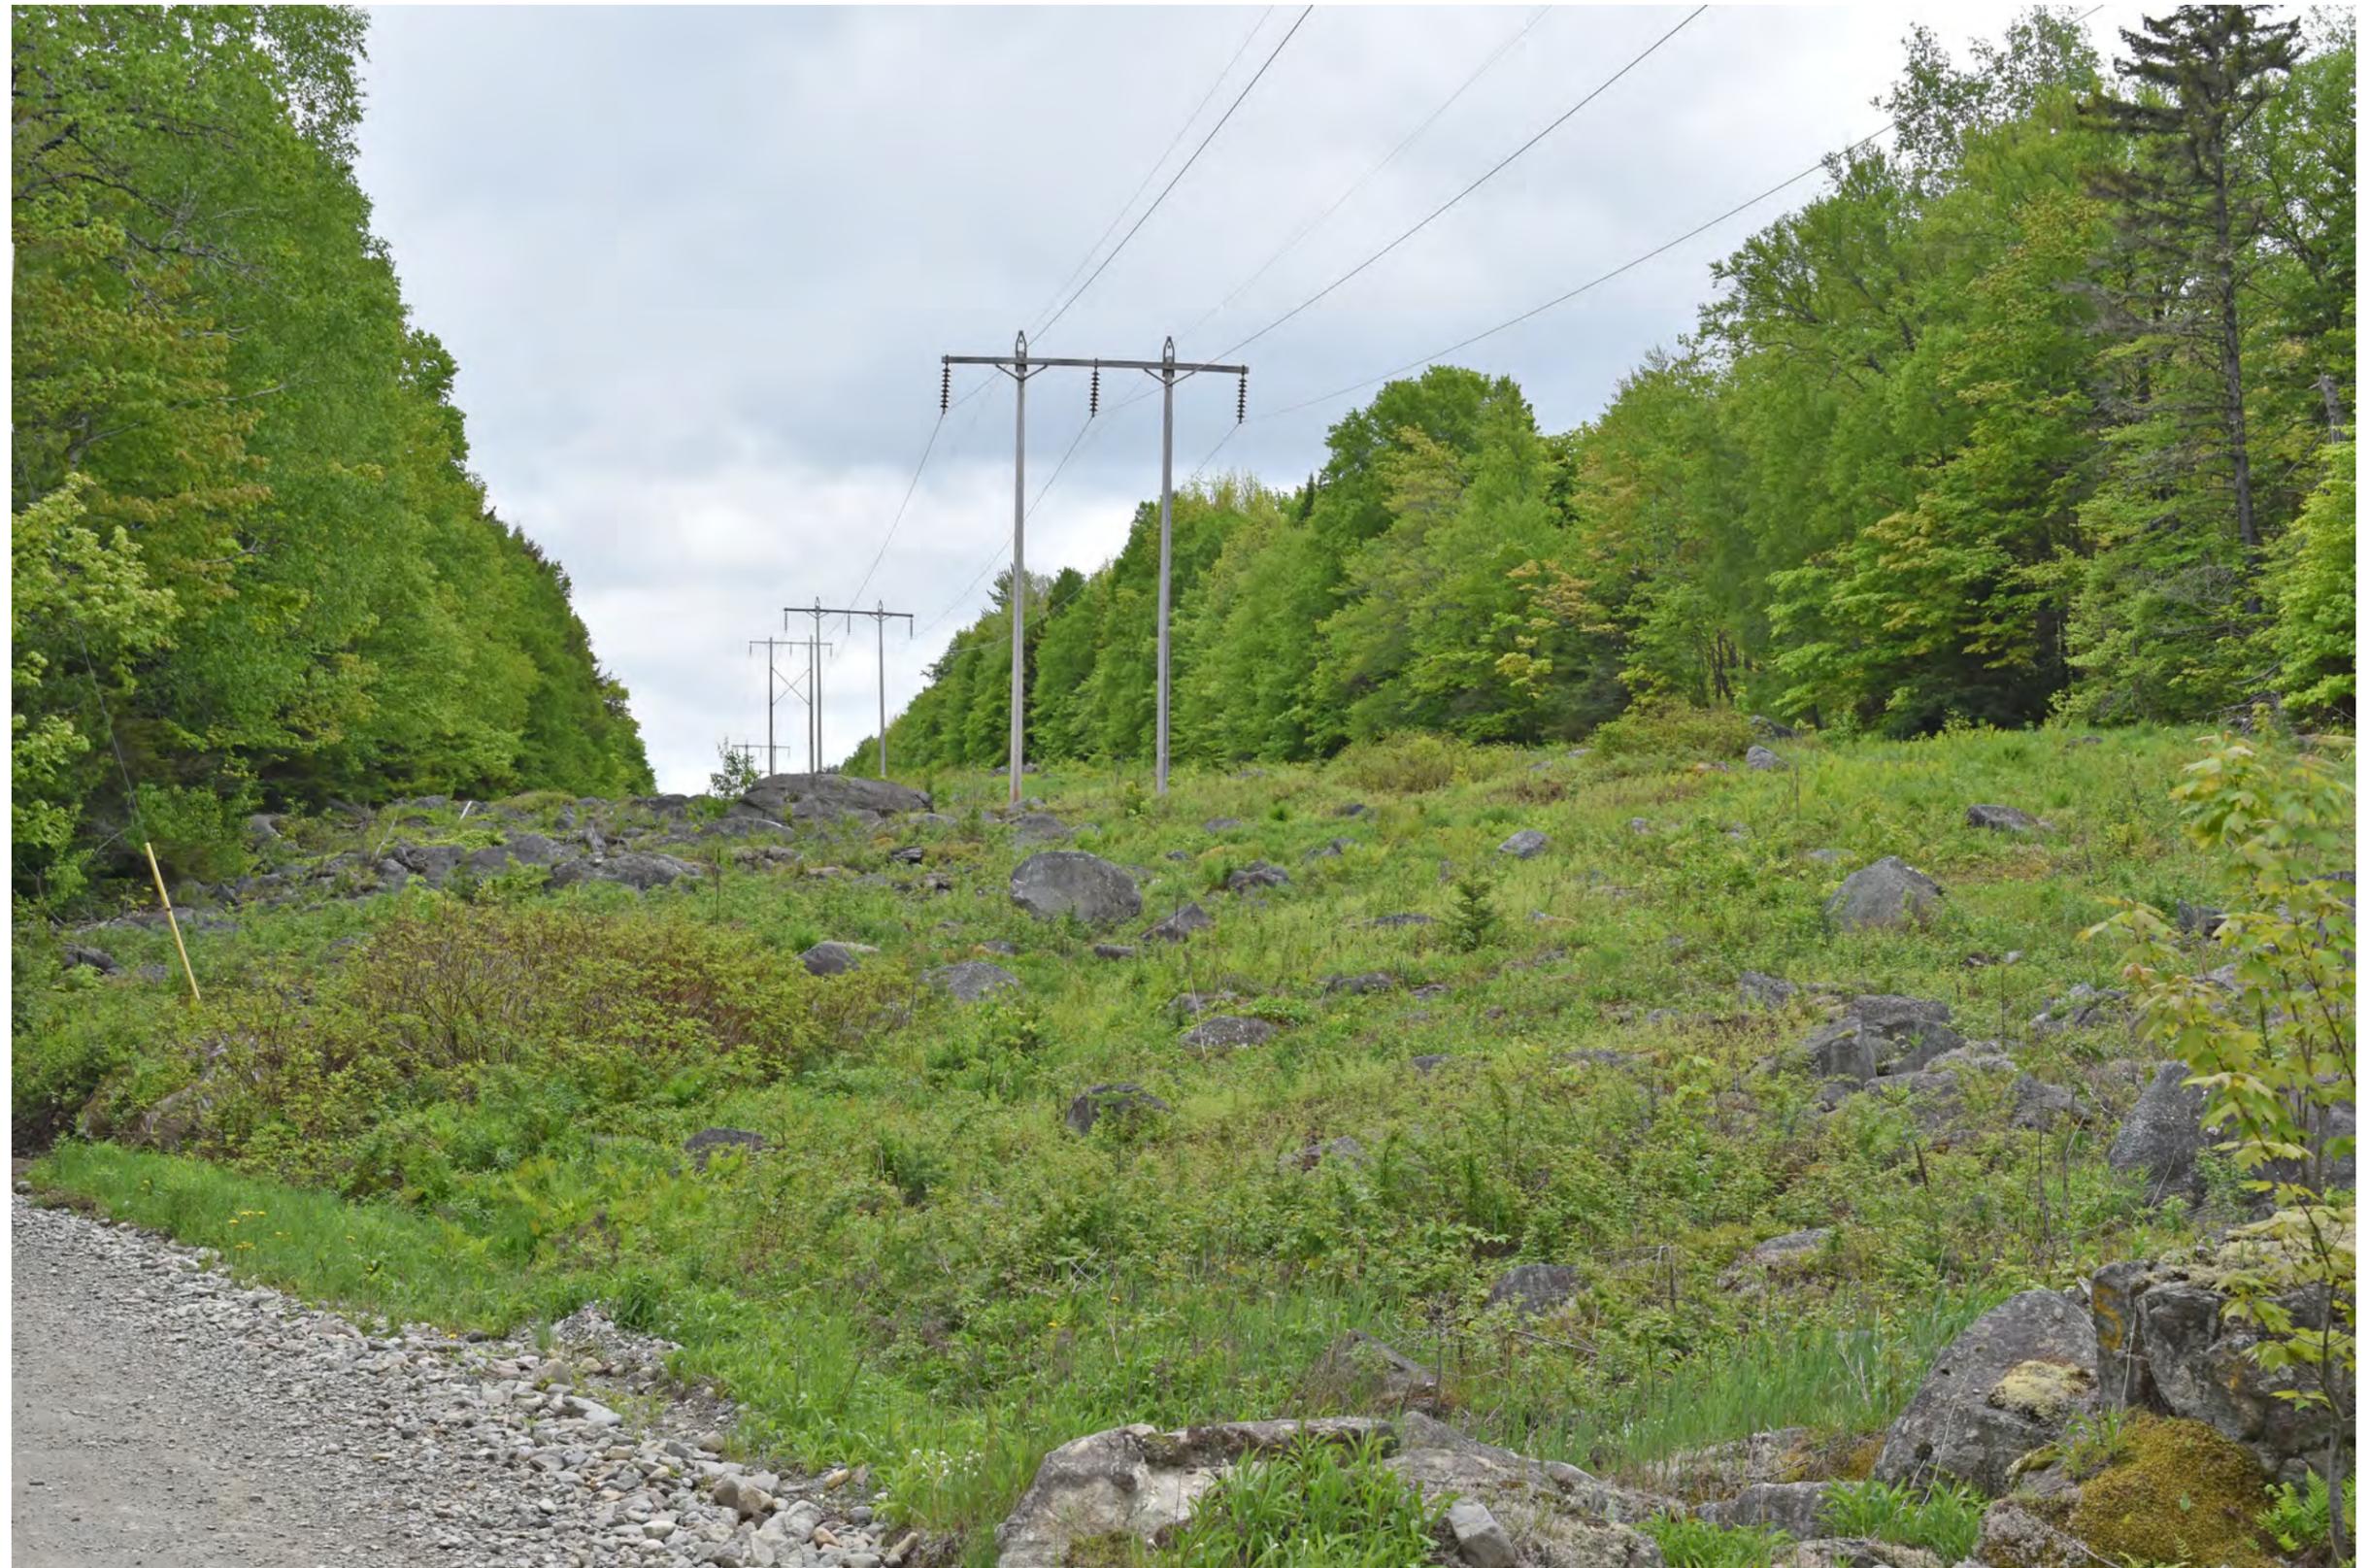
**PHOTOSIMULATION I8A:TROUTDALE ROAD, The Forks Plt**

**Existing Conditions:** Normal view looking southeast from Troutdale Road toward the existing 115 kV transmission line within a 150' wide cleared corridor.

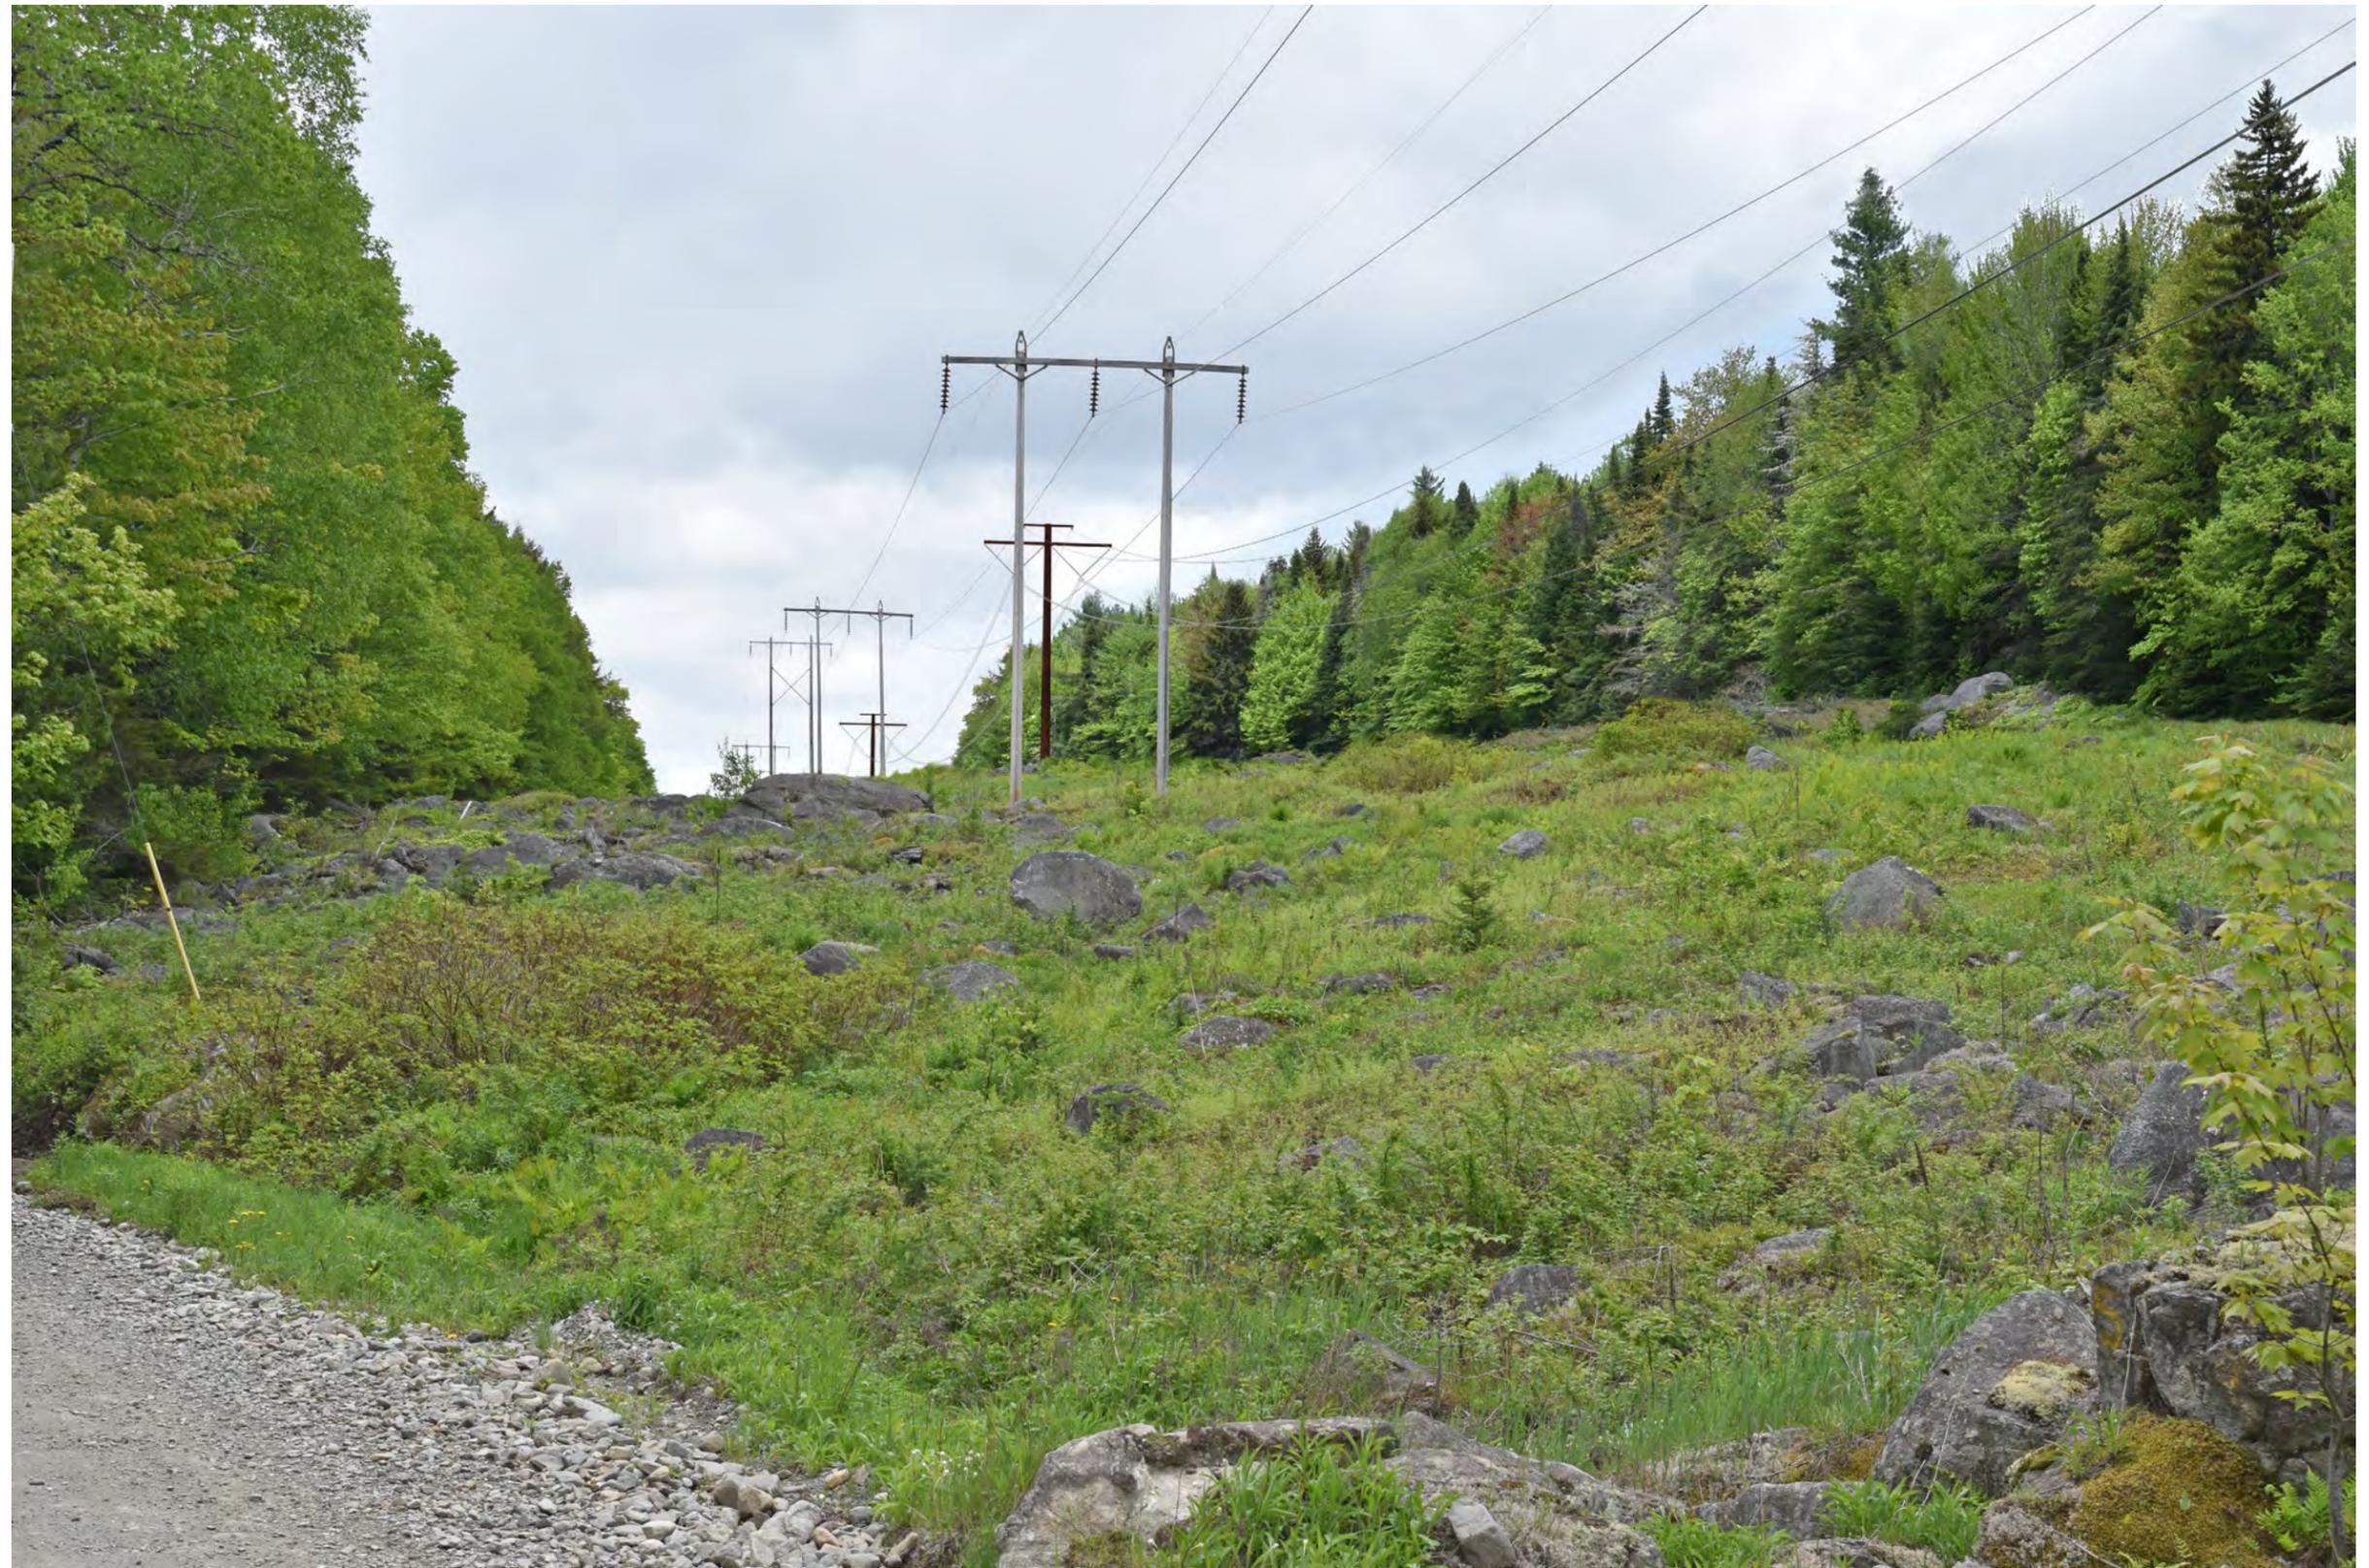
**PHOTOSIMULATION I8A:TROUTDALE ROAD, The Forks Plt**

**Proposed Conditions:** Normal view looking southeast from Troutdale Road toward the proposed co-located HVDC transmission line. The existing 150' wide corridor clearing will be widened by 75' on the western side to accommodate the new transmission line. Two HVDC transmission structures will be visible looking to the southeast.

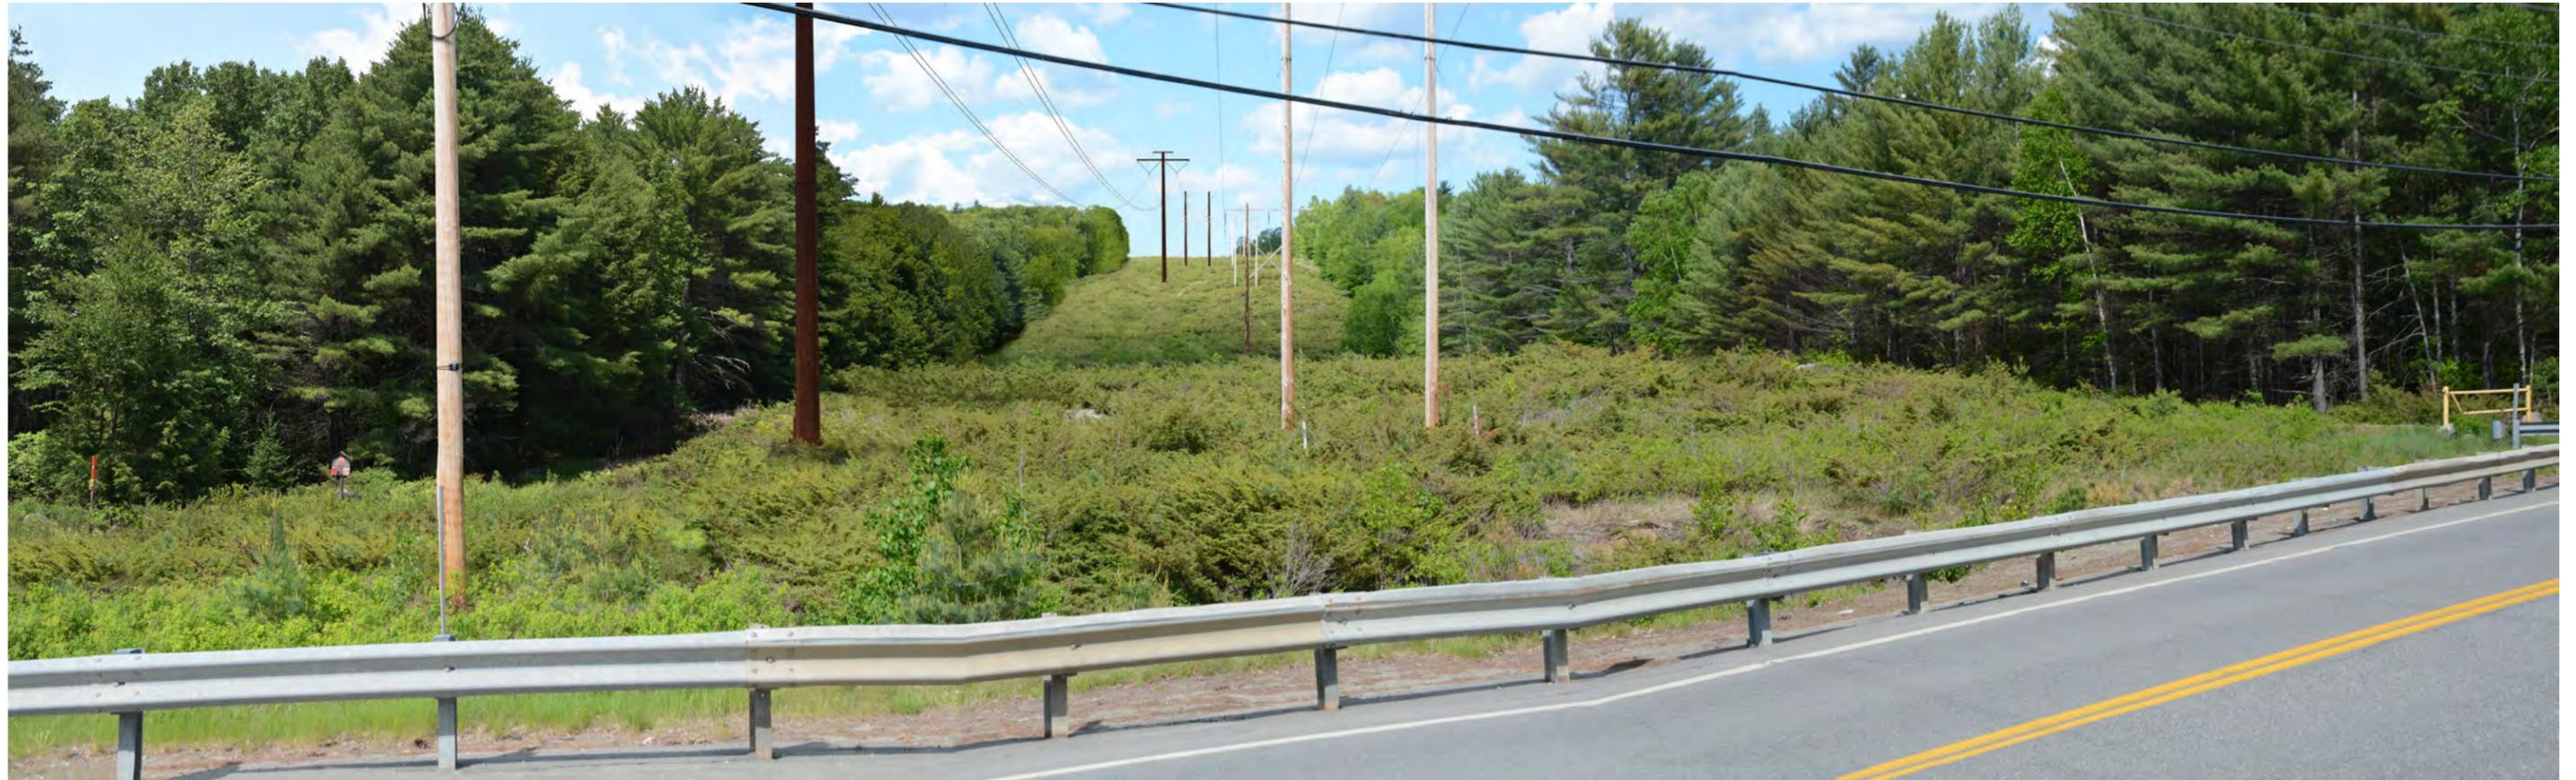
# PHOTOSIMULATION 19: ROUTE 201, Moscow

**Proposed Conditions:** Panoramic view looking from northeast to east from Route 201 in Moscow toward the proposed co-located HVDC transmission line. The Wyman Hydro Electric Facility is visible in the opposite direction of this viewpoint. The existing 225' wide corridor clearing will be widened by 75' on the western side (left of corridor in image) to accommodate the proposed HVDC transmission line. Three structures will be visible from this viewpoint. See Appendix B: Study Area Photographs for additional images.

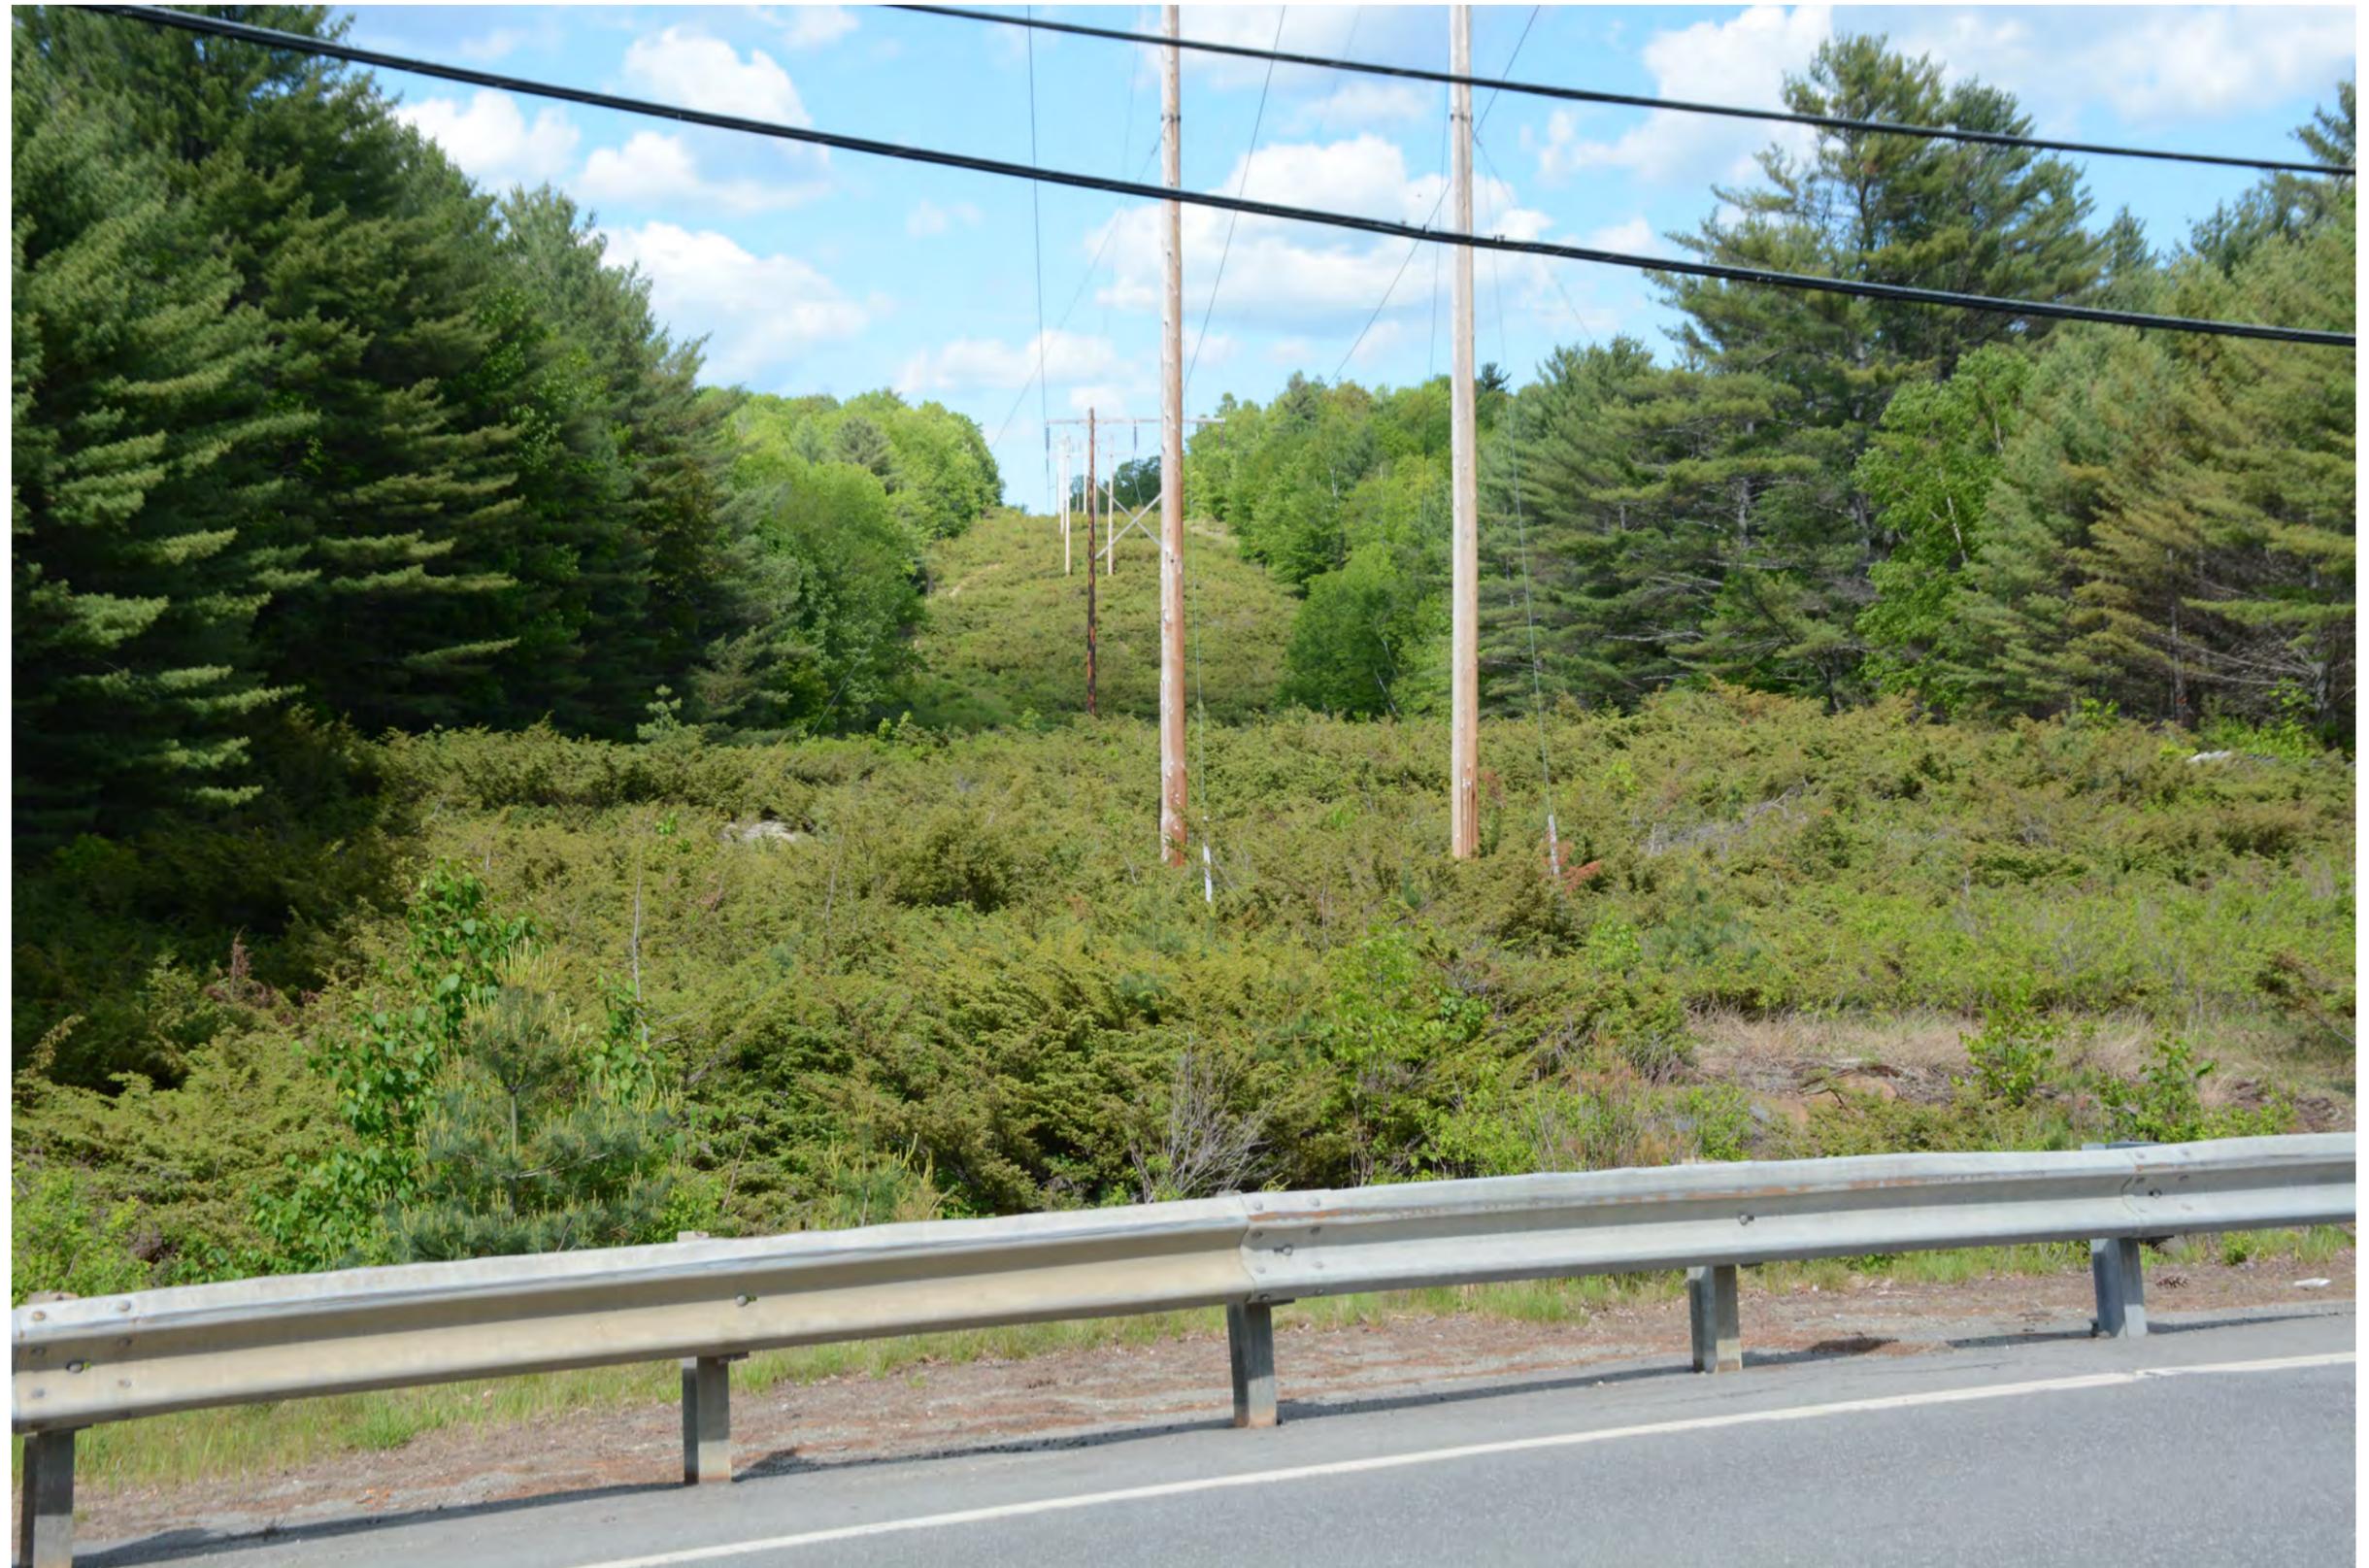
**Existing Conditions:** Normal view looking east from Route 201 toward the existing 115 kV transmission line corridor.

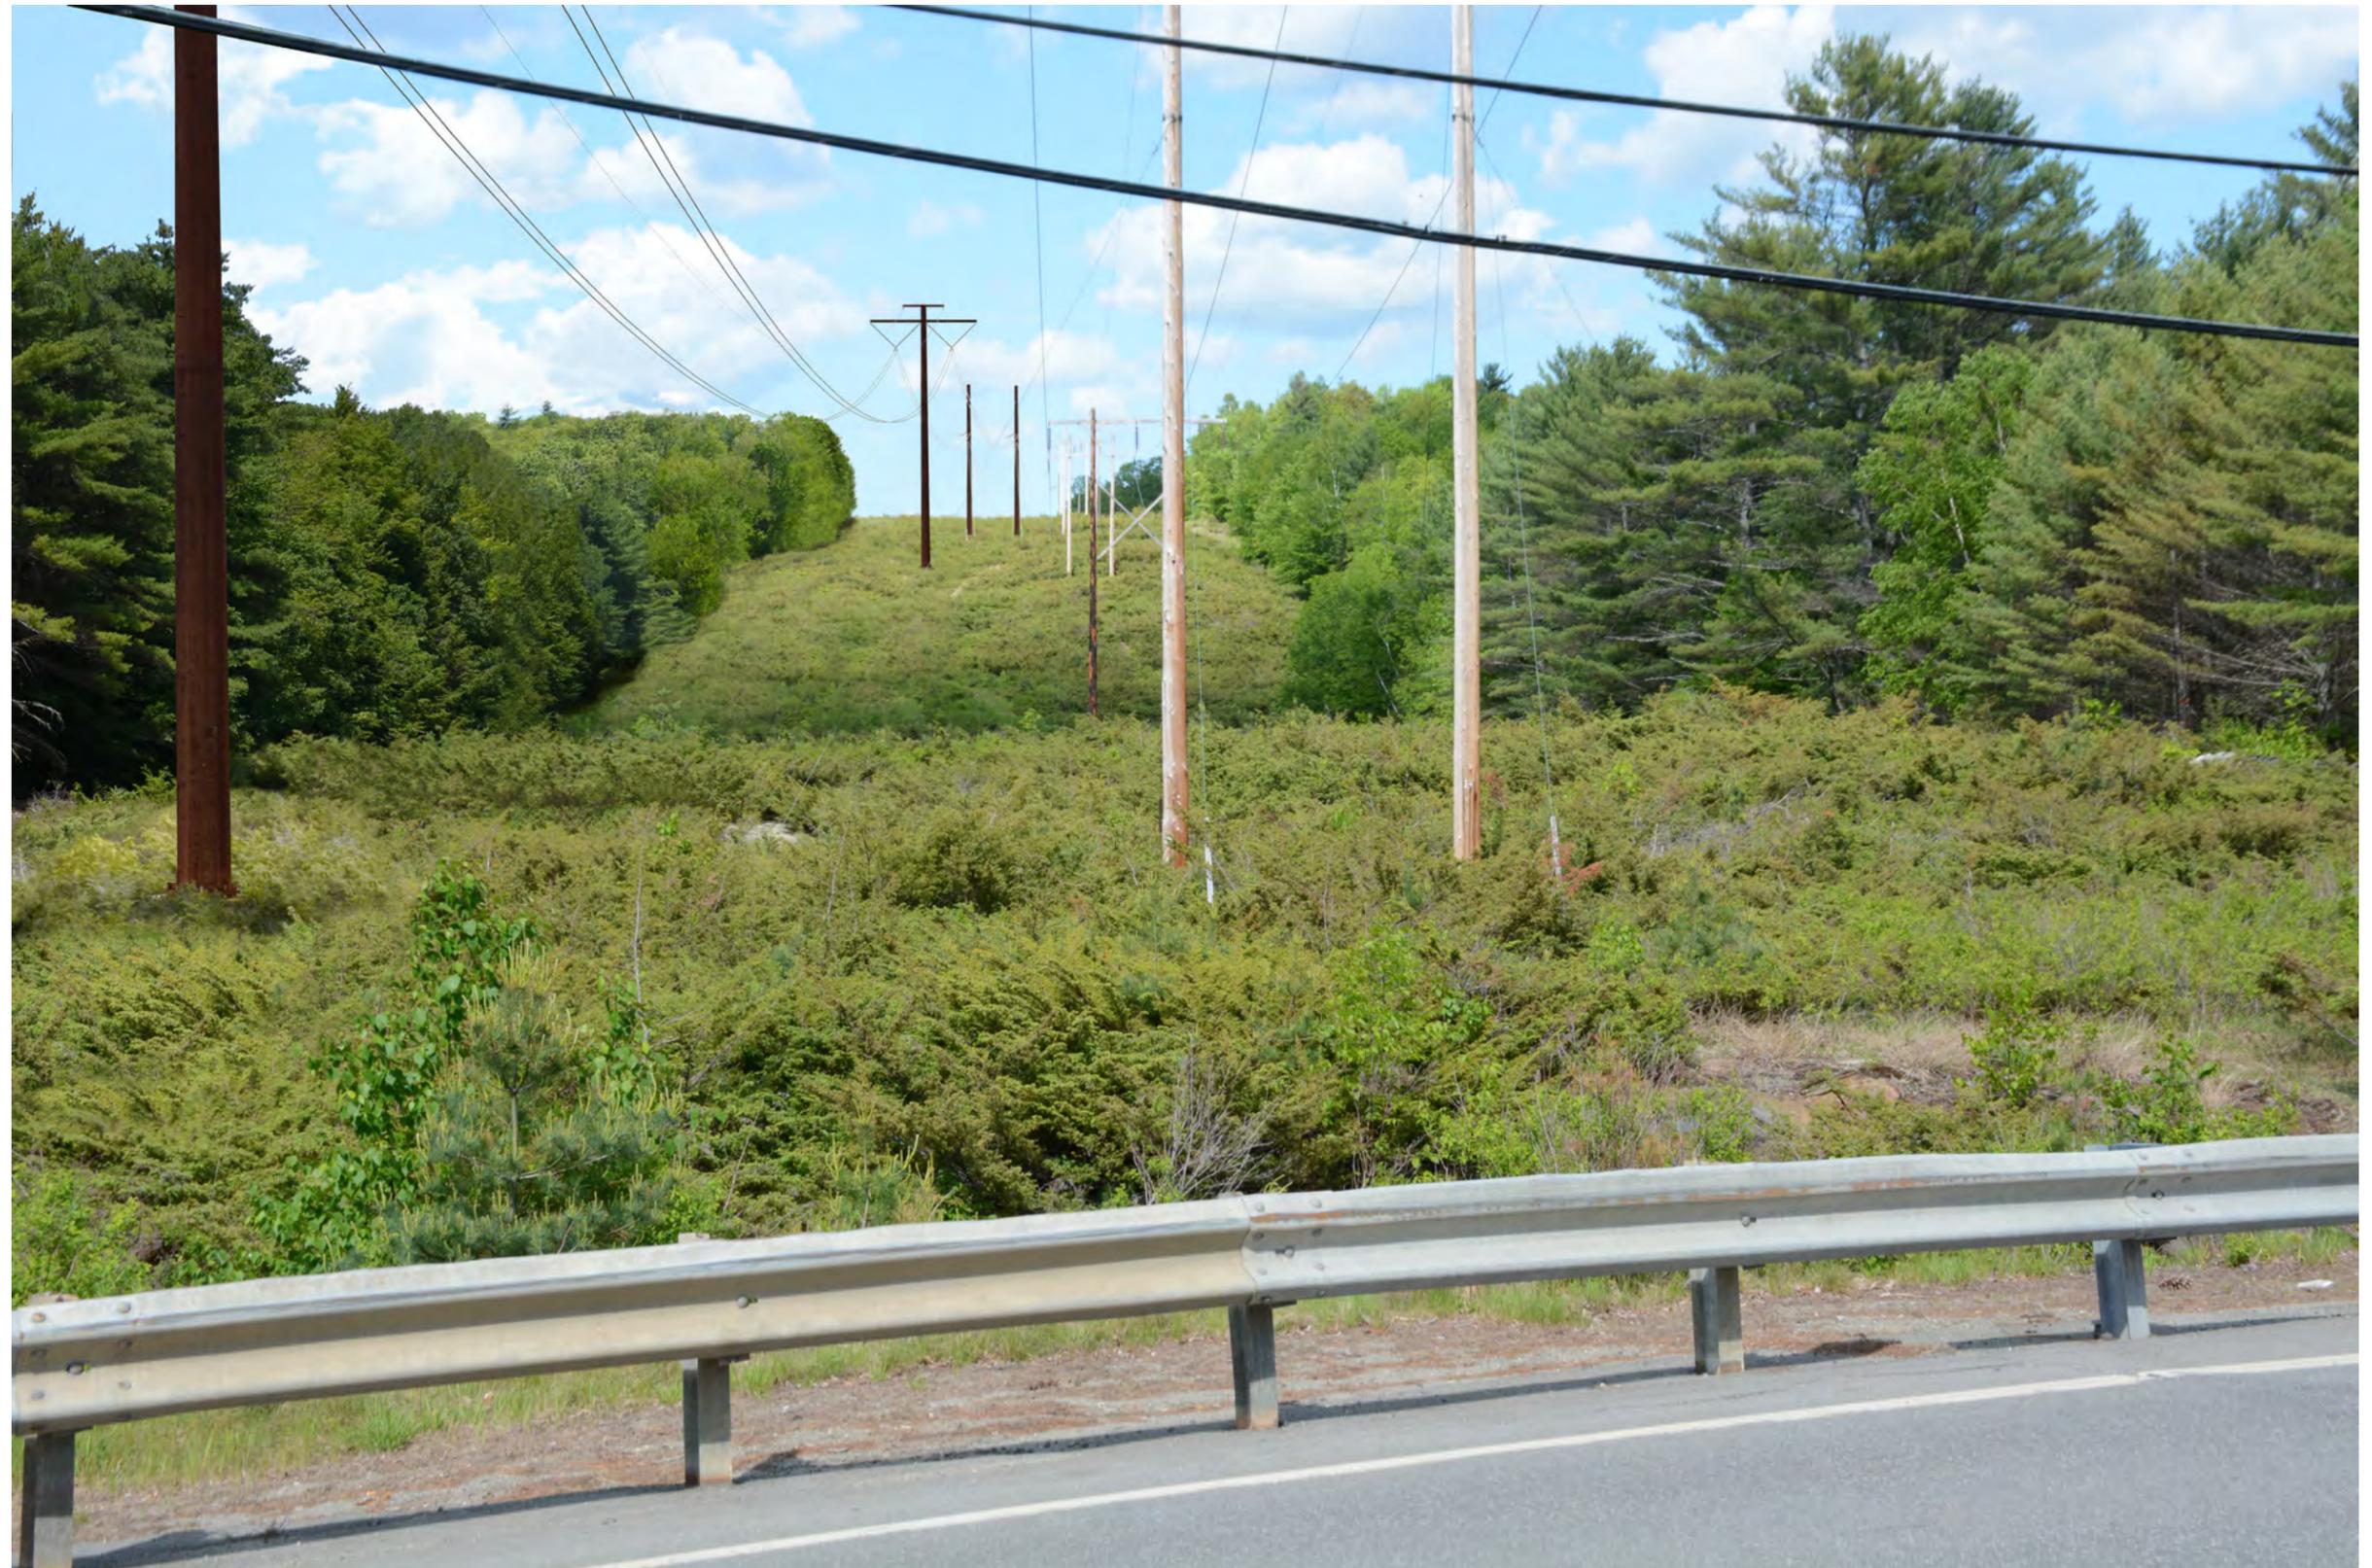
**PHOTOSIMULATION 19A: ROUTE 201, Moscow**

**Proposed Conditions:** Normal view looking east from Route 201 in Moscow toward the proposed co-located HVDC transmission line. The existing 225' wide corridor clearing will be widened by 75' on the western side (left of corridor in image) to accommodate the proposed HVDC transmission line. Three structures will be visible from this viewpoint.

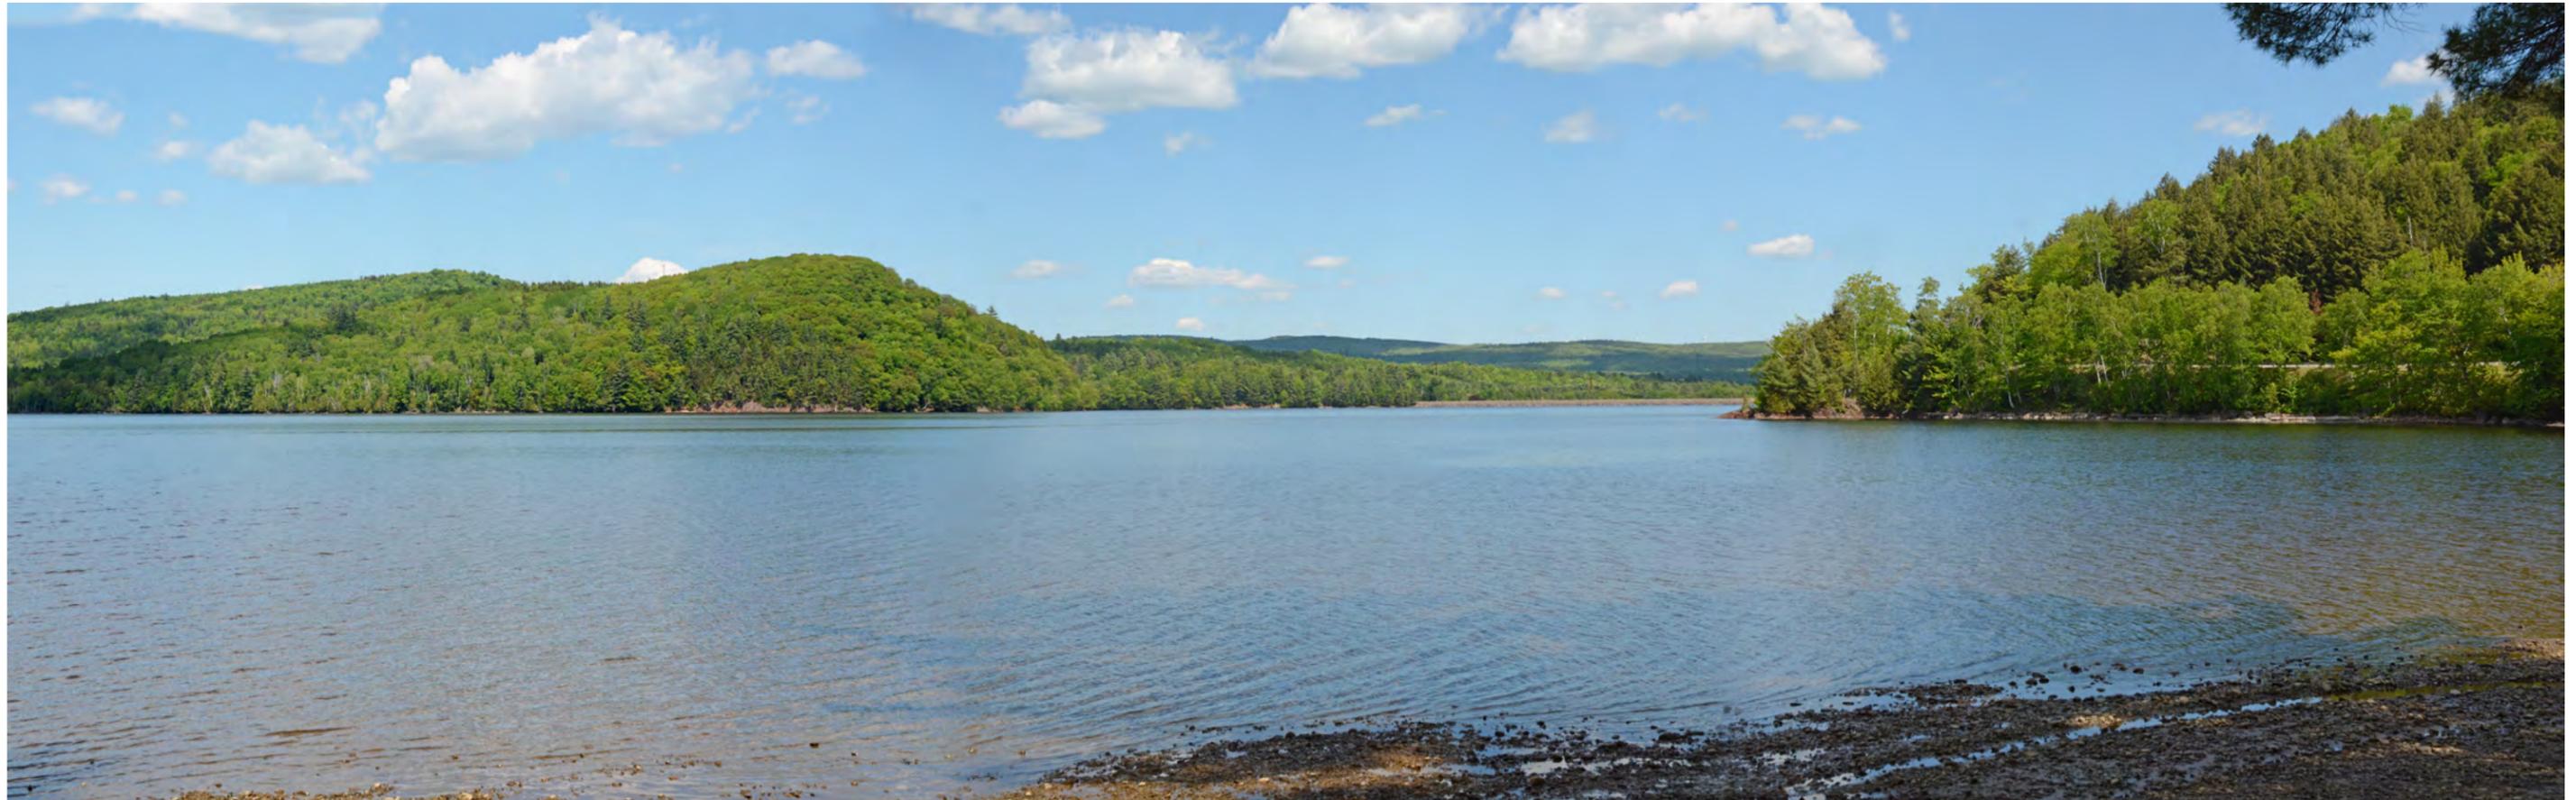
# PHOTOSIMULATION 20: WYMAN LAKE RECREATION AREA, Pleasant Ridge Plt

**Proposed Conditions:** Panoramic view looking from northeast to southeast from the Wyman Lake Recreation Area toward the proposed co-located HVDC transmission line. The proposed HVDC transmission line would be visible adjacent to the existing 115 kV transmission line and seen in context with the Wyman Hydro Dam and portions of six Bingham Wind turbines. Three HVDC transmission structures and conductors will be visible at distances of 0.9 - 1.3 miles from this viewpoint. See Appendix B: Study Area Photographs for additional images.
