# PHOTOSIMULATION 13: MOXIE POND - North, East Moxie Twp

**PHOTOSIMULATION 13A: MOXIE POND - North, East Moxie Twp**

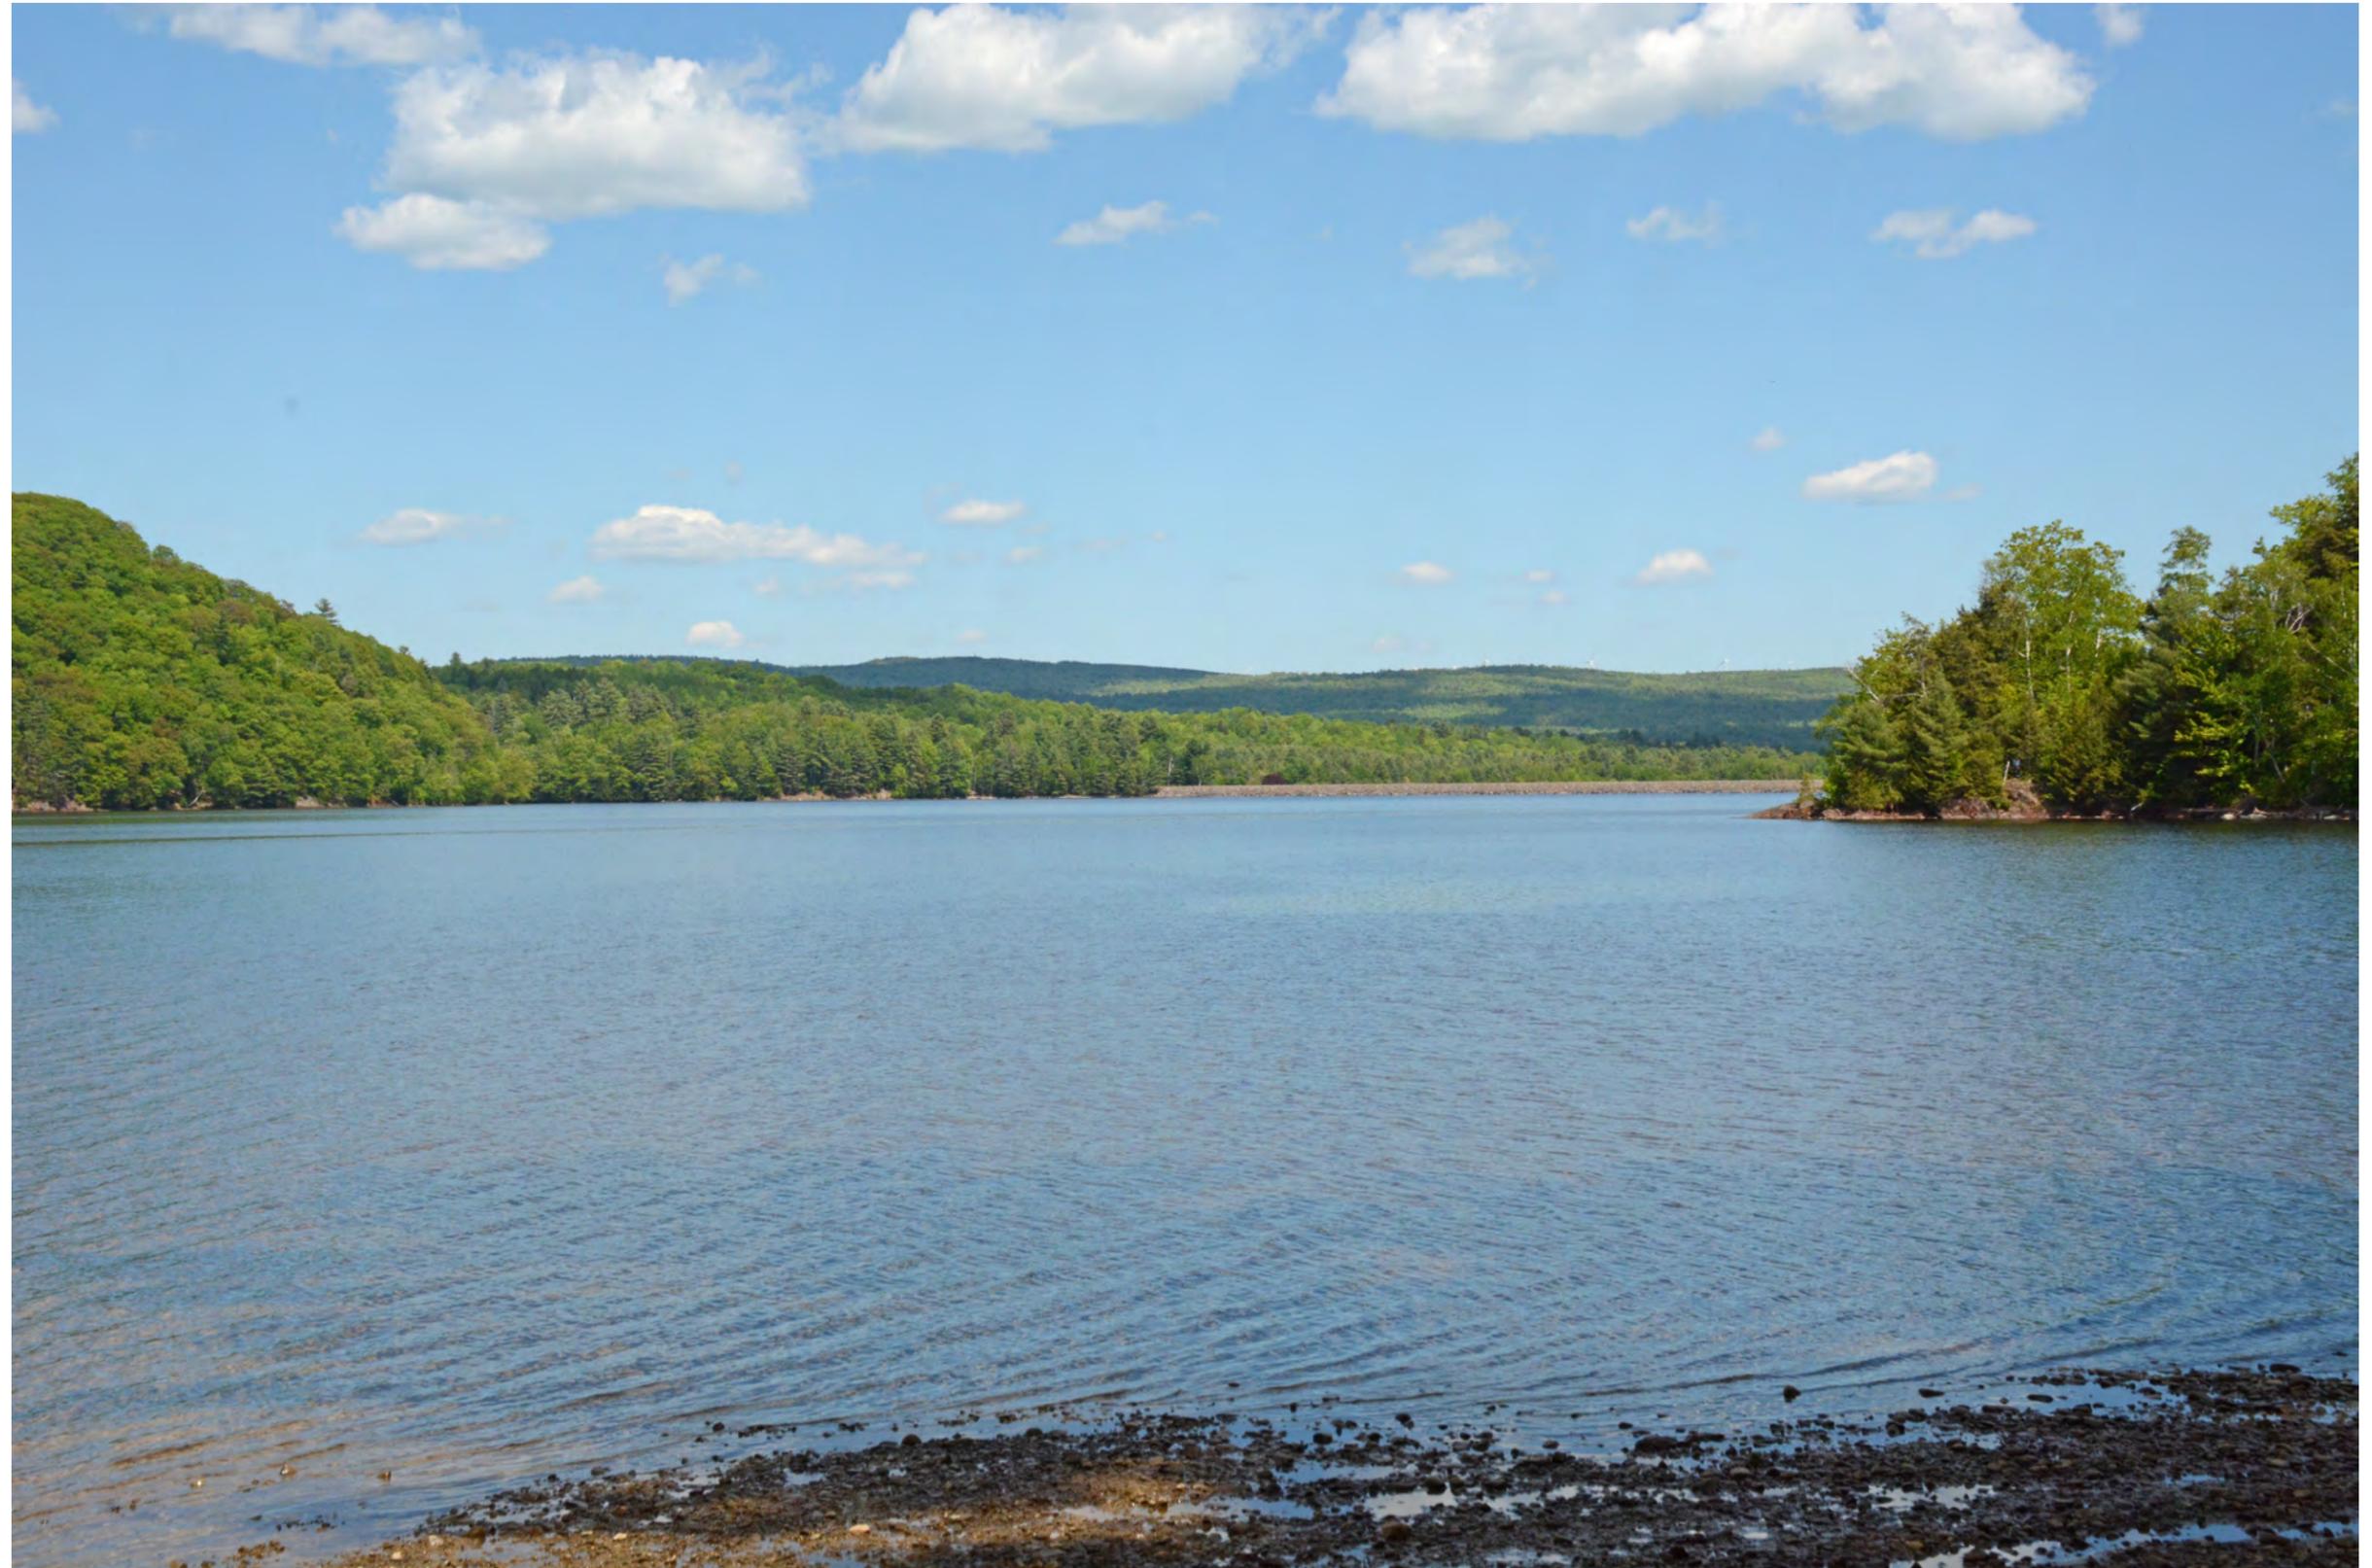
**Existing Conditions:** Normal view looking east from the Wyman Lake Recreation Area towards the Wyman Hydro Dam.

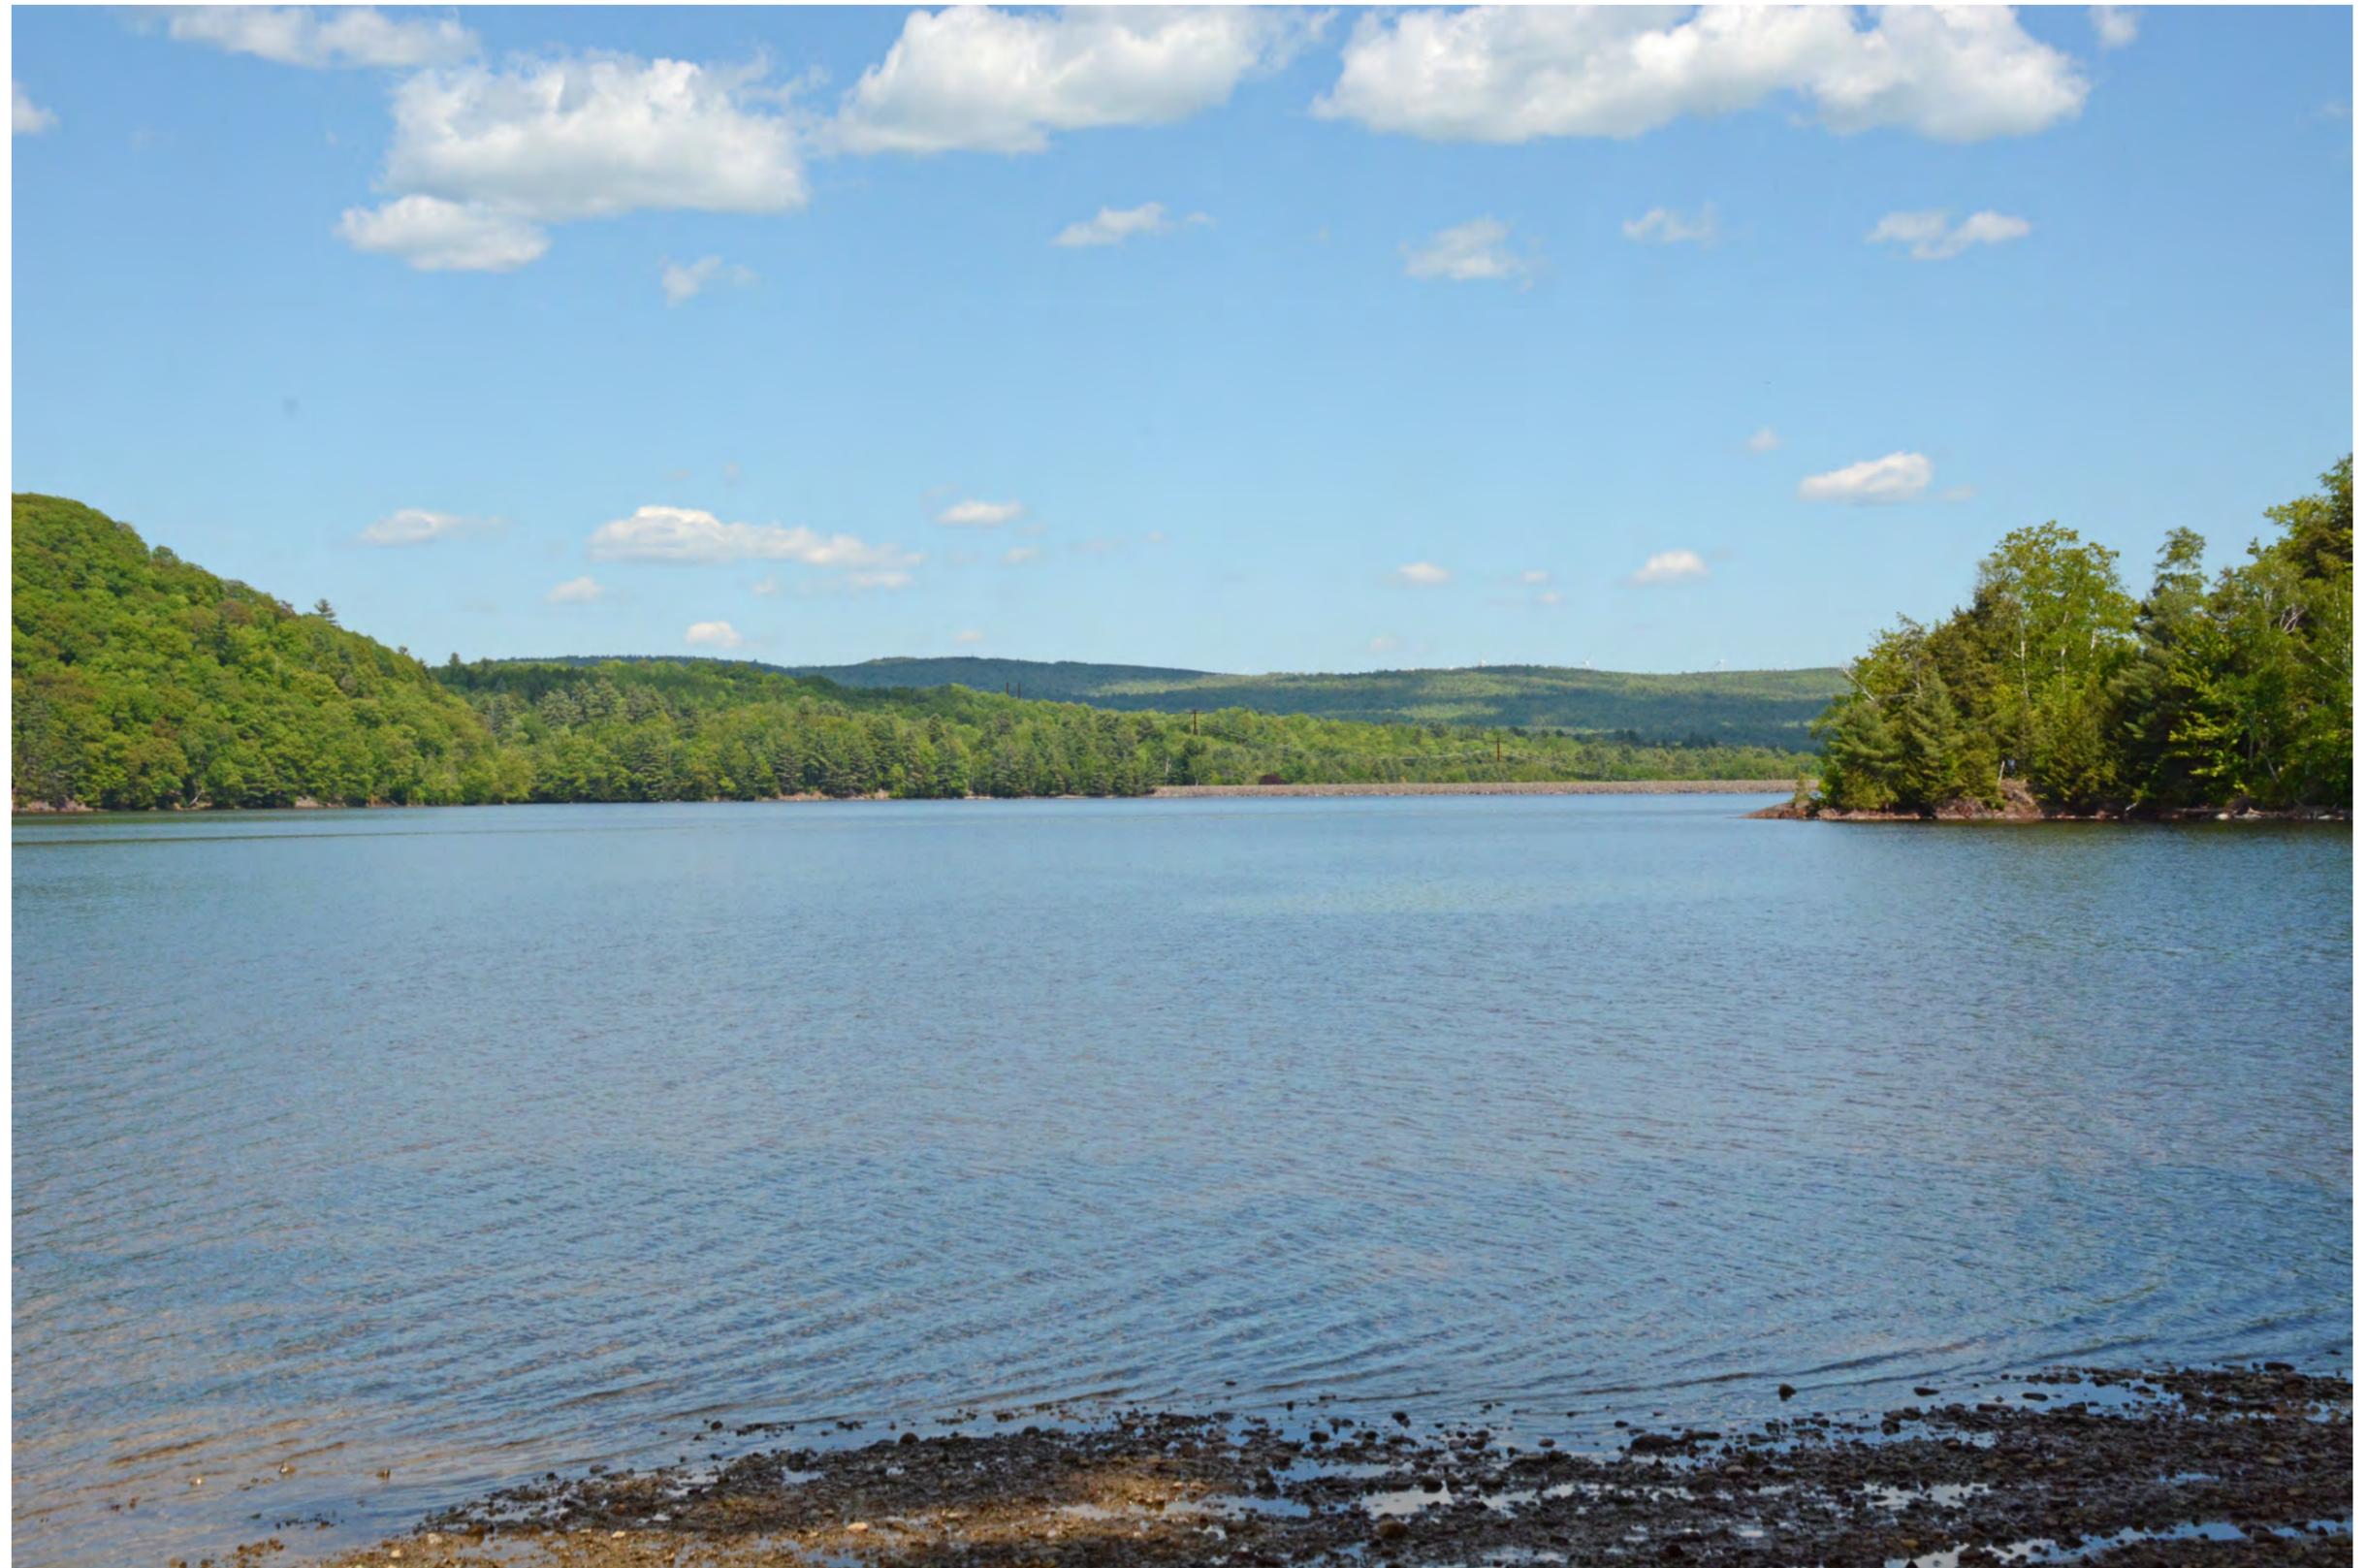
**PHOTOSIMULATION 20A: WYMAN LAKE REST AREA, Pleasant Ridge Plt**

**Proposed Conditions:** Normal view looking east from the Wyman Lake Recreation Area toward the proposed co-located HVDC transmission line. The proposed HVDC transmission line would be visible adjacent to the existing 115 kv transmission line and seen in context with the Wyman Hydro Dam and portions of six Bingham Wind turbines. Three structures, conductors, and portions of the cleared corridor will be visible at distances of 0.9 - 1.3 miles from this viewpoint.

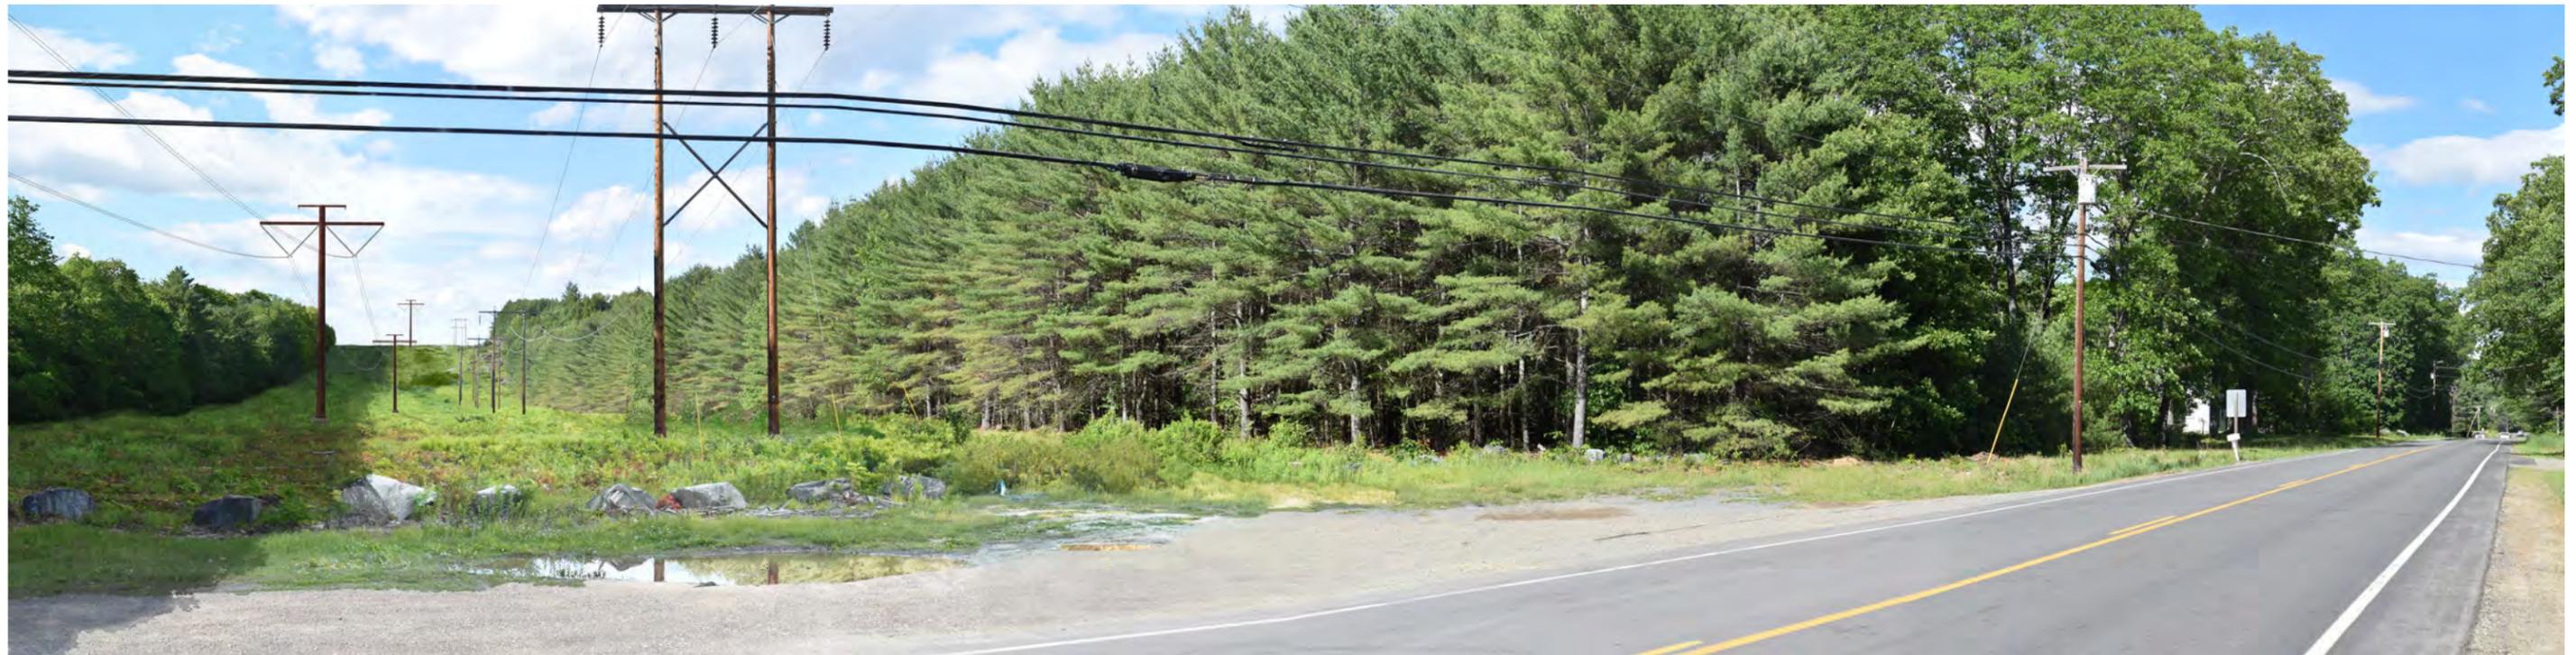
## PHOTOSIMULATION 21: ROUTE 8, Anson

**Proposed Conditions:** Panoramic view looking from north to east from Route 8 (Solon Rd) toward the proposed co-located HVDC transmission line. The existing 150' wide cleared corridor will be widened by 75' on the western side to accommodate the HVDC transmission line. Three of the proposed HVDC structures and conductors will be visible from this viewpoint. See Appendix B: Study Area Photographs for additional images.

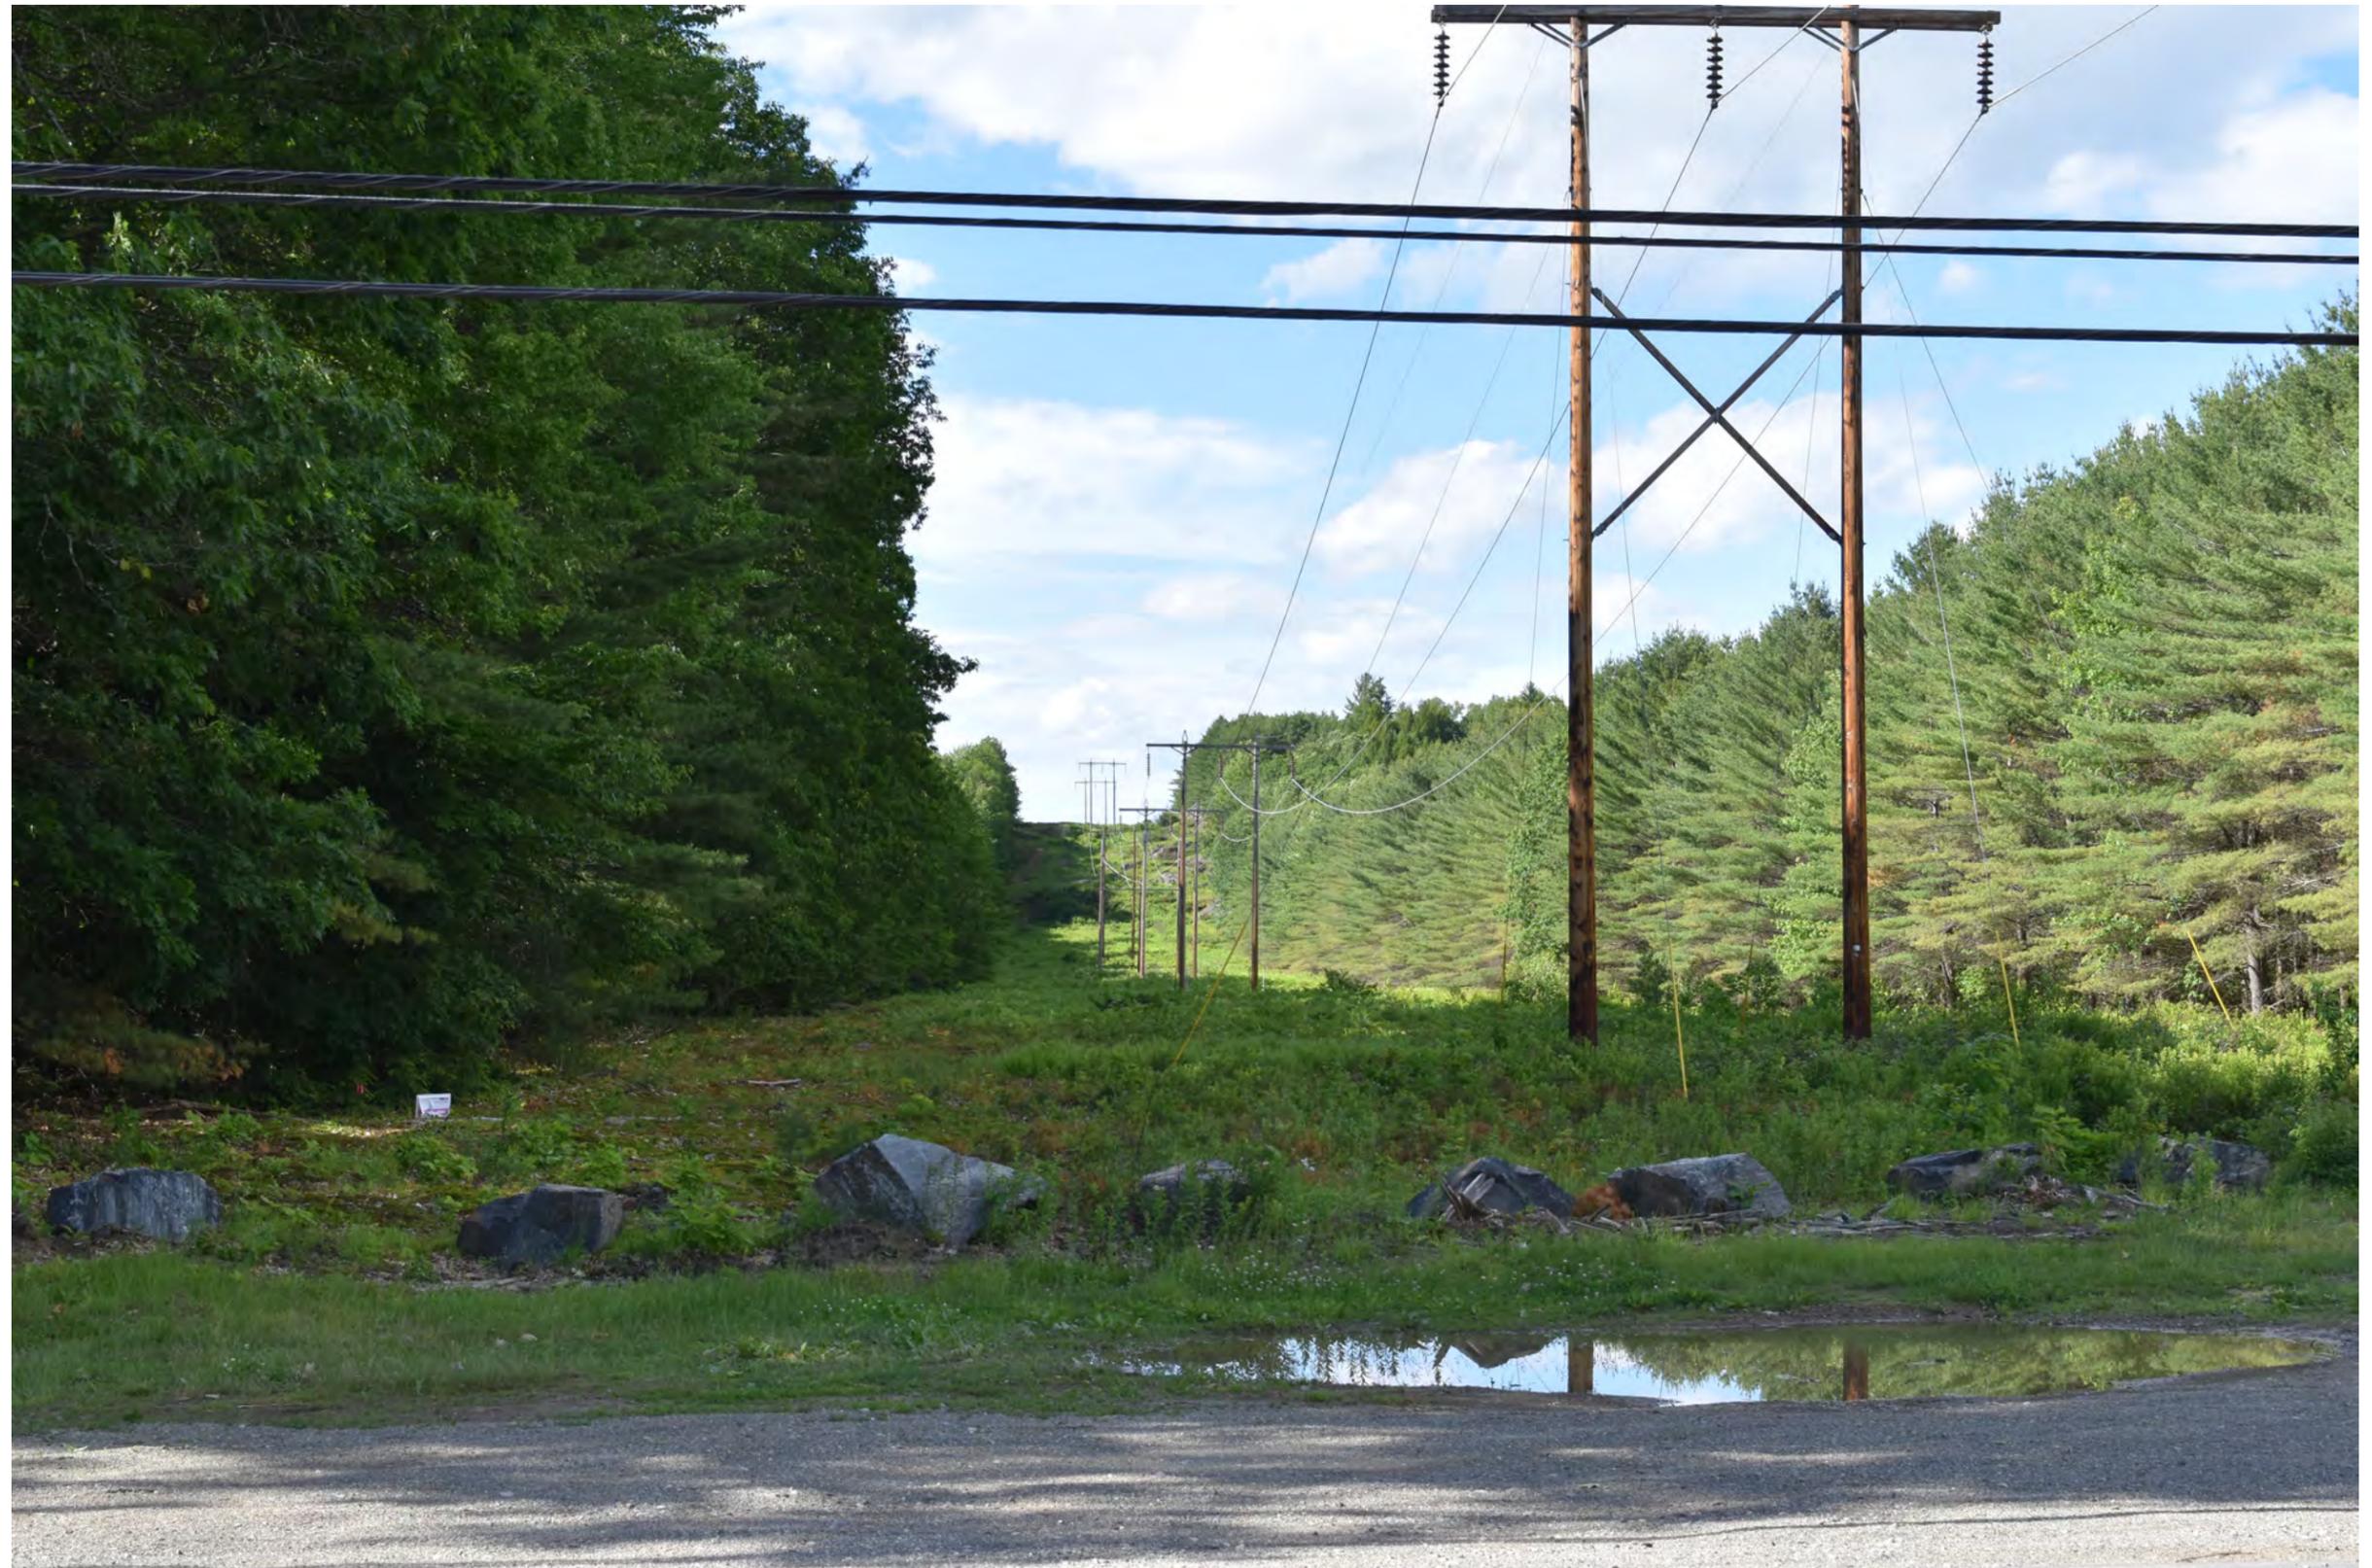
**PHOTOSIMULATION 21A: ROUTE 8, Anson**

**Existing Conditions:** Normal view looking north from Route 8 (Solon Rd) at the existing 115 kV transmission line.

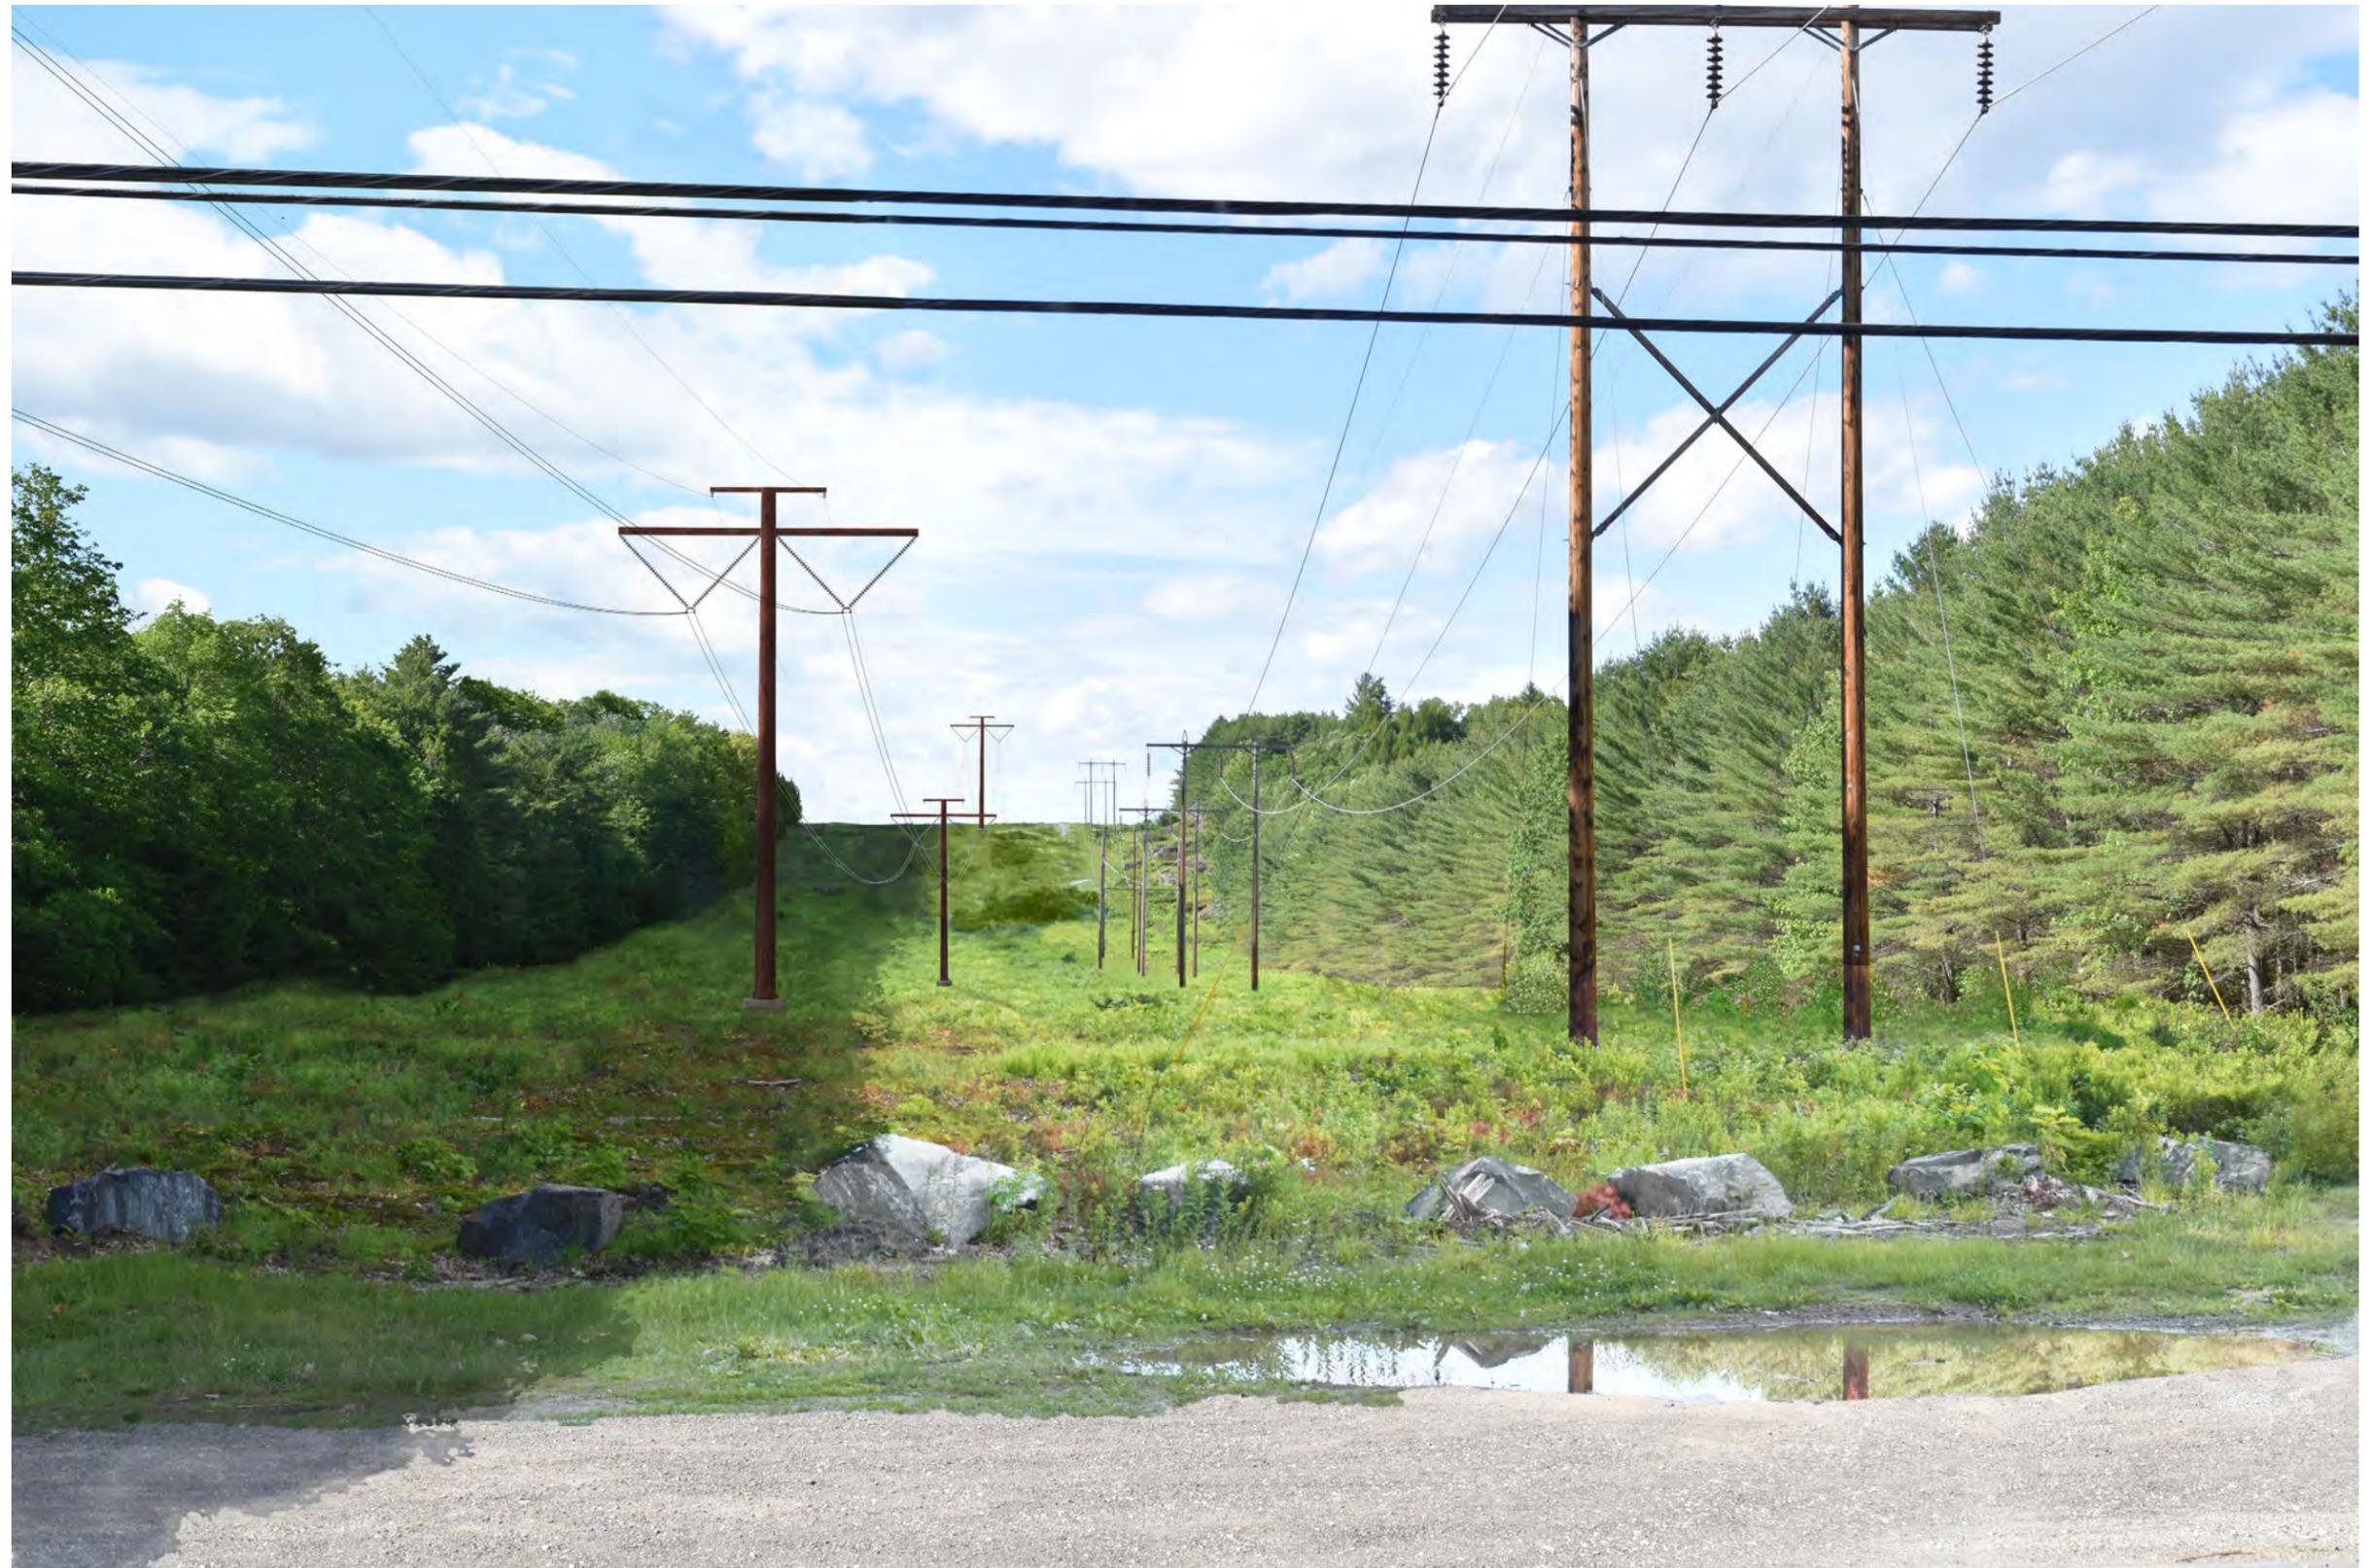
**PHOTOSIMULATION 21A: ROUTE 8, Anson**

**Proposed Conditions:** Normal view looking north from Route 8 (Solon Rd) toward the proposed co-located HVDC transmission line. The existing 150' wide cleared corridor will be widened by 75' on the western side to accommodate the proposed HVDC transmission line. Three of the proposed HVDC structures and conductors will be visible from this viewpoint.

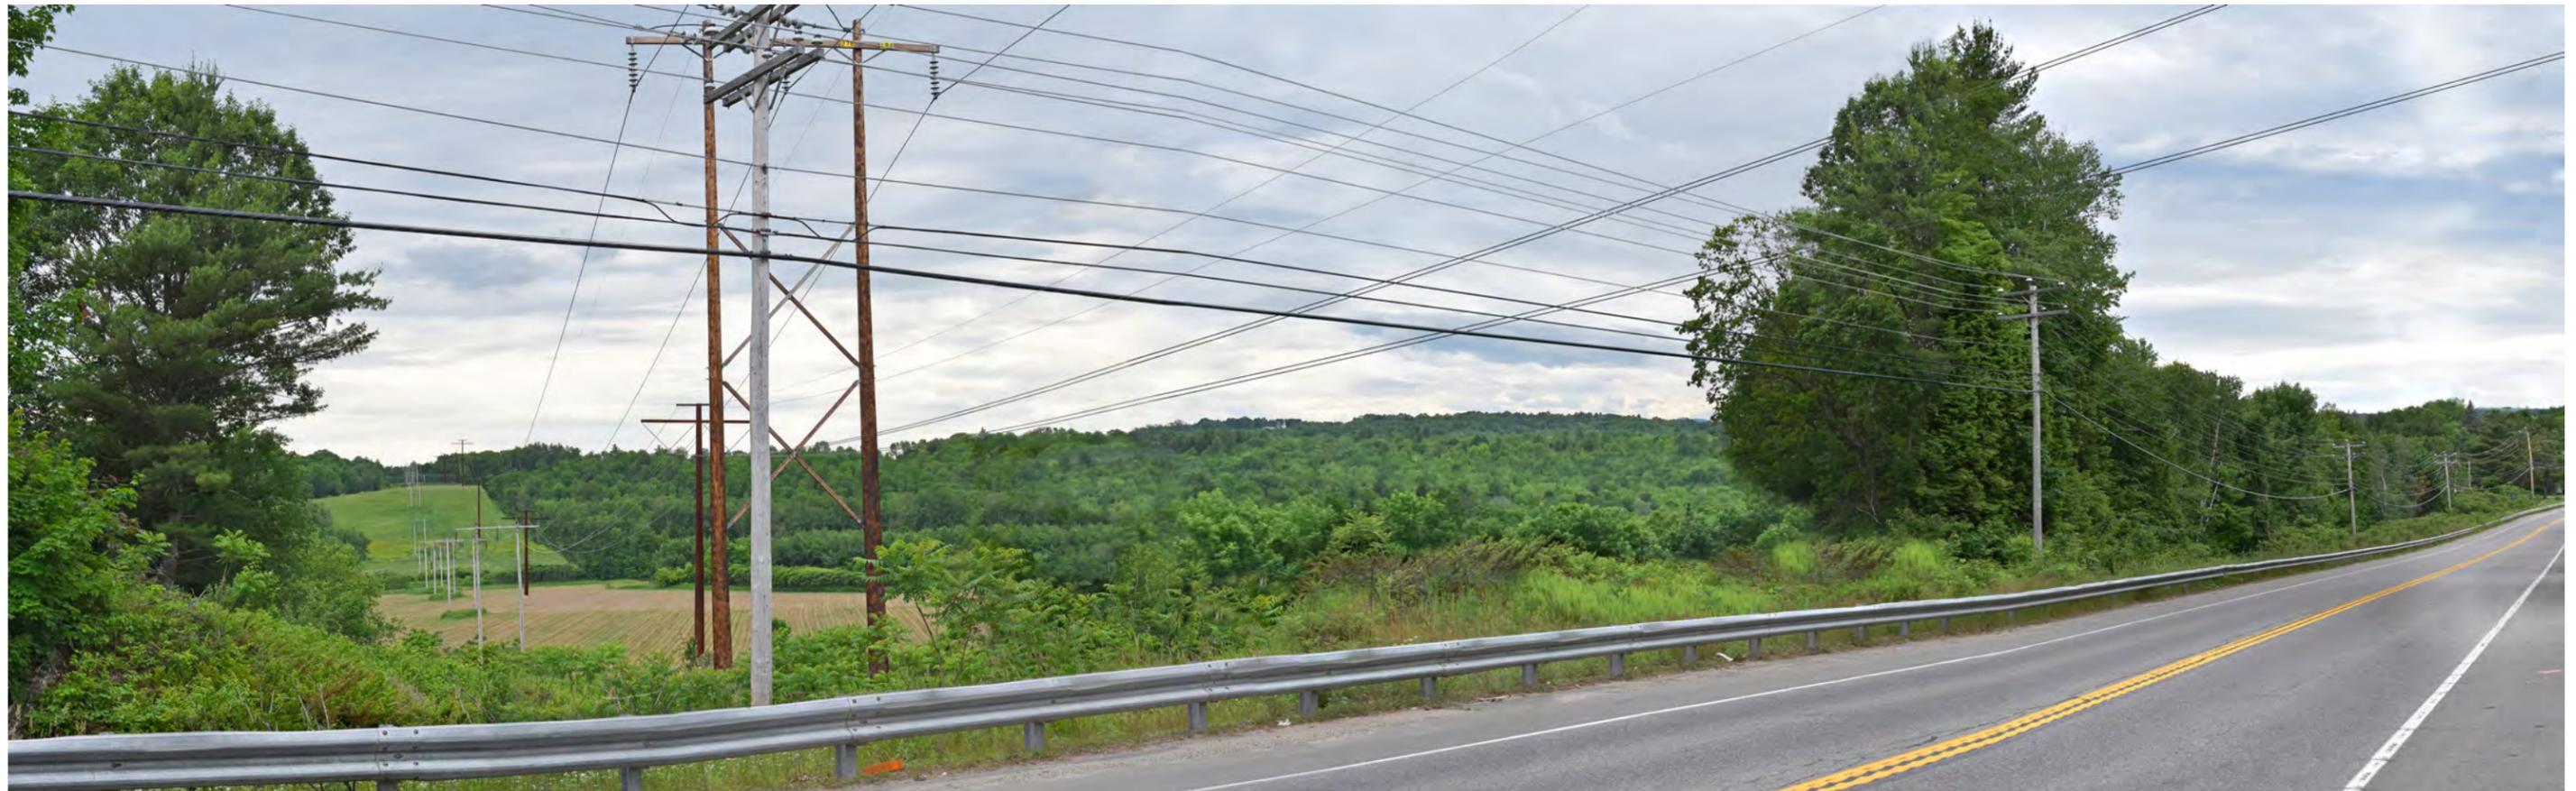
## PHOTOSIMULATION 22: ROUTE 2, Farmington

**Proposed Conditions:** Panoramic view looking from south to west from Route 2 in Farmington toward the proposed co-located HVDC transmission line. The existing 225' wide cleared corridor will be widened by 75' on the western side to accommodate the proposed HVDC transmission line. Six of the proposed HVDC structures and conductors will be visible from this viewpoint. See Appendix B: Study Area photographs for additional images.

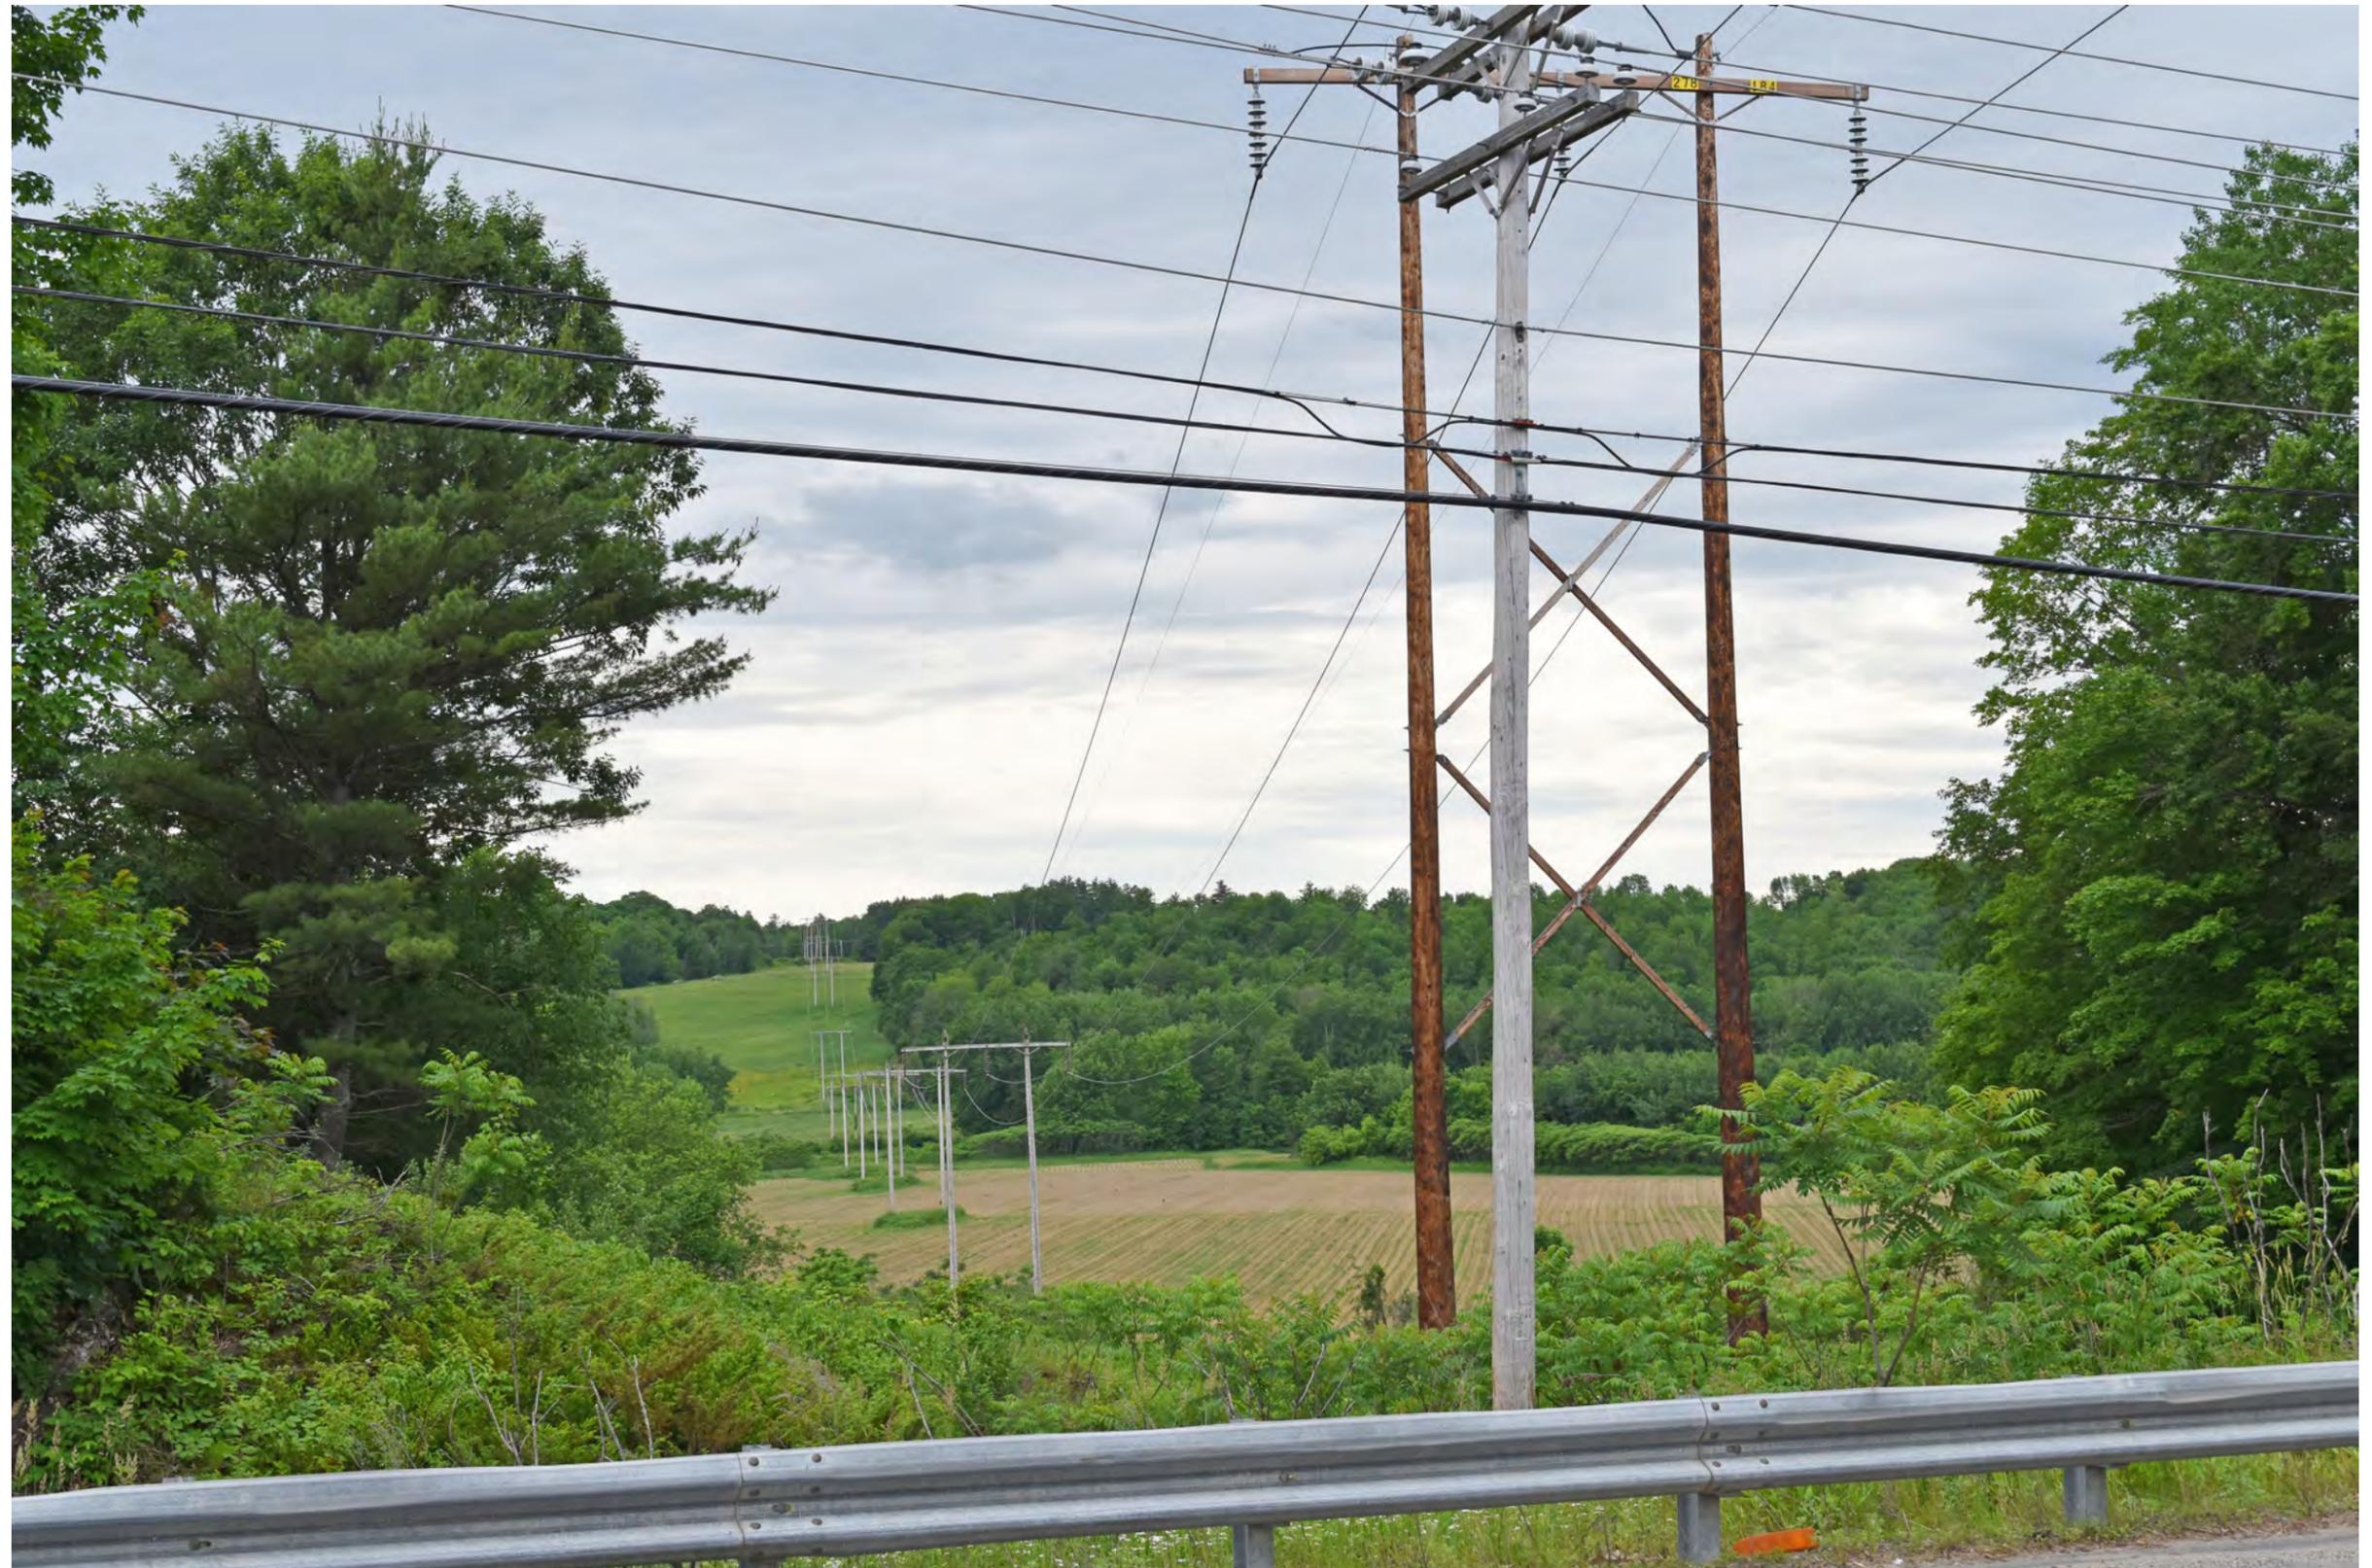
**PHOTOSIMULATION 23A: ROUTE 2, Farmington**

**Existing Conditions:** Normal view looking from southwest from Route 2 toward the existing 115 kV transmission line.
