# PHOTOSIMULATION 13: MOXIE POND - North, East Moxie Twp

**PHOTOSIMULATION 13A: MOXIE POND - North, East Moxie Twp**

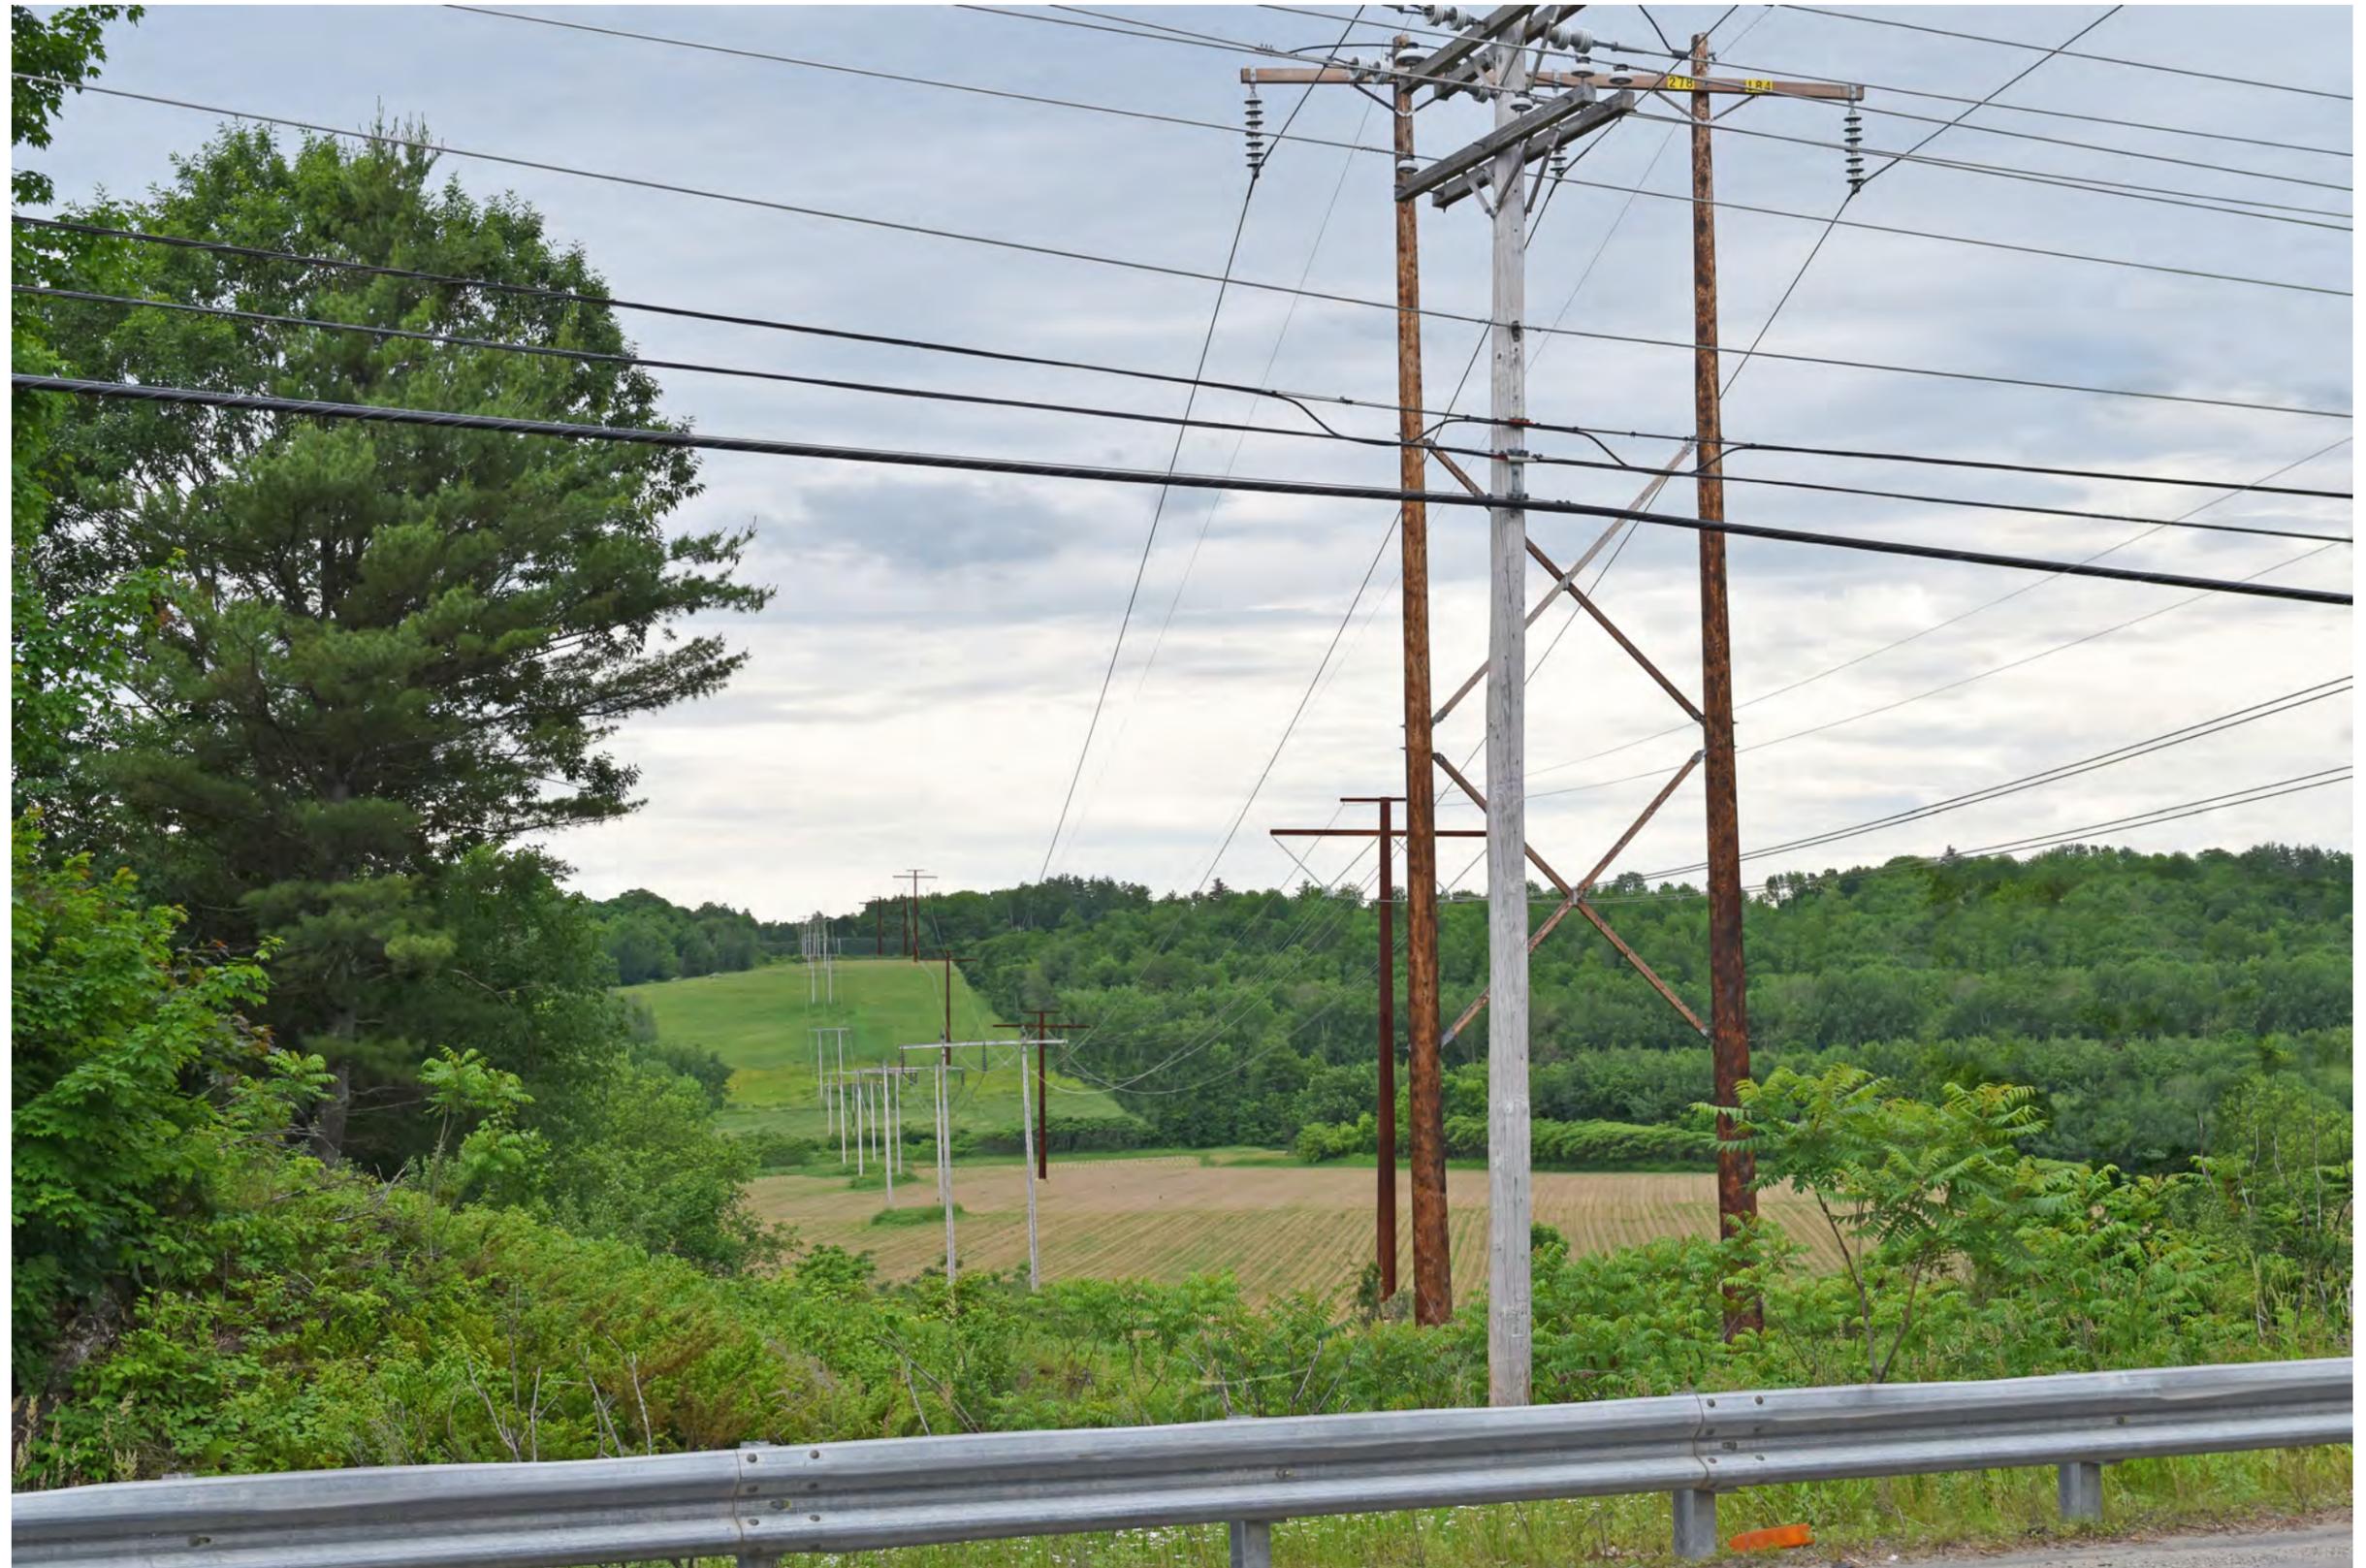
**PHOTOSIMULATION 23A: ROUTE 2, Farmington**

**Proposed Conditions:** Normal view looking from southwest from Route 2 toward the proposed co-located HVDC transmission line. The existing 225' wide cleared corridor will be widened by 75' on the western side to accommodate the new HVDC transmission line. Six of the proposed HVDC structures and conductors will be visible from this viewpoint.

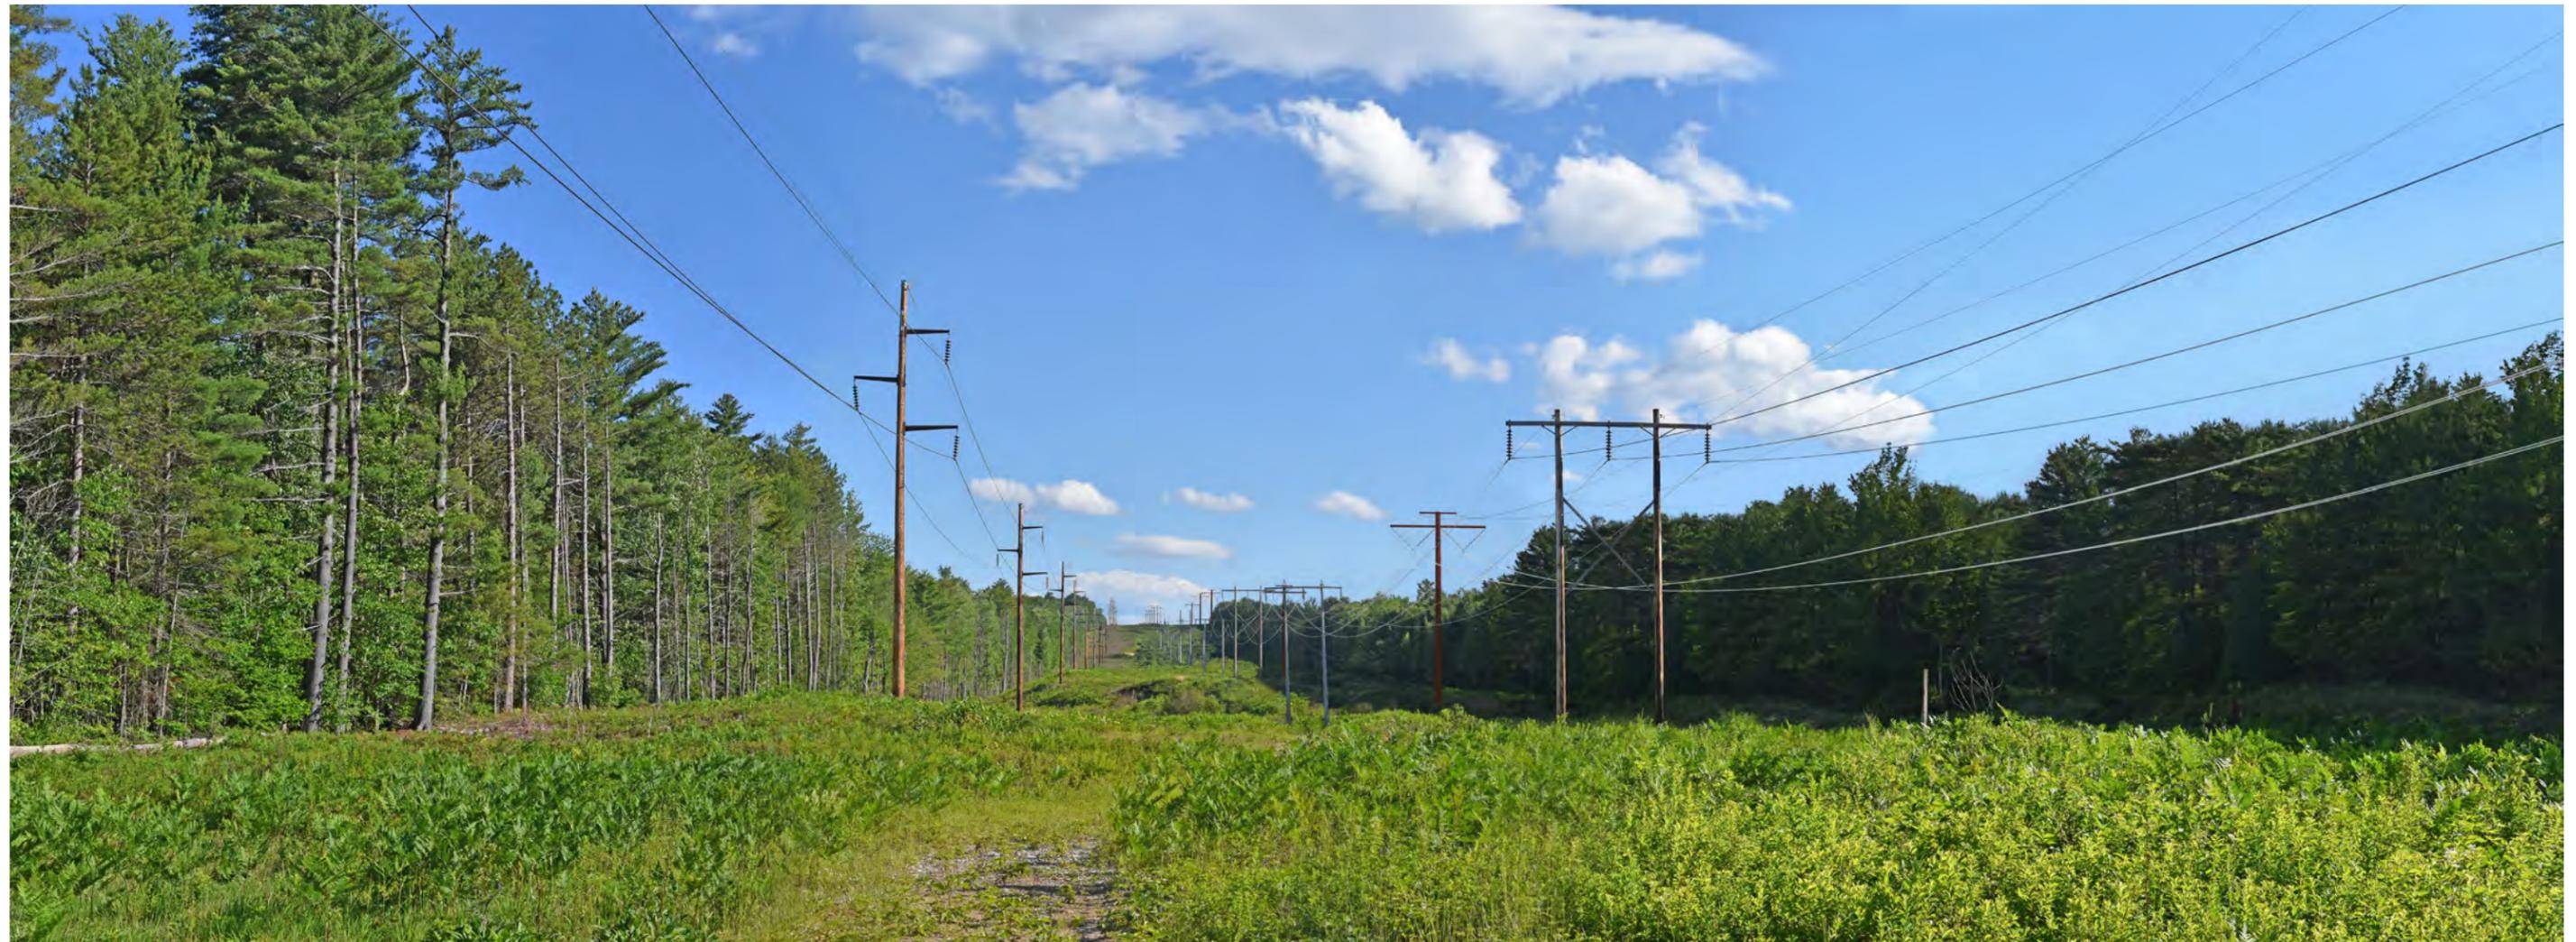
# PHOTOSIMULATION 23: ANDROSCOGGIN RIVERLANDS STATE PARK, Existing Transmission Line, Leeds

**Proposed Conditions:** Panoramic view looking from southeast to southwest from an access road crossing the existing transmission line within the Androscoggin Riverlands State Park toward the proposed co-located HVDC transmission line. The existing 225' corridor clearing will be widened by 75' on the western side to accommodate the new transmission line. See Appendix B: Study Area Photographs for additional images of the State Park.

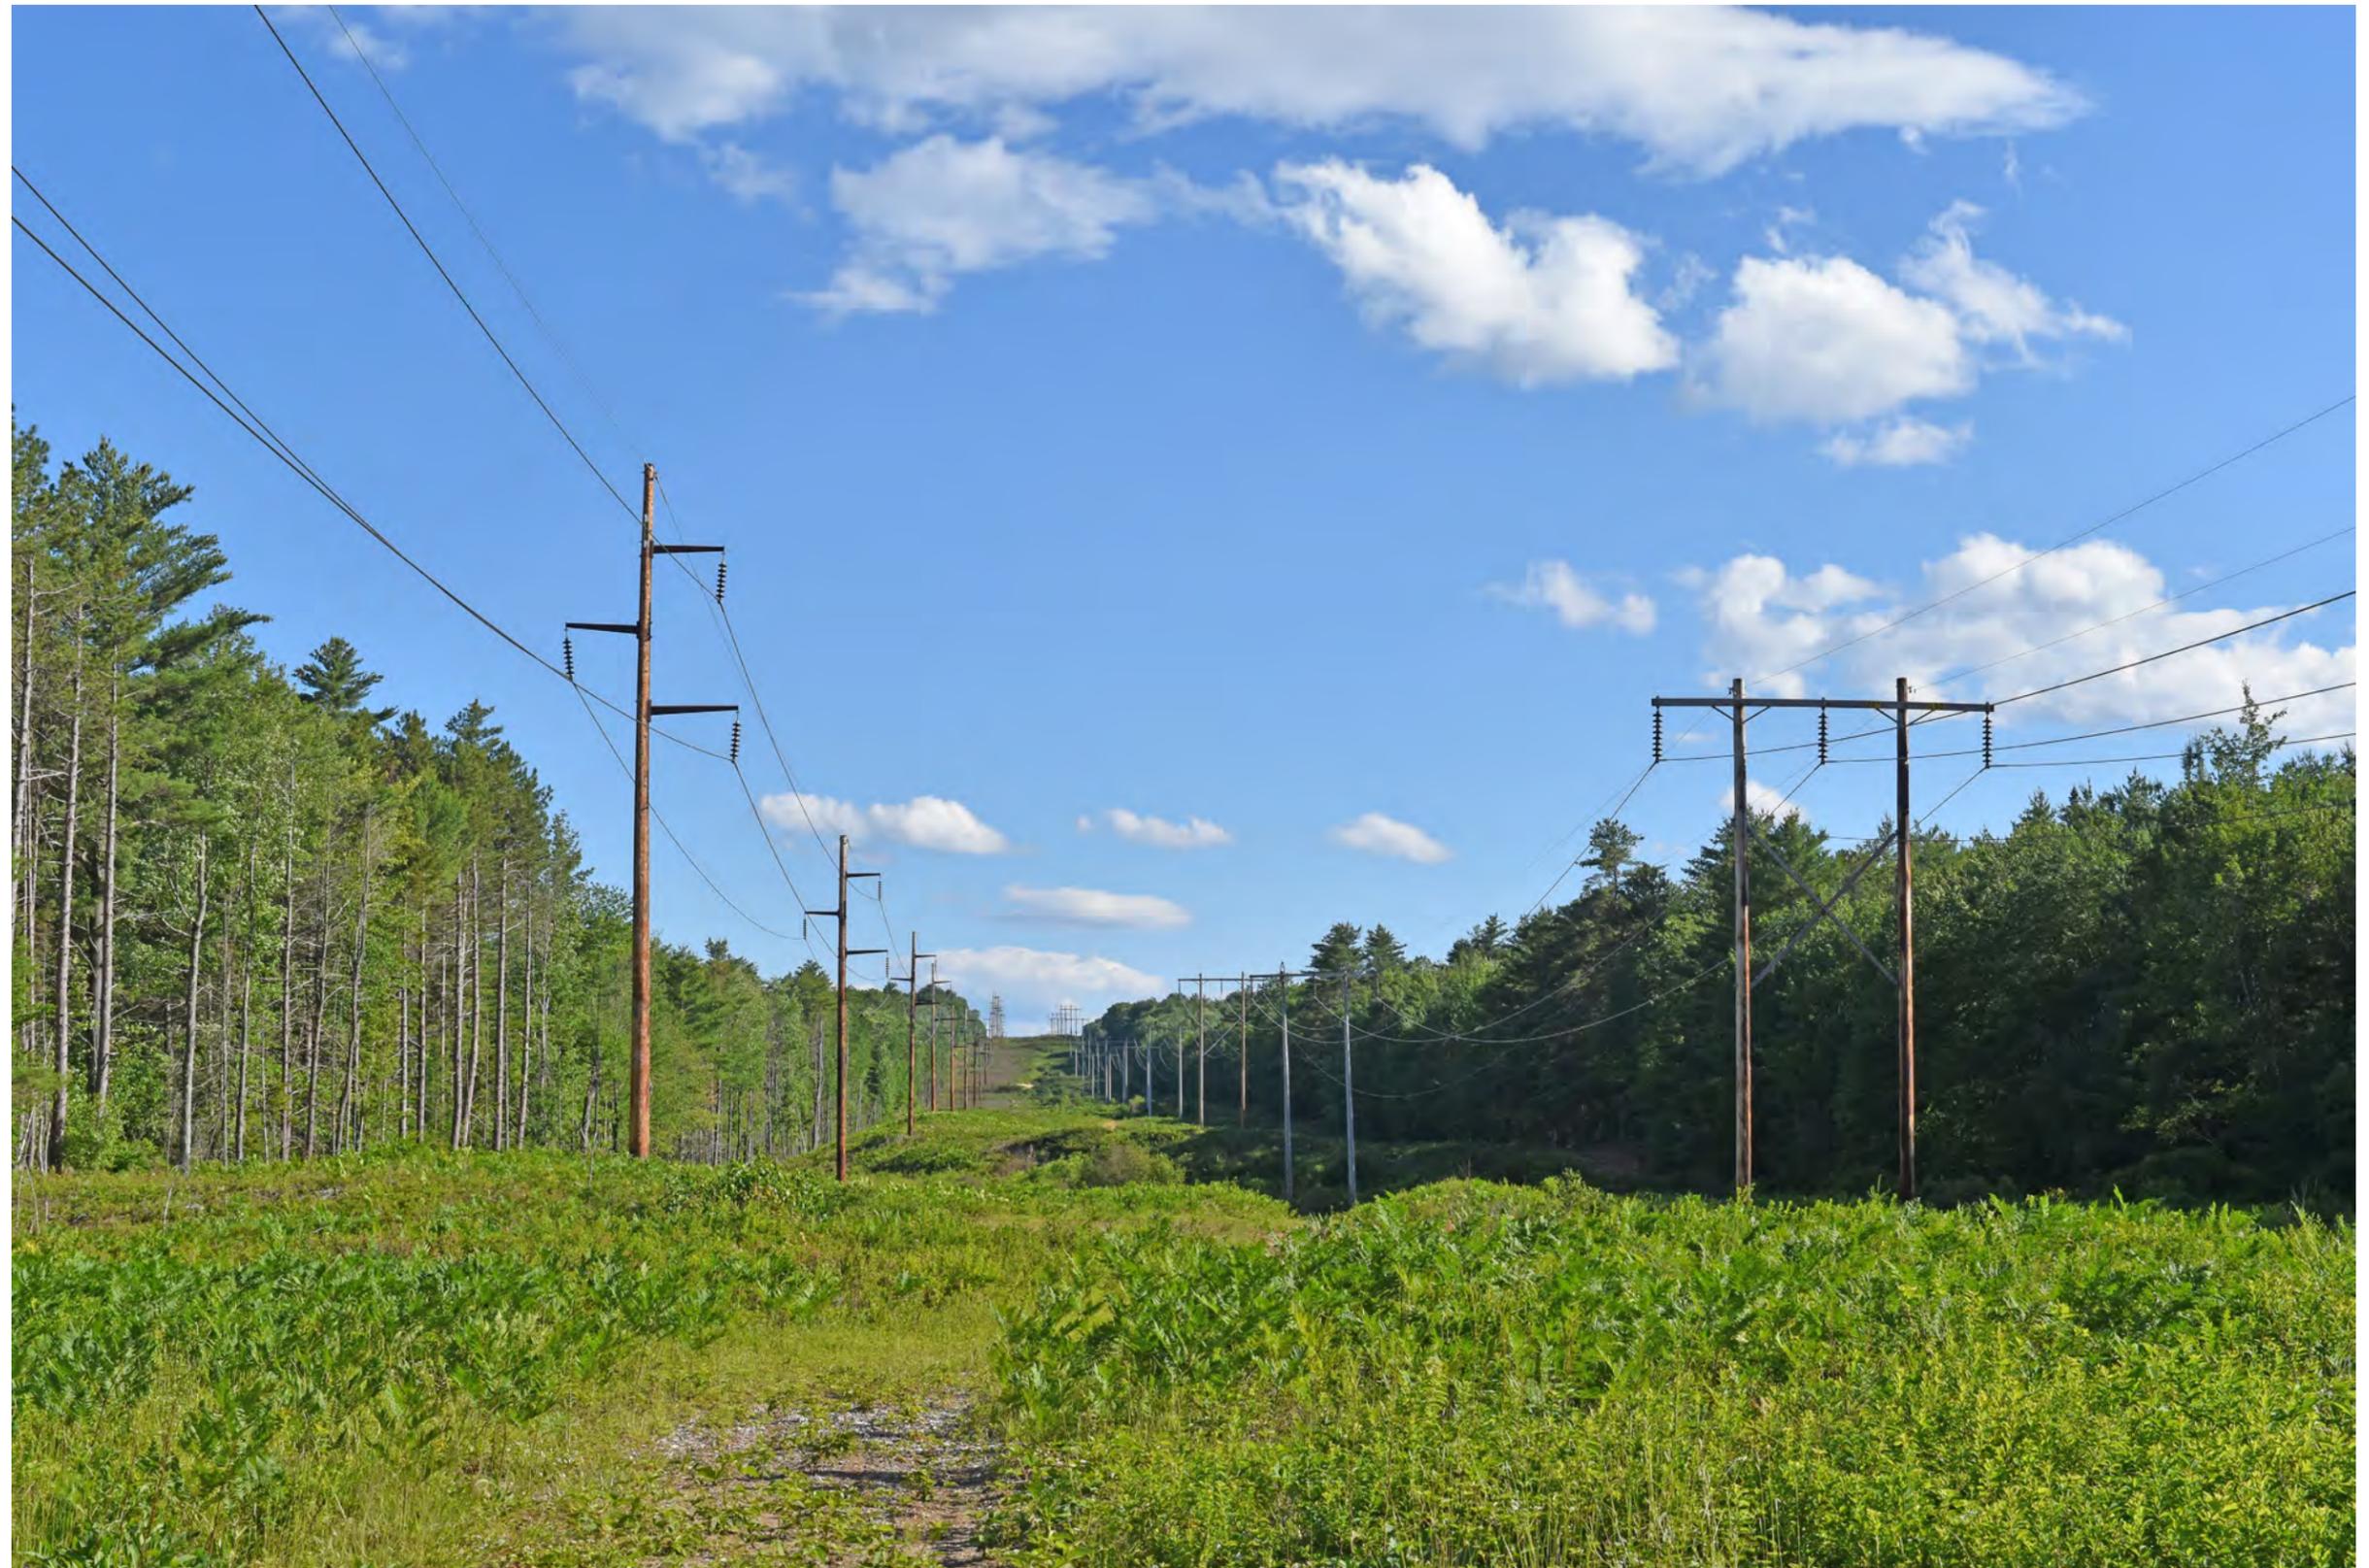
**PHOTOSIMULATION 23A: ANDROSCOGGIN RIVERLANDS STATE PARK, Existing Transmission Line, Leeds**

**Existing Conditions:** Normal view looking south from an access road within the Androscoggin Riverlands State Park crossing the existing transmission line.

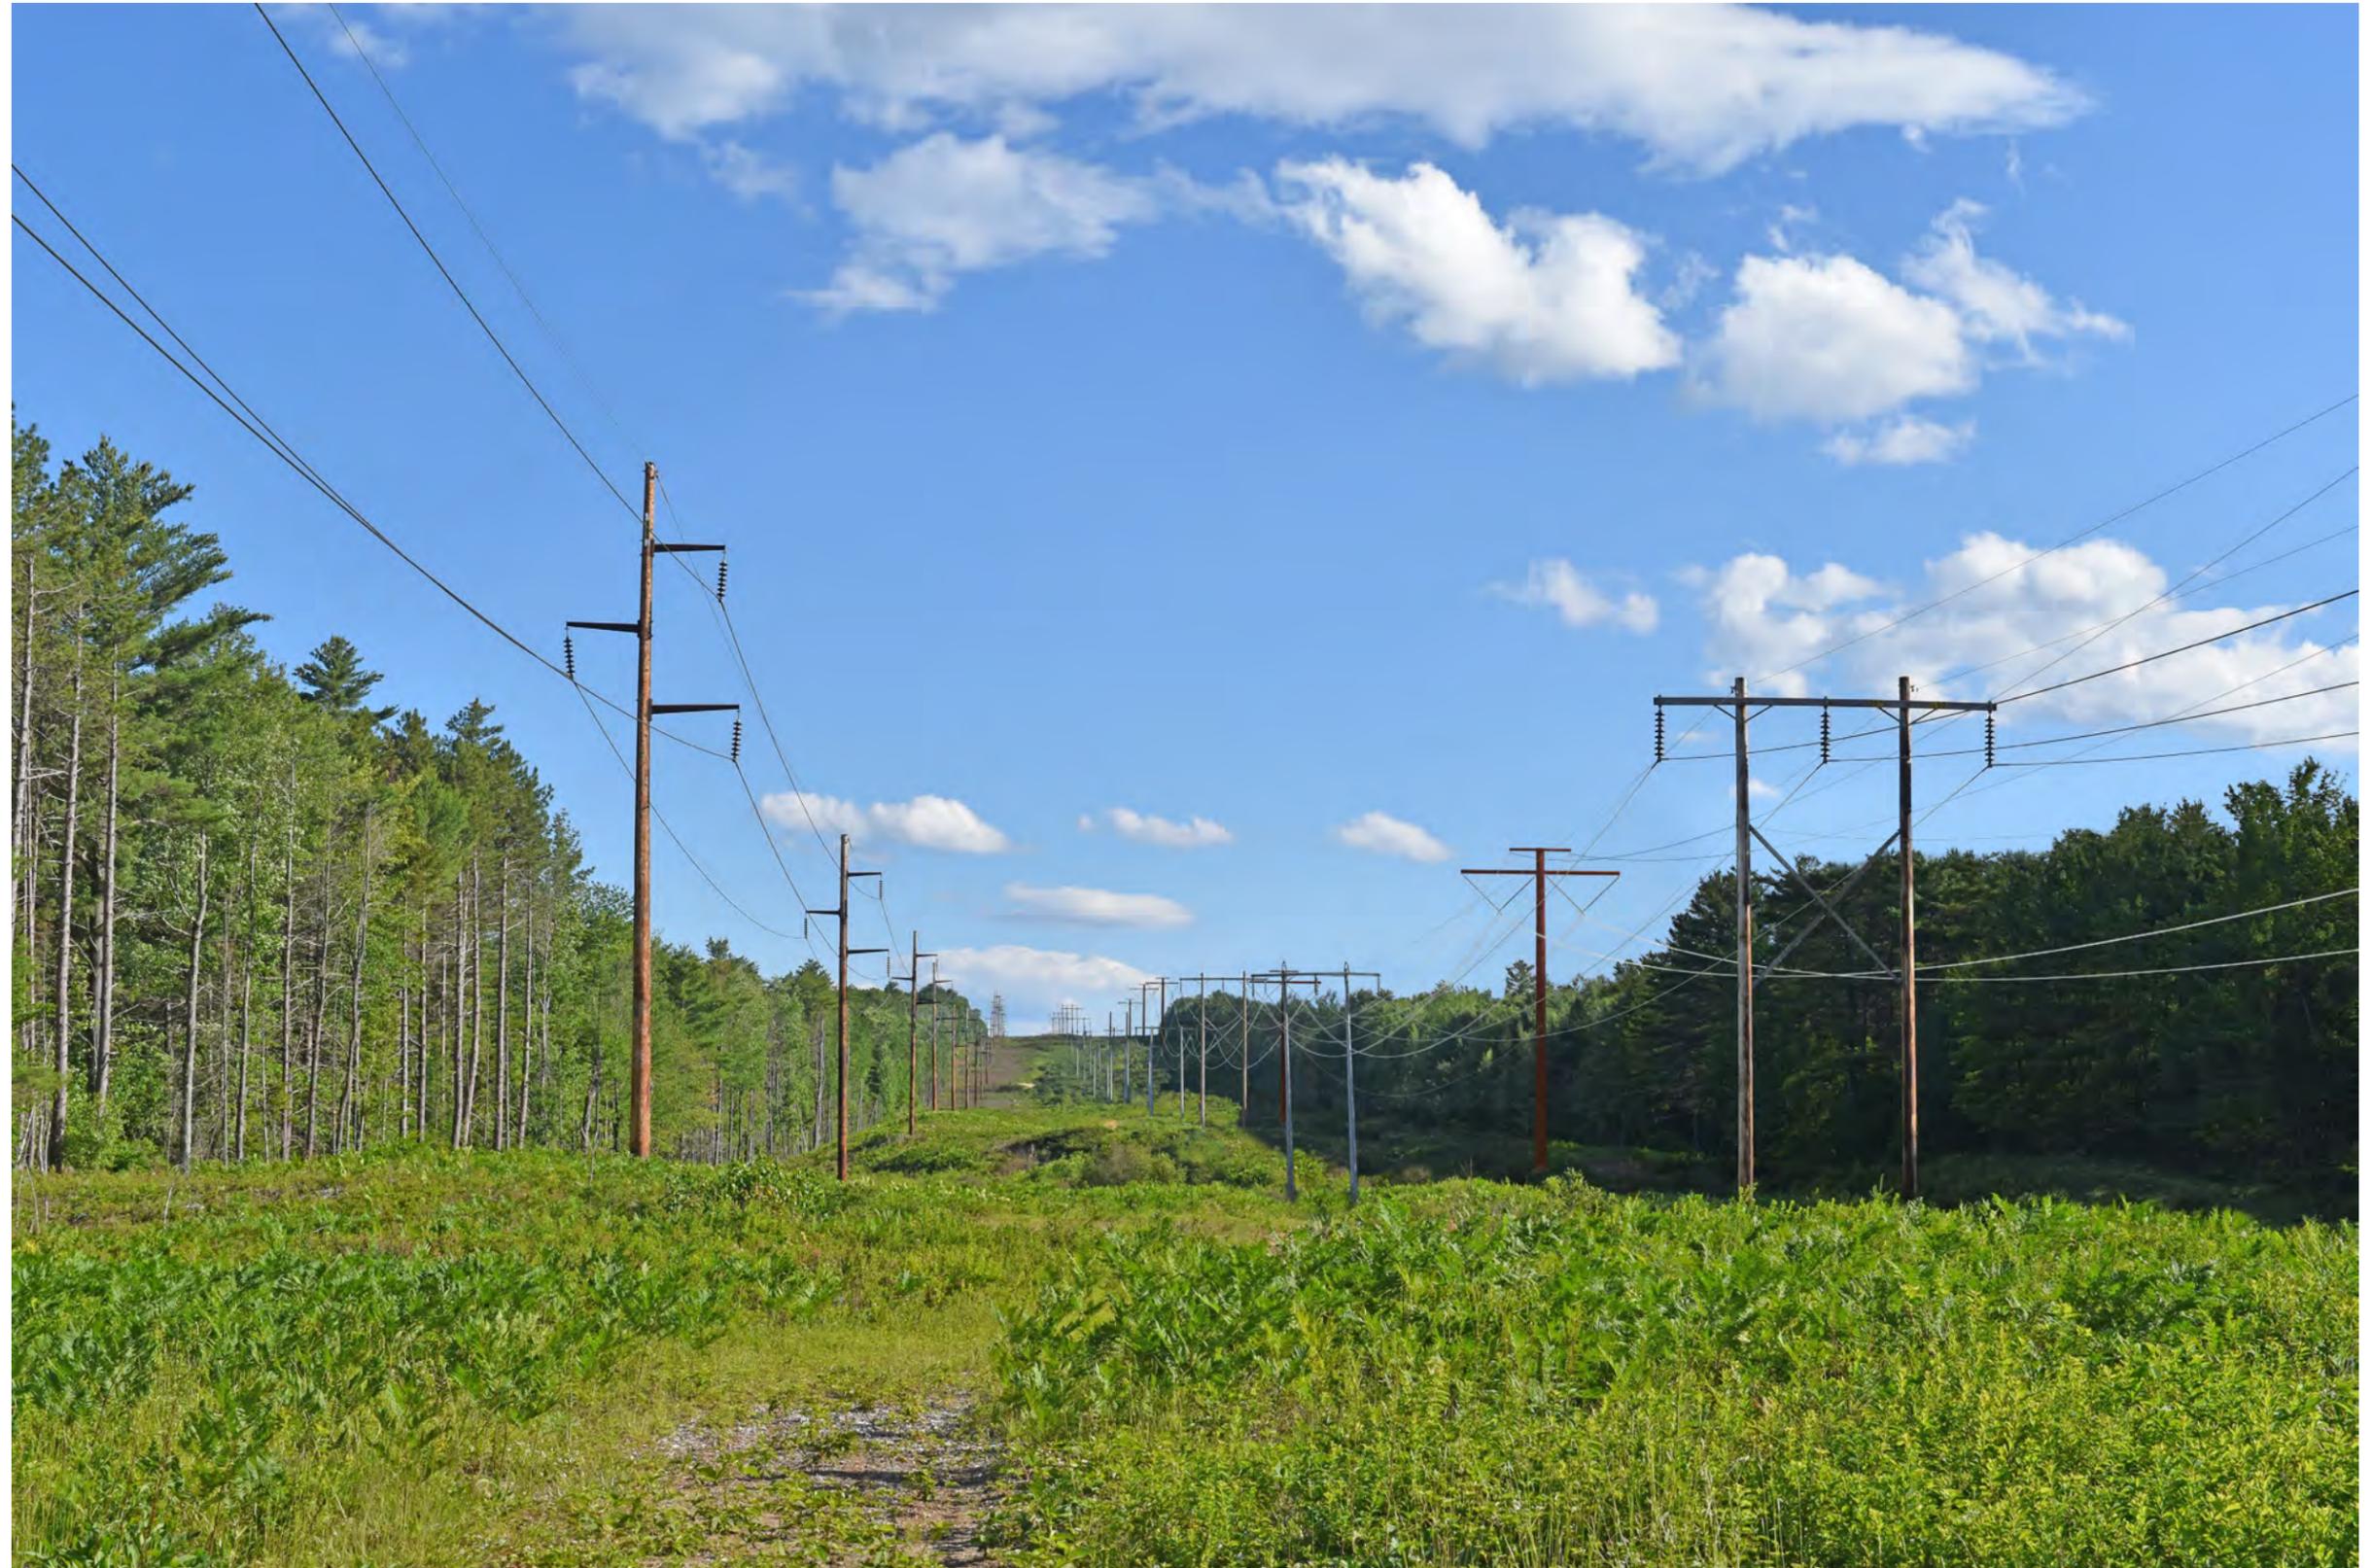
**PHOTOSIMULATION 23A: ANDROSCOGGIN RIVERLANDS STATE PARK, Existing Transmission Line, Leeds**

**Proposed Conditions:** Normal view looking south from an access road (off Church Hill Road) crossing the existing transmission line within the State Park toward the proposed co-located HVDC transmission line. The existing 225' corridor clearing will be widened by 75' on the western side to accommodate the new transmission line.

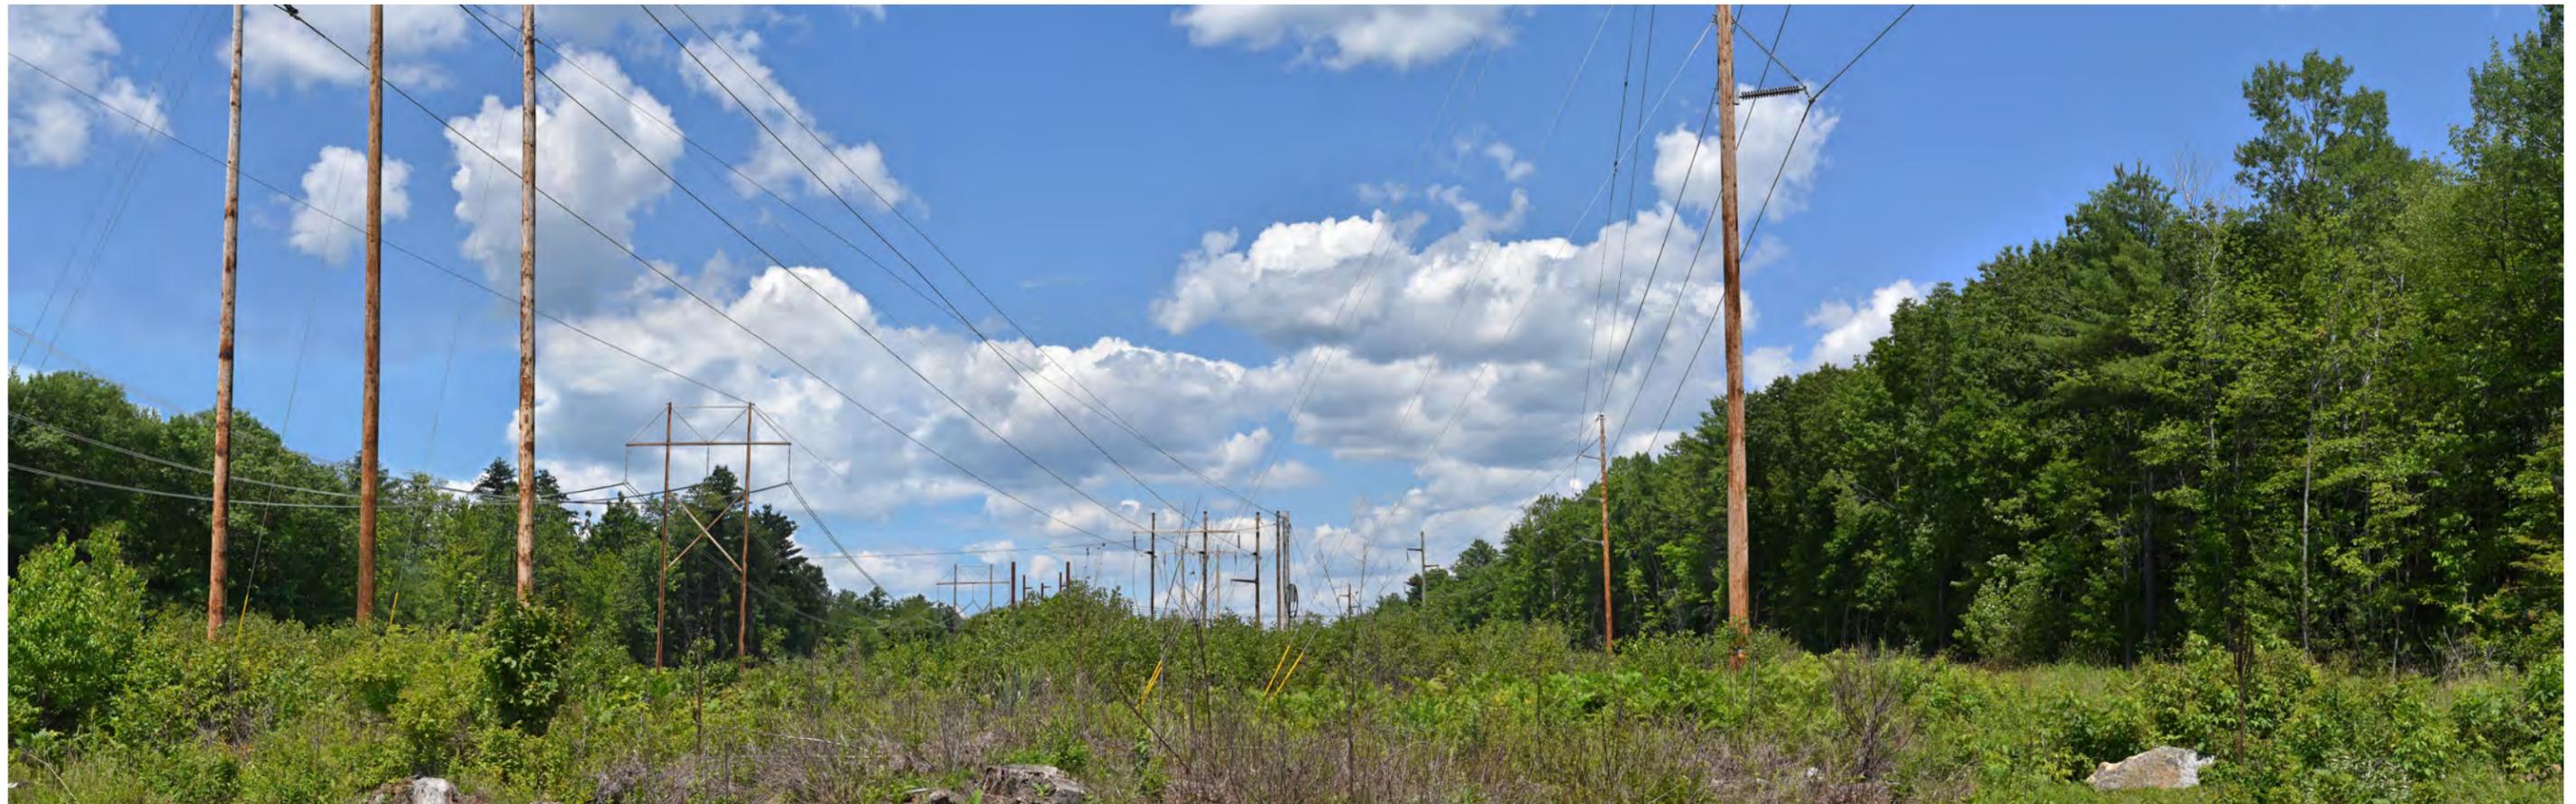
## PHOTOSIMULATION 24: MERRILL ROAD, Lewiston

**Proposed Conditions:** Panoramic view looking from north to northeast from Merrill Road toward the proposed Merrill Road Converter Station and co-located HVDC transmission line. The Converter Substation will be located approximately 2,400 feet north of Merrill Road and screened from view by the existing vegetation on the east side of the corridor to remain. The cleared corridor will be widened by 75' on the west side, (left side of corridor in image), to accommodate the proposed 345 kV to +/- 320 kV transmission line connection to the Larabee Substation, located south of this viewpoint. A 20' wide gravel access road, gate, and grassed lined stormwater facility will be visible from Merrill Road, but screened from view by vegetation from this viewpoint. See Appendix B: Study Area Photographs for additional images.

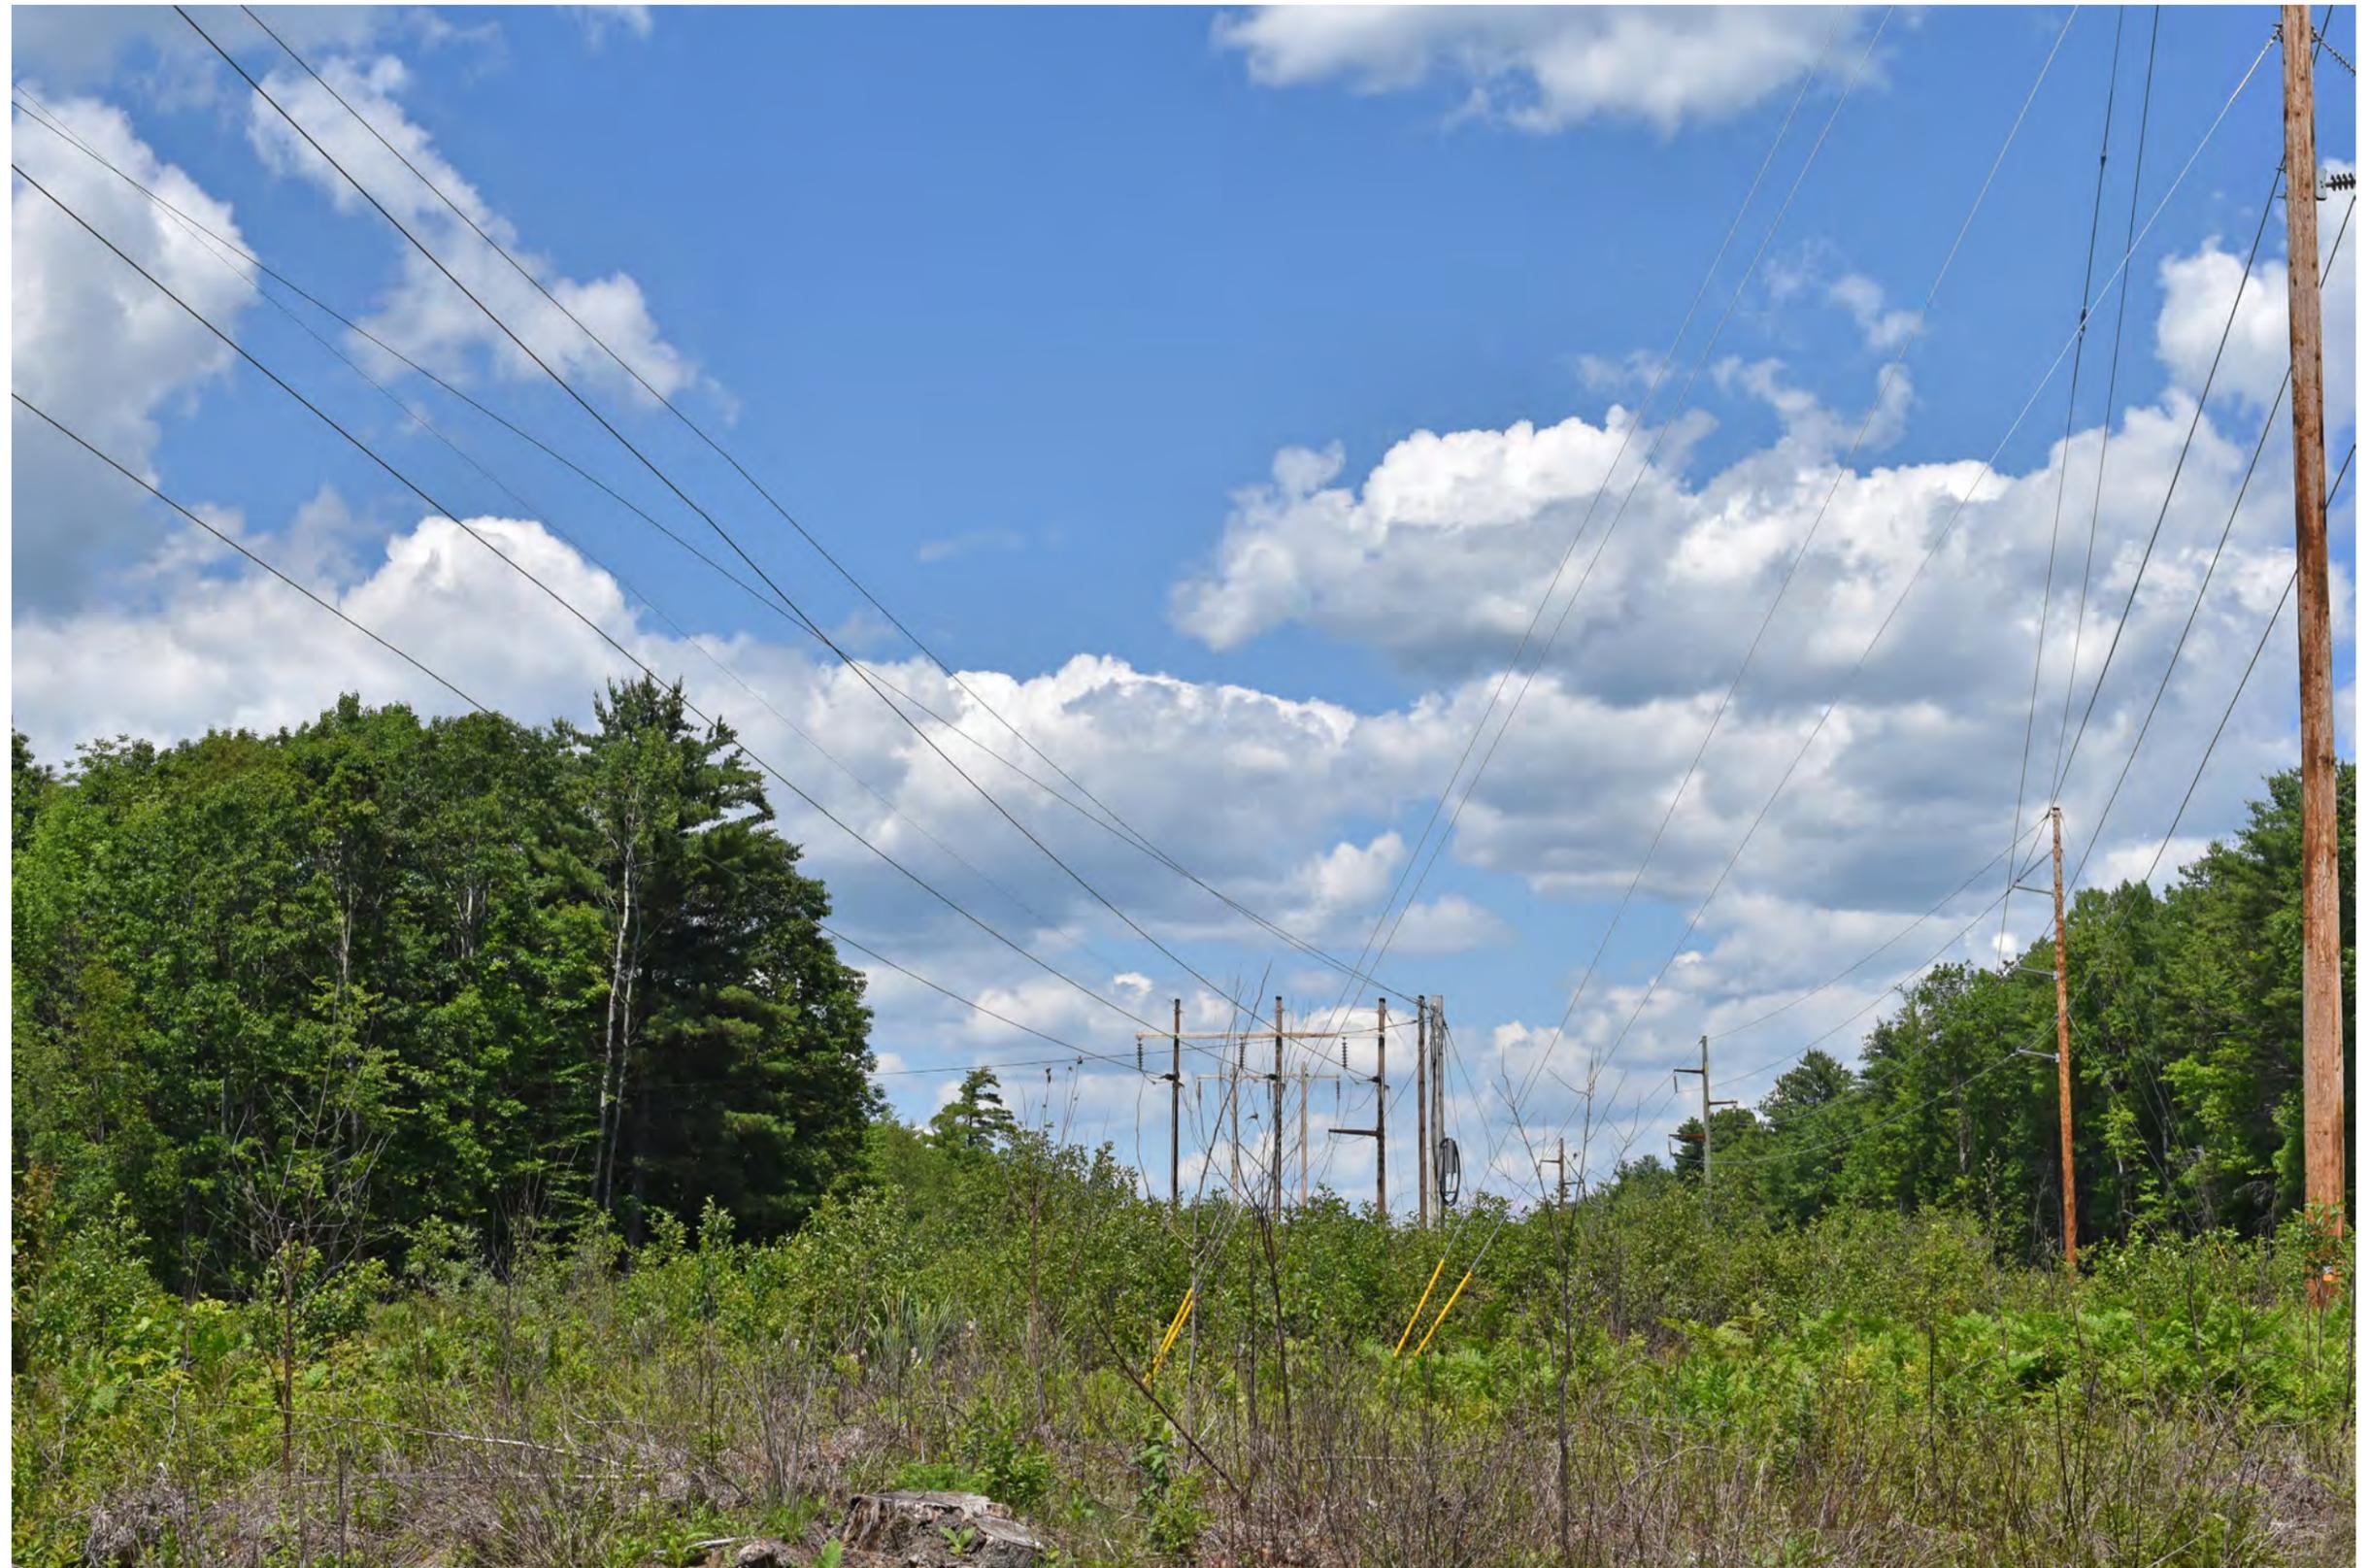
**PHOTOSIMULATION 24A: MERRILL ROAD, Lewiston**

**Existing Conditions:** Normal view looking from north from Merrill Road.
