# PHOTOSIMULATION 13: MOXIE POND - North, East Moxie Twp

**PHOTOSIMULATION 13A: MOXIE POND - North, East Moxie Twp**

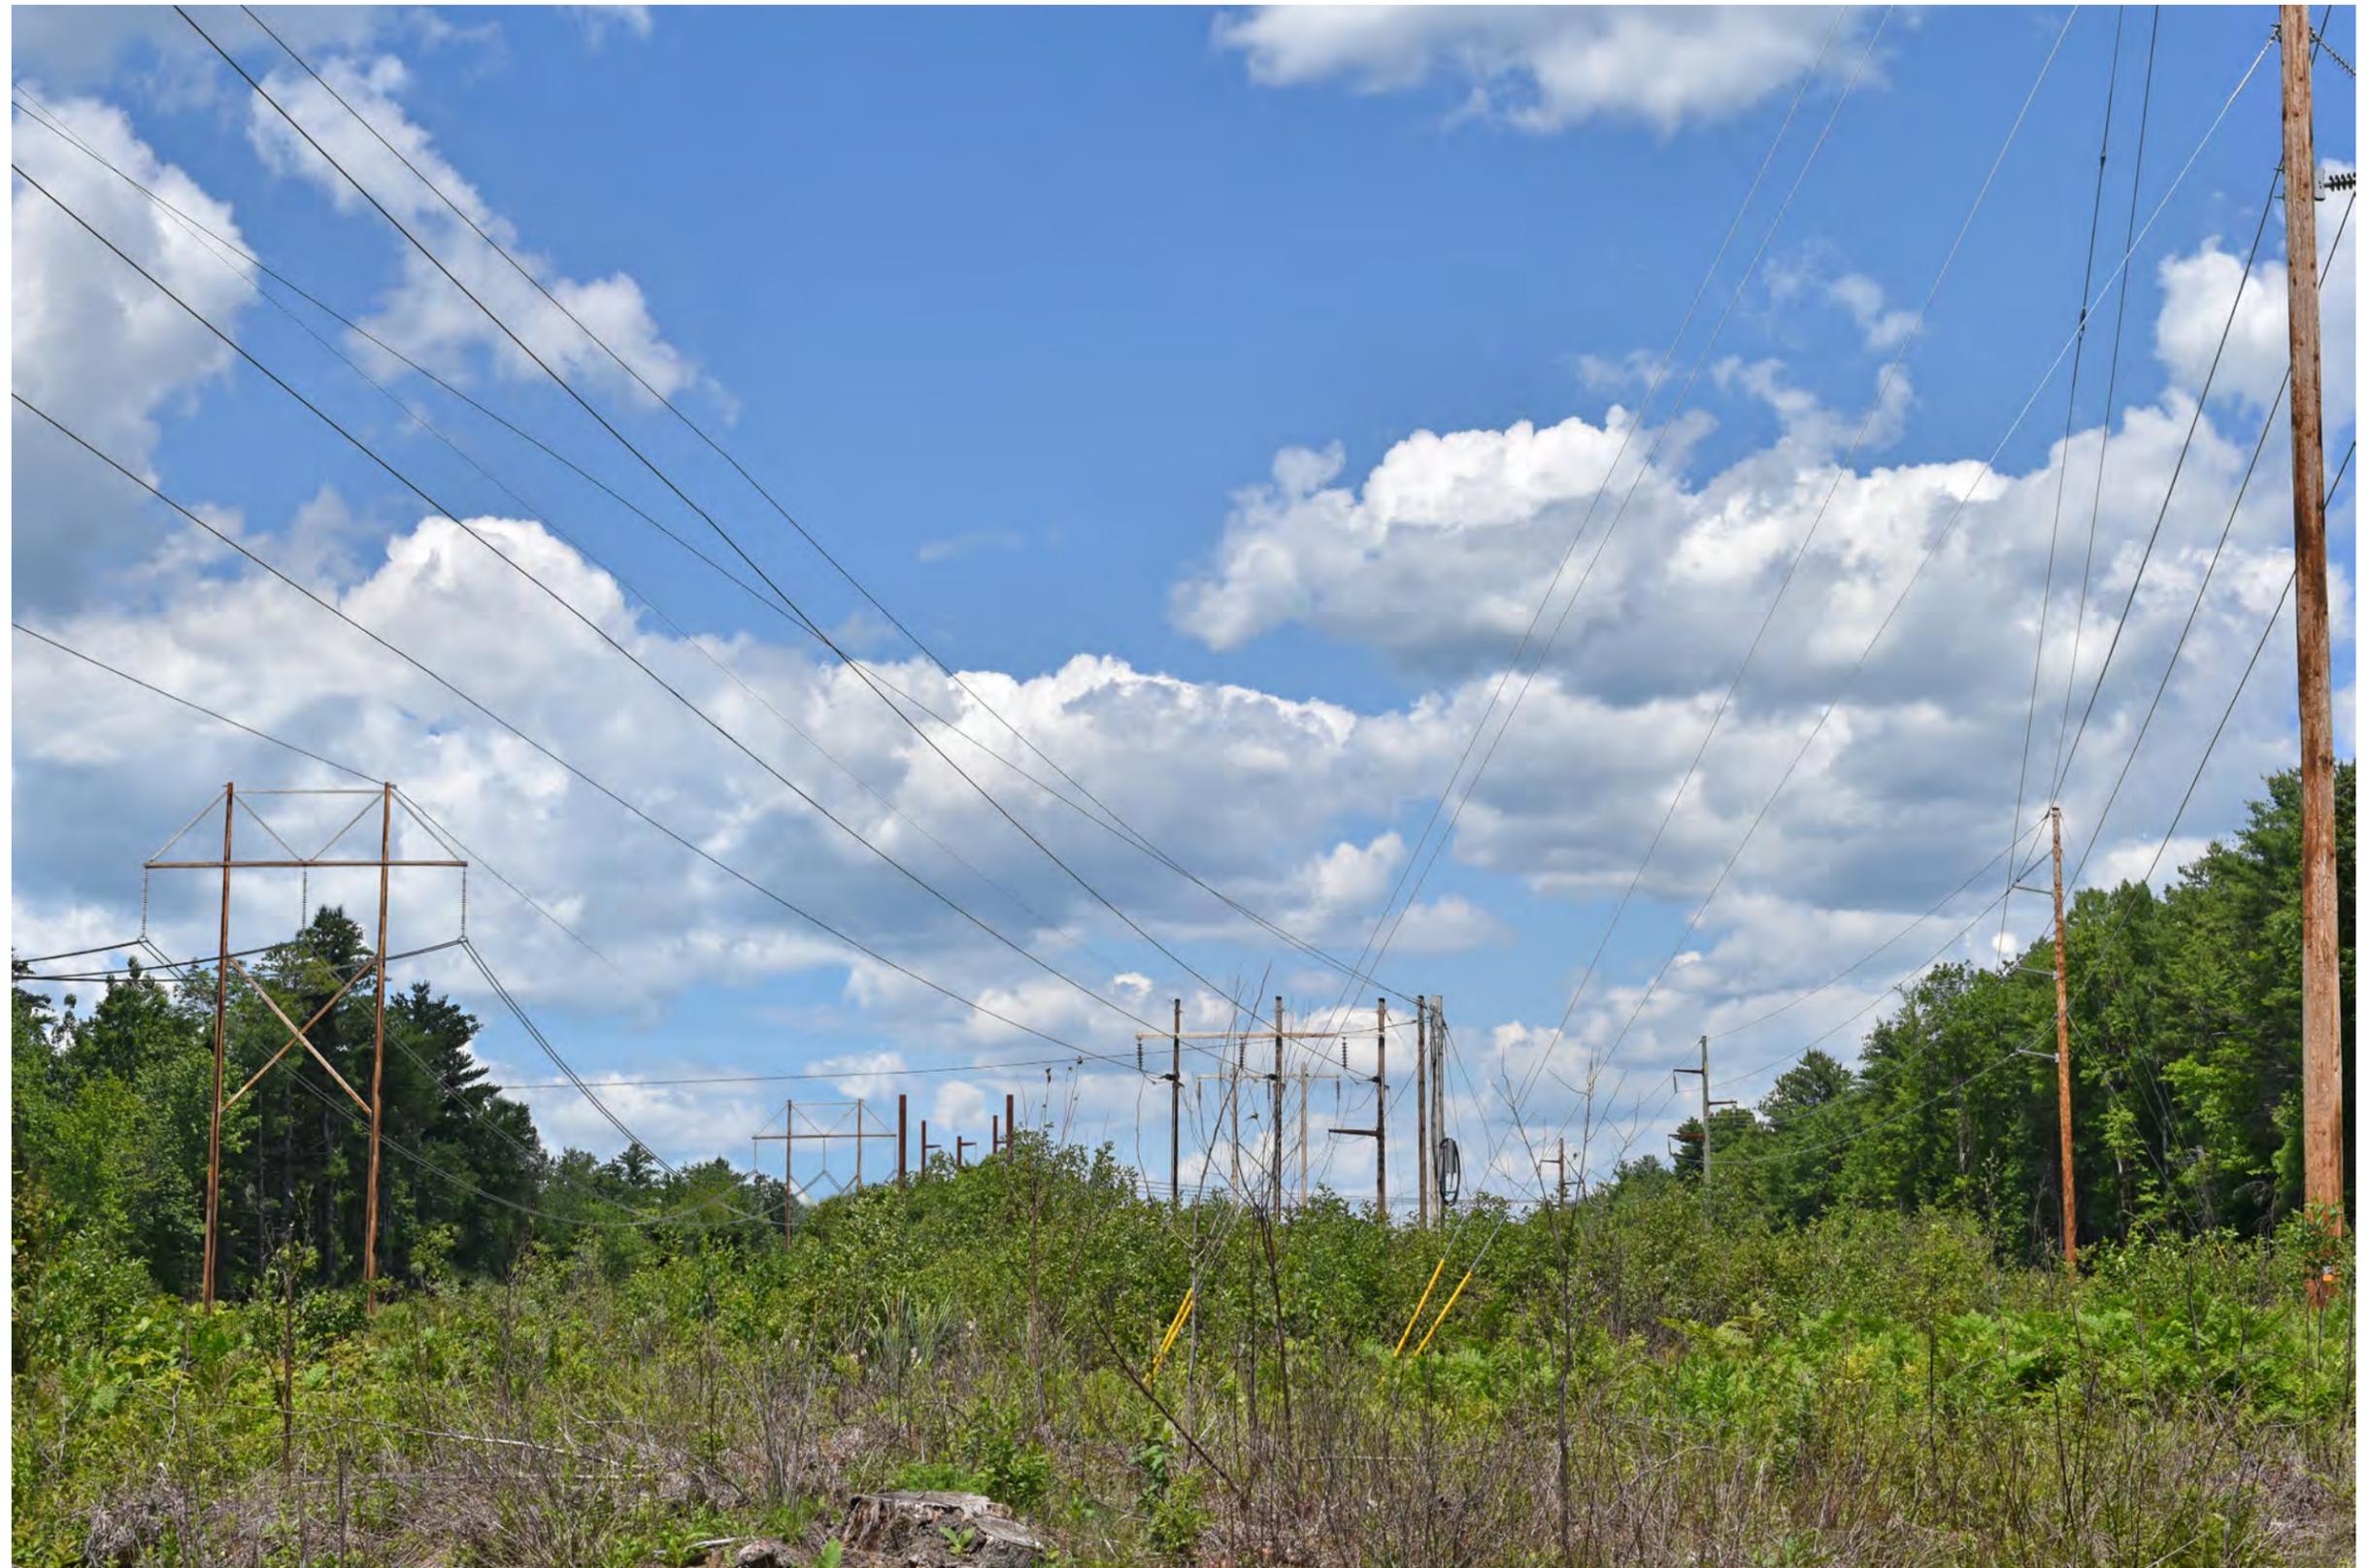
**PHOTOSIMULATION 24A: MERRILL ROAD, Lewiston**

**Proposed Conditions:** Normal view looking from north from Merrill Road toward the proposed Merrill Road Converter Station and co-located HVDC transmission line. The cleared corridor will be widened by 75' on the west side, (left side of corridor in image), to accommodate the proposed 345 kV to +/- 320 kV transmission line connection to the Larabee Substation, located south of this viewpoint.
