Juniper Ridge Landfill

Gap Assessment - Summary of Observations, Findings, and Recommendations

January 2025

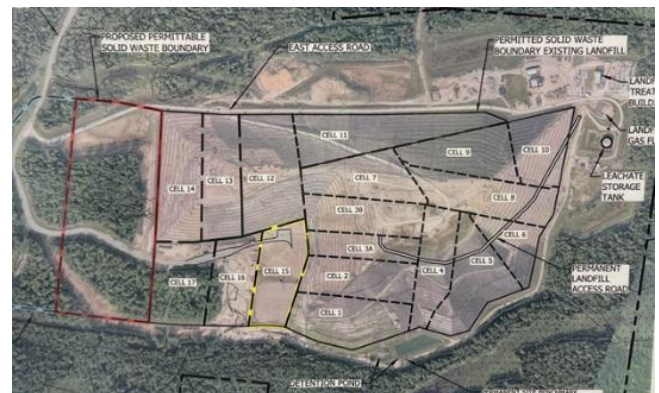
- The landfill entrance, scale area and support buildings appeared to be well maintained, functioned as intended and presented a positive image.
- The paved and unpaved access roads were in sound condition which allowed customers to safely and efficiently access the facility in all weather conditions.

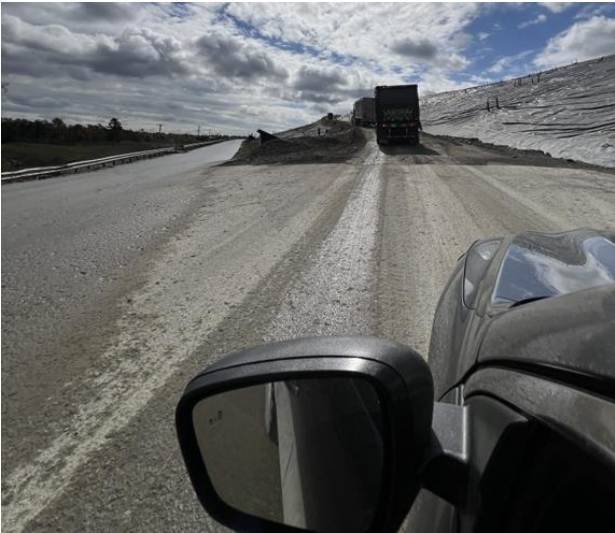
While on-site, we found the paved access roads were properly constructed, were in sound condition which allowed customers to safely and efficiently access the facility in all weather conditions. The length of the paved access road allowed mud and debris to be tracked on-site rather than leaving the property and negatively impacting the surrounding community. The all-weather access roads were properly graded and constructed with plenty of rock/aggregate which also allowed customers to safely and efficiently access the facility in all weather conditions.

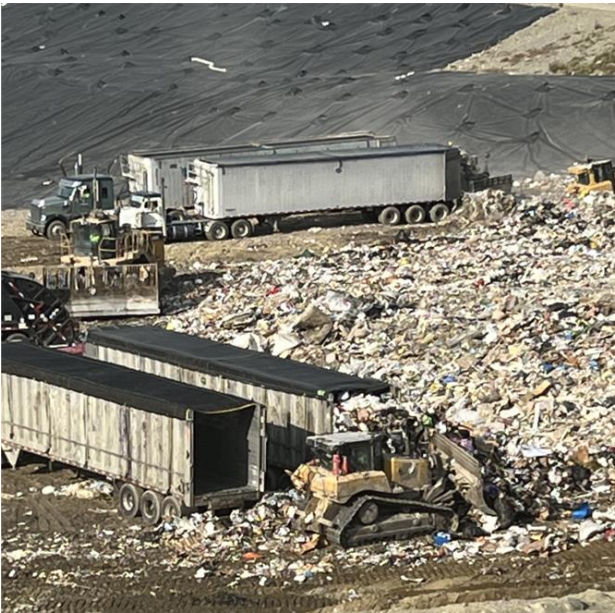
While on-site, we did not observe a dedicated spotter that provided direction to customers at the active tipping area. It is our understanding that commercial customers are required to have and utilize radios when on-site at the JRL. We were told that all of the communication and direction with the commercial drivers occurs solely over the radio. While on-site, we found minimal signage and directional delineation (cones, barricades, etc.) as we traveled to and approached the active tipping area.

Considering the relatively large deck that was available to tip customers, only four customers were allowed to dump at a time. This tipping configuration led to less-than-ideal delays and queues for customers waiting to dump their loads. The configuration also caused the bulldozers to use a non-traditional approach of peeling the loads perpendicular to the length of the trailer as they were being ejected from the live floor trailers. Not only was this process inefficient it created an unsafe condition with the bulldozers working too close to the customers' trailers and potentially the drivers.

Tipping areas are typically the busiest and most hazardous areas at any landfill. At times that is also true for the JRL, especially when considering the seasonal and daily fluctuations in customer transactions/tonnage. Given the sites average daily tonnage we recommend utilizing a dedicated spotter during peak tonnage hours. Standard Operating Procedures (SOP) should be developed for spotting customers and JRL staff should be trained and uniformly abide by these SOP.

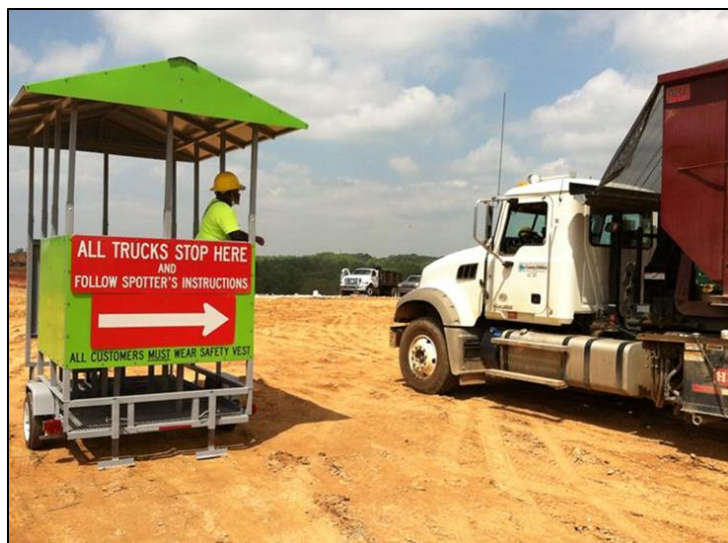
We recommend that the spotter consistently utilizes a fixed spotter station strategically positioned at the active tipping area. This spotter station could be a mobile spotter station (see example), vehicle, or concrete barriers. From the safety of the spotter station, the spotter can greet each customer, visually check loads, and provide verbal (face to face) direction. We recommend that the spotter stay in or is physically protected by the spotter station at all times, as this is the only way to truly protect them from hazards. When properly positioned, a spotter can adequately provide direction while viewing what is taking place at the tipping area.

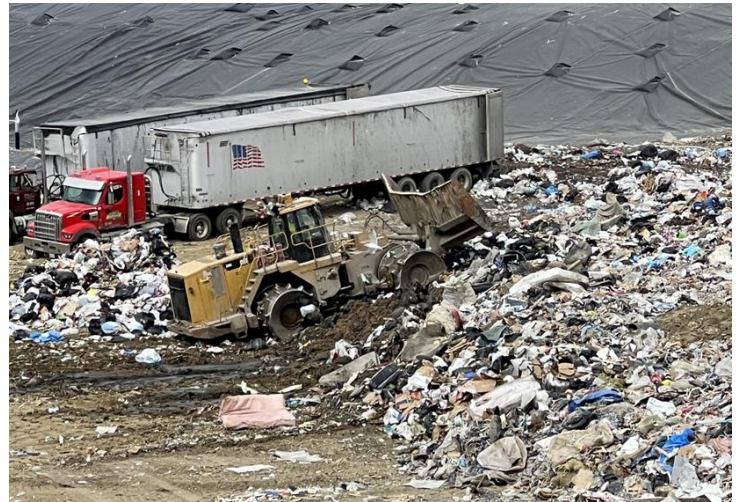
While on-site we observed a traditional advancing face, daily waste cell construction technique. It appeared that sludge was being mixed with waste by the heavy equipment on the tipping floor and deposited on the working face slope. While common in our industry, an advancing face requires compaction to take place primarily on the slope which sacrifices density (compaction). The geometry associated with an advancing face does not optimize the ratio between the daily waste volume and surface area that requires cover soil or ADC each day. As shown in the adjacent photo, it appeared that existing soil (and waste derived ADC) was not stripped or removed at the toe of the advancing face before new waste was placed and compacted. Leaving thick lenses of compacted soil (or waste derived ADC) between the lifts of waste can be a contributing factor to leachate seeps and landfill gas compartmentalization.

Selecting the best daily waste cell construction method can be a complex task. Many of the major factors are inter-related. For example, to minimize the use of cover soil (on each lift of waste), a very thick lift would be preferable. However, a thick lift, when combined with uphill pushing results in the heavy equipment having to work much harder. Similarly, a steep working face will minimize the surface area, but will also slow the compactor, thus resulting in decreased density. In the following paragraphs, we will present what we believe are the most significant issues related to daily waste cell construction.

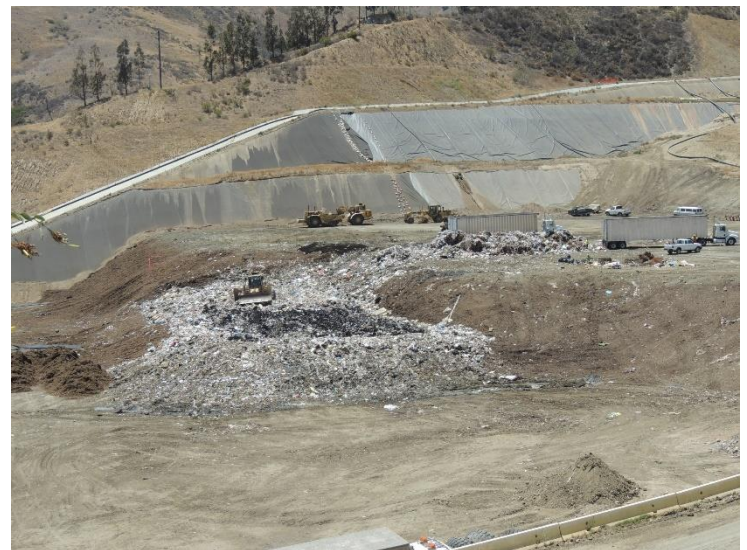
At the beginning of a new weekly pancake, all previously placed cover material (soil or waste derived ADC) on the footprint and slope below (or above) the tipping floors are stripped and stockpiled. Once the cover material has all been stripped, waste can be spread horizontally across the stripped area and compacted. Once the initial lift of waste has been spread and compacted, the compactor(s) briefly vacates the horizontal surface allowing the bulldozers to push (always pushing sludge downhill) a thin lift of sludge across the compacted waste surface. Once the bulldozers have finished pushing the sludge a lift of waste shall be spread across the sludge before the compactor(s) resumes compaction. This process eliminates the need for mixing the sludge with waste on the tipping floor, enhances density (compaction) and prevents the compactor(s) teeth from coming in contact and plugging with sludge. This process would be repeated throughout each day and each weekly pancake. At the end of the first day, the exposed waste surfaces are covered with spray on ADC (white surfaces). Only the one slope receives salvaged cover soil or other suitable cover material.

Each subsequent day, more waste (and sludge) is placed and compacted on the horizontal surface. At the end of each day spray on ADC and salvaged cover soil are utilized for cover.

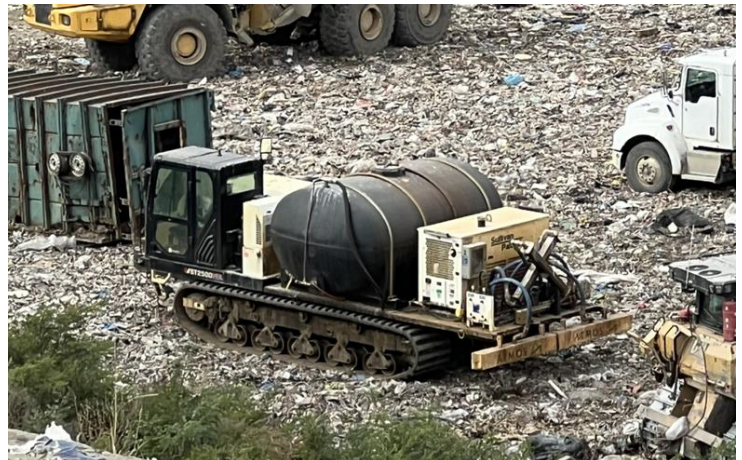
As previously mentioned, it appeared that existing soil (and waste derived ADC) was not stripped or removed at the toe of the advancing face before new waste was placed and compacted throughout the day. Leaving thick lenses of compacted soil (or waste derived ADC) between the lifts of waste can be a contributing factor to leachate seeps and landfill gas compartmentalization. We recommend that CWS explore the process of removing compacted soil (or waste derived ADC) before new waste is placed and compacted throughout each day.

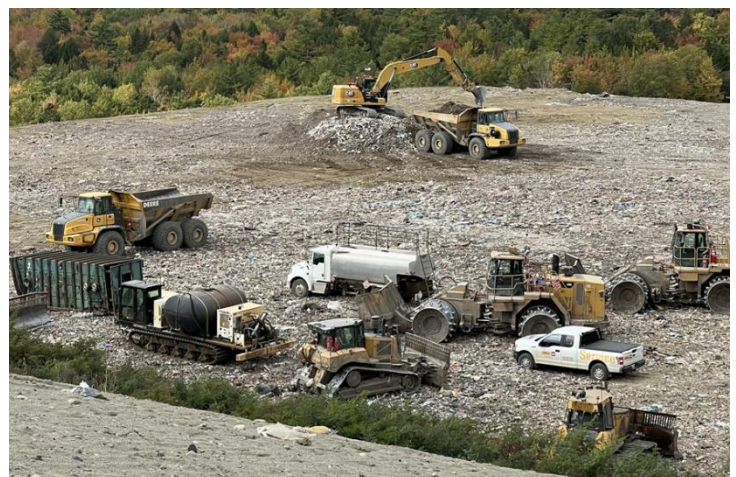
Overall, the primary landfill equipment fleet was modern, appeared to be in sound condition and was well maintained. The redundancy within the fleet allowed uninterrupted services for scheduled or unplanned equipment downtime. The heavy equipment operators appeared to be skilled and capable of performing their respective tasks.

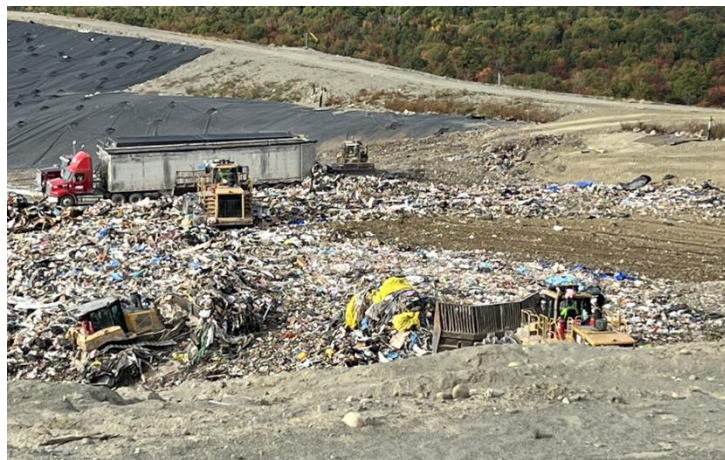
While on-site, we observed the 836 compactors pushing, mixing and spreading waste and sludge. Given their specialized nature and significant owning and operating cost, we suggest allowing the compactors to focus solely on compacting and occasionally trimming waste. Optimizing the use of the compactors can increase waste density and potentially prolong the life of the landfill. Ideally, the bulldozers would be more appropriately tasked with mixing, pushing and spreading waste into the daily waste cell.

In comparison to the industry and respective daily landfill tonnage at the JRL, we were surprised at the decision to rely solely on smaller (D6) sized bulldozers. We recognize that this may be an operational preference, but larger (D8) sized bulldozers could be more cost effective at pushing and spreading waste than several smaller (D6) bulldozers.

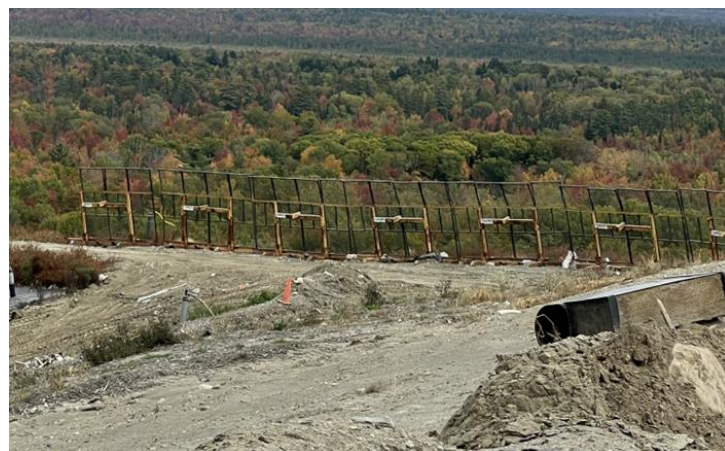
Excessive litter can be costly and cumbersome to clean up and can lead to issues with neighbors and regulatory compliance. While on-site, we did not observe any excessive accumulation of wind-blown litter or litter blowing off-site. It appeared that CWS relied on portable litter fences (7 sections) and some permanent litter fences to contain wind-blown litter.

When properly deployed, portable litter fencing can be highly effective at containing litter at the point of generation, minimizing its distribution throughout the site. When utilized, it is important that portable fences be tightly arranged, free of gaps and downwind of and as close to the active tipping area(s) as possible. In our experiences, we have found that portable litter fencing is the most crucial component of an effective litter control campaign. We recommend that CWS invest in enough portable litter fences to adequately surround the downwind portions of the active tipping areas.

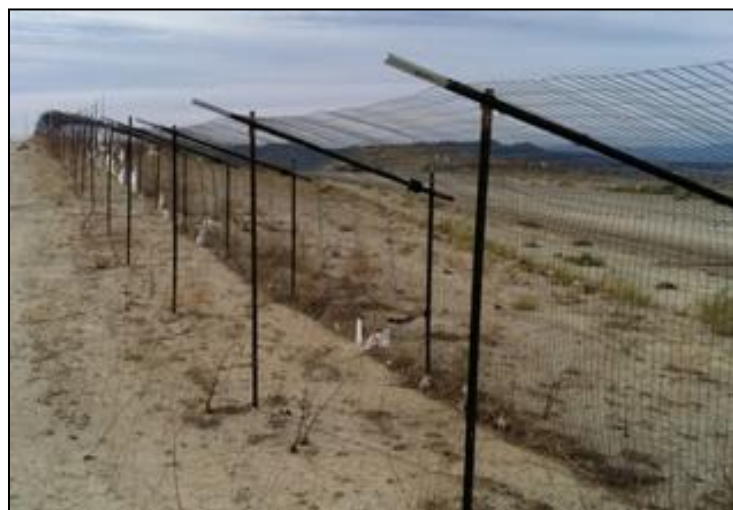
As a secondary litter control measure, we recommend utilizing temporary litter fencing. When strategically placed, this type of fencing is effective at containing surface litter that has migrated beyond the portable litter fencing zone. Typically, this type of fence consists of t-posts and welded wire fencing, 4-6' high. The use of horizontal and/or vertical litter traps can be incorporated into the fence design, trapping litter, and

containing it within the fence. To be as effective as possible, this fencing needs to be periodically de-constructed and repositioned to the most effective locations. Dependent on on-site conditions and topography a series of temporary litter fences may be needed to collect and contain surface blown litter.

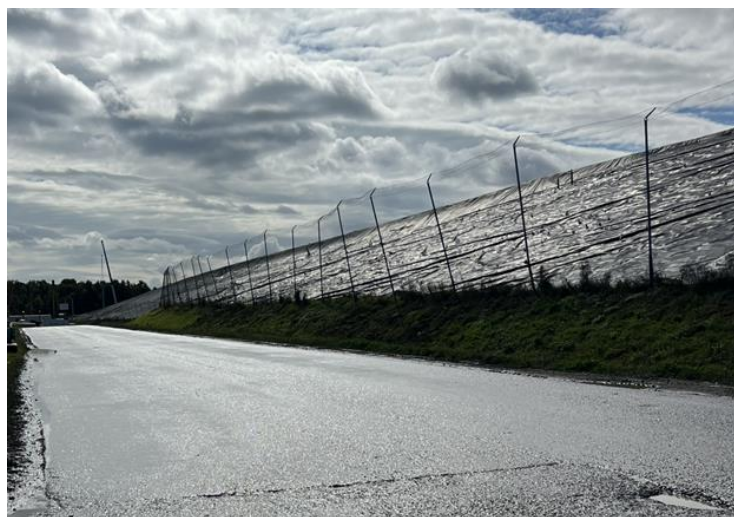
If not in place, periodic and regular maintenance and cleaning procedures should be in place for all types of litter fencing. Litter fencing is most effective when wind is allowed to flow freely through the fence, once the fence becomes saturated with litter, the dynamics of the fence change and litter could potentially be blown above or around the fence.

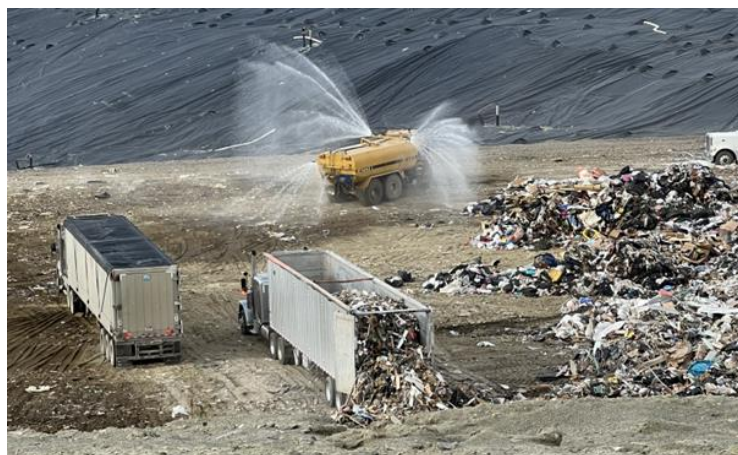
While on-site, dust control measures included frequently wetting the paved and unpaved access roads with a water wagon. Dust was further reduced by keeping the surfaces of the paved roads free of dirt and buildup. During our time on-site, we did not observe and dust issues that could potentially impact the surrounding community.

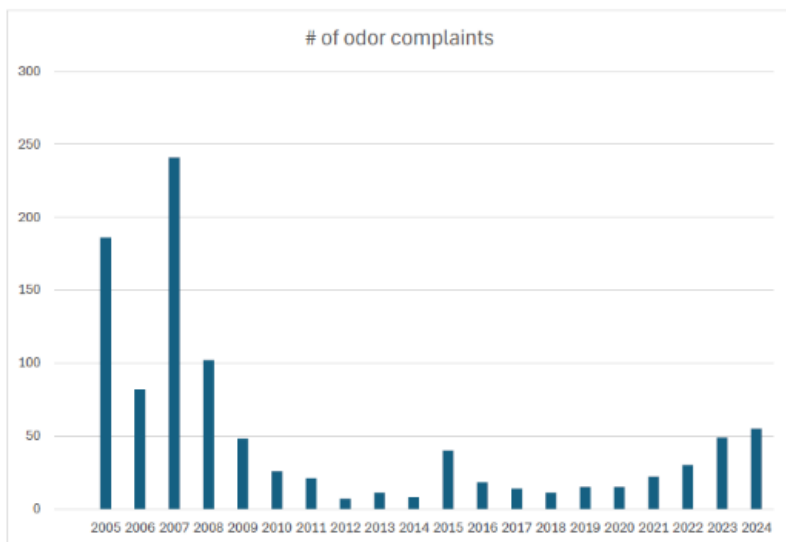
CWS has weekly odor meetings discussing game plans and remedies. The adjacent table shows the odor complaints that have been logged between 2005-2024. We were told that the rise in complaints between 2019-2024 coincides with the increased disposal rate of MSW bypass and sludge. Considering the average daily tonnage and the fact that 9% of the average daily tonnage is sludge, we consider the recent number of complaints to be low. Not to be dismissive toward these complaints, but it is typical for landfills with significant odor issues to have complaints numbering in the thousands per month.

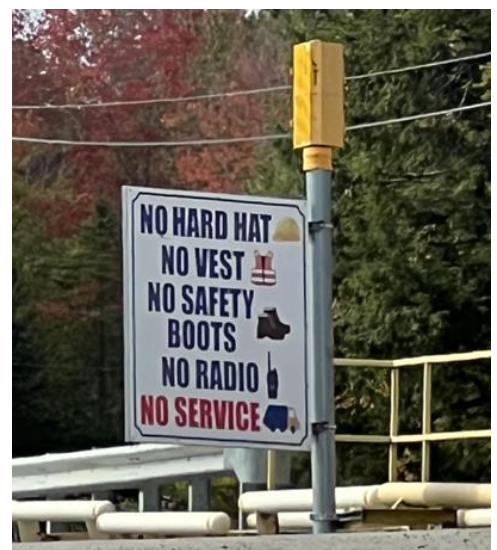
While on-site we did not observe any safety issues and there was evidence of a safety culture that protected employees and customers. We noted the following safety measures that were in place while we were on-site.

- Personal Protective Equipment (PPE) for staff (hard hats, high-vis safety apparel, footwear)
- Strict requirement for customers to wear high-vis safety apparel when on-site
- Adequate spacing between customers at the tipping area
- Radio communications with customers
