**Figure 4-11**

**Flow Field 2 Overburden Groundwater Composite PFAS Analytical Results**

Remedial Investigation Site Characterization Summary Report  
Former Loring Air Force Base, Limestone, ME

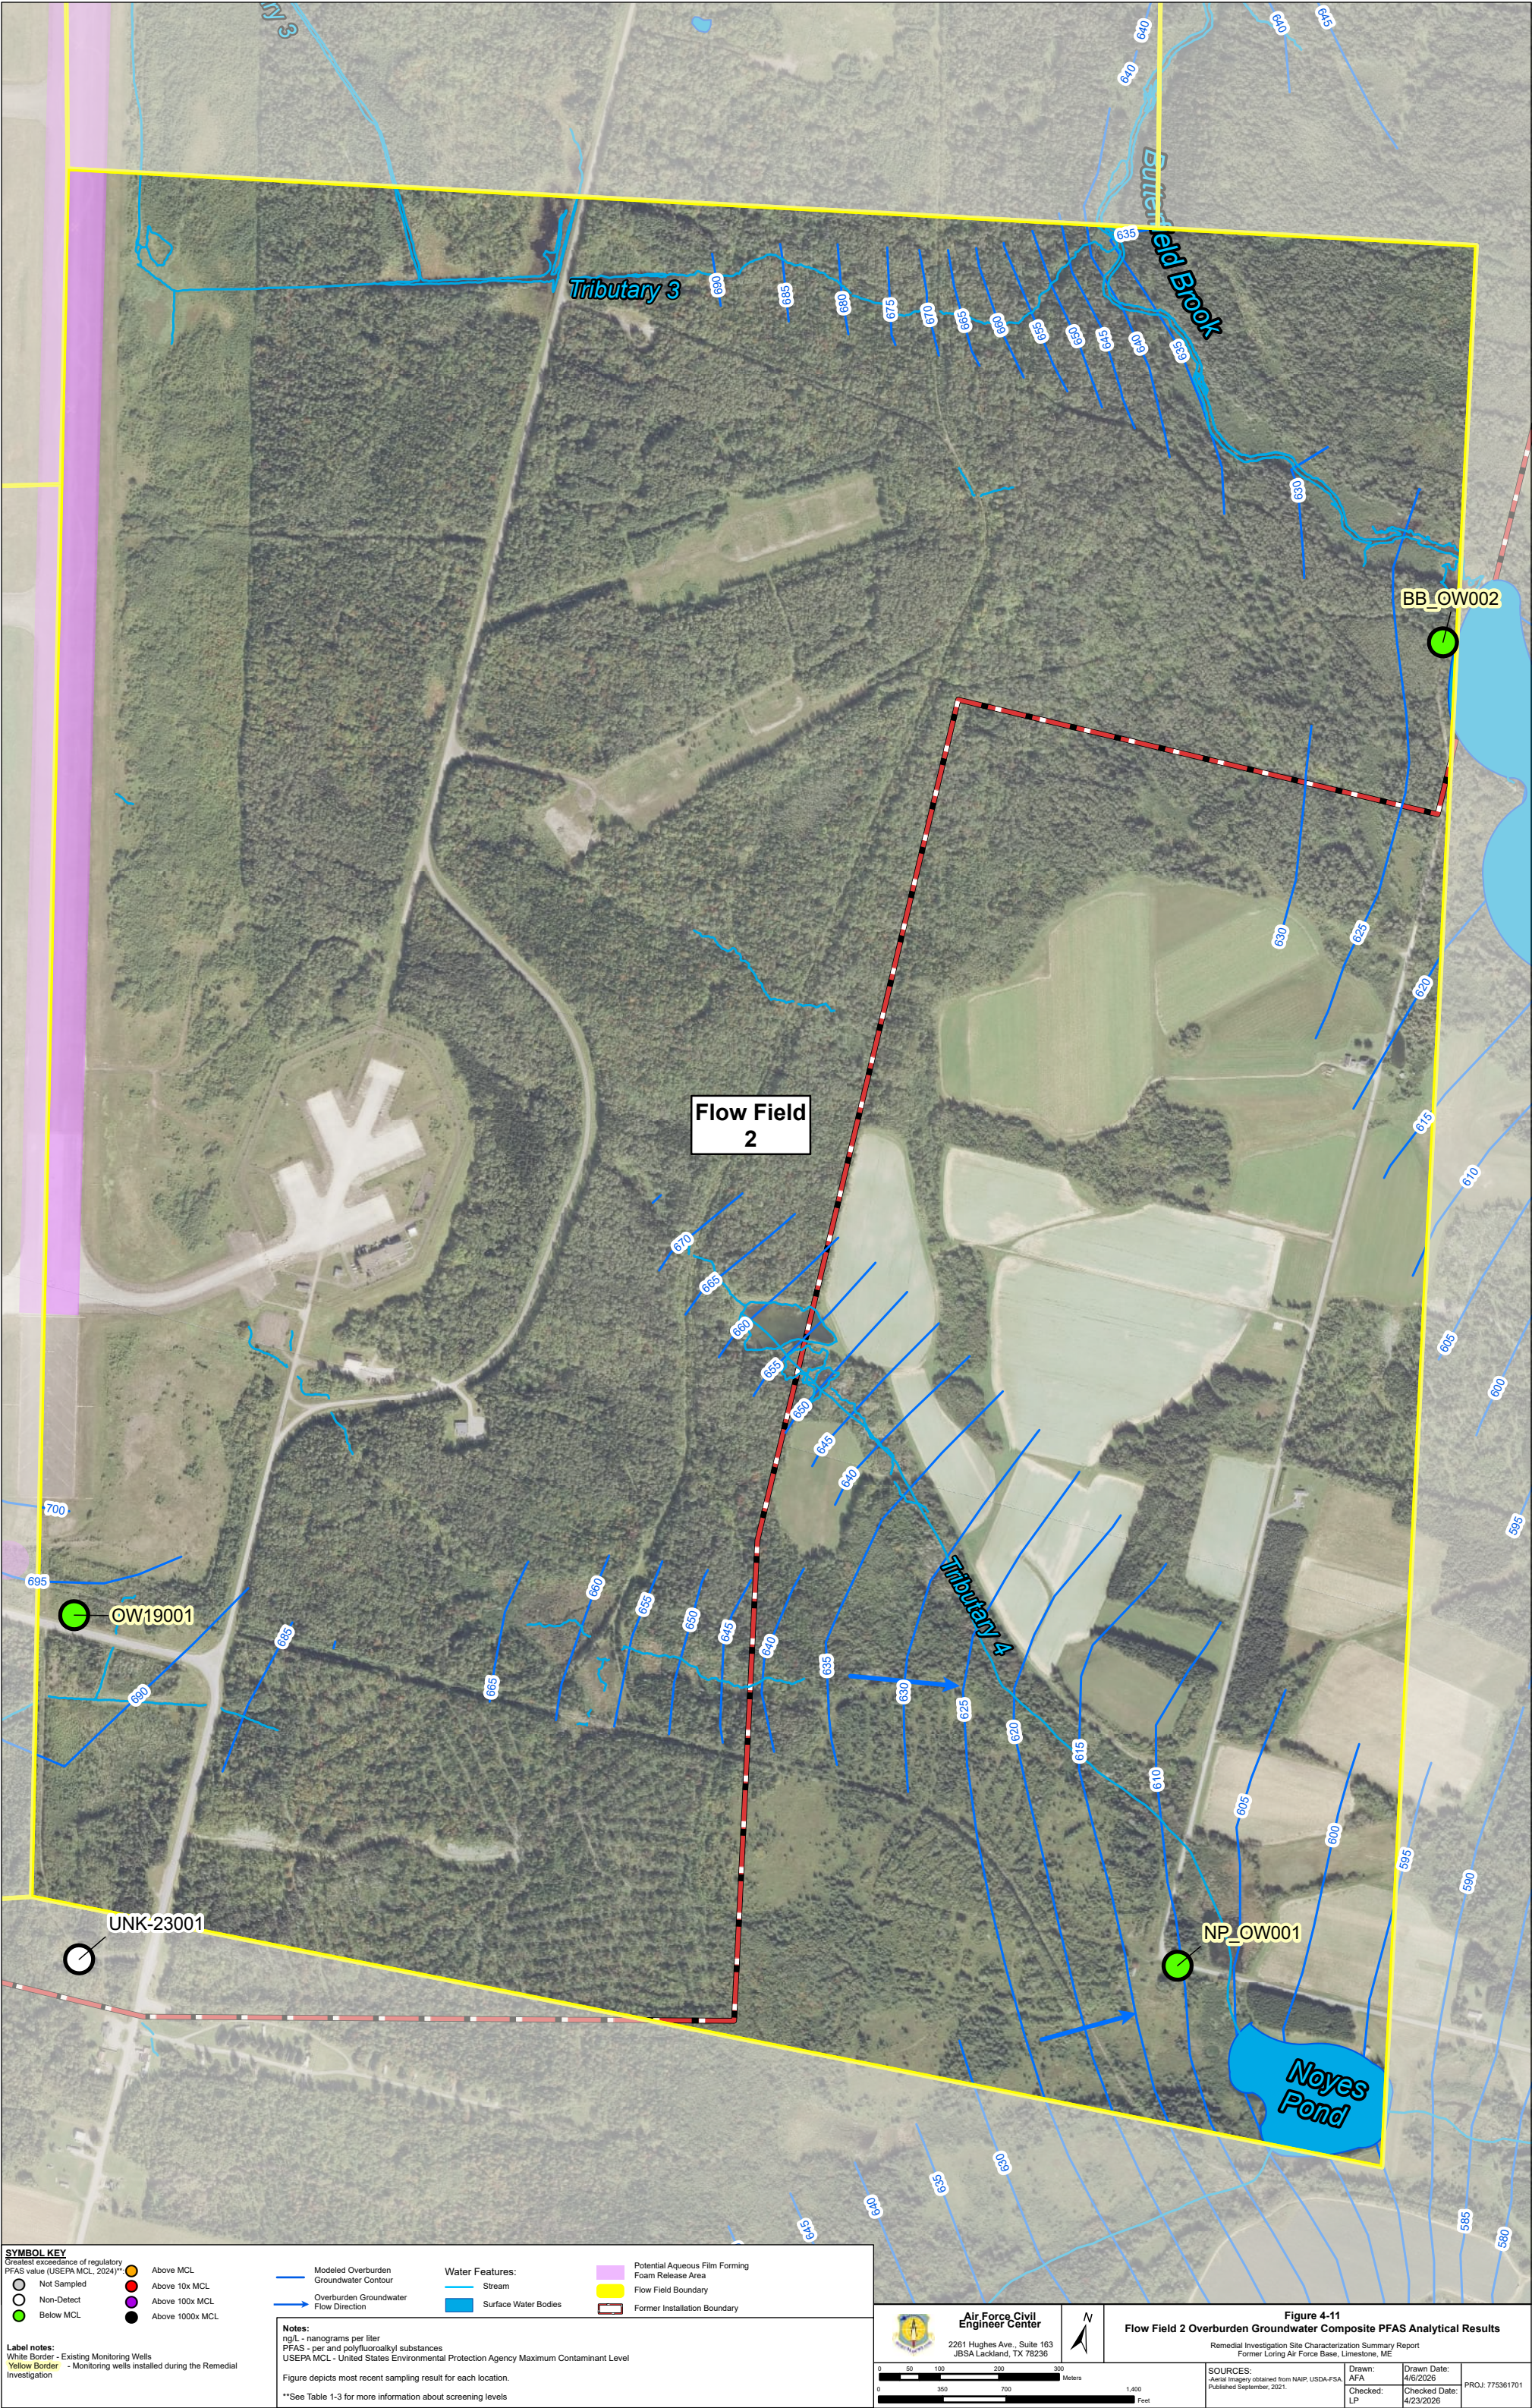
Greatest exceedance of regulatory PFAS value (USEPA MCL, 2024):

Figure depicts most recent sampling result for each location.  
\*\*See Table 1-3 for more information about screening levels
