**Figure 4-20**

**Flow Field 6 Bedrock Groundwater Composite PFAS Analytical Results**

Remedial Investigation Site Characterization Summary Report  
Former Loring Air Force Base, Limestone, ME

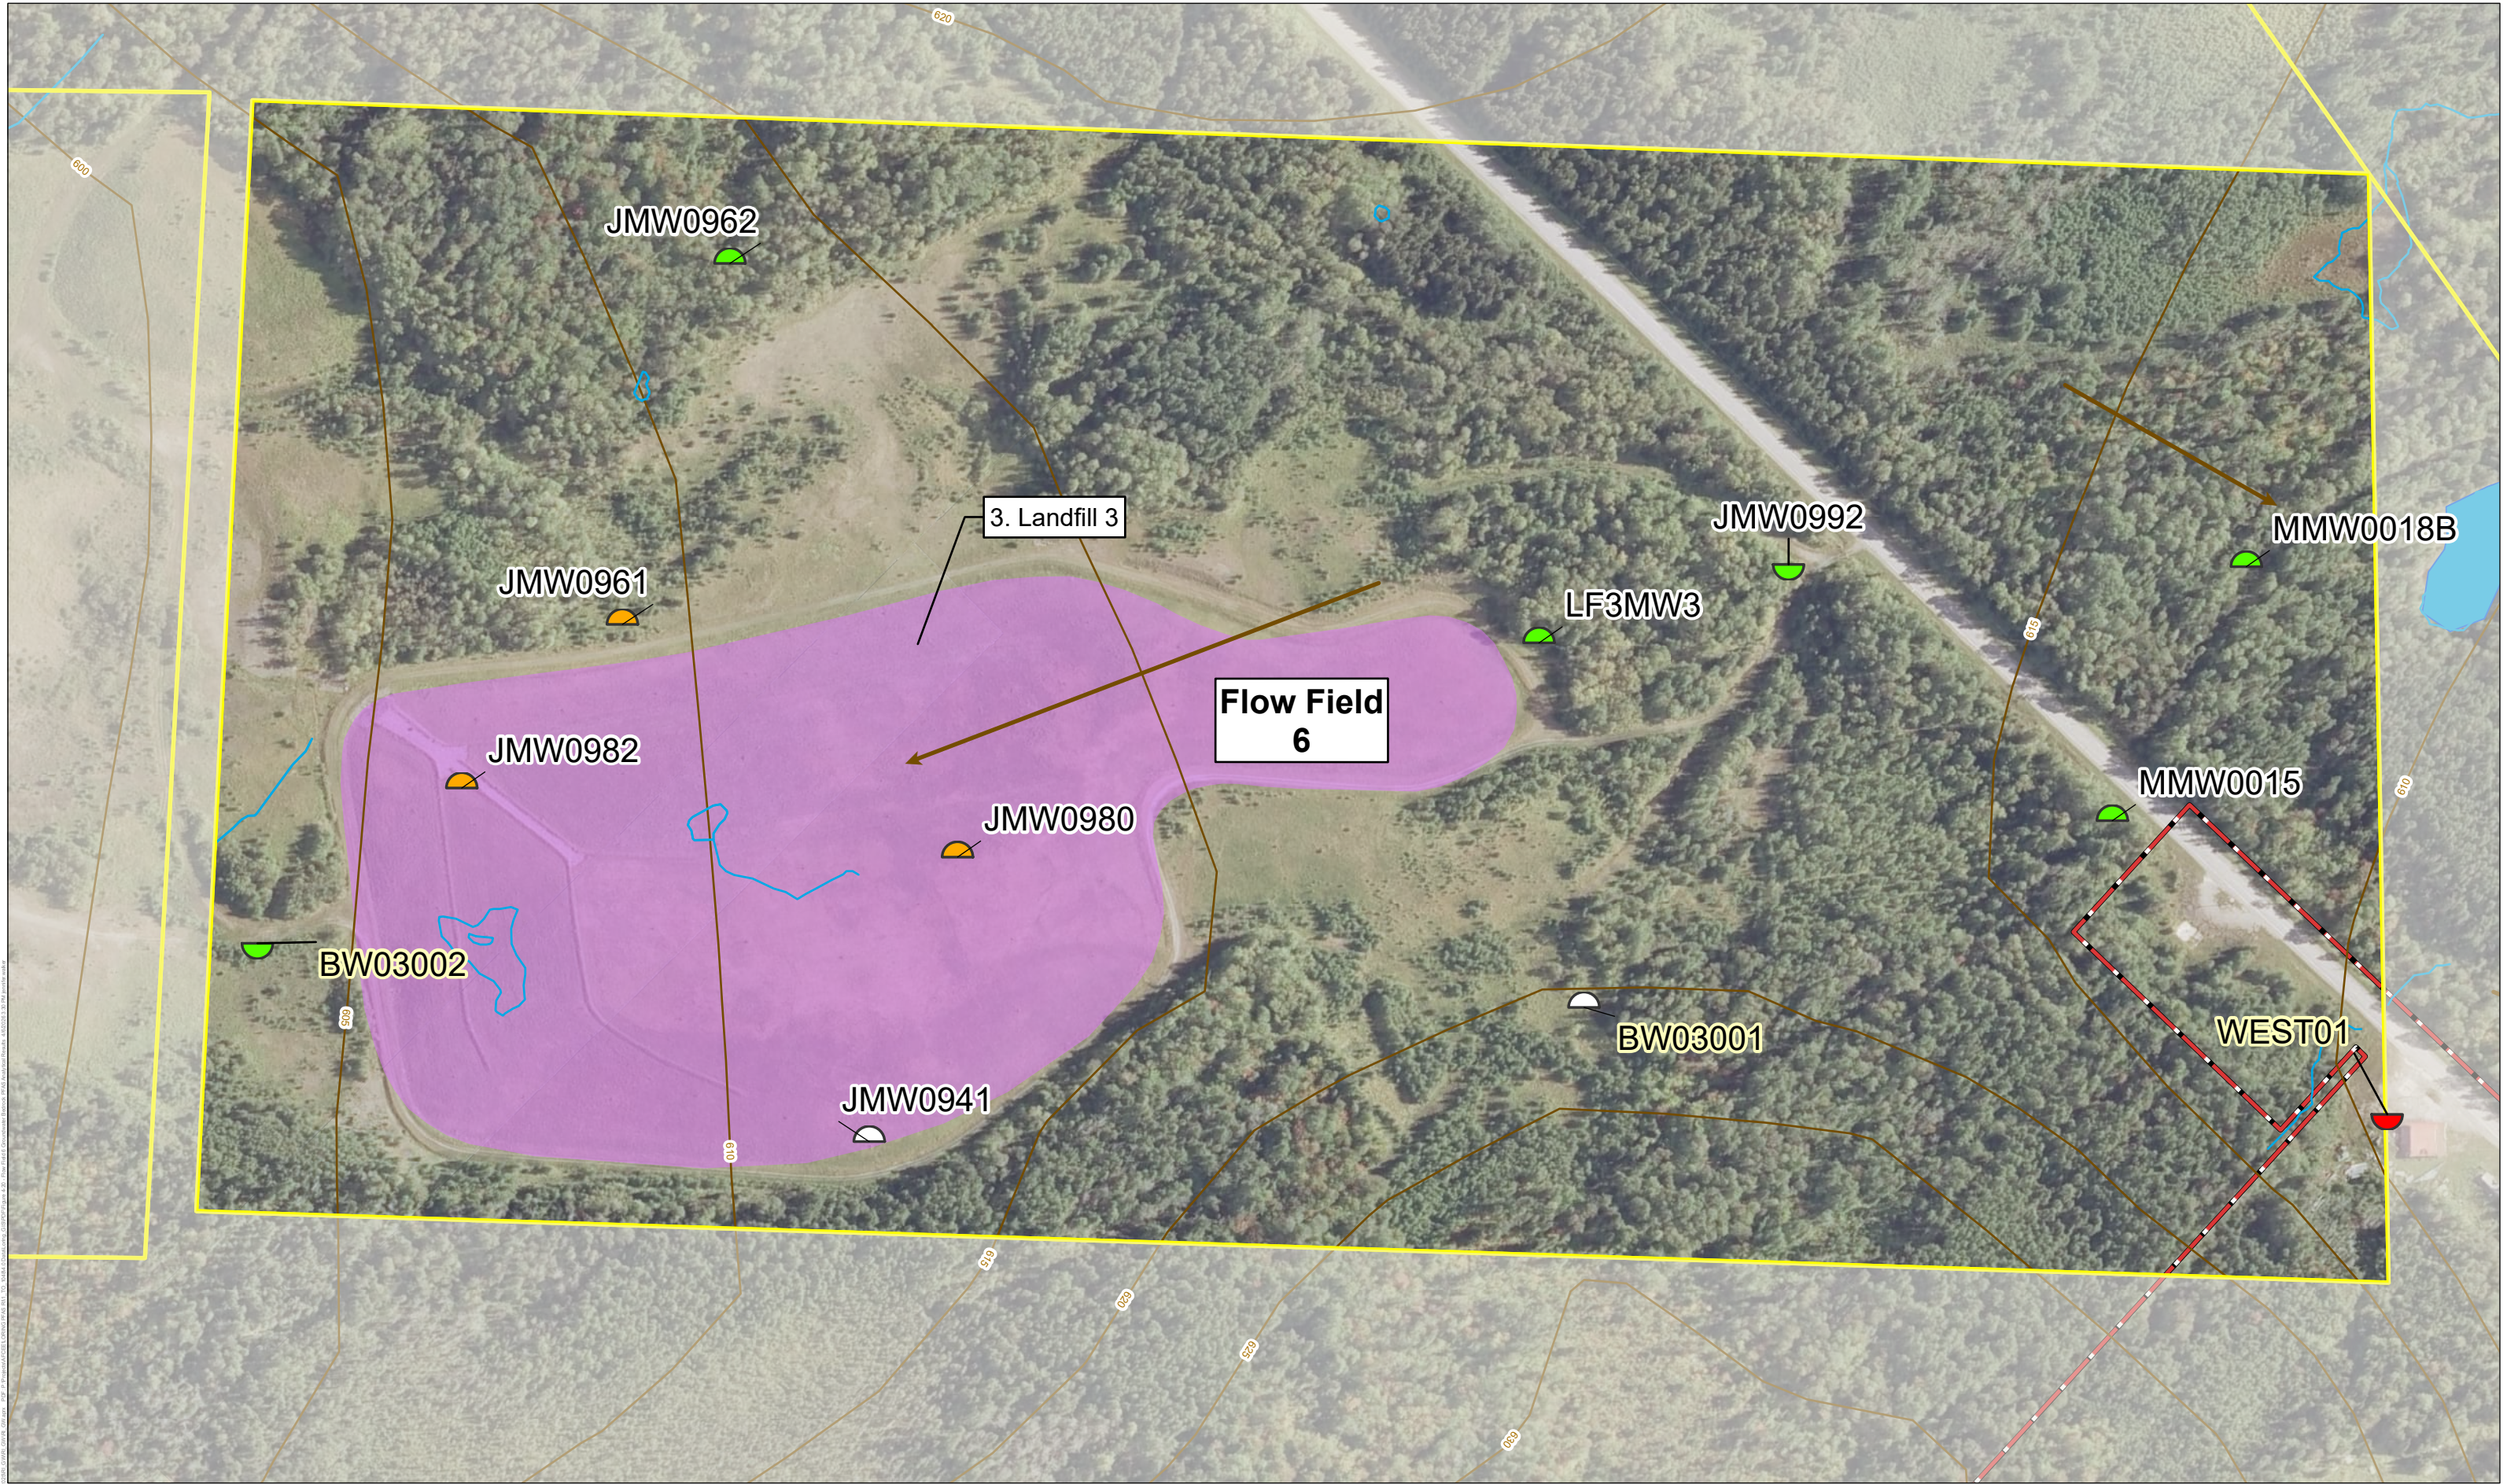
Bedrock wells depicted as half circles to indicate depth.

Figure depicts most recent sampling result for each location.
