**Figure 4-9**

**Flow Field 1 Overburden Groundwater Composite PFAS Analytical Results**

Remedial Investigation Site Characterization Summary Report  
Former Loring Air Force Base, Limestone, ME

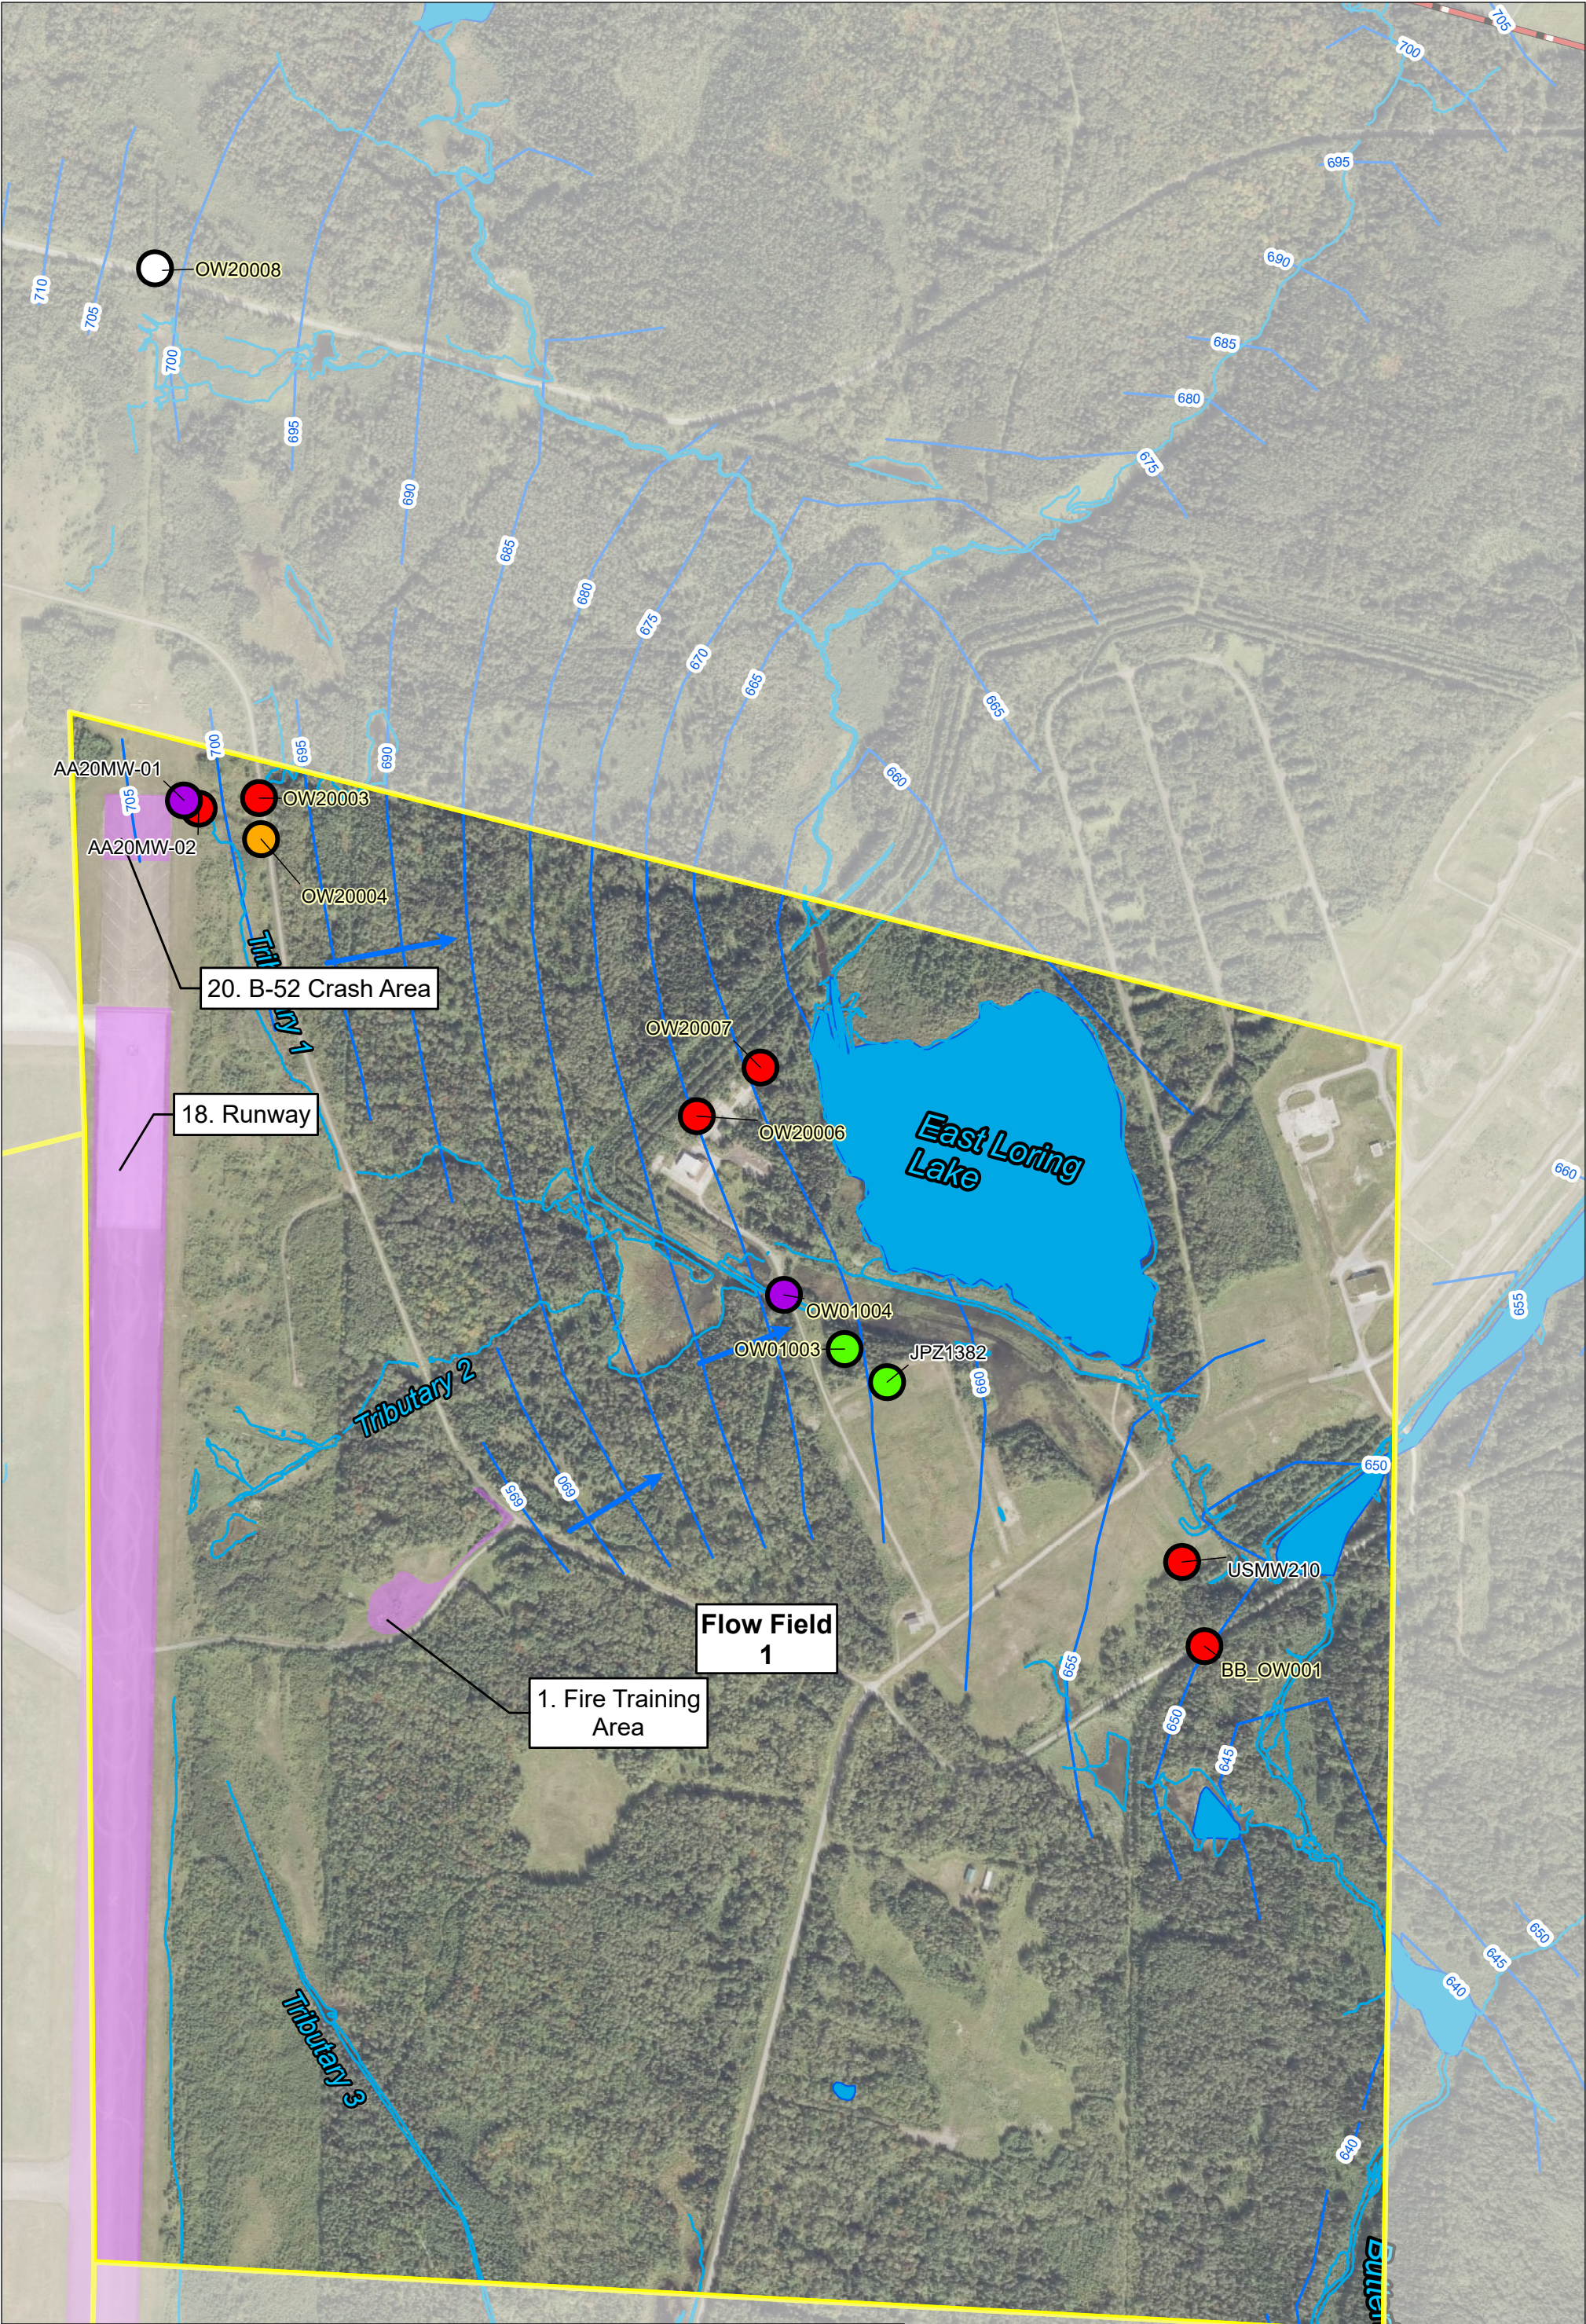
Modeled Overburden Groundwater Contour

Overburden Groundwater Flow Direction

Figure depicts most recent sampling result for each location.
