PHOTOSIMULATION 33: NORTH OF PICNIC AREA, 3 Structure Option

REV: October 16, 2018

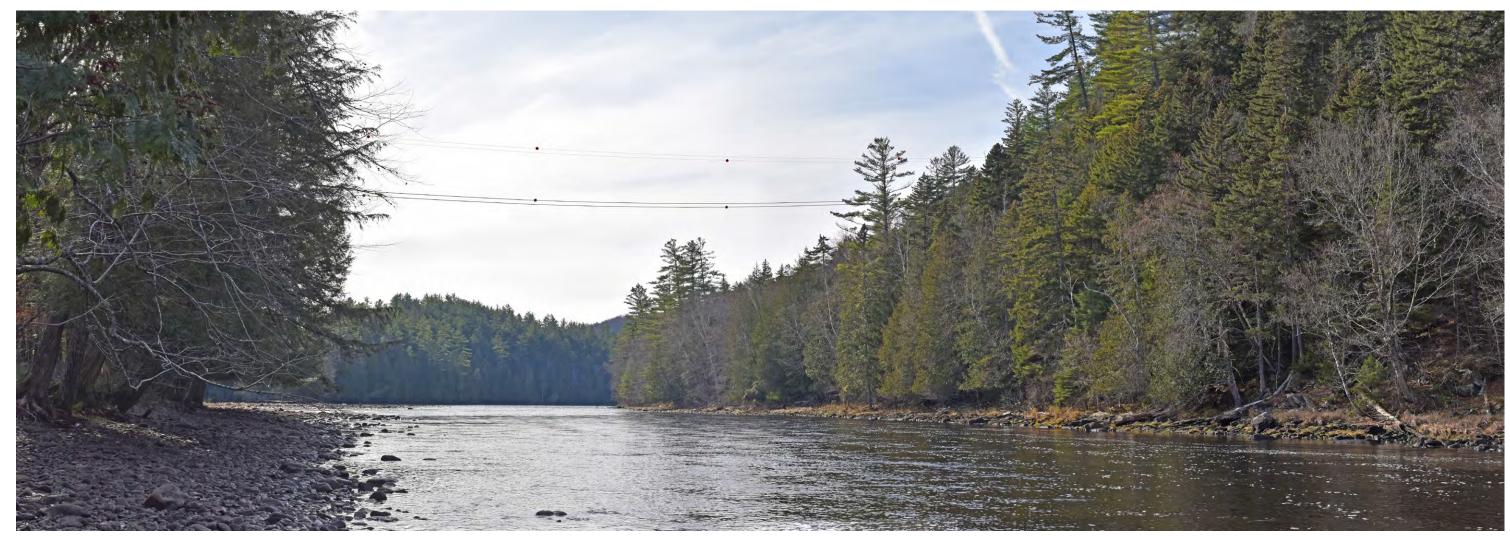
Proposed Conditions: Panoramic view looking southwest from a point 1,150' +/- north of the proposed HVDC transmission line crossing of the Kennebec River, north of a picnic area. The closest structure, screened by vegetation in this view, is 1,250' +/- to the southwest. Conductors, approximately 200' above the river, will be visible to recreational boaters for approximately 1,600' approaching the crossing. Marker balls will be visible on the shield wires and conductors.

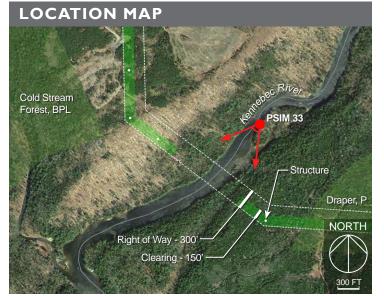
TECHNICAL INFORMATION		
3 Structure Option Cross Section	Photograph / Photosimulation Information	
Marker Ball Shield Wires Conductors Conductor Safety Zone (30' below conductors) Structure 3006-21 Ht93' Elev846' White Pines 475' Required Clearance Zone Forested Buffer NOTES: Looking south at proposed HVDC Corridor Crossing -Base information from POWER Engineers	Location Viewing Direction Horizontal Angle of View Date and Time Camera Focal Length Camera Make/Model Photo Source Proposed Structures Visible Approximate Distance to Nearest Structure	45.375273°, -69.939843° Southwest 49° 11/09/17 at 1:40 pm 35 mm Nikon D5500 TJD&A 0 1,250 Feet tjd&a
-Average height of vegetation within the forested buffer is 75' however, sentinel White Pines are shown as 100' to 125' in height to more closely represent vegetation observed along the river's edge.	June 21, 2018	PAGE 8 OF 12

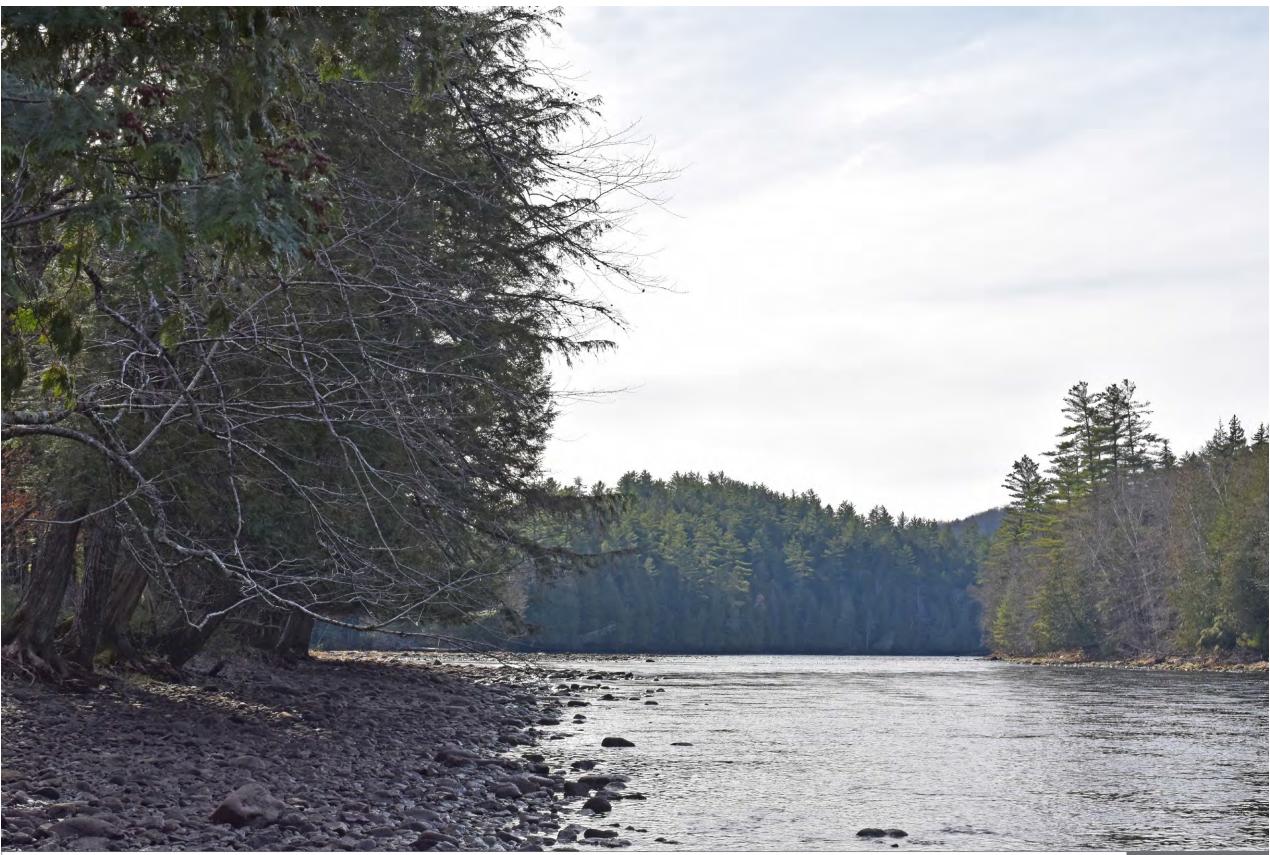
EXISTING CONDITIONS 33A: NORTH OF PICNIC AREA, 3 Structure Option

Existing Conditions: Normal view looking southwest on the Kennebec River, north of the picnic area.

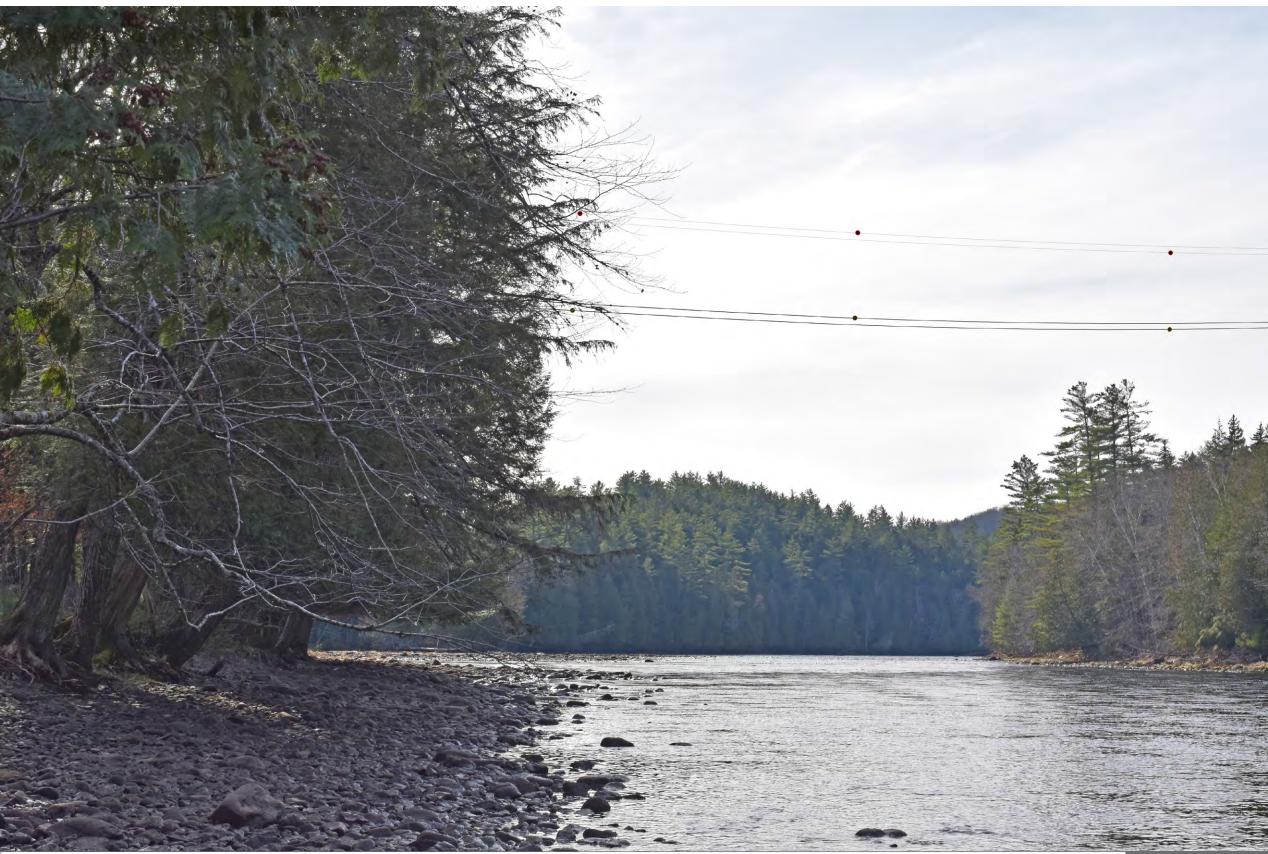
PHOTOSIMULATION 33B: NORTH OF PICNIC AREA, 3 Structure Option

Proposed Conditions: Normal view looking southwest from a point 1,150' +/- north of the proposed HVDC transmission line crossing of the Kennebec River, north of the picnic area. The closest structure, screened by vegetation in this view, is 1,250' +/- to the southwest. Conductors over the river will be visible to recreational boaters for approximately 1,600' approaching the crossing.

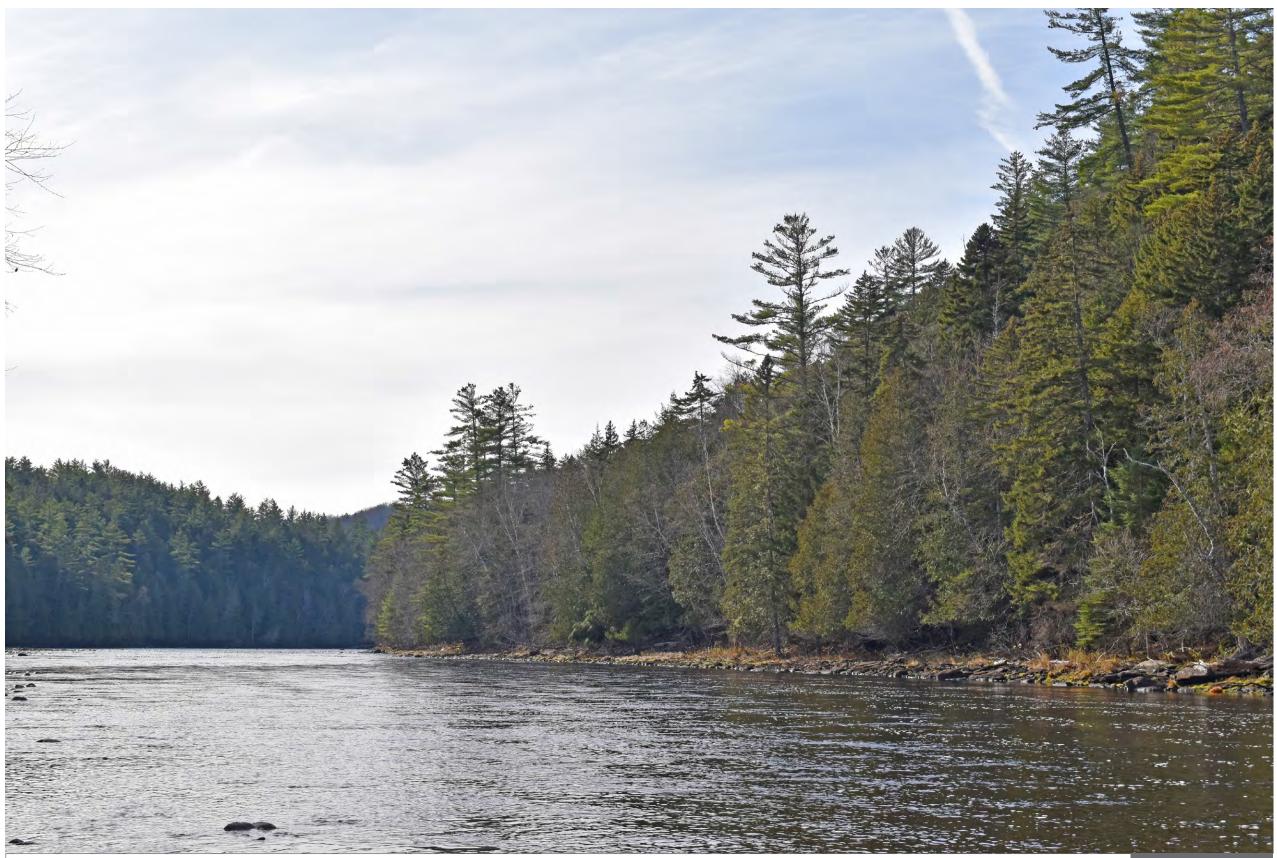
EXISTING CONDITIONS 33C: NORTH OF PICNIC AREA, 3 Structure Option

Existing Conditions: Normal view looking southwest from the Kennebec River, north of the picnic area.

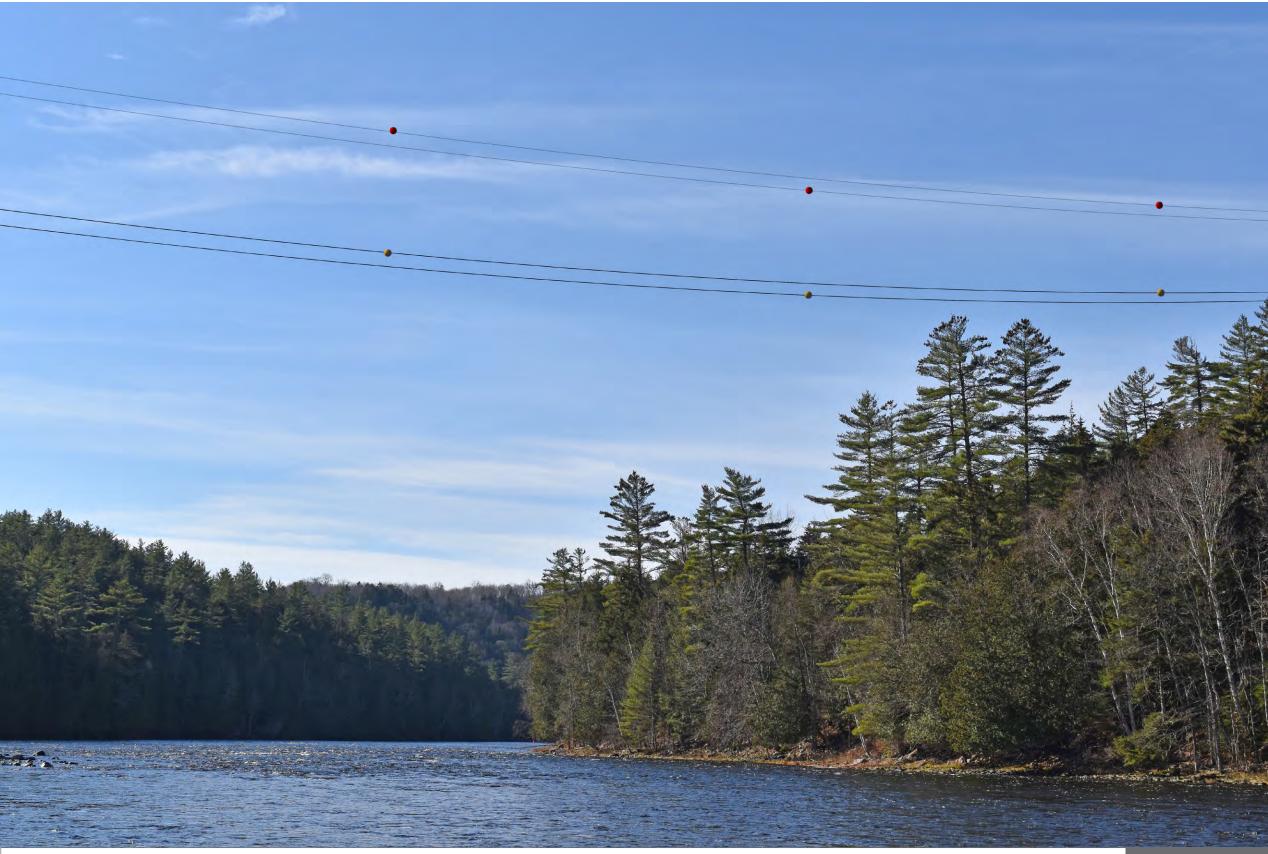
PHOTOSIMULATION 33D: FROM NORTH OF PICNIC AREA, 3 Structure Option

Proposed Conditions: Normal view looking southwest from the Kennebec River toward the proposed HVDC transmission line conductors and marker balls. Structures would be screened from view by vegetation. Conductors over the river will be visible to recreational boaters for approximately 1,600' approaching the crossing.
