**PHOTOSIMULATION 44: COBURN MOUNTAIN, OBSERVATION TOWER, Upper Enchanted Twp**

TECHNICAL INFORMATION	
<b>Typical Cross Section</b> 	<b>Photograph / Photosimulation Information</b>
Location	45.468580°, -70.126432°
Viewing Direction	East to South
Horizontal Angle of View	73°
Date and Time	11/11/18 at 4:08 pm
Camera Focal Length	35 mm (50 mm equiv.)
Camera Make/Model	Nikon D5500
Photo Source	TJD&A
Proposed Structures Visible	11 within 3 miles
Approximate Distance to Nearest Visible Structure	1.0 mile
January 8, 2019      PAGE 1 OF 8

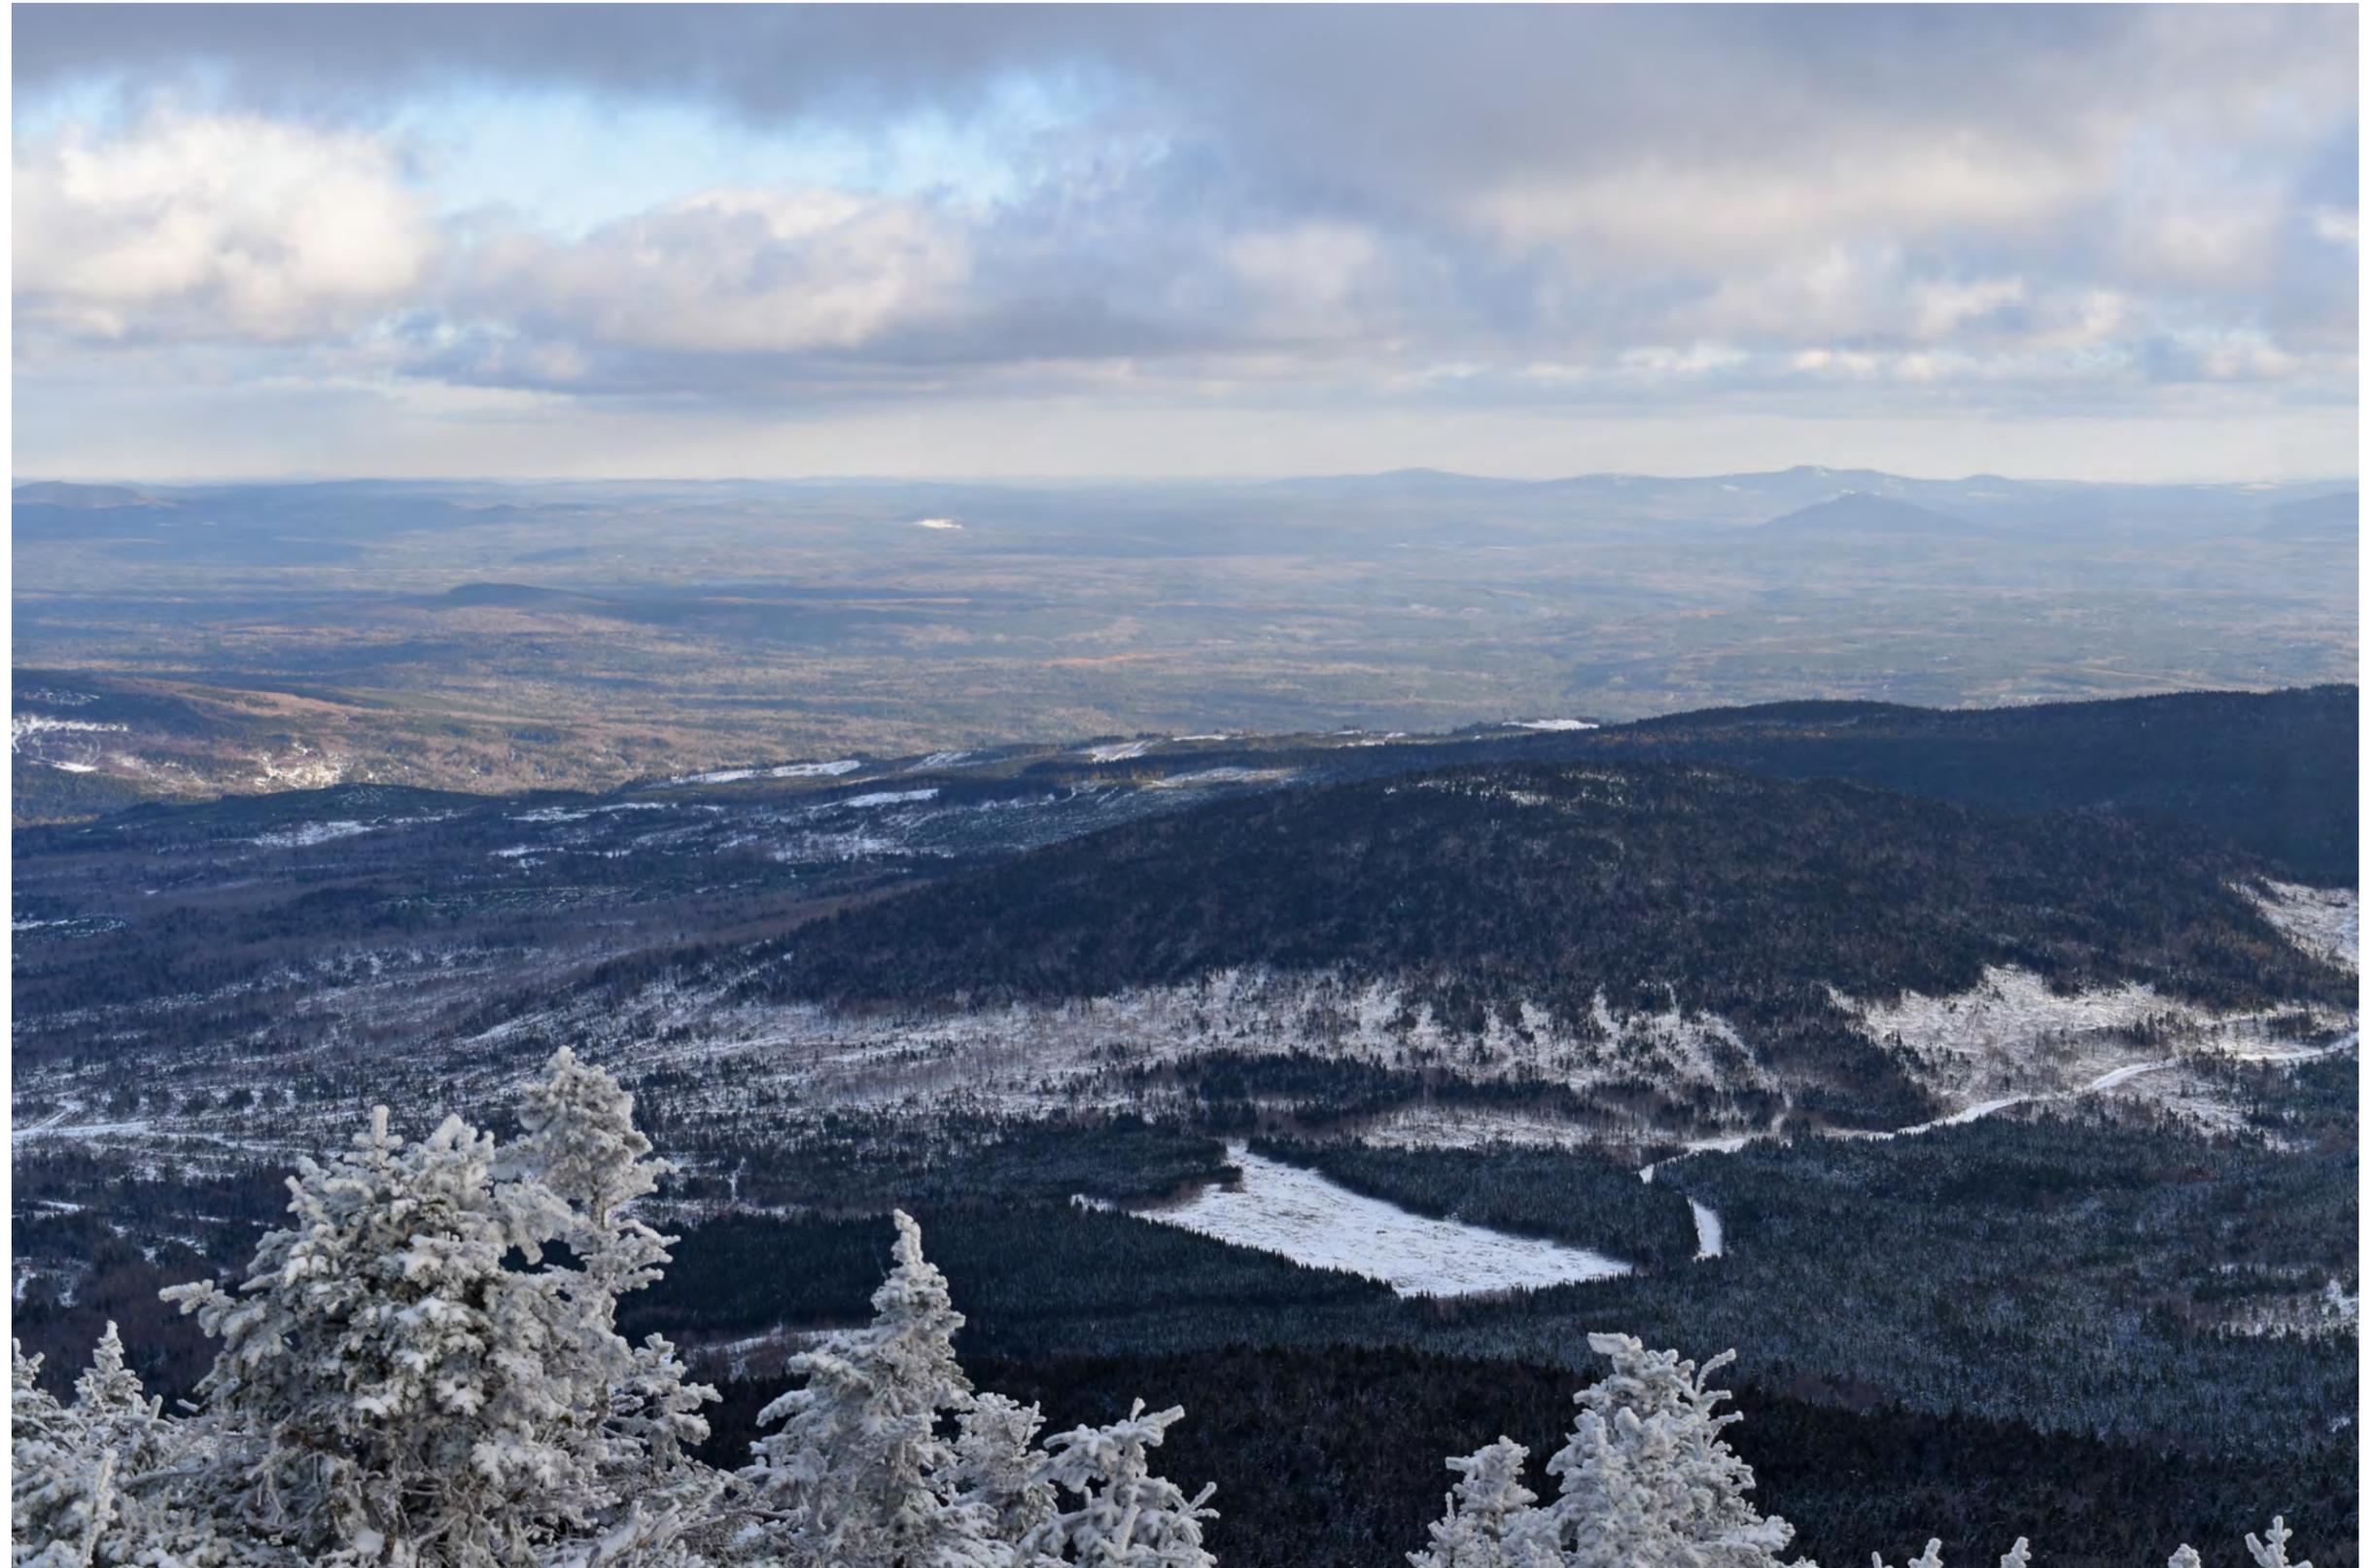
**EXISTING CONDITIONS 44A: COBURN MOUNTAIN, OBSERVATION TOWER, Upper Enchanted Twp**

**Existing Conditions:** Normal view looking east from the observation tower at the summit of Coburn Mountain. Evidence of active timber harvesting (patch cuts and haul roads) are visible in the midground on Johnson Mountain off an unnamed road in Johnson Mountain Twp.

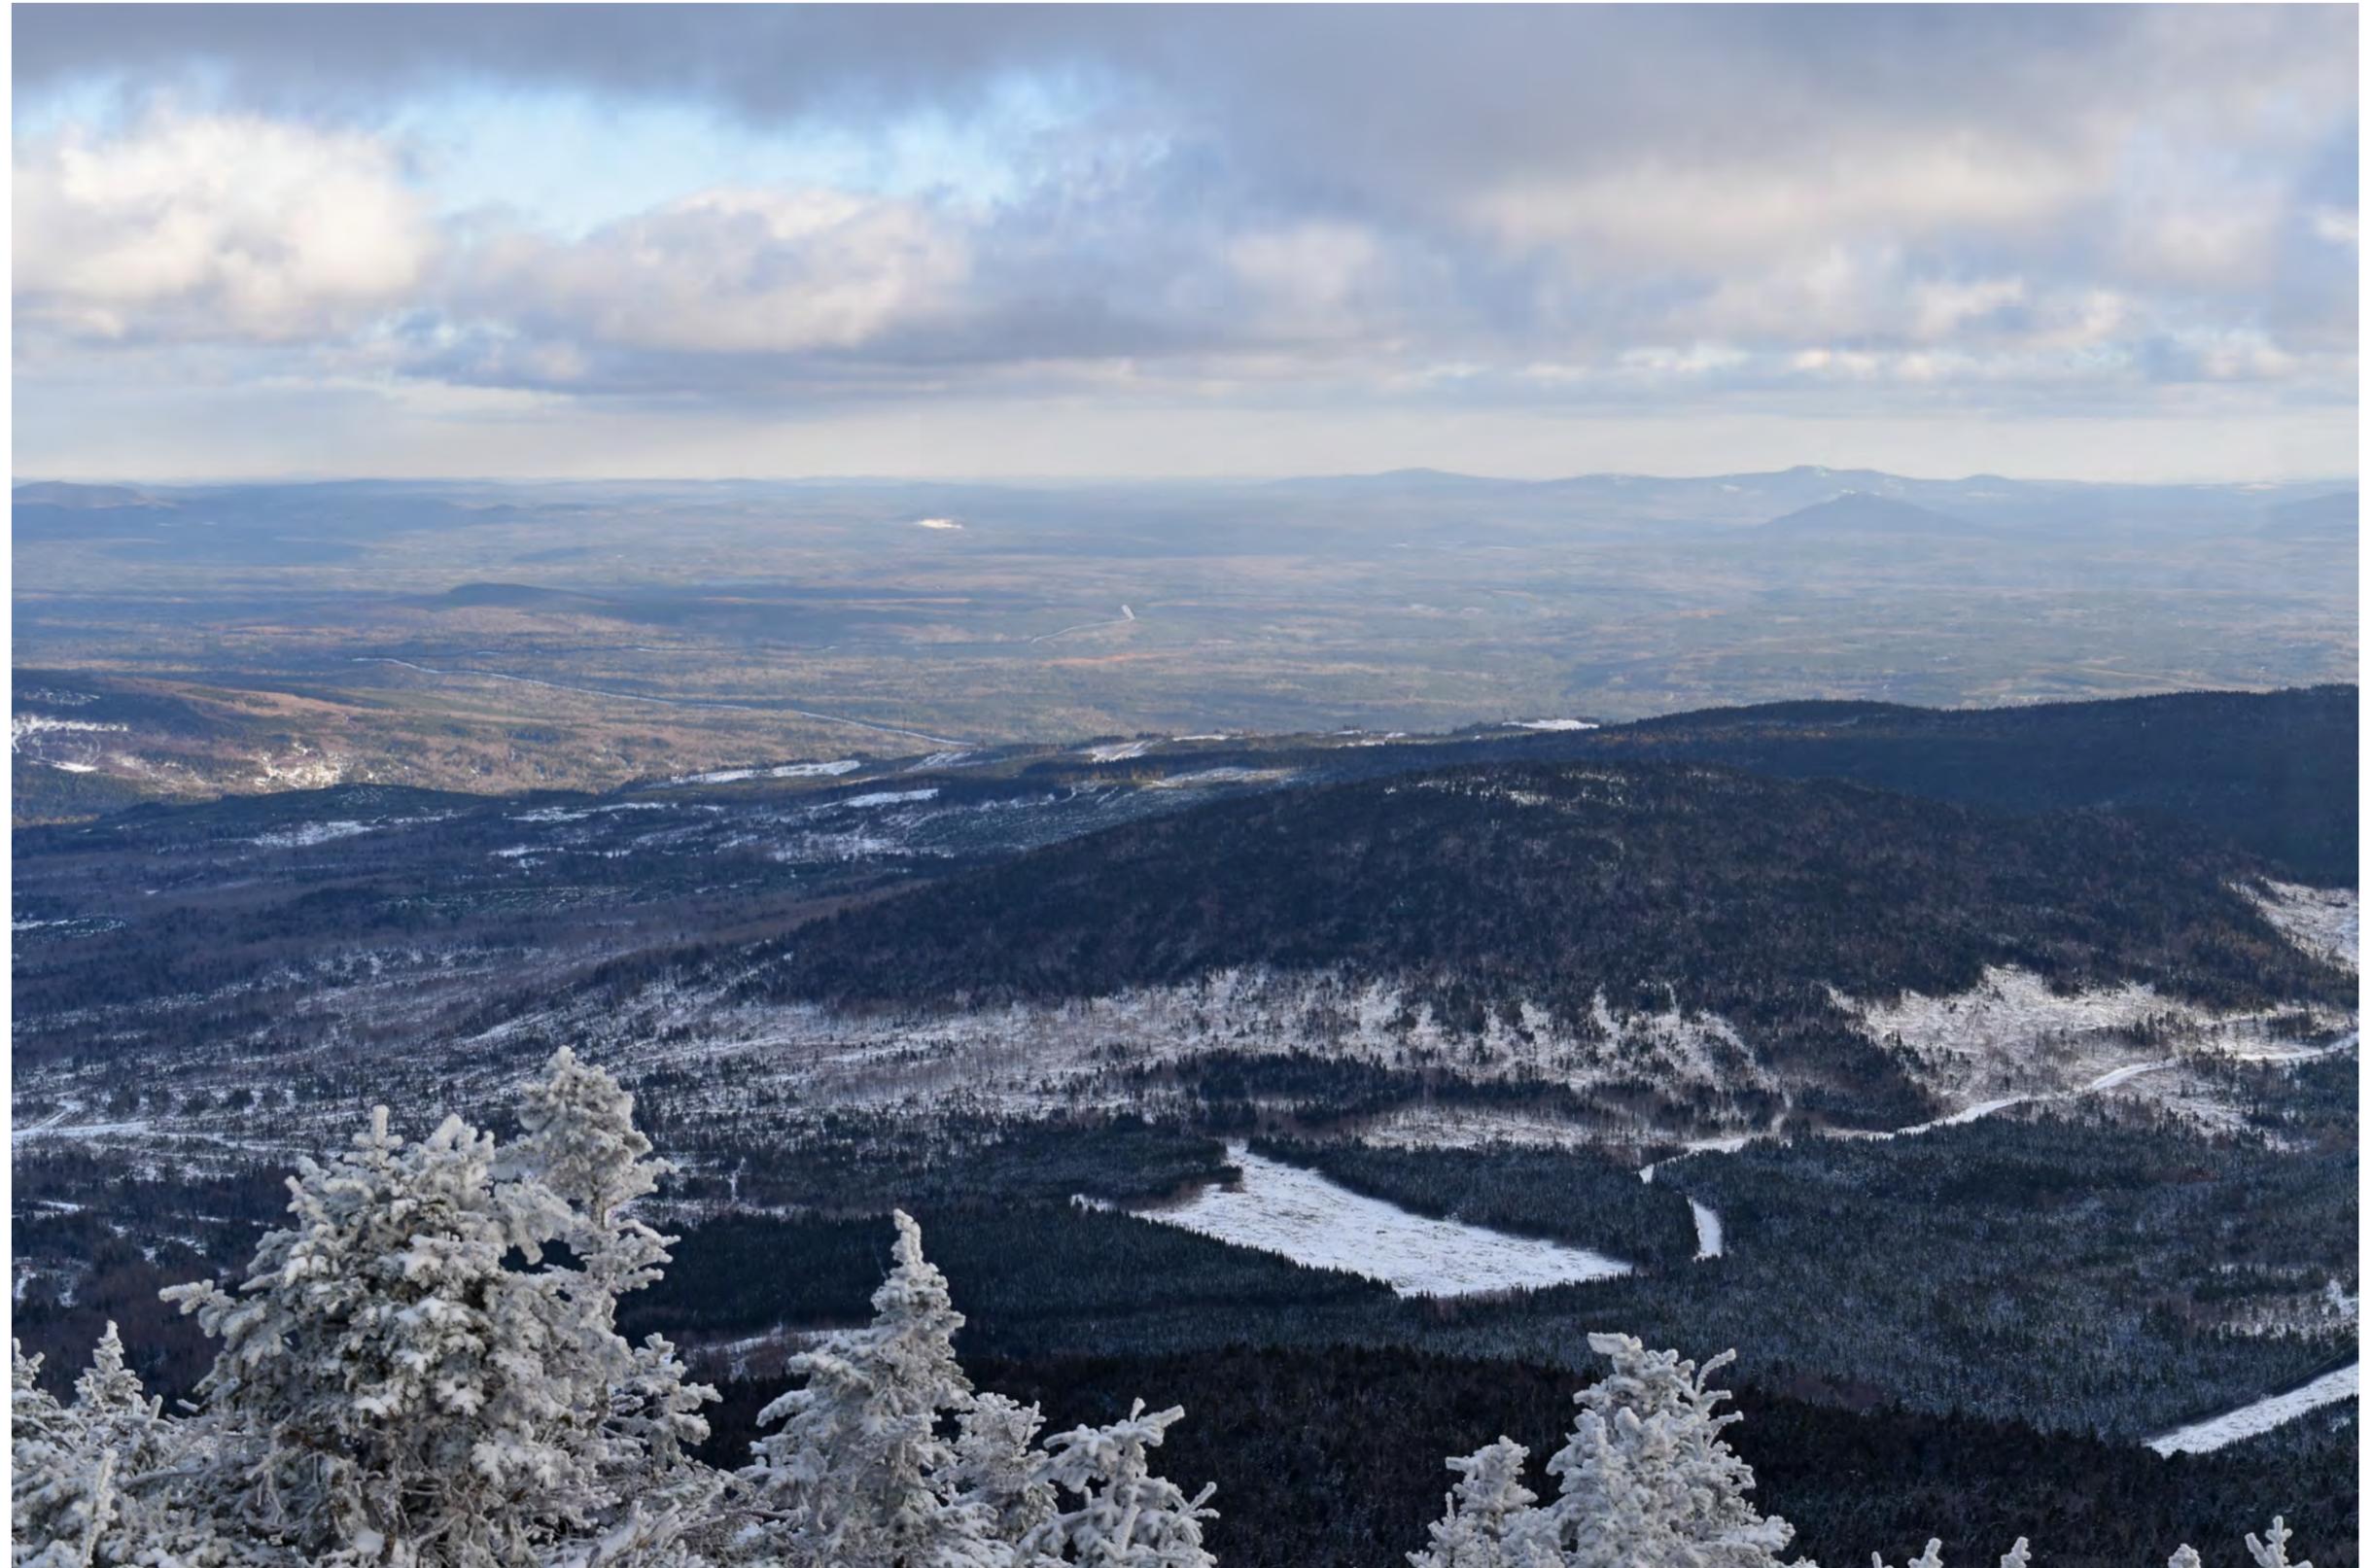
**PHOTOSIMULATION 44A: COBURN MOUNTAIN, OBSERVATION TOWER, Upper Enchanted Twp**

**Proposed Conditions:** Normal view looking east from the observation tower at the summit of Coburn Mountain toward the proposed HVDC transmission line. The proposed corridor clearing and HVDC transmission line structures will be minimally visible in the background, to the left of Johnson Mountain in the photograph.

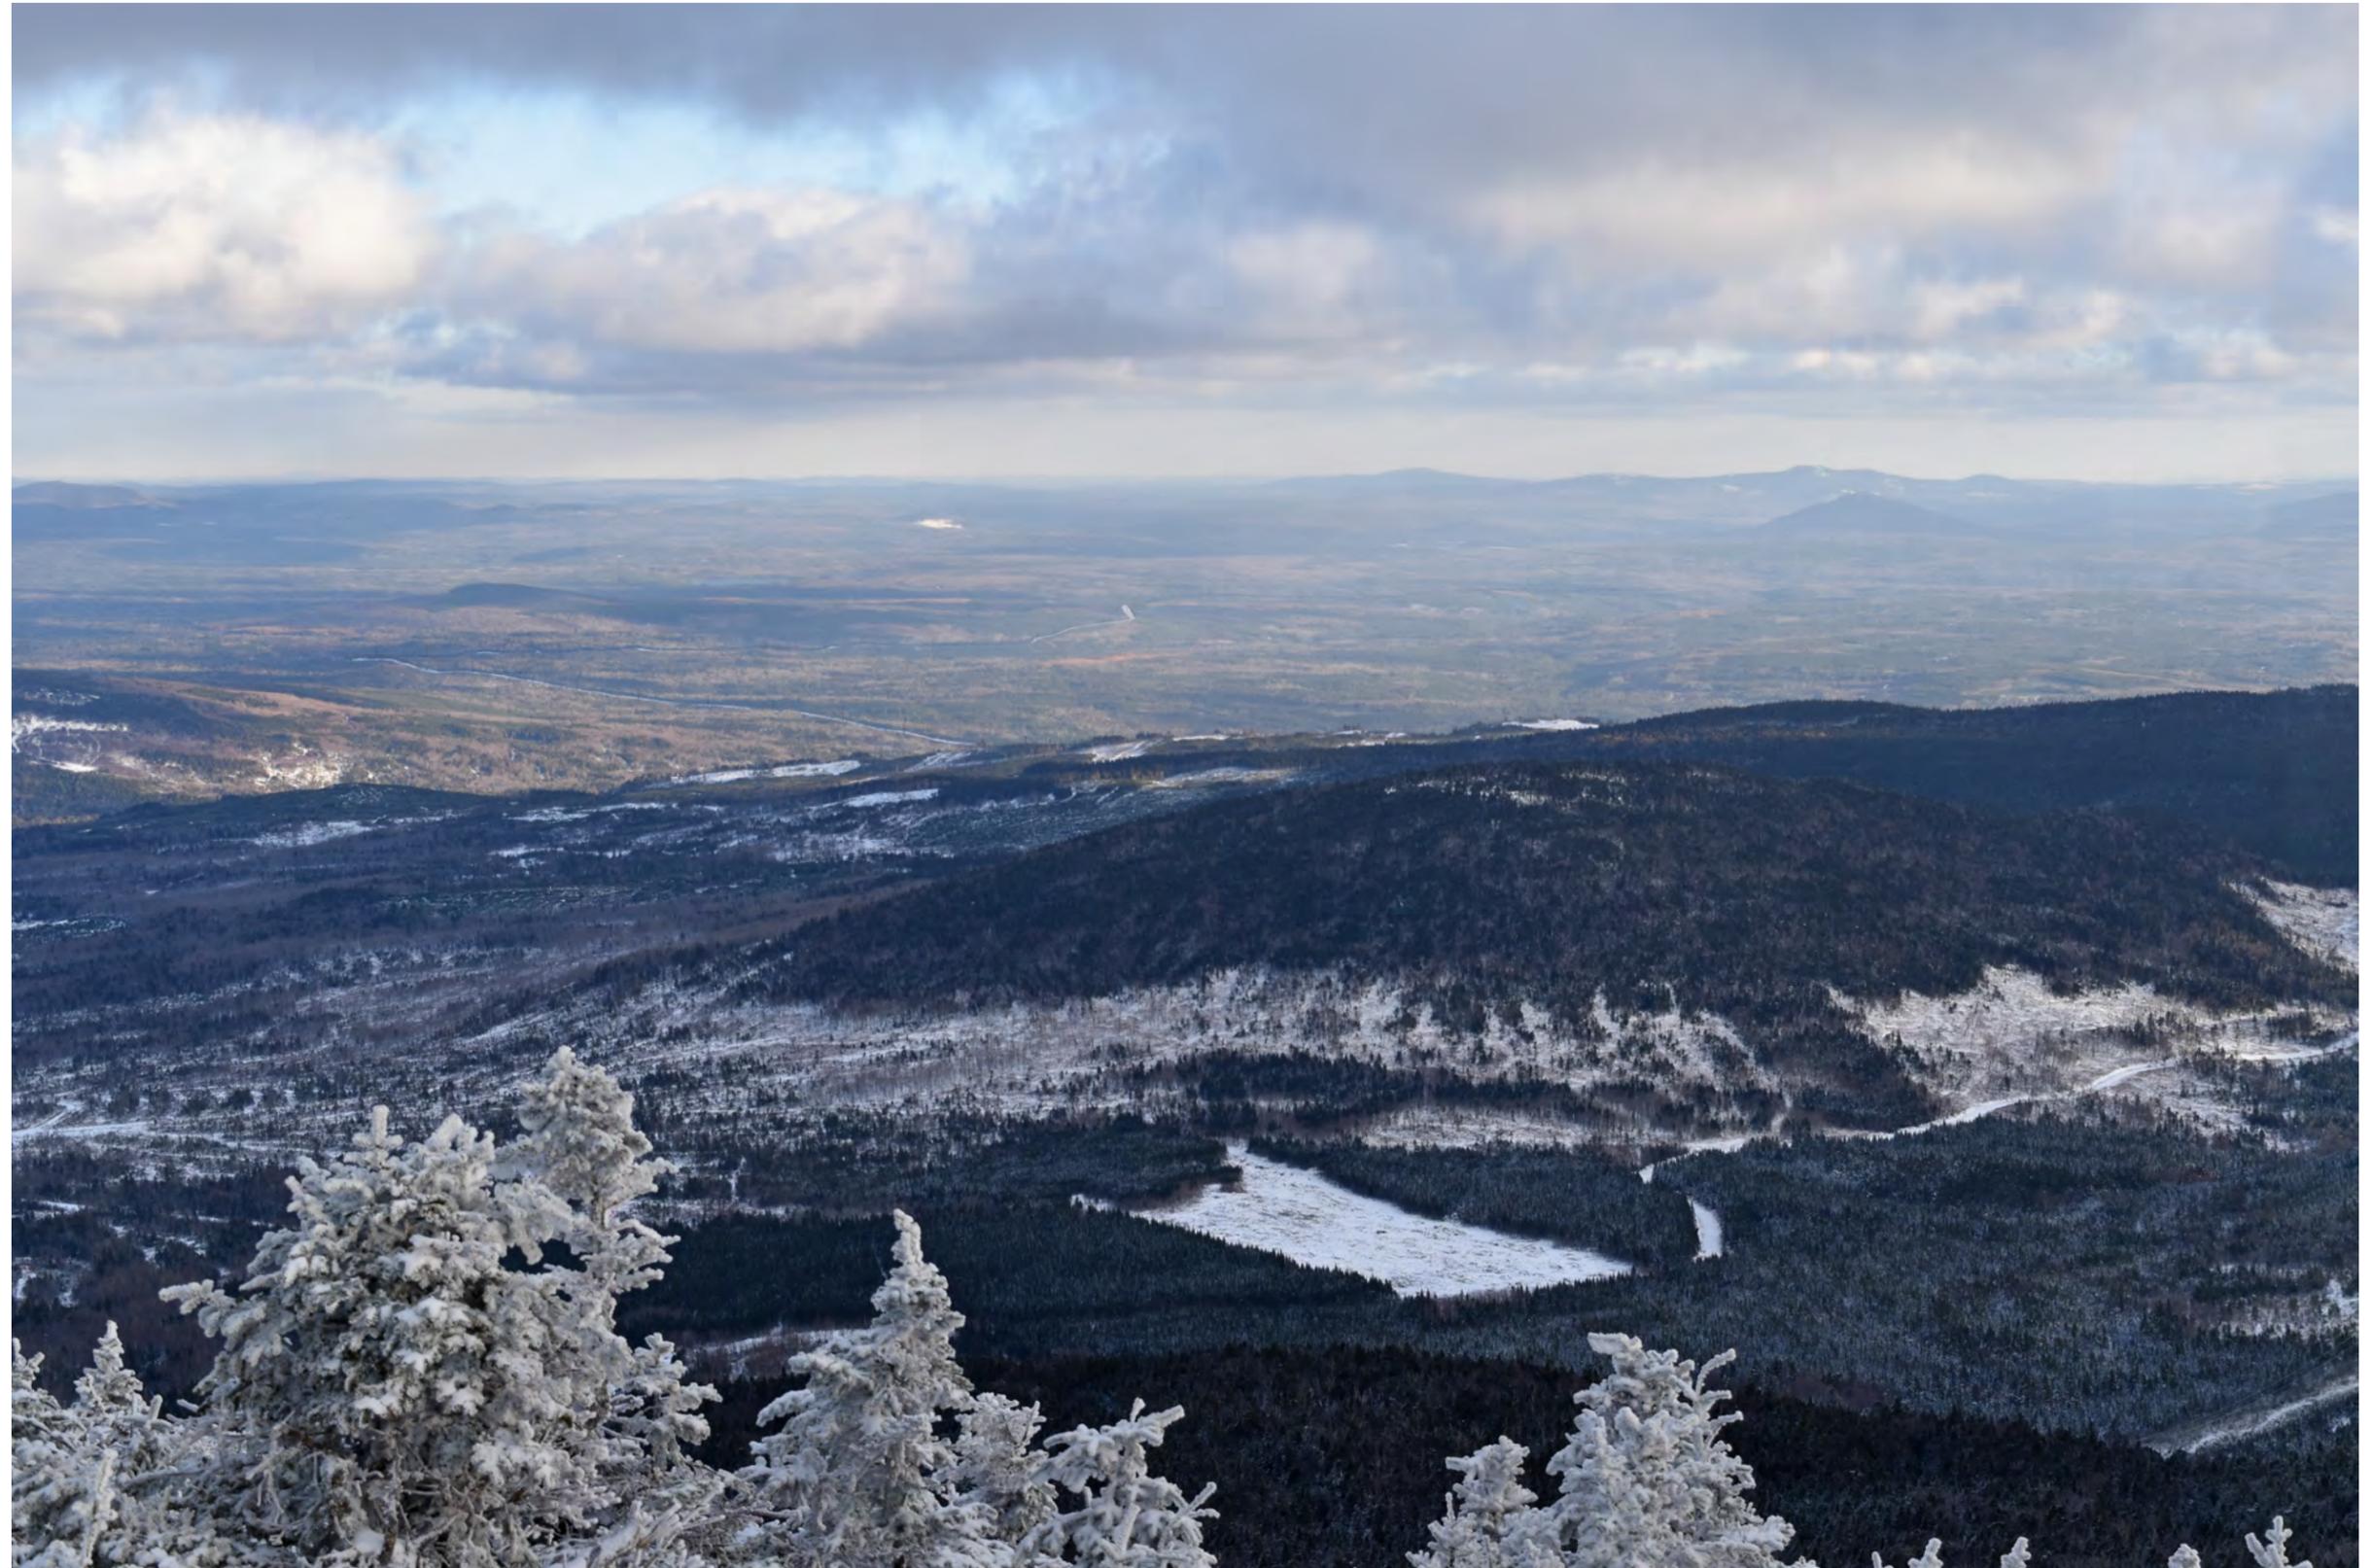
**PHOTOSIMULATION 44A: COBURN MOUNTAIN, OBSERVATION TOWER, Upper Enchanted Twp**

**Proposed Conditions:** Normal view looking east from the observation tower at the summit of Coburn Mountain toward the proposed HVDC transmission line. The proposed corridor clearing and HVDC transmission line structures will be minimally visible in the background, to the left of Johnson Mountain in the photograph. This photosimulation illustrates how the proposed tapered vegetation management would visually reduce the appearance of the 150 ft wide corridor on the west side of Johnson Mountain (lower right in image.)

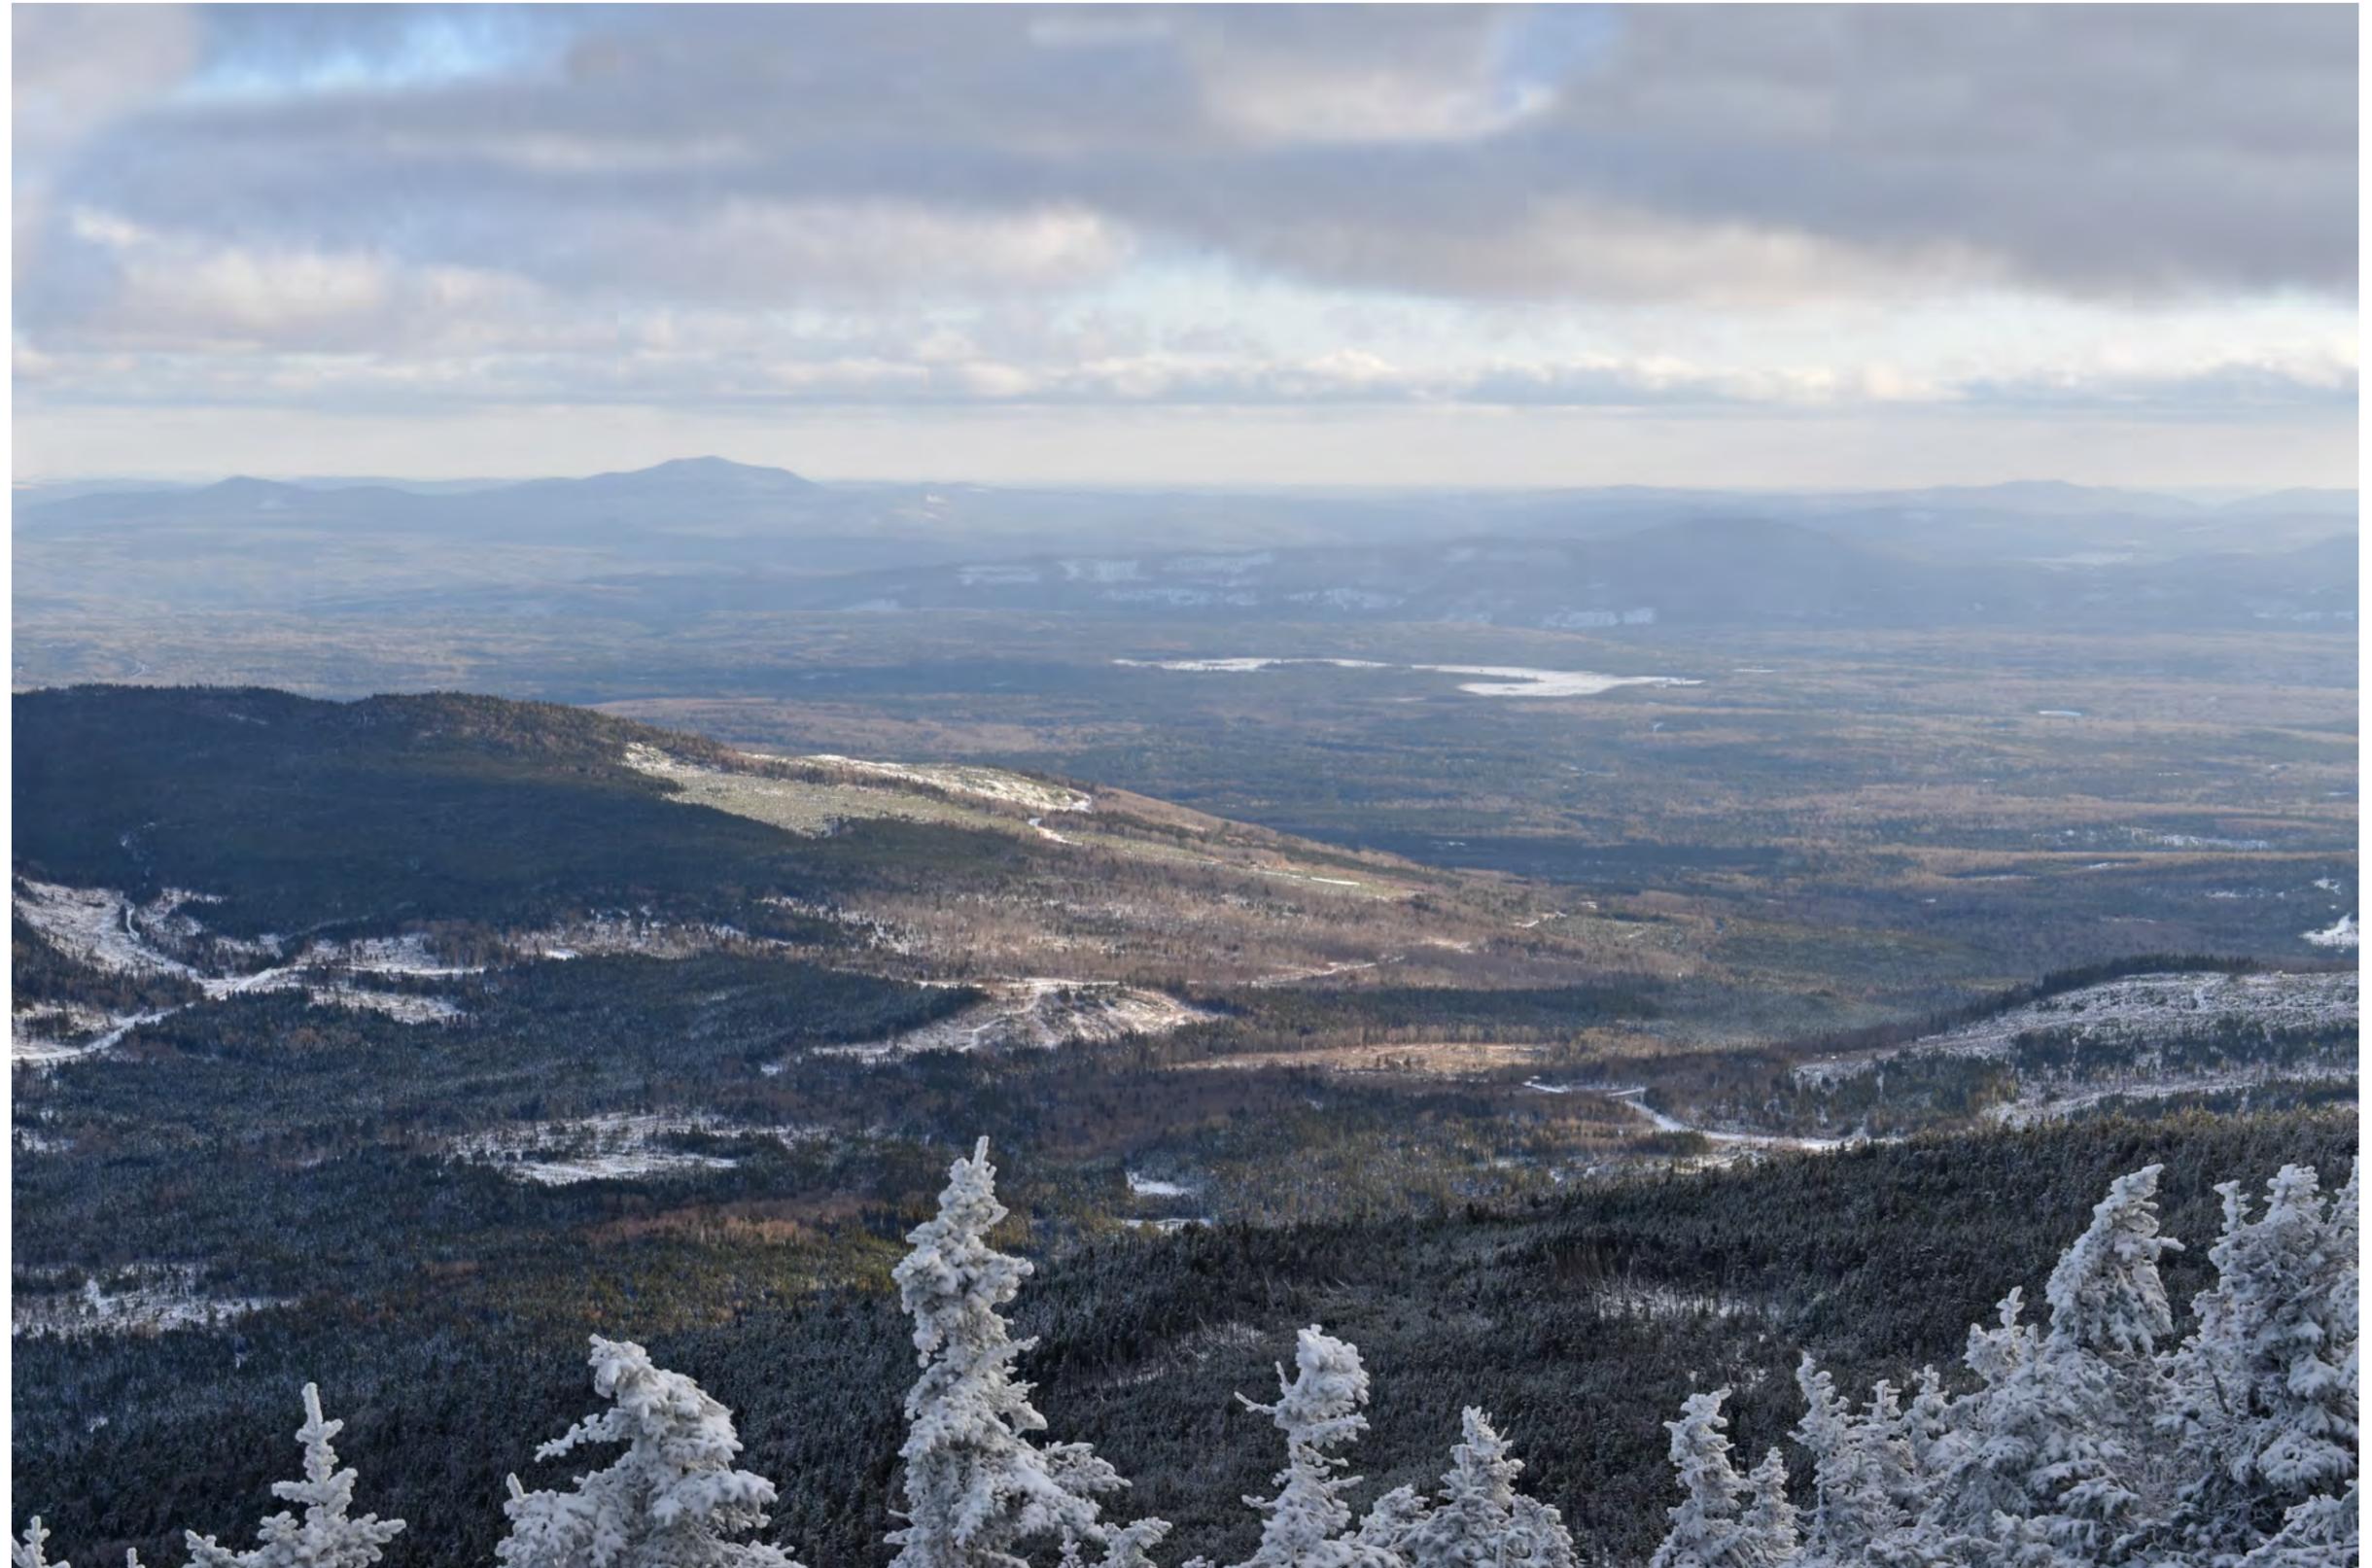
**EXISTING CONDITIONS 44B: COBURN MOUNTAIN, OBSERVATION TOWER, Upper Enchanted Twp**

**Existing Conditions:** Normal view looking south from the observation tower at the summit of Coburn Mountain. Evidence of active timber harvesting (patch cuts and haul roads) are visible in the midground on Johnson Mountain off an unnamed road in Johnson Mountain Twp.

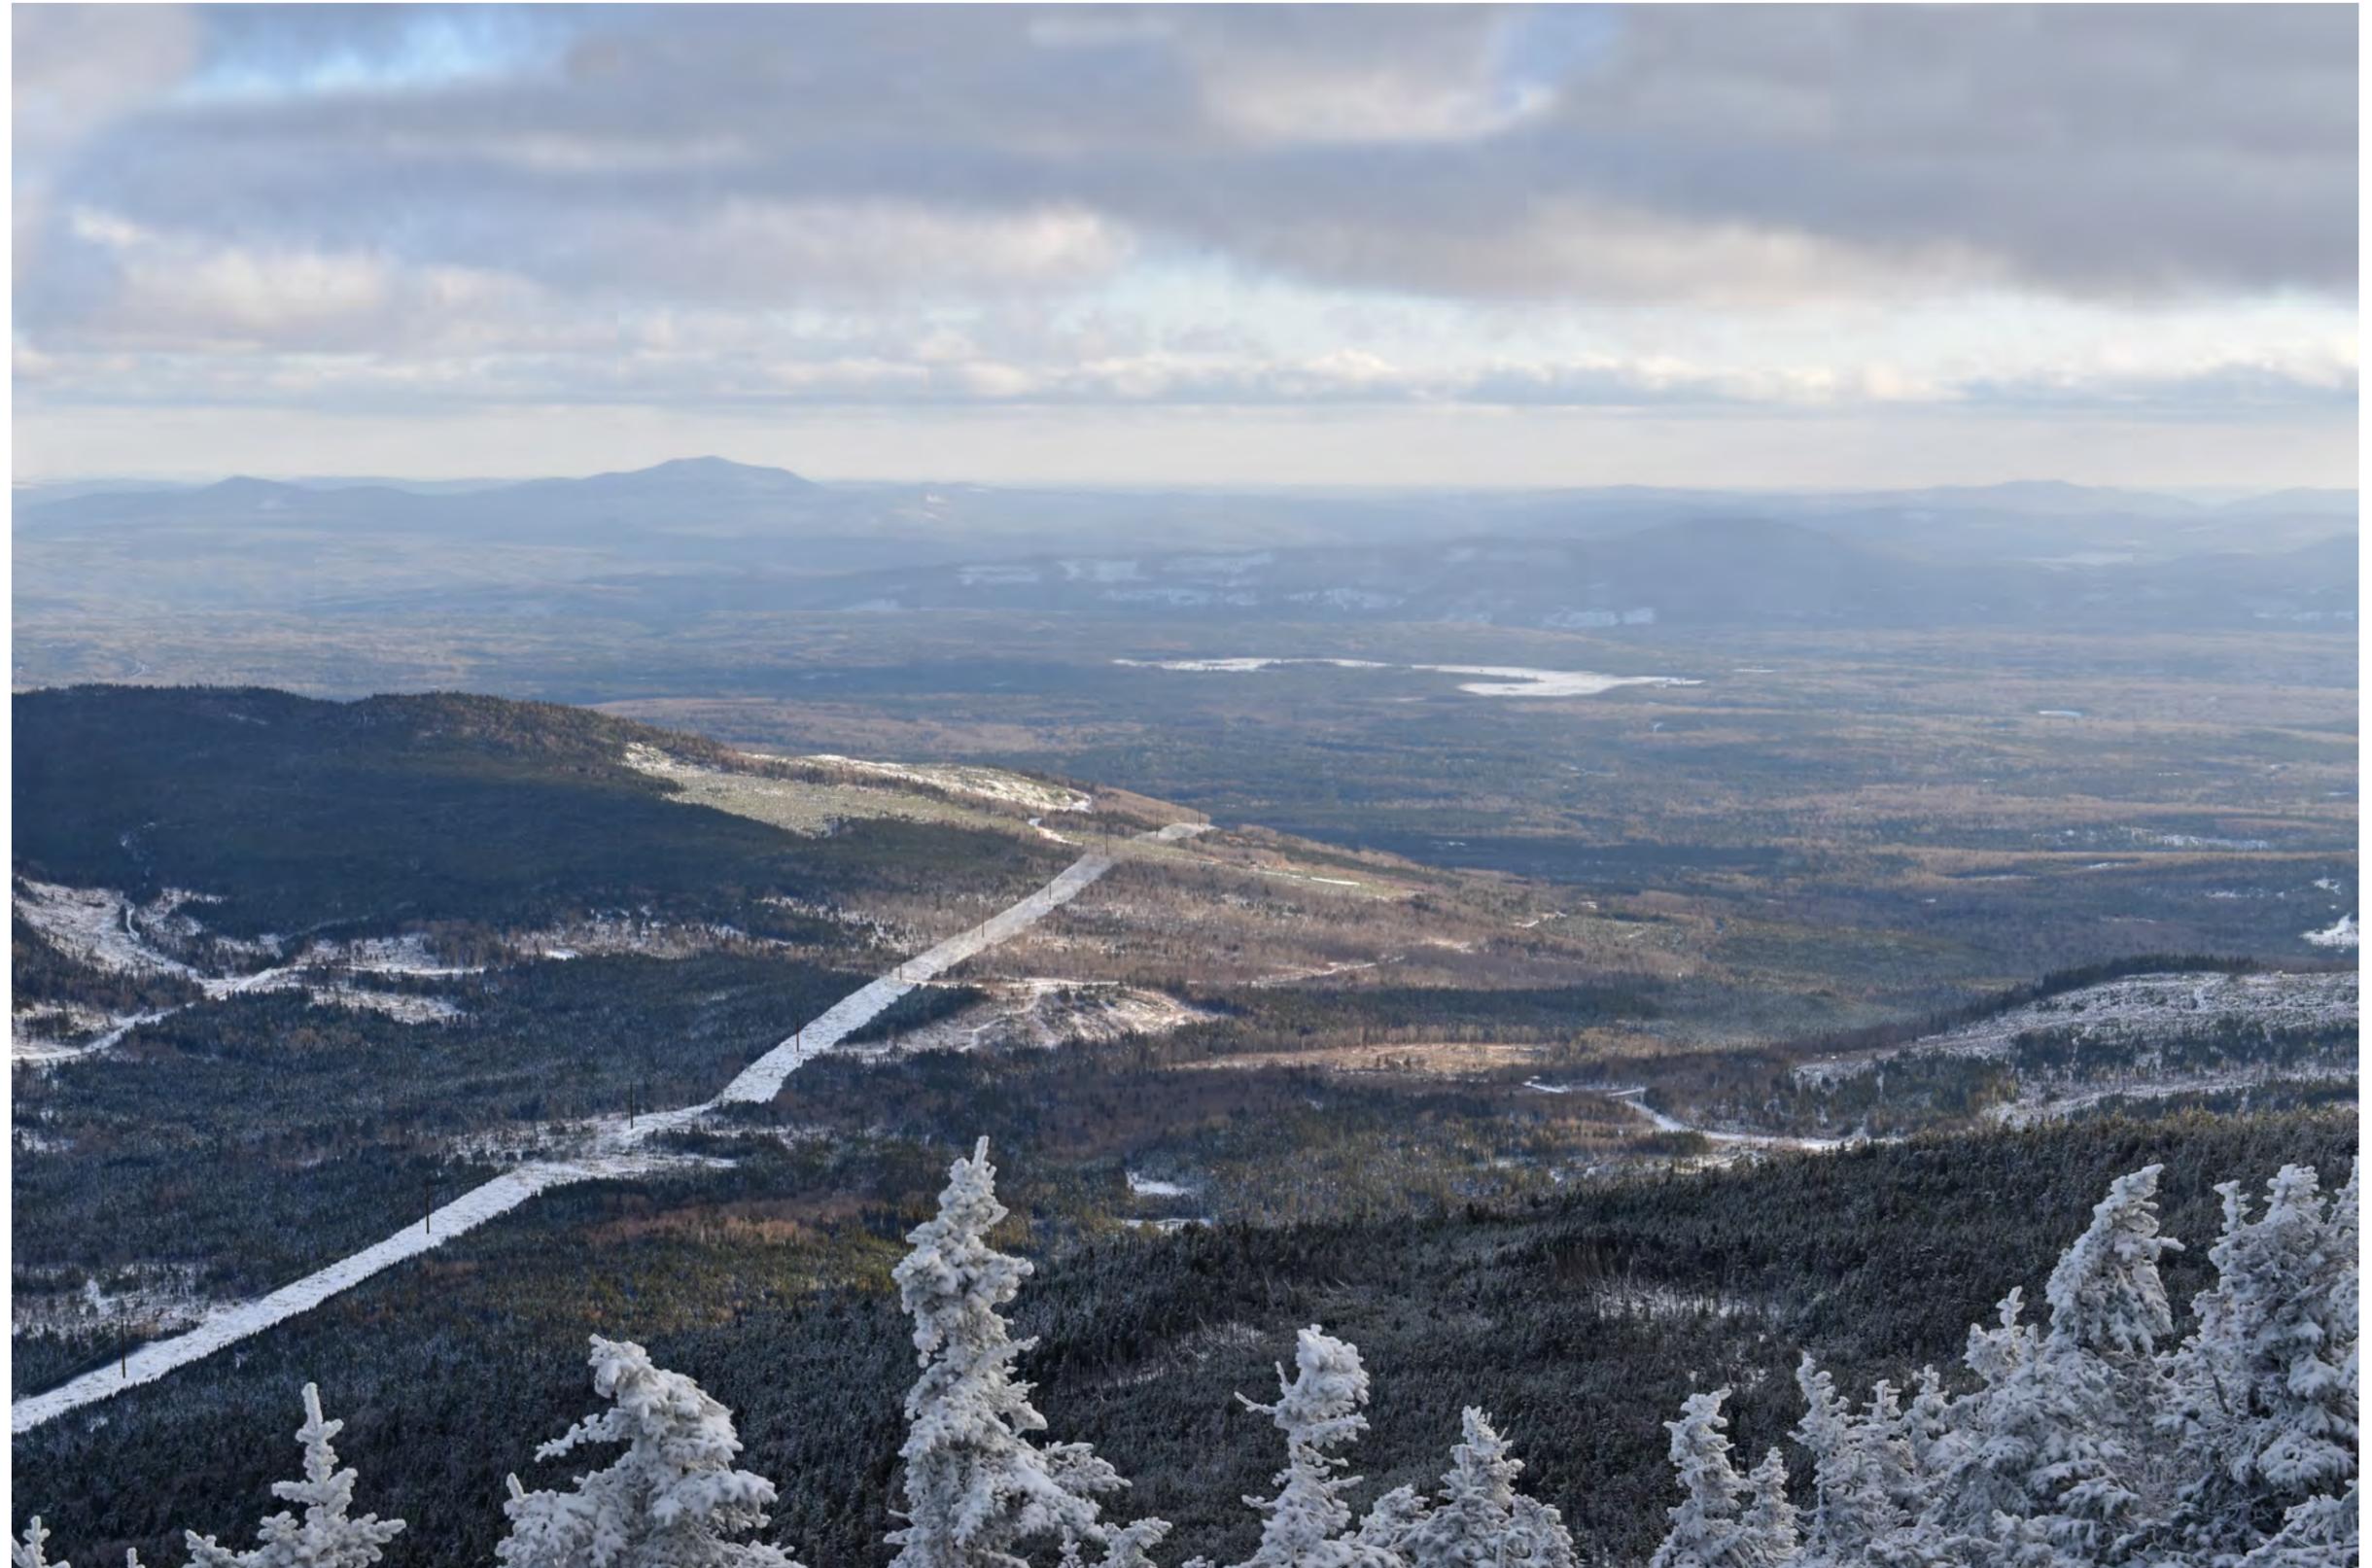
**PHOTOSIMULATION 44B: COBURN MOUNTAIN, OBSERVATION TOWER, Upper Enchanted Twp**

**Proposed Conditions:** Normal view looking south from the observation tower at the summit of Coburn Mountain toward the proposed HVDC transmission line. The new 150 ft wide corridor clearing will be visible in the midground on the west side of Johnson Mountain. The closest visible structure and conductors will be 1.0 miles from this viewpoint.

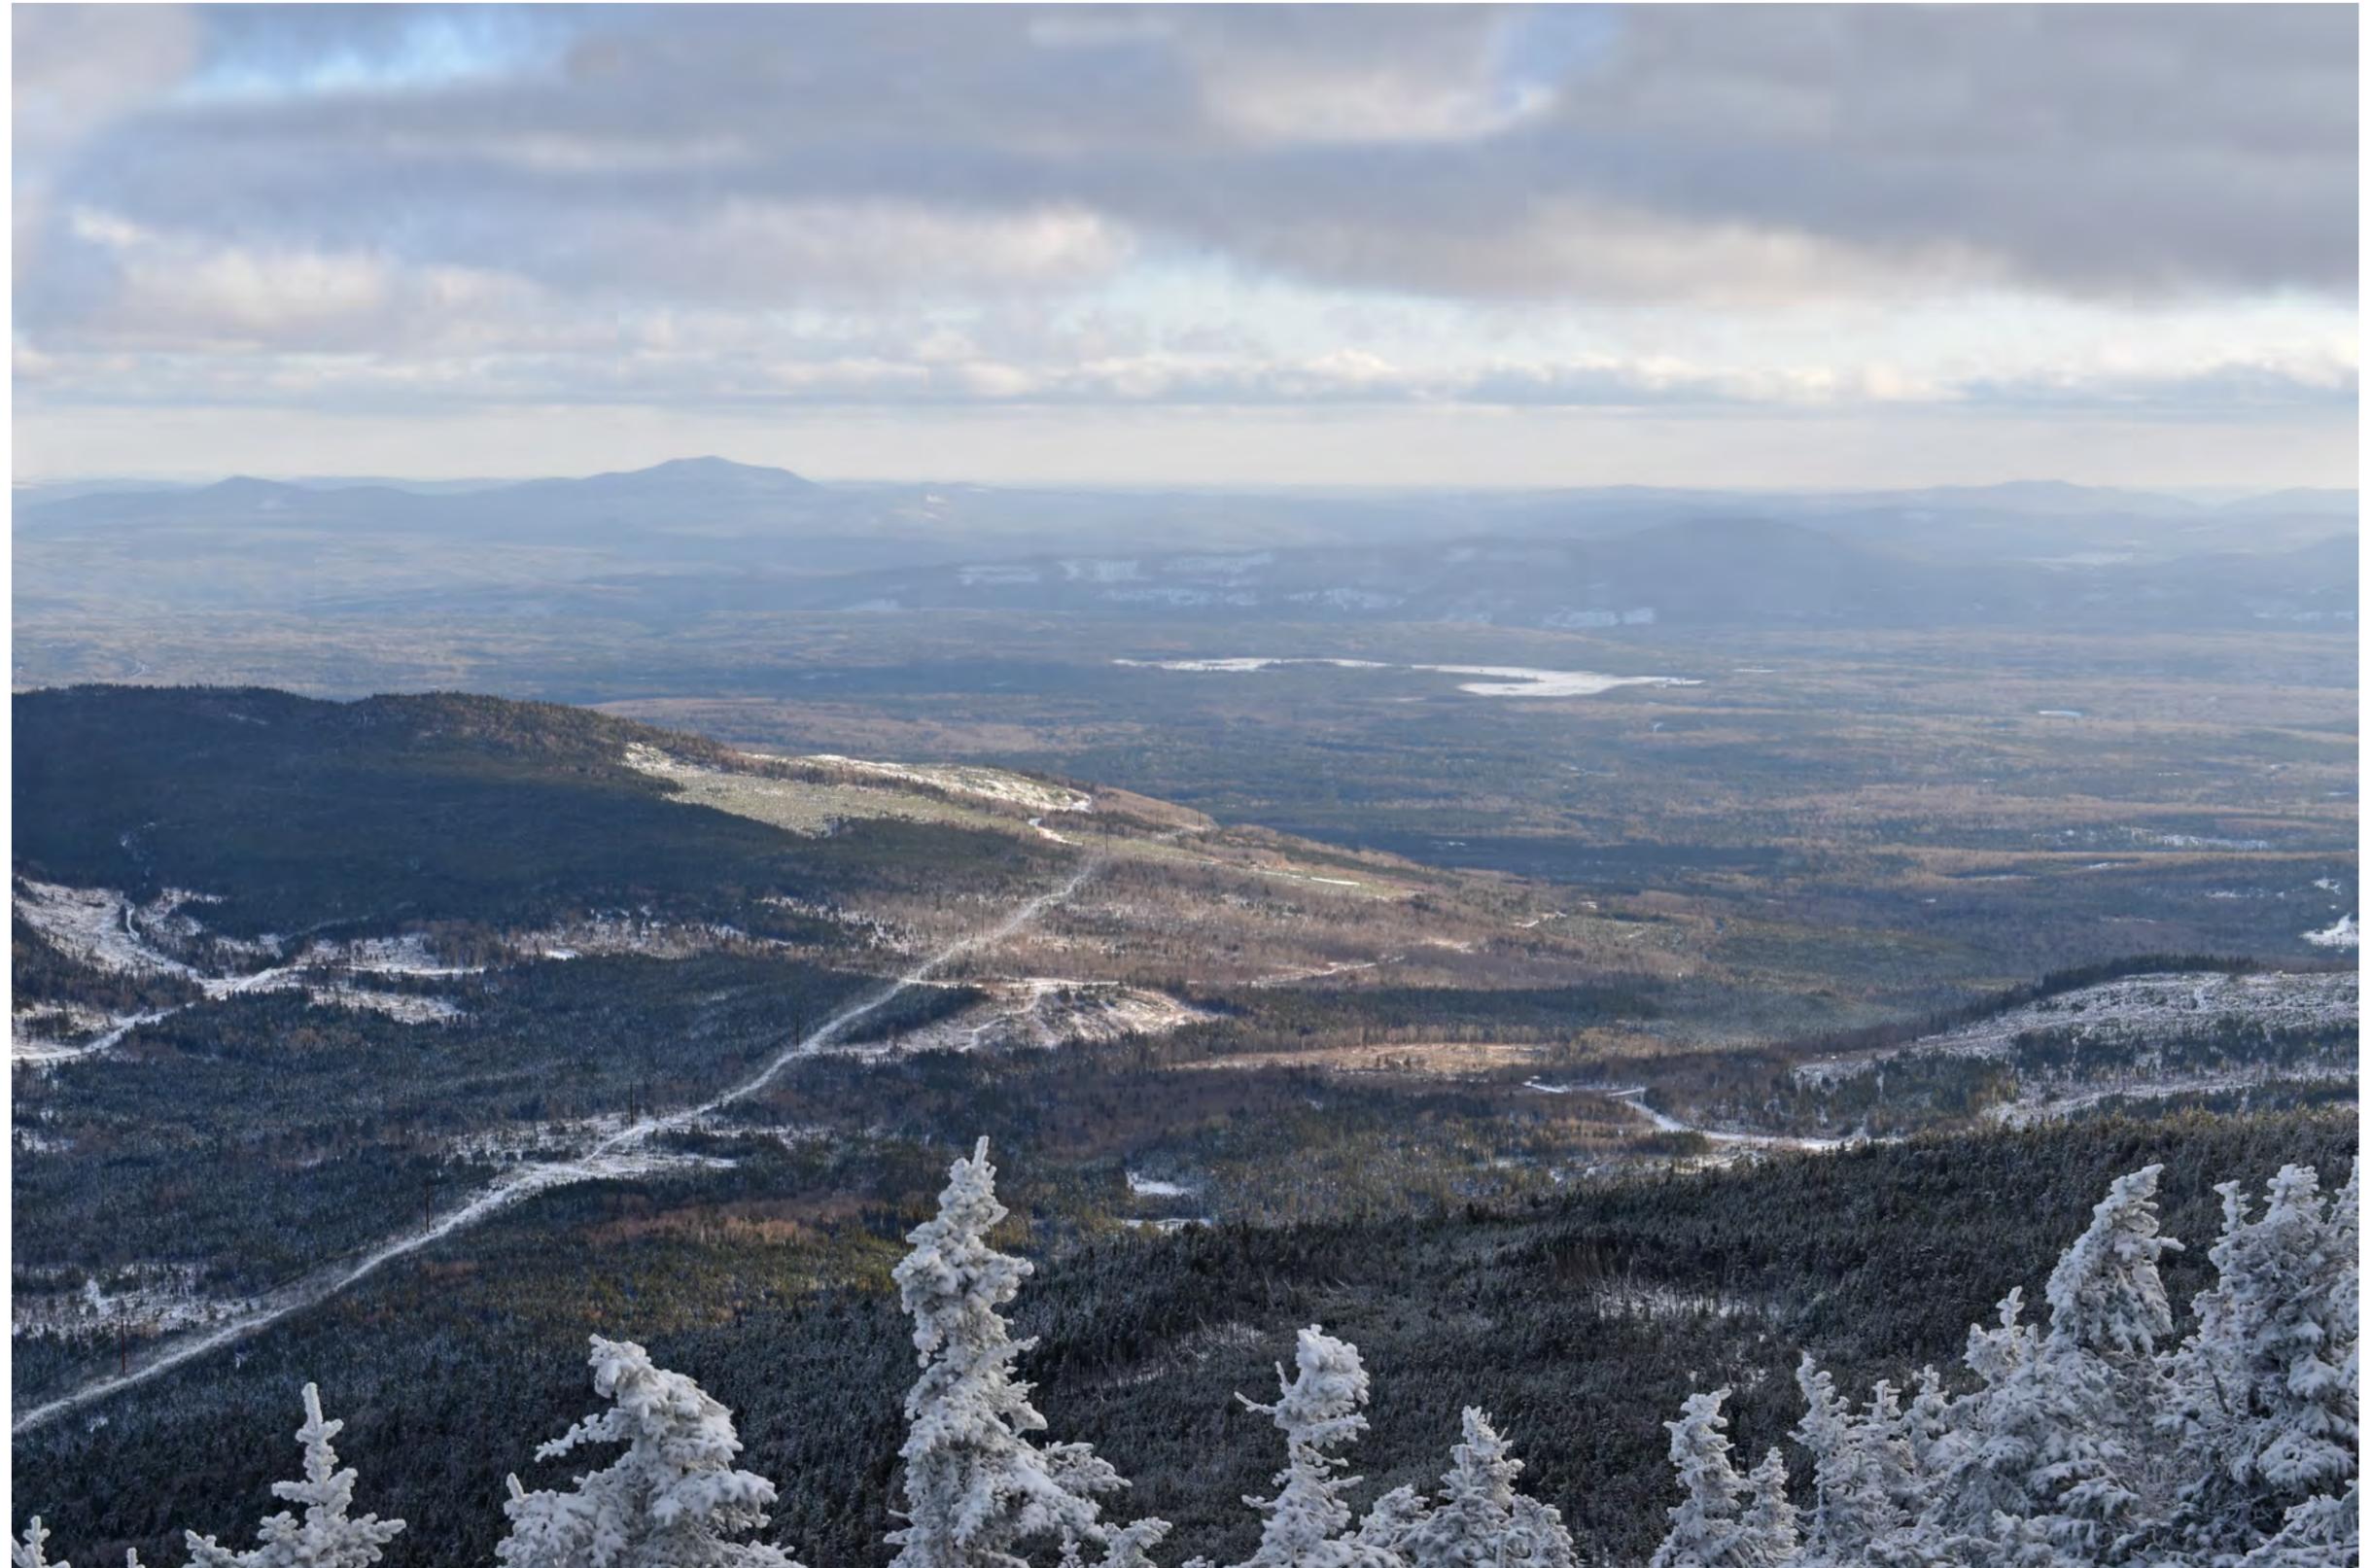
**PHOTOSIMULATION 44B: COBURN MOUNTAIN, OBSERVATION TOWER, Upper Enchanted Twp**

**Proposed Conditions:** Normal view looking south from the observation tower at the summit of Coburn Mountain toward the proposed HVDC transmission line. This photosimulation illustrates how the proposed tapered vegetation management would visually reduce the appearance of the 150 ft wide corridor on the west side of Johnson Mountain. The closest visible structure and conductors will be 1.0 miles from this viewpoint.
