**GEOTECHNICAL REPORT  
FRYEBURG RAIL TRAIL  
FRYEBURG, MAINE**

**P.I.N. 16130.00**

**Maine Department of Transportation  
16 State House Station  
Augusta, Maine 04333**

**URS Corporation  
115 Water Street, Suite 3  
Hallowell, Maine 04347**

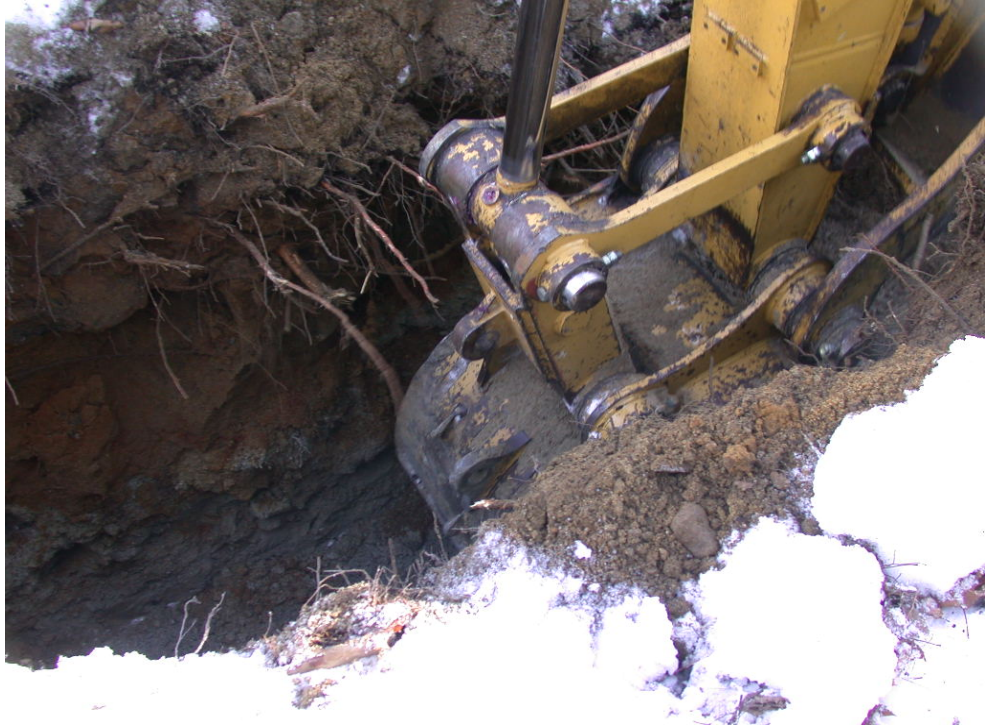
01

TP-1 showing soil overlying bedrock

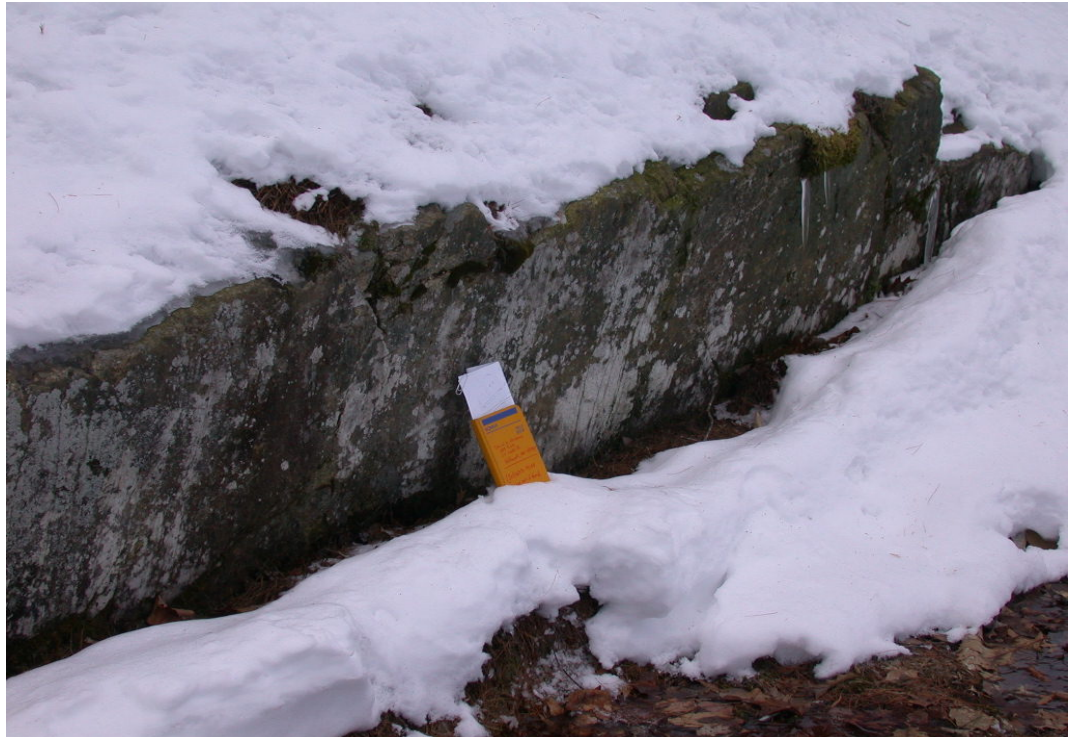
02

Granite outcrop in rail road cut

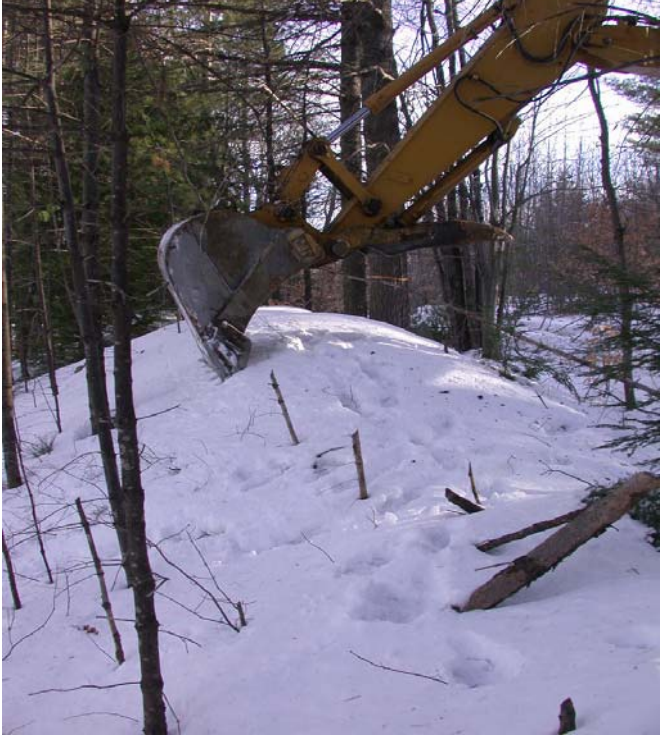
On-site observations indicate a somewhat different topography than shown on Sheet 1. A man-made berm, roughly four feet high and 10 to 12 feet wide at the base, parallels the top of the cut slope on the south side of the rail bed from approximately station 17+00 to station 19+25. The berm can be seen on the site photographs.

| <b>Description:</b><br>Berm at approximately<br>Station 17+ 45 | | | |

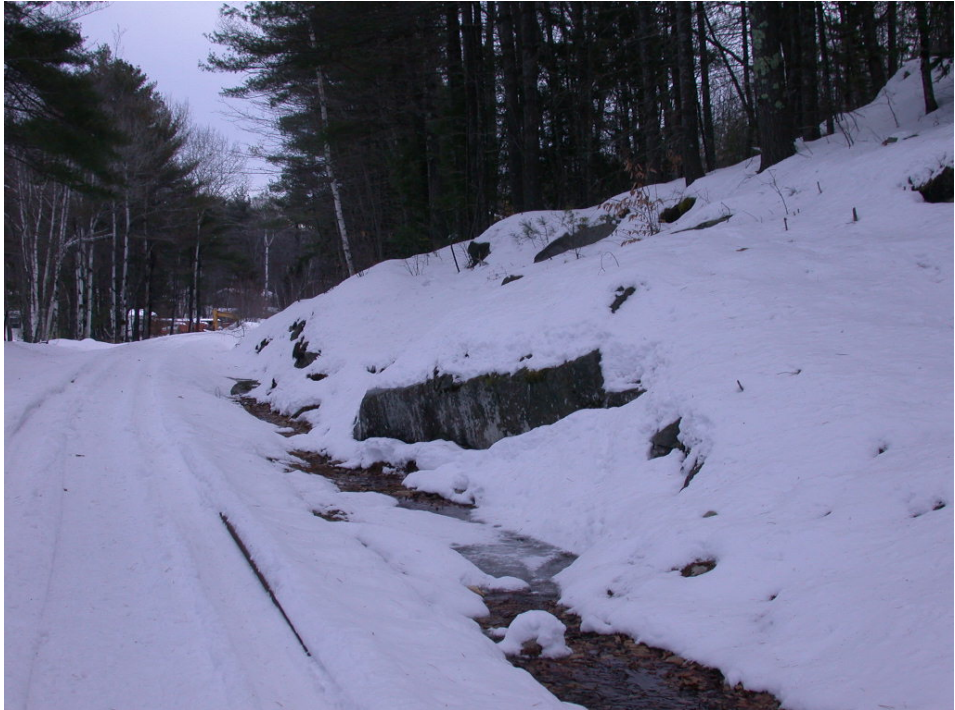
| <b>Description:</b><br>Rail road cut. Note berm in<br>upper right corner of<br>photograph | | |

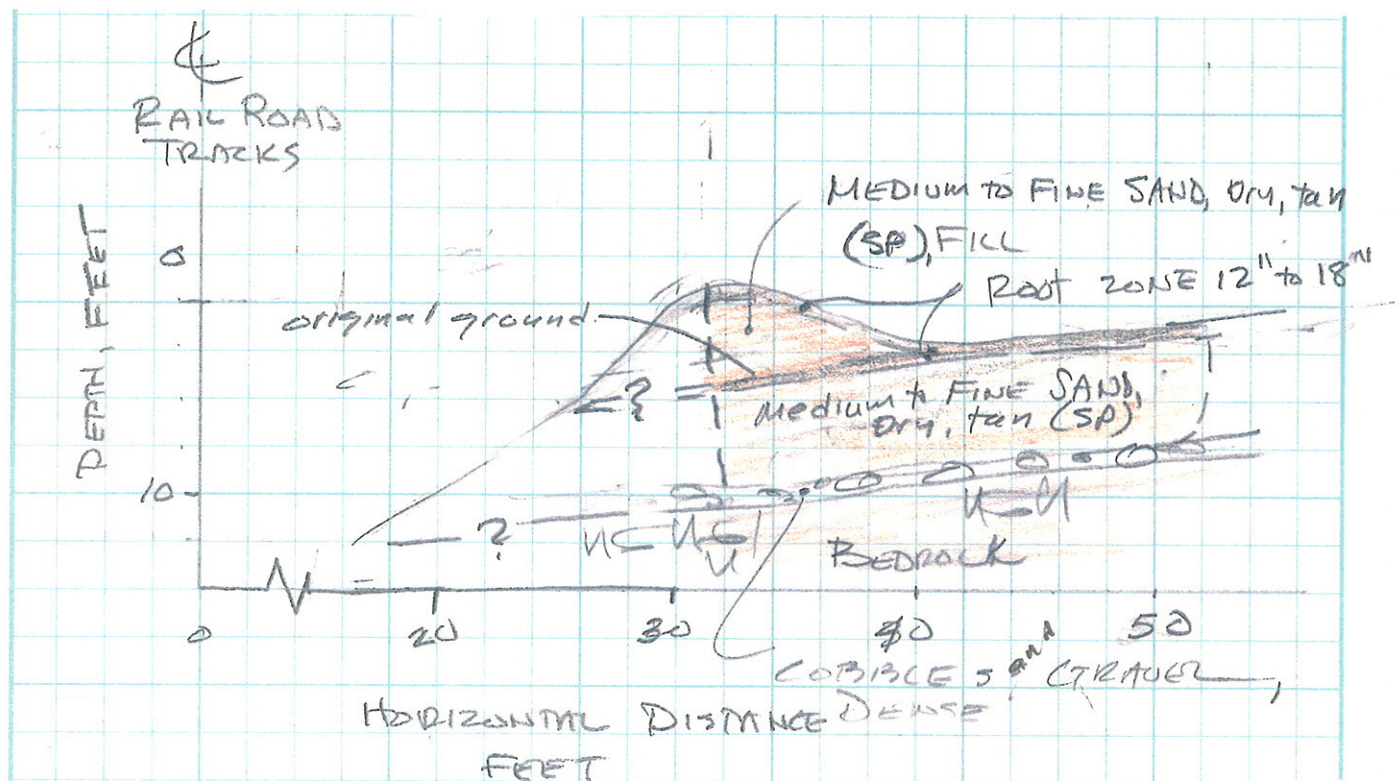
TP-4

| Location | STATION 17 + 45 Right 42 ft. (center of test pit) | | | | |
