**Pedestrian Ramp Report**  
**WIN 24471.00 – Farmingdale, Route 201**  
**February 12, 2020**

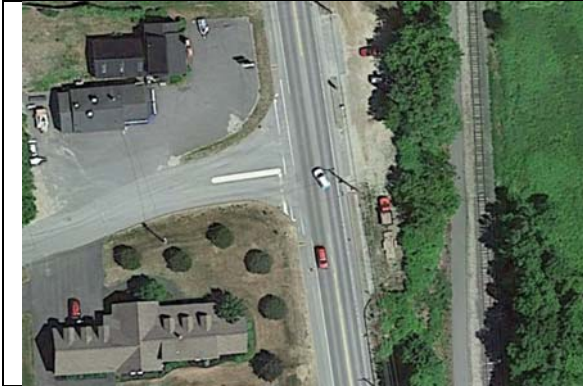
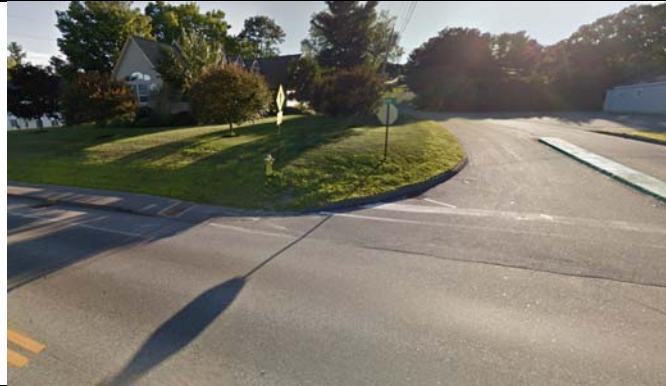
**PARK ST (81+93)**

(2 EACH in this location)

- Install the DWF and regrade ramps to ADA compliance. May include replacing bituminous curb.
