Scour Critical Bridge
Plan of Action (POA) Report

Town: Bingham
Bridge Number: 2027
Bridge Name: Austin
Feature Carried: Rt. 201
Waterway Crossed: Austin Stream

Scour Critical Bridge Plan of Action

Bridge Name: Austin	Town: Bingham	Bridge #: 2027
Feature Carried: Rt. 201	Stream: Austin St.	Review Date: 7/23/2009

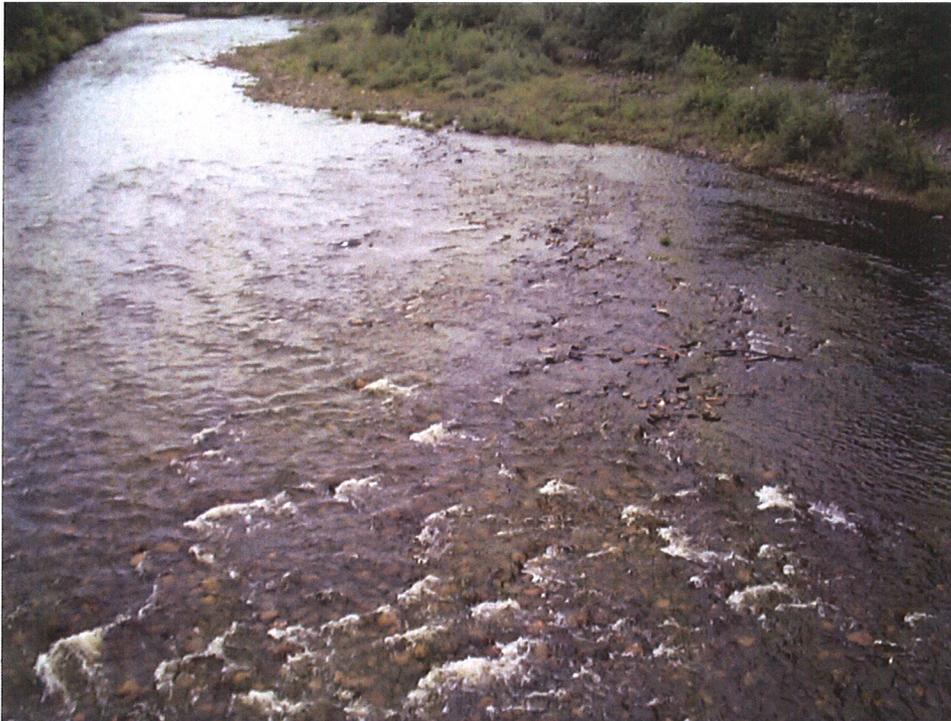
Photo 5.
U/S Left Channel
& Gravel Bar

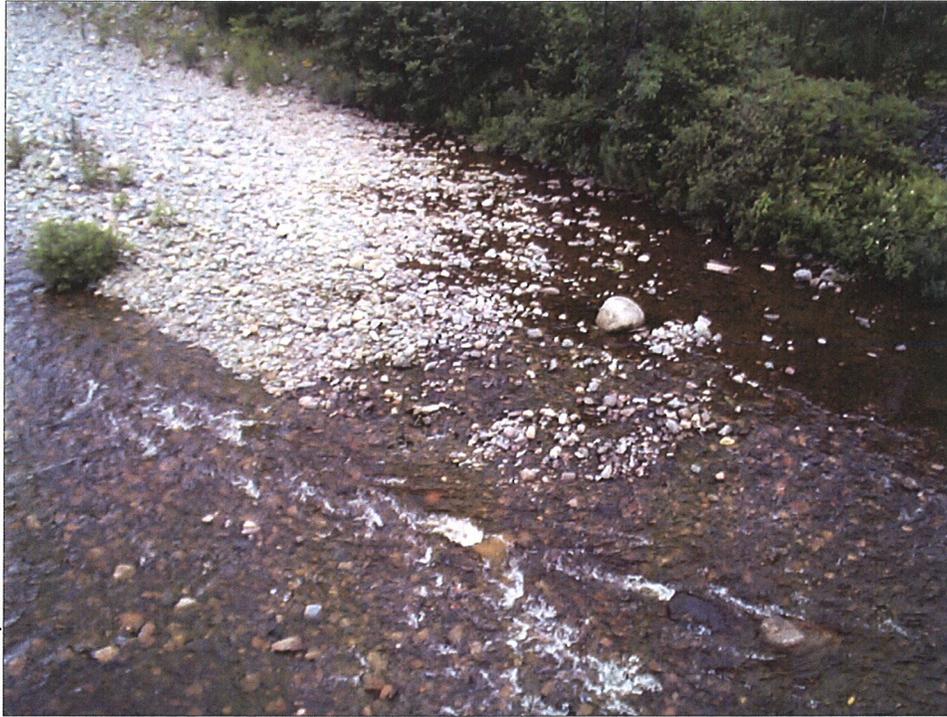
Photo 9.
D/S Right Gravel
Bar

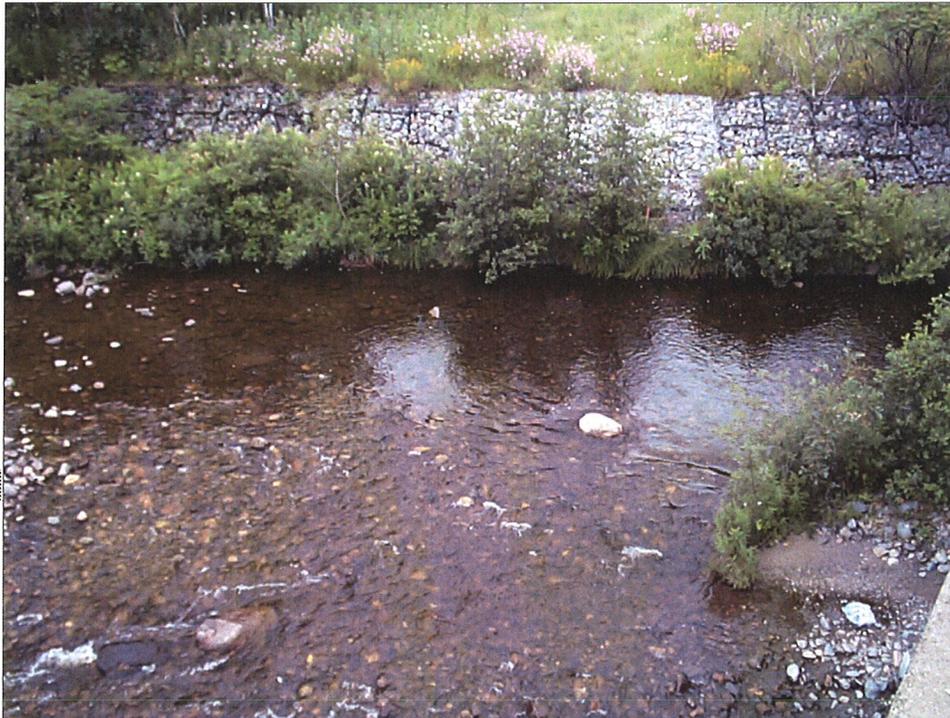
Photo 10.
D/S Right Gabion
Lined Bank

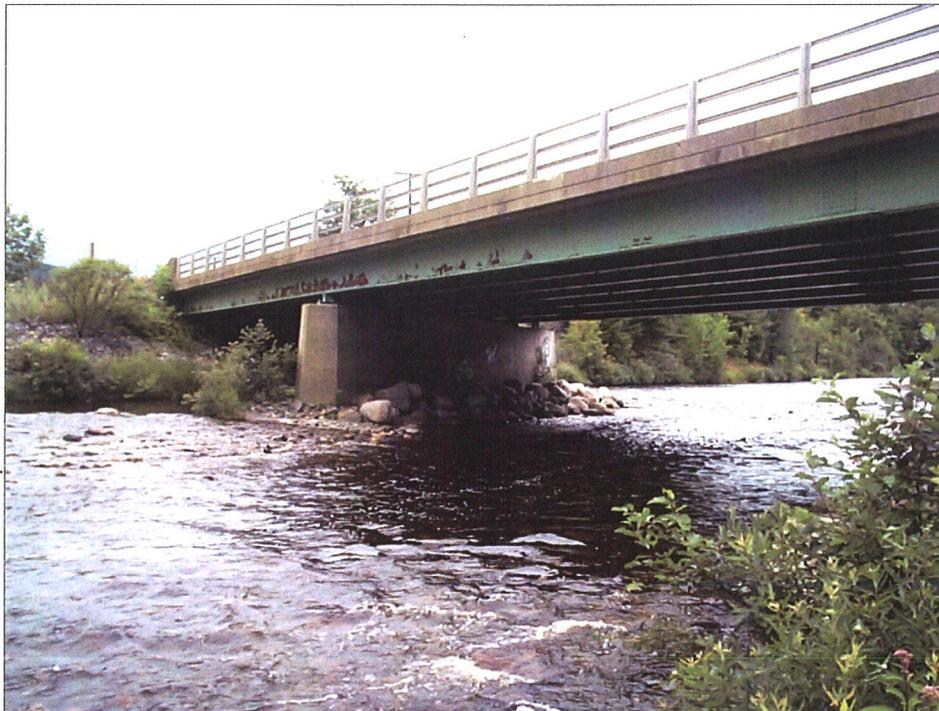
Both piers are protected by riprap that is in poor condition and which appears to have been placed in 2000 based on a review of available inspection files. The riprap revetment at the piers is not adequately designed, and there are areas of missing riprap. This riprap is assessed to be in poor condition. The extent of coverage of the riprap around the piers is also not consistent with the recommendations of HEC-23.

Photo 12.
D/S Fascia &
Riprap Along
Left Side of Right
Pier (Pier 2)

Rehabilitation of existing scour countermeasures or installation of new scour countermeasures is recommended at both abutments. Installation of properly designed pier scour countermeasures is recommended at the piers. A revetment consisting of cable concrete is recommended at the piers. It is further recommended the flood monitoring begin when a Flood Warning is Issued by the National Weather Service; scour monitoring begin at the 10-YR event (4870 cfs, WSE 354.1); and that the bridge be closed at the 50-YR event (7569 cfs, WSE 355.2).

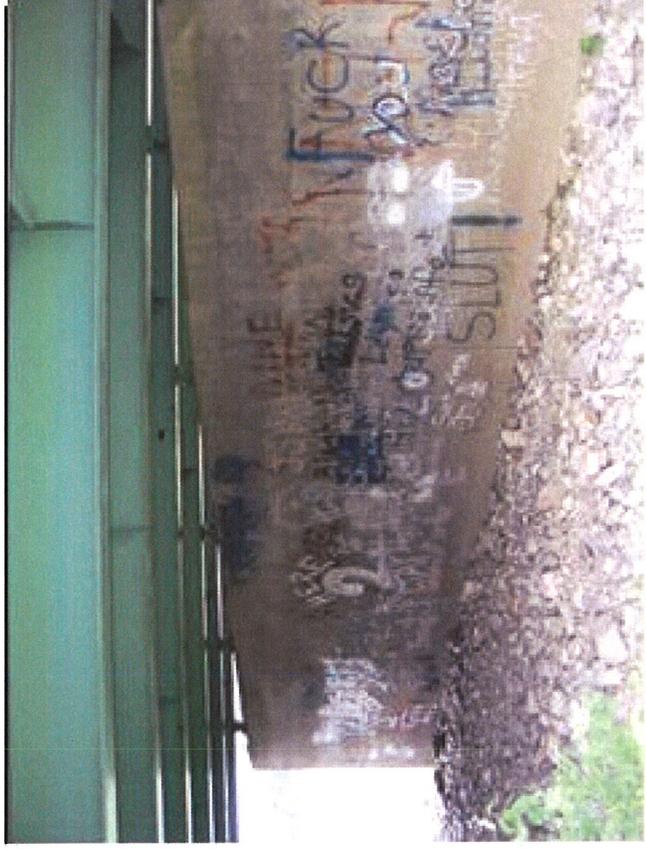
pier condition

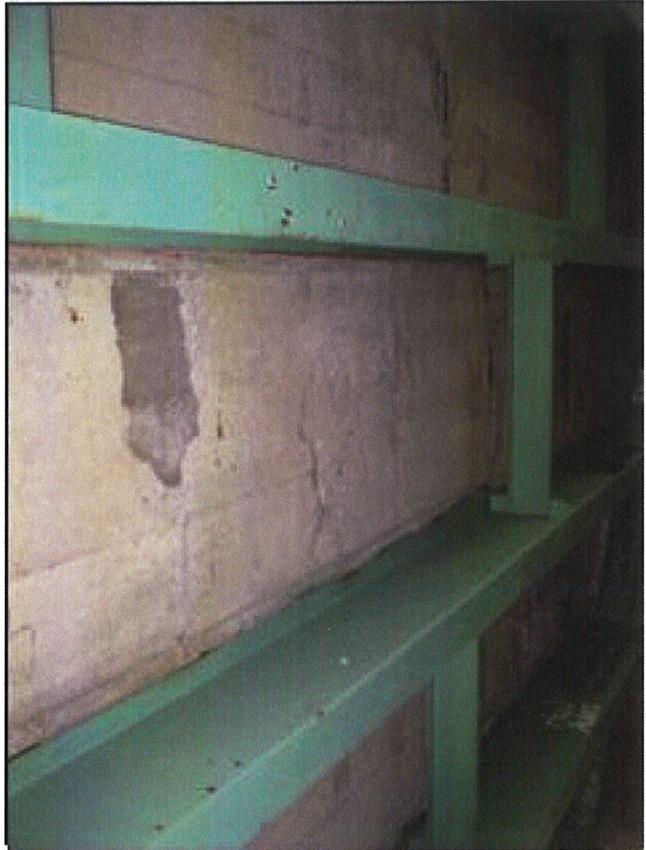
Lots of delaminating WFS

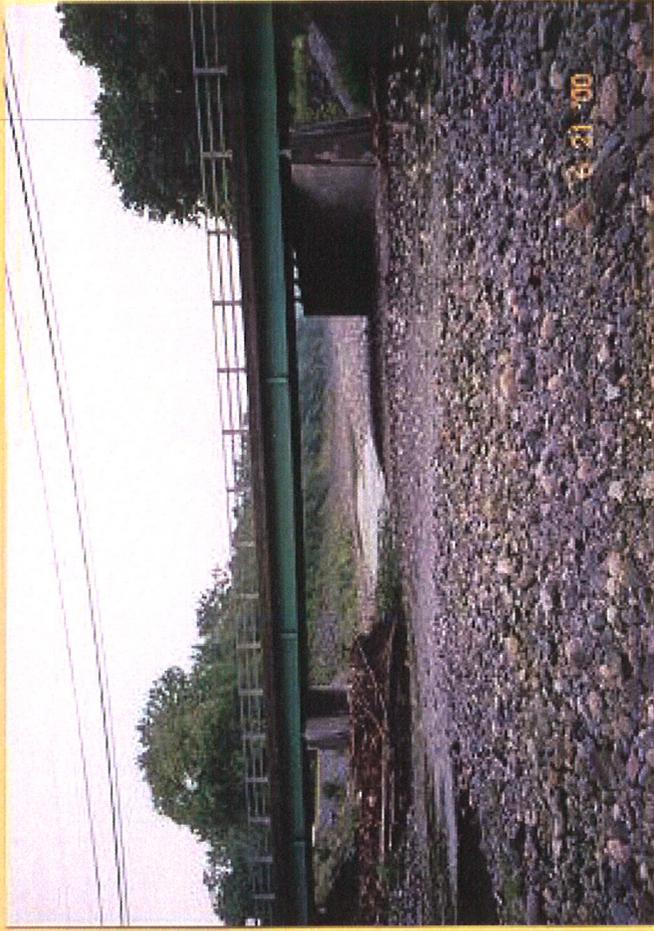
Drift accumulation @ nose of S'ly pier. Scour hole present adj. to S'ly pier.

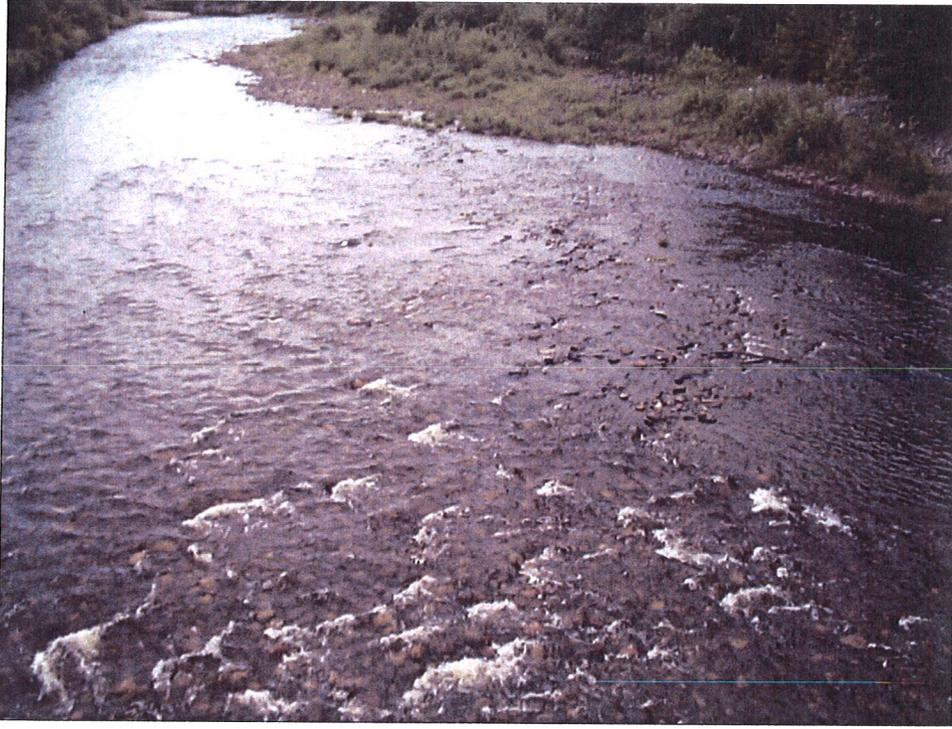
Photo 5.
U/S Left Channel
& Gravel Bar

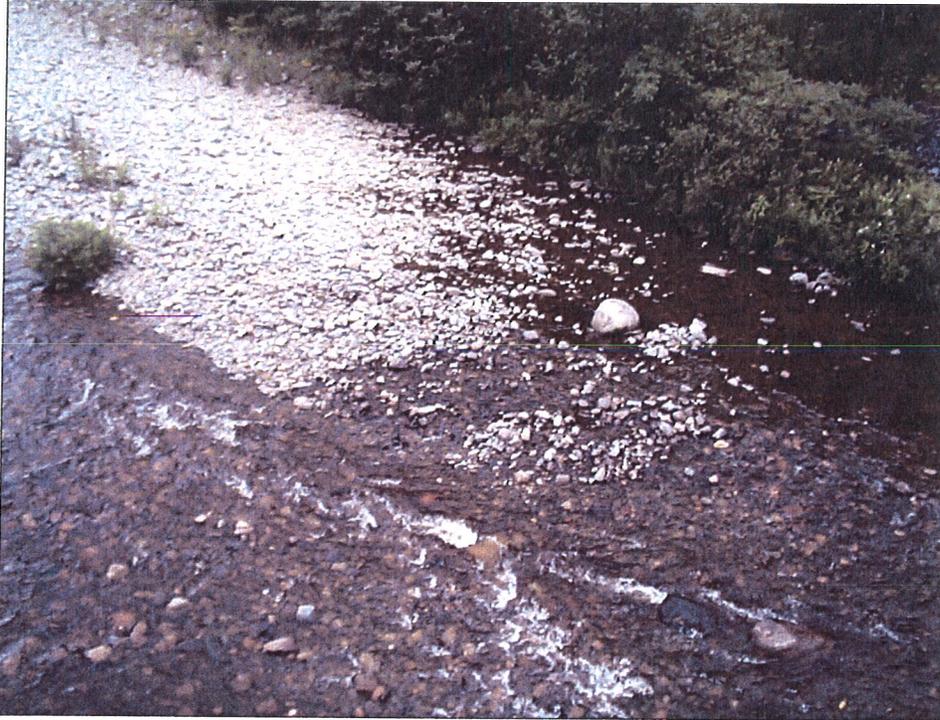
Photo 9.
D/S Right Gravel
Bar
