# **Highway Bridge Inspection Report**

**BR# 5196**

## **AUGUSTA MEMORIAL BRIDGE**

**Inspection Date:** 05/12/2021

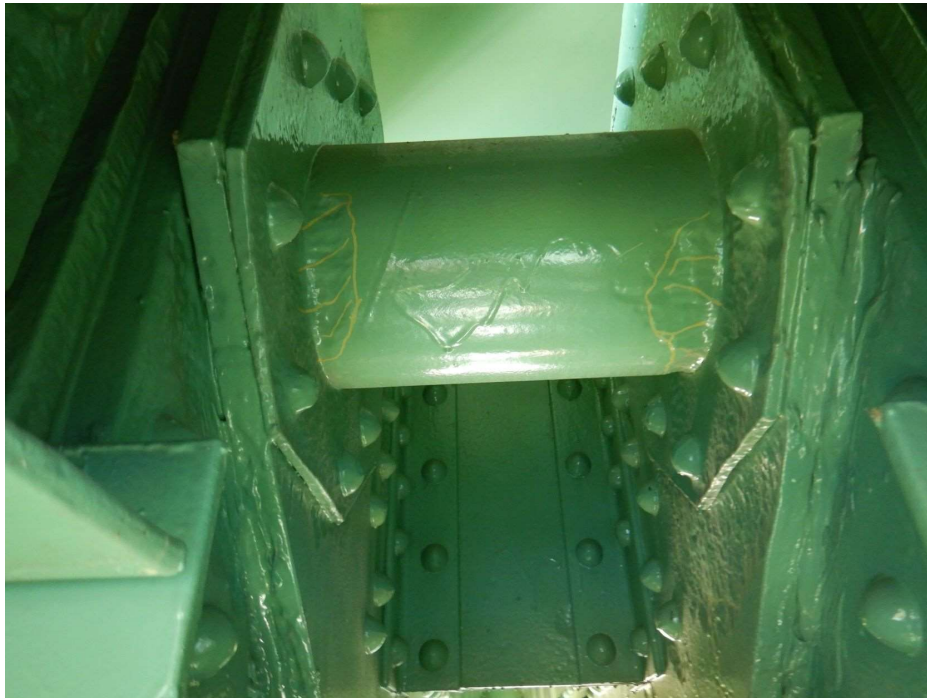
PHOTO 4

Description Bottom of Pin X3 of Span 2. Note minor pitting on the bottom of the pin at both ends and adjacent connection plates.

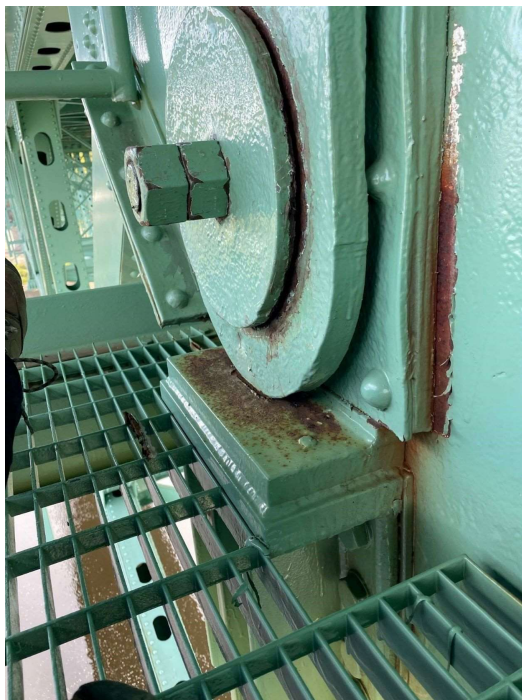
PHOTO 7

Description Upstream end on Pin mg of Span 4. Note plates have shifted approximately 9/16". The plates have also warped due to previously arrested pitting.

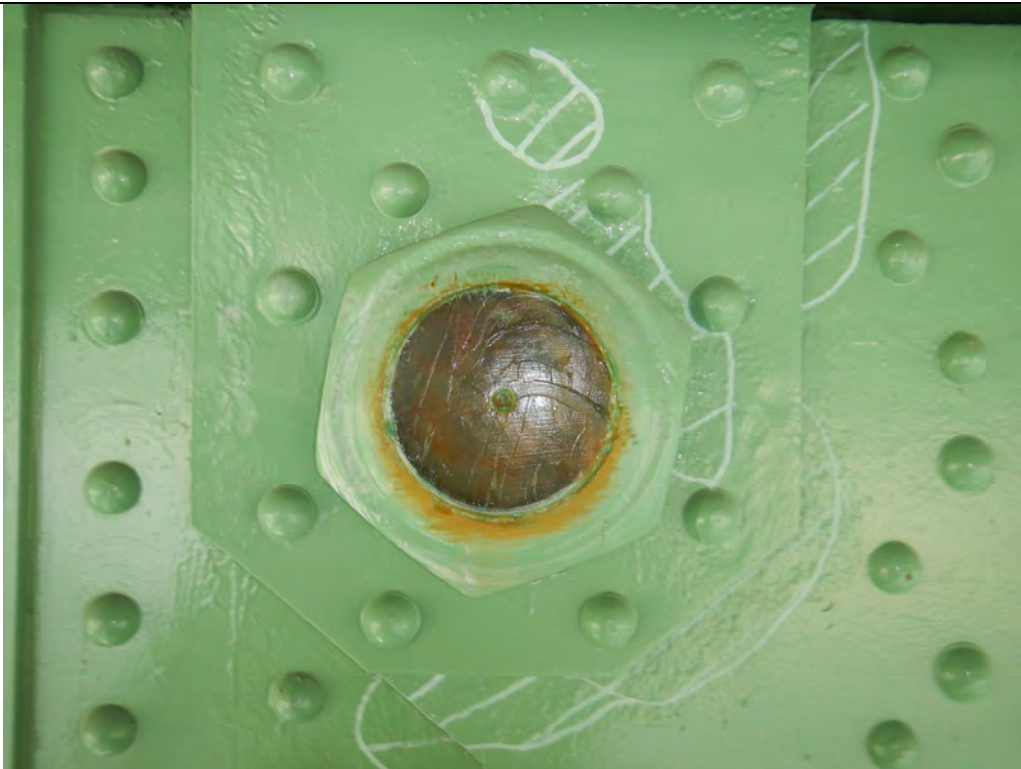
**Location:** *Span No. 4, Pin X7, Downstream*

**Description:** *Upstream end.*

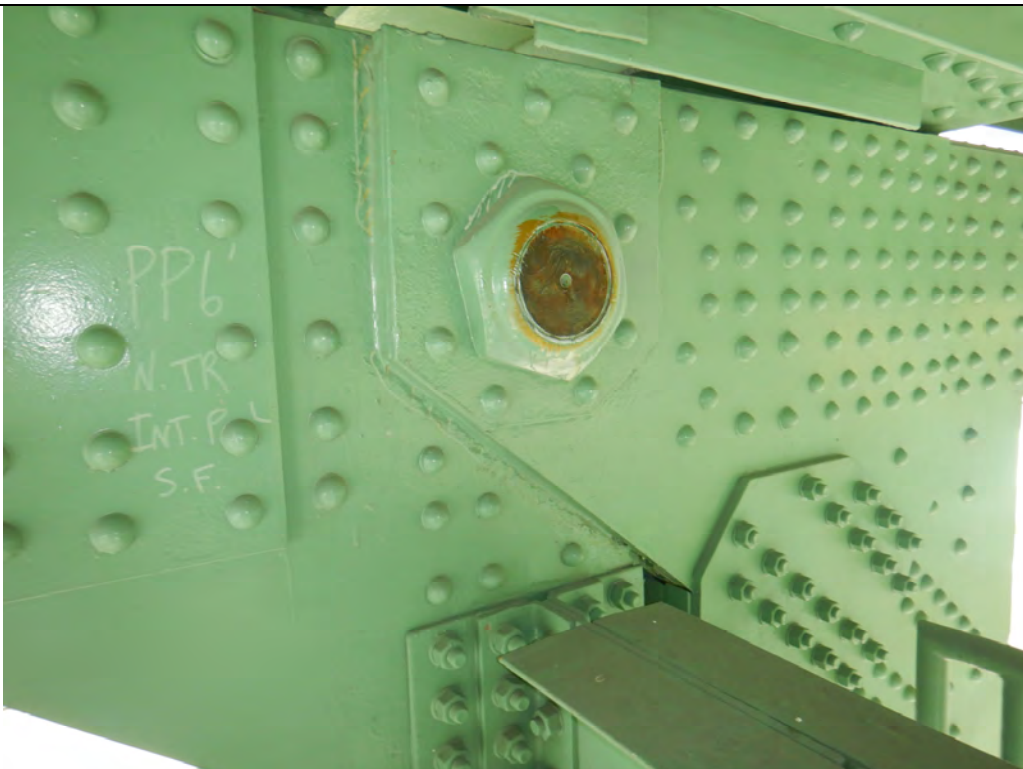
**Location:** *Span No. 6, Pin X3, Upstream*

**Description:** *Downstream end.*

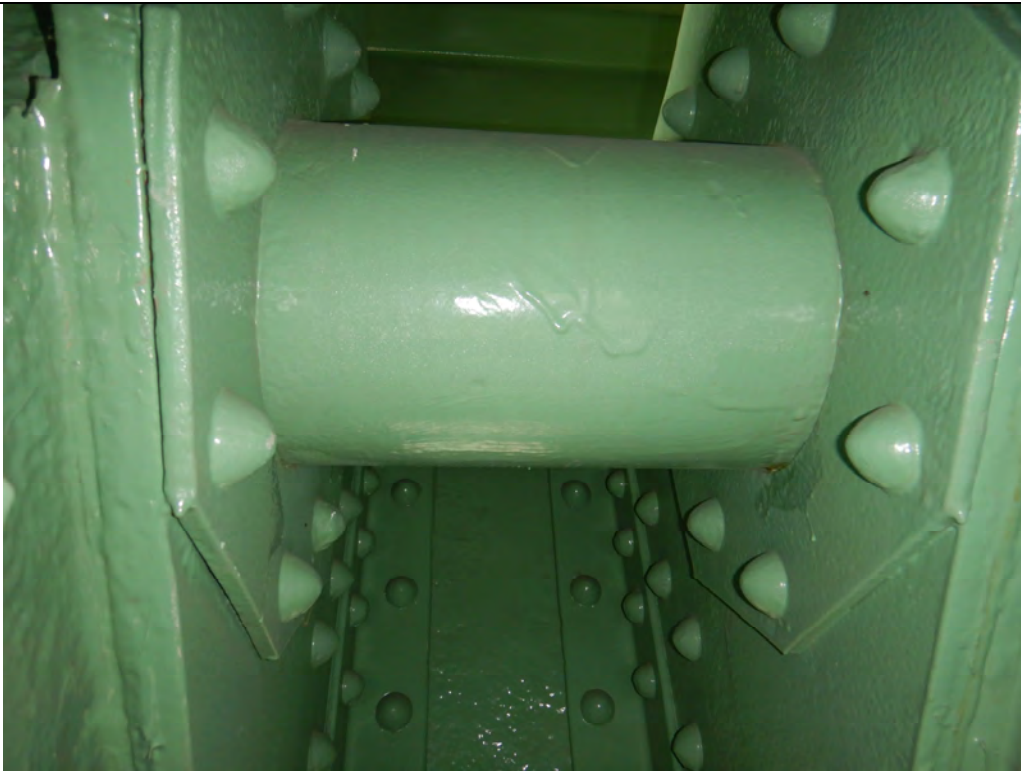
**Location:** *Span No. 6, Pin X3, Upstream*

**Description:** *Interior plates and pin.*
