Inspector: TYLIN, TYLIN
Inspection Date: 09/06/2024

Structure Number: 5784
Facility Carried: DRUMMOND RD

Highway Bridge Inspection Report

Bridge Name: DRUMMOND ROAD / I-95

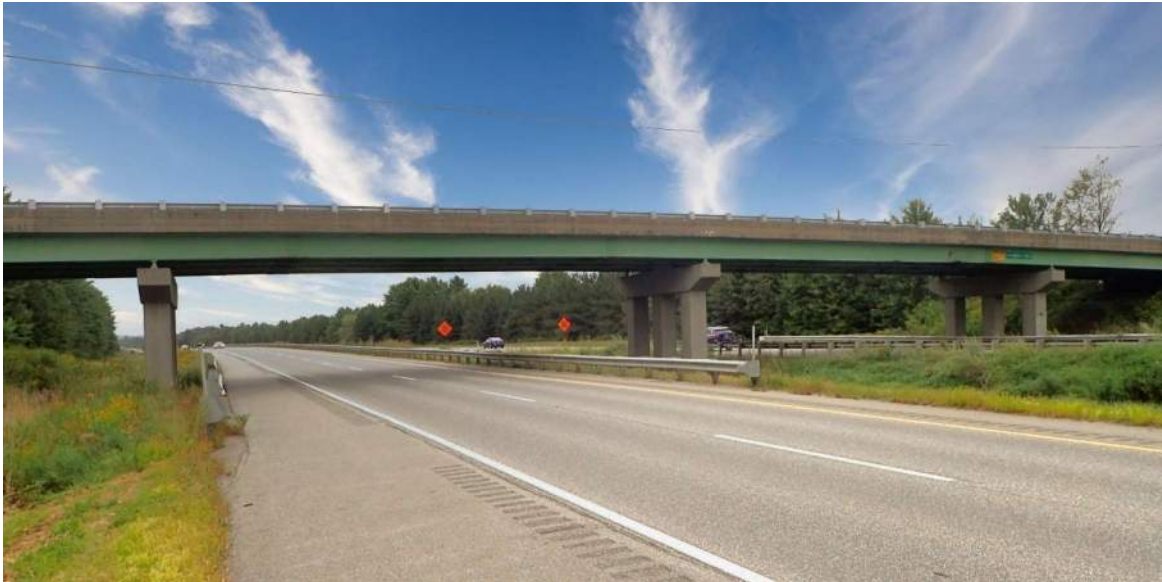
PHOTO 1 Elevation
Description South Elevation

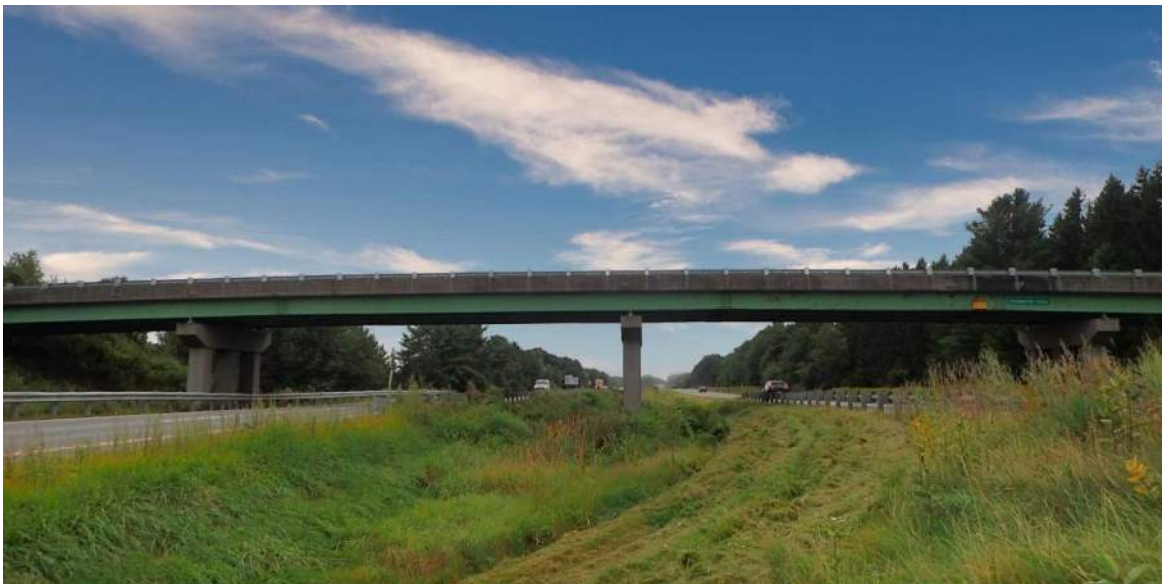
PHOTO 2 Elevation
Description North Elevation

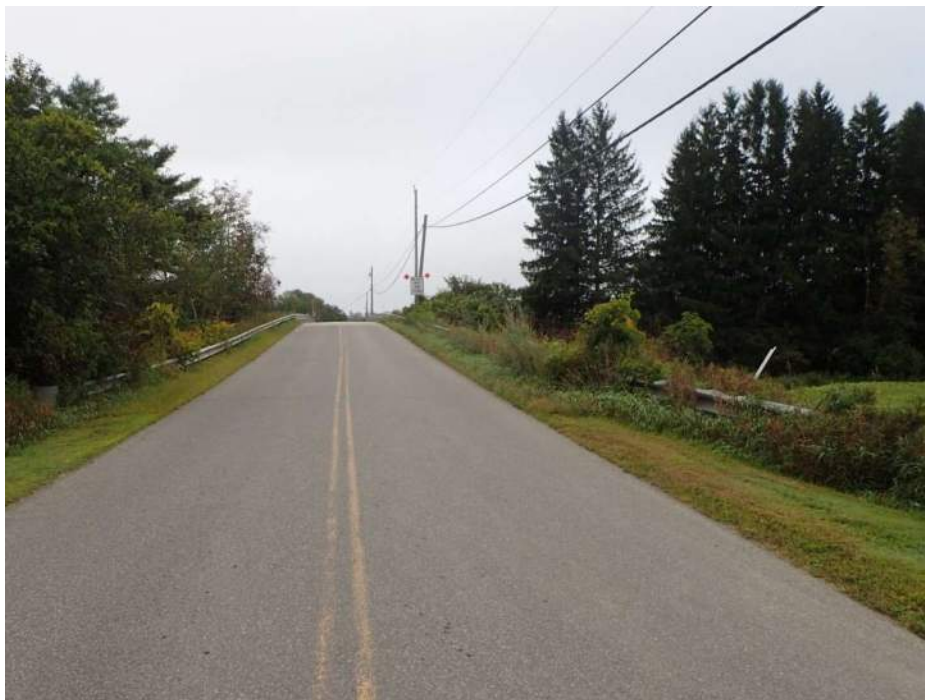
PHOTO 3 Condition
Description West Approach

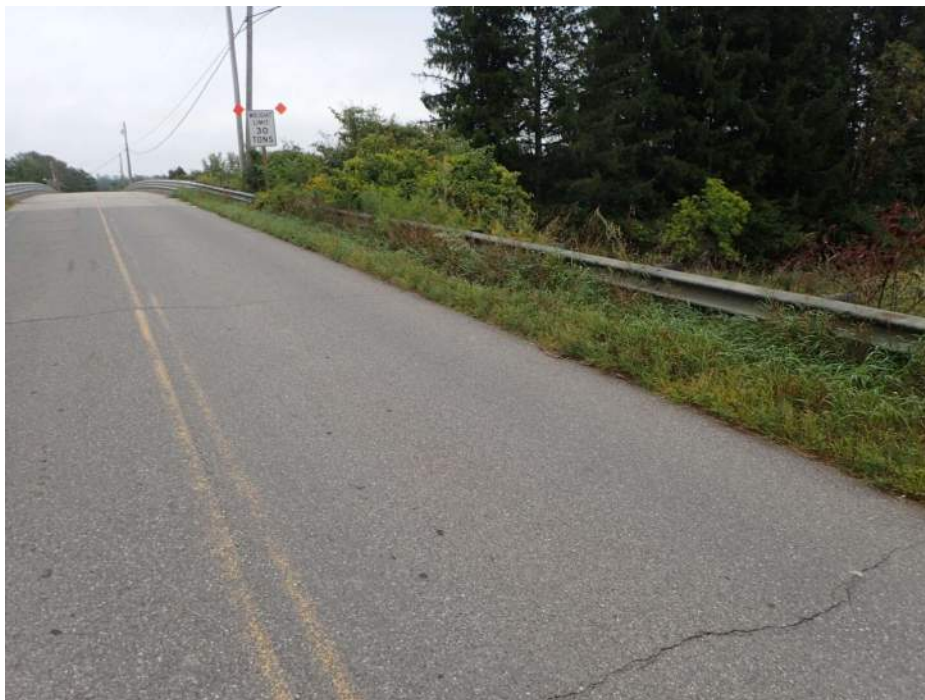
PHOTO 5 Condition

Description West Approach - South guardrail

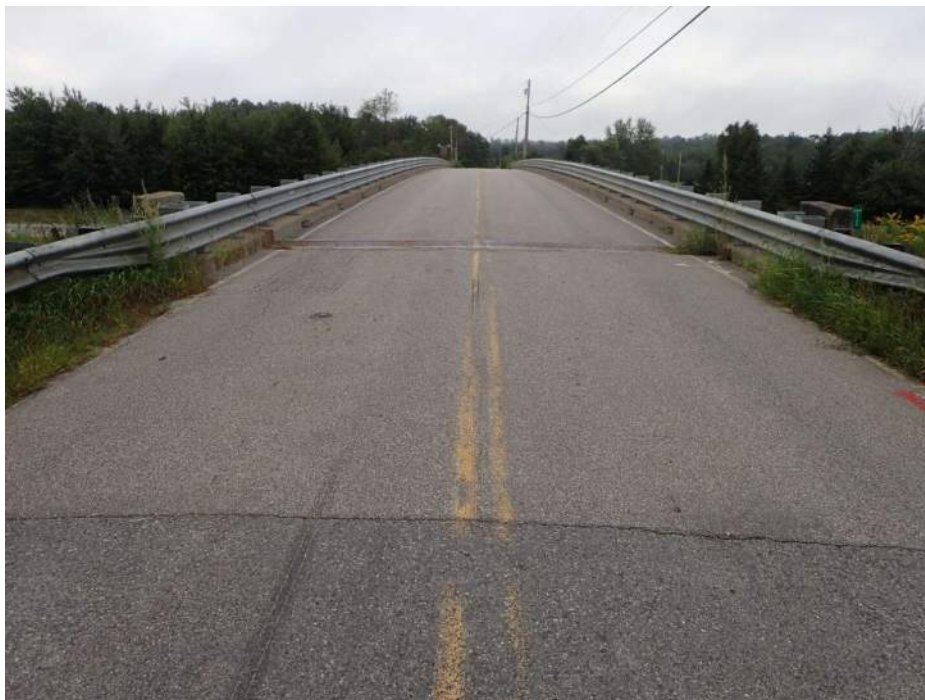
PHOTO 8 Condition

Description West Approach

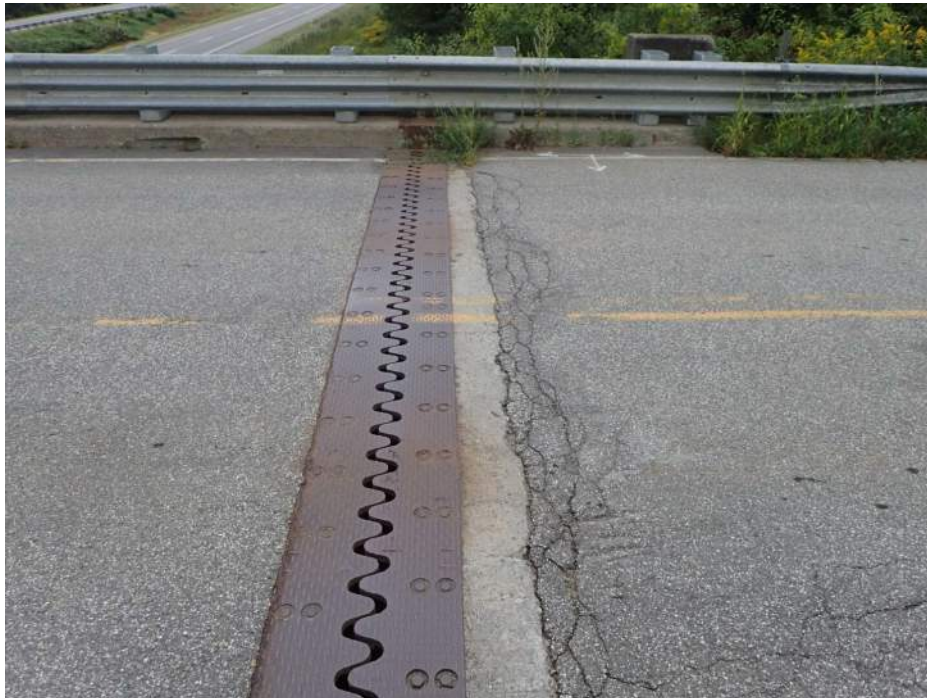
PHOTO 12 Condition

Description Finger Joint over Abutment 1 - Looking South

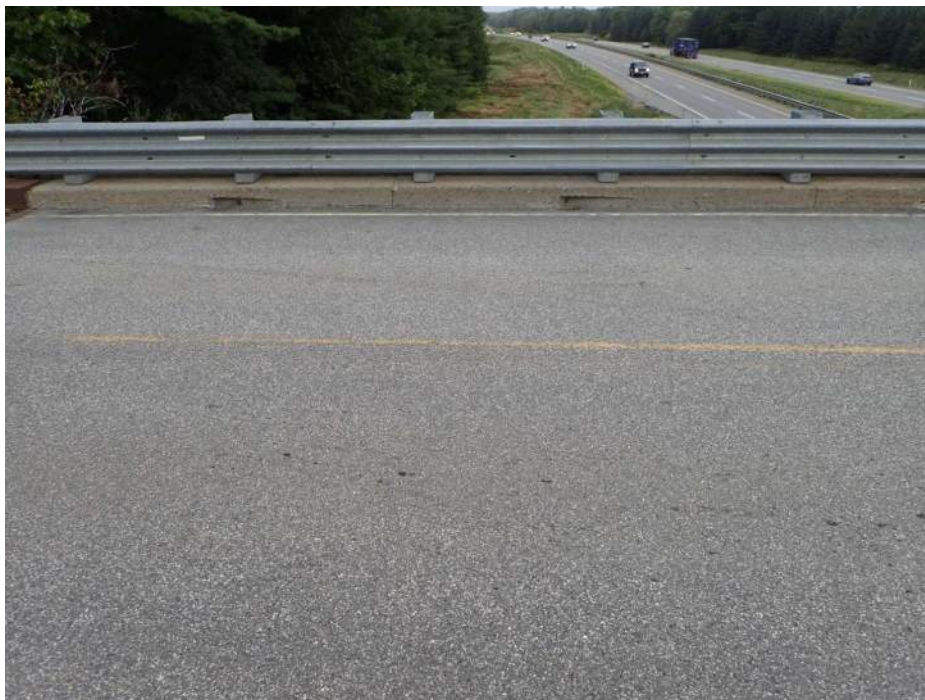
PHOTO 14 Condition

Description Bridge Deck & North Railing - West to East photo 1 of 4

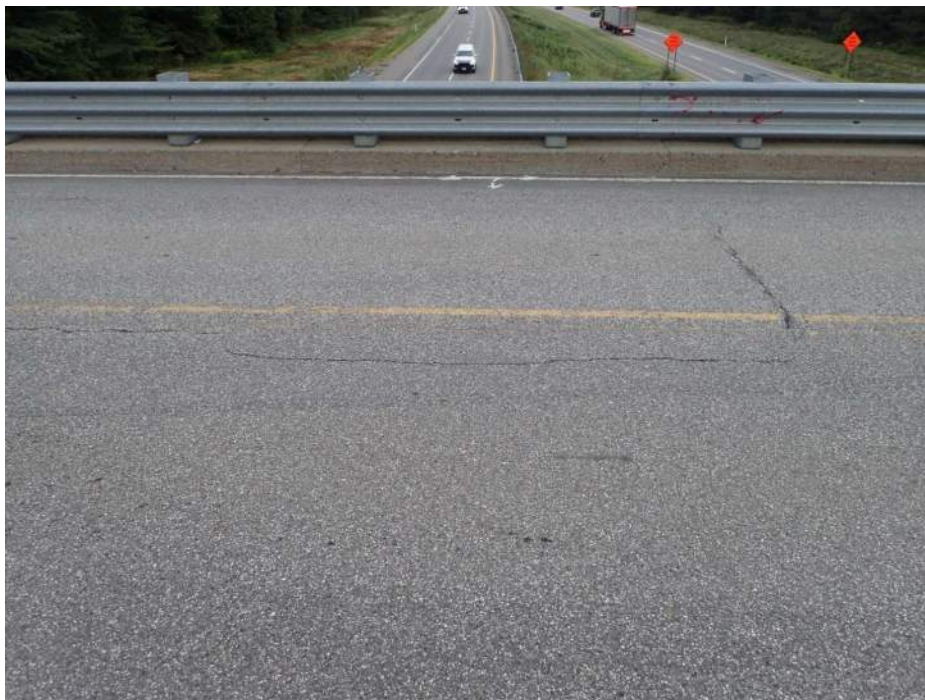
PHOTO 15 Condition

Description Bridge Deck & North Railing - West to East photo 2 of 4

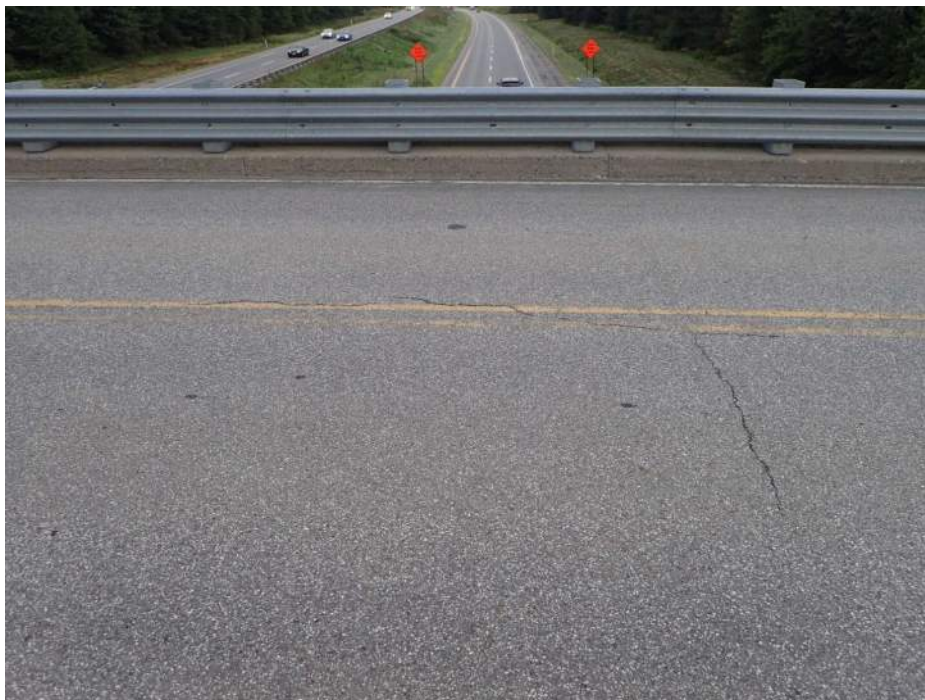
PHOTO 16 Condition

Description Bridge North Deck & Railing - West to East photo 3 of 4

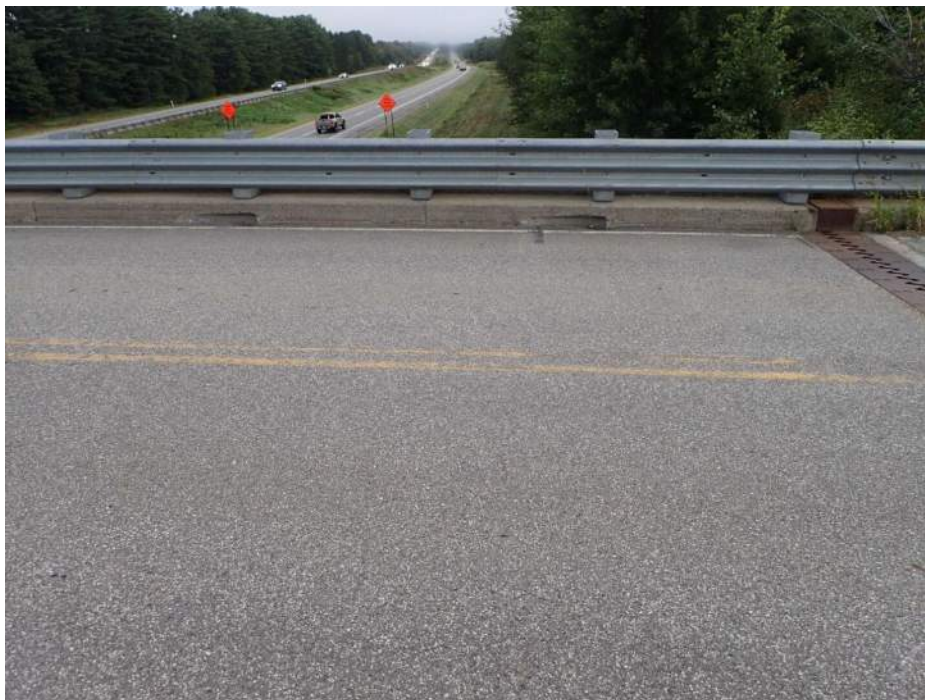
PHOTO 17 Condition

Description Bridge Deck & North Railing - West to East photo 4 of 4

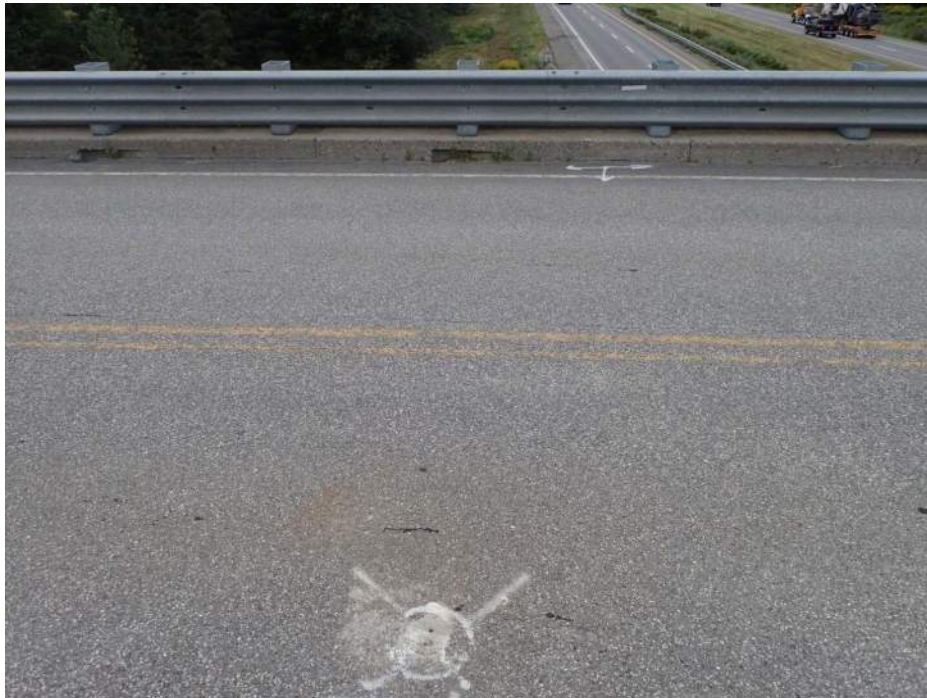
PHOTO 22 Condition

Description Bridge Deck & South Railing - East to West photo 1 of 4

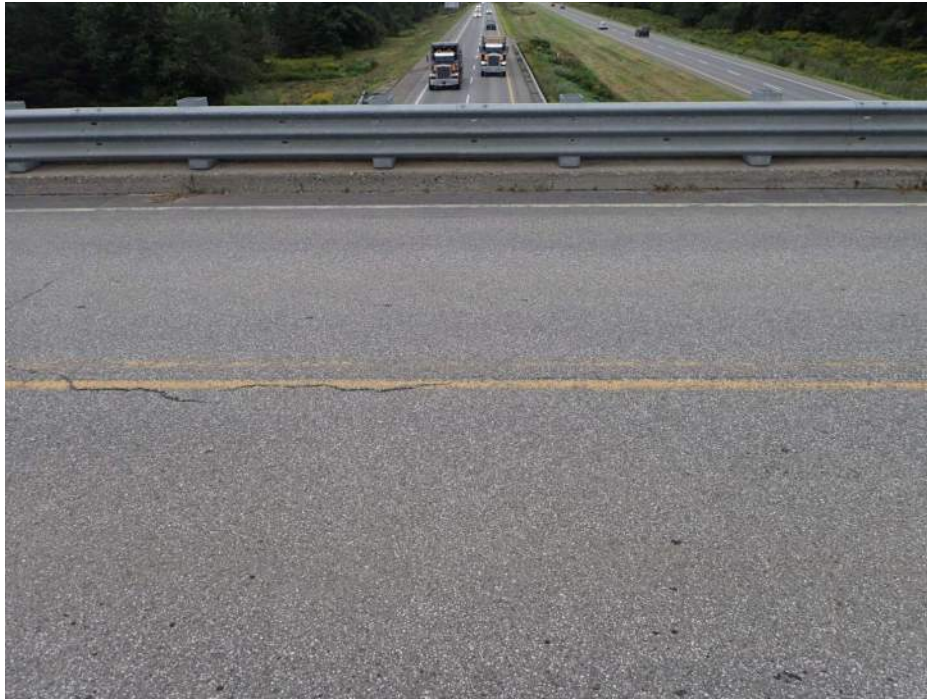
PHOTO 23 Condition

Description Bridge Deck & South Railing - East to West photo 2 of 4

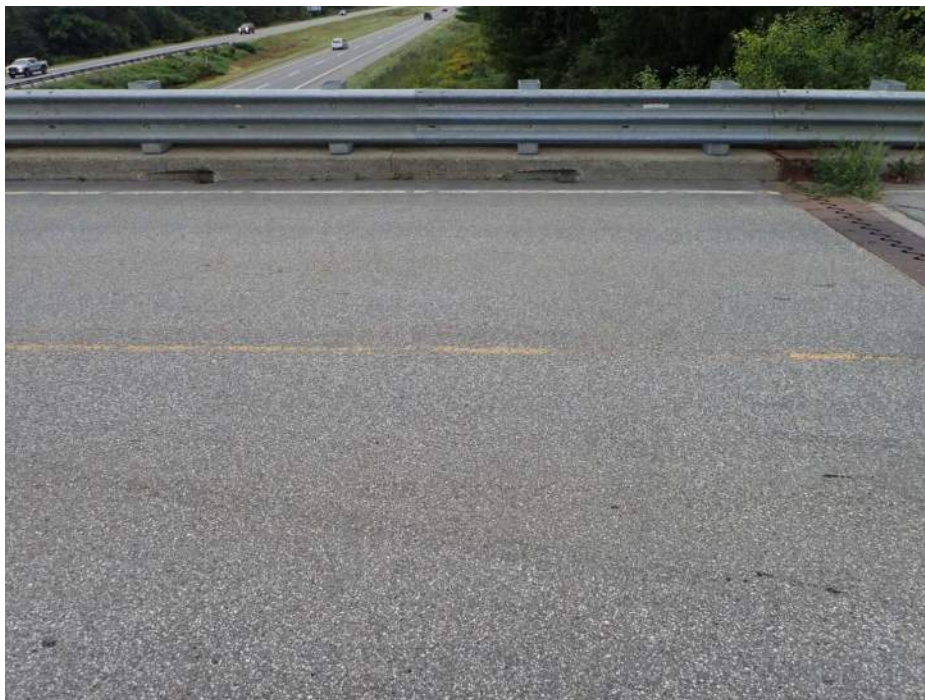
PHOTO 25 Condition

Description Bridge Deck & South Railing - East to West photo 4 of 4

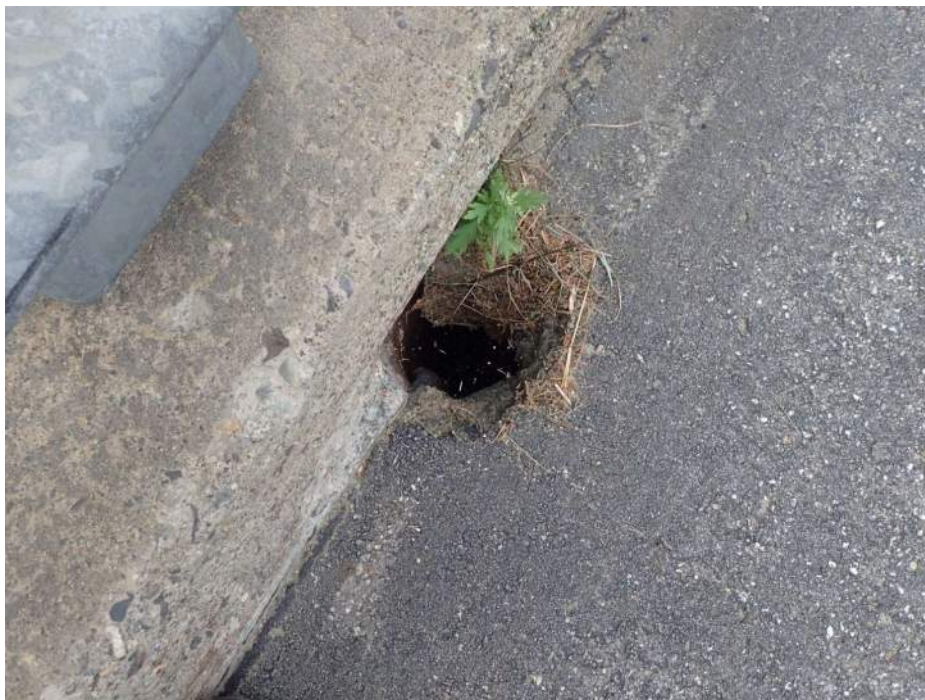
PHOTO 26 Condition

Description Typical Bridge Drain

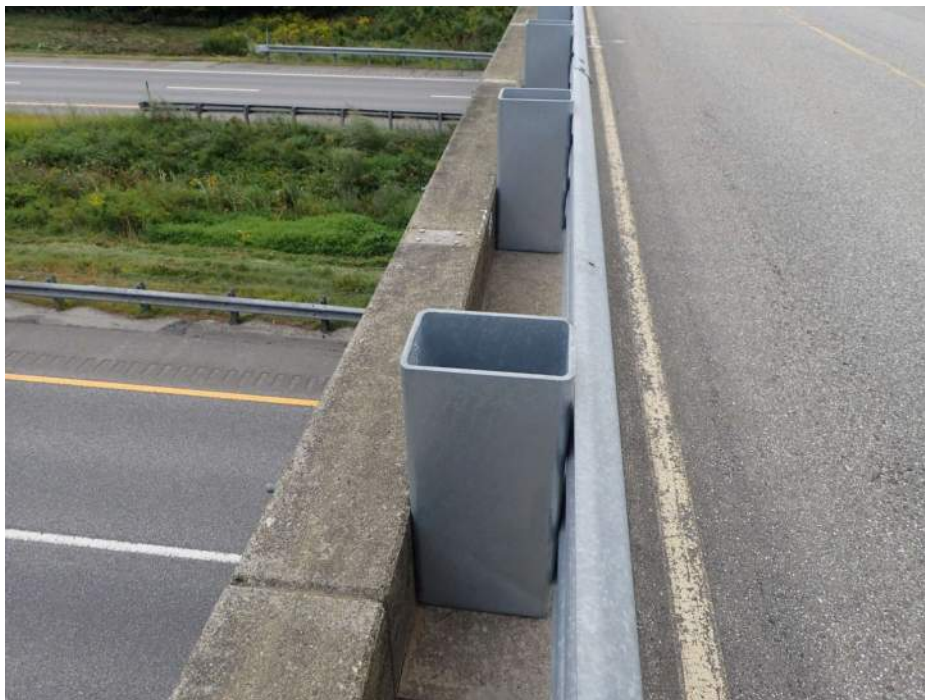
PHOTO 27 Condition

Description Typical retrofitted bridge post

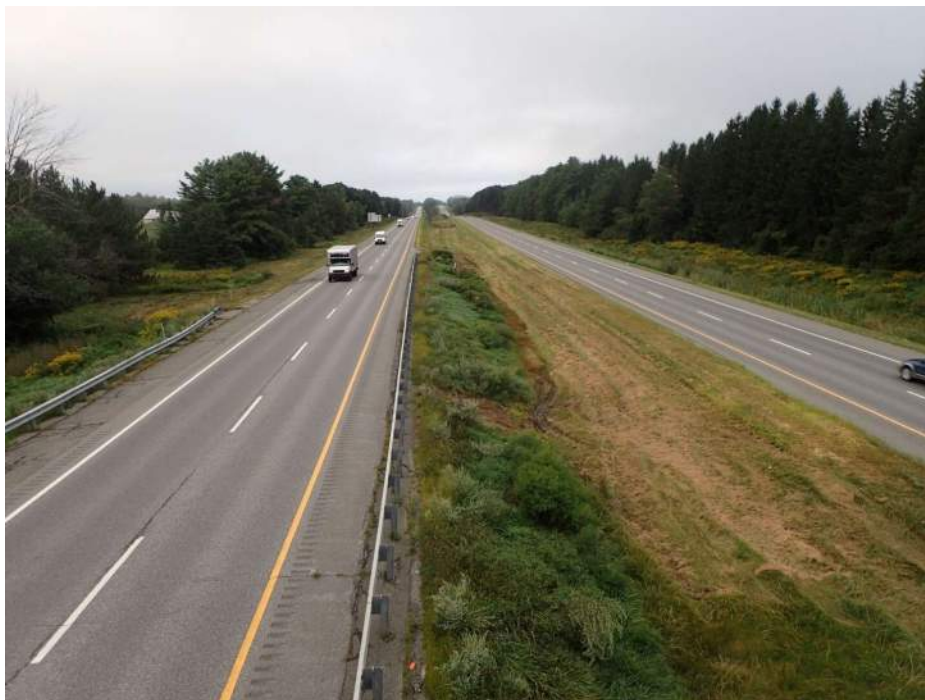
PHOTO 29 Condition

Description Interstate 95 running under bridge - South view

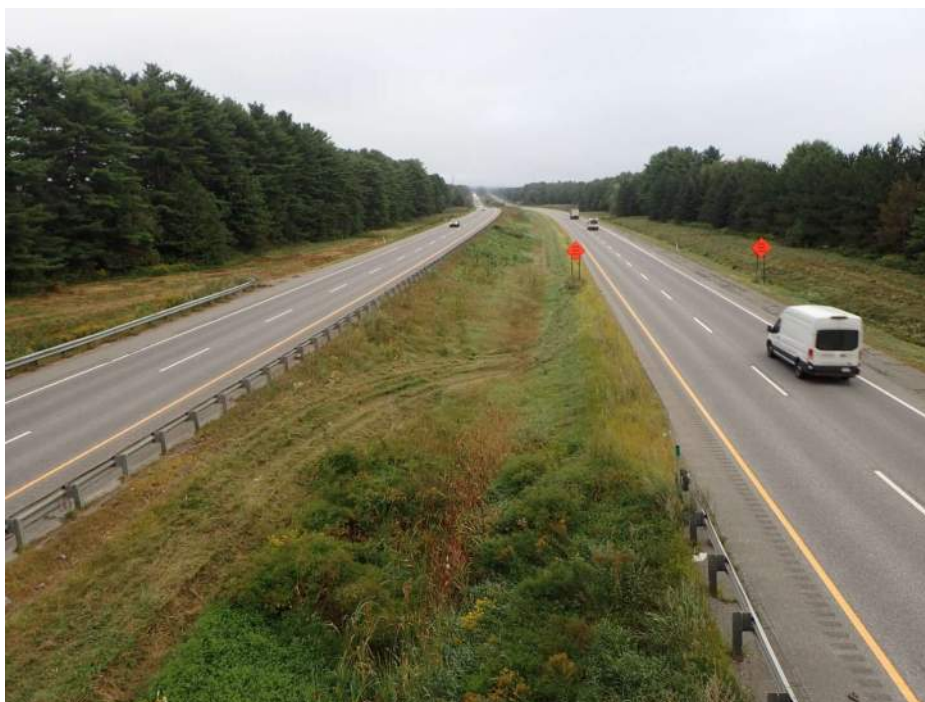
PHOTO 30 Condition

Description Interstate 95 running under bridge - North view

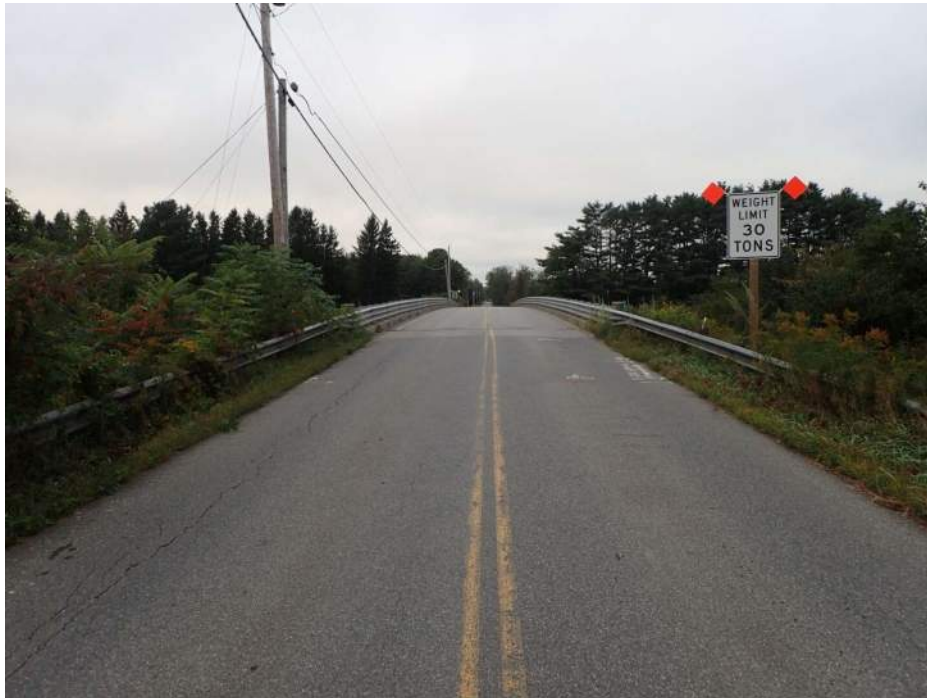
PHOTO 32 Condition

Description East Approach - Longitudinal wide cracking & settling in outer wheel path of Eastbound lane, full length of approach roadway. Photo 1 of 3

Description East Approach - Photo 2 of 3

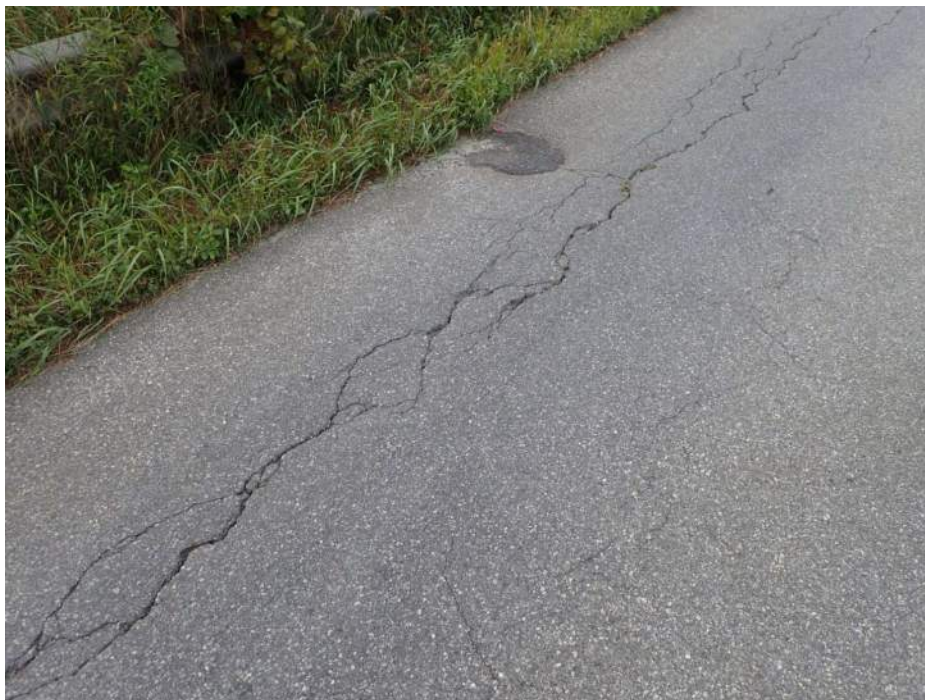
PHOTO 33 Condition

Description East Approach - Photo 3 of 3

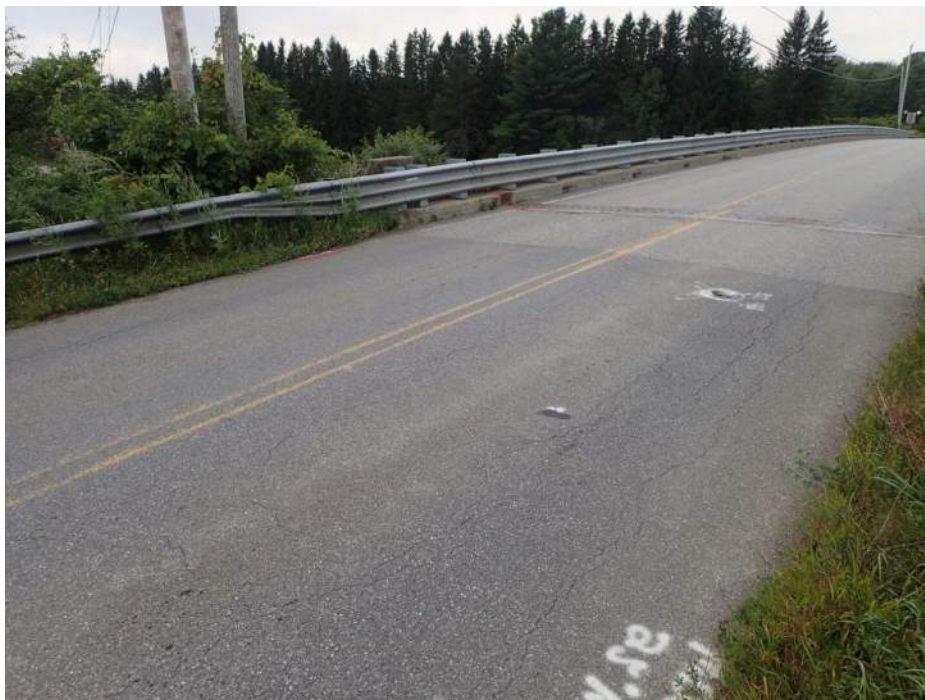
PHOTO 34 Condition

Description East Approach - South guardrail transition

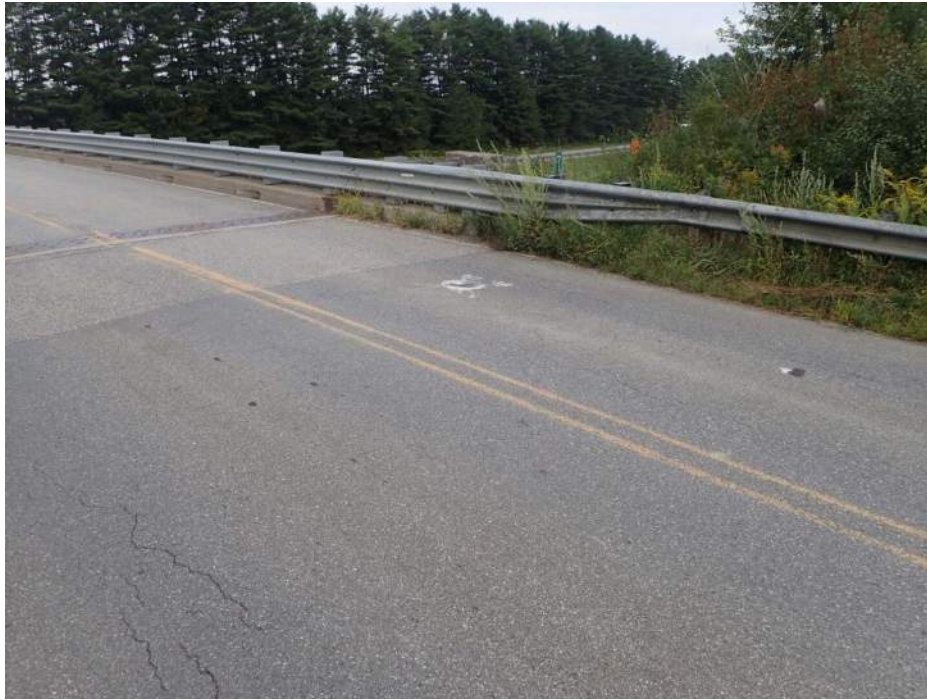
PHOTO 35 Condition

Description East Approach - North guardrail transition

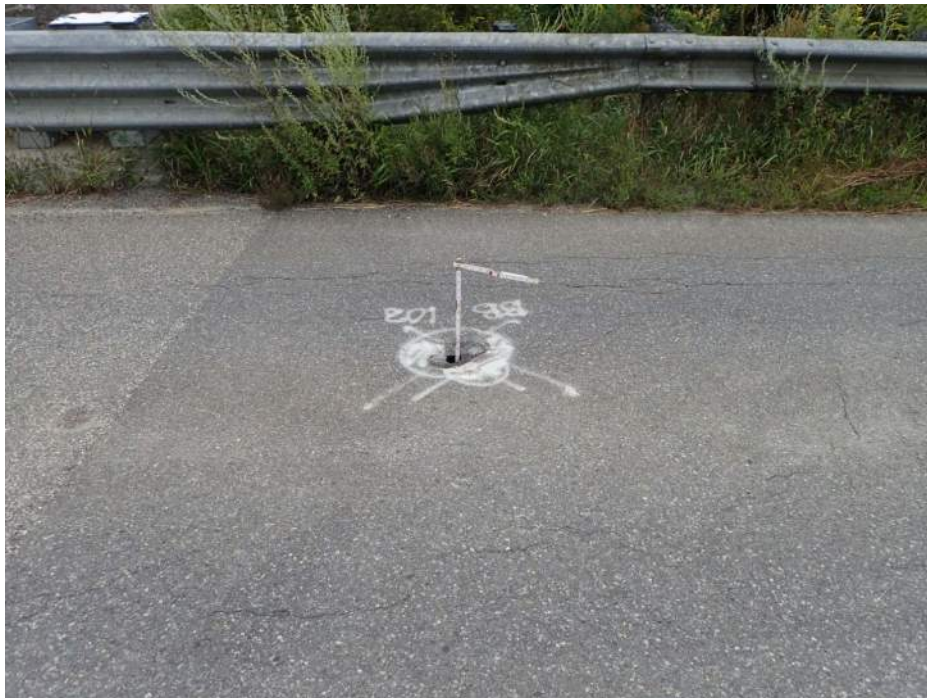
PHOTO 36 Condition

There is an area of heavy map cracking along the joint header for the full length along with a deep spall. In the north travel lane, there is a pothole in the approach measuring 4" Dia. at the surface and extending up to 6" Dia. inside and 1'-3" deep. There is moderate settlement with wide longitudinal cracking in the eastbound lane and minor settlement with minor longitudinal cracking in the westbound lane.

Description East Approach - Westbound lane at North guardrail transition, boring washing out. Opening 4" dia. through pavement, hole is large under pavement, approximately 6" in diameter inside and 1'- 3" deep. Photo 1 of 2

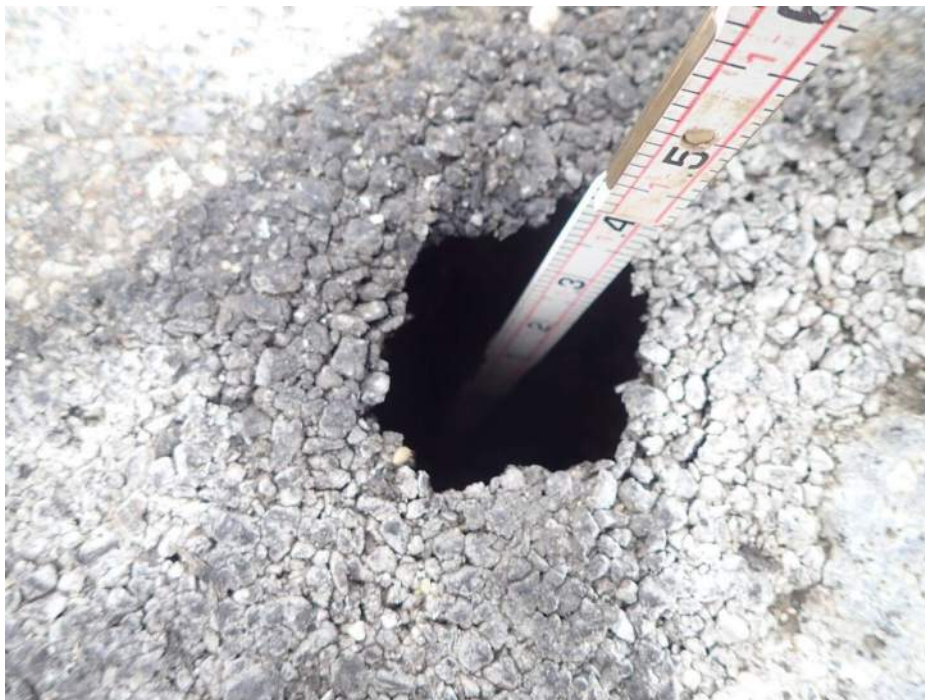
PHOTO 37 Condition

Description East Approach - Photo 2 of 2

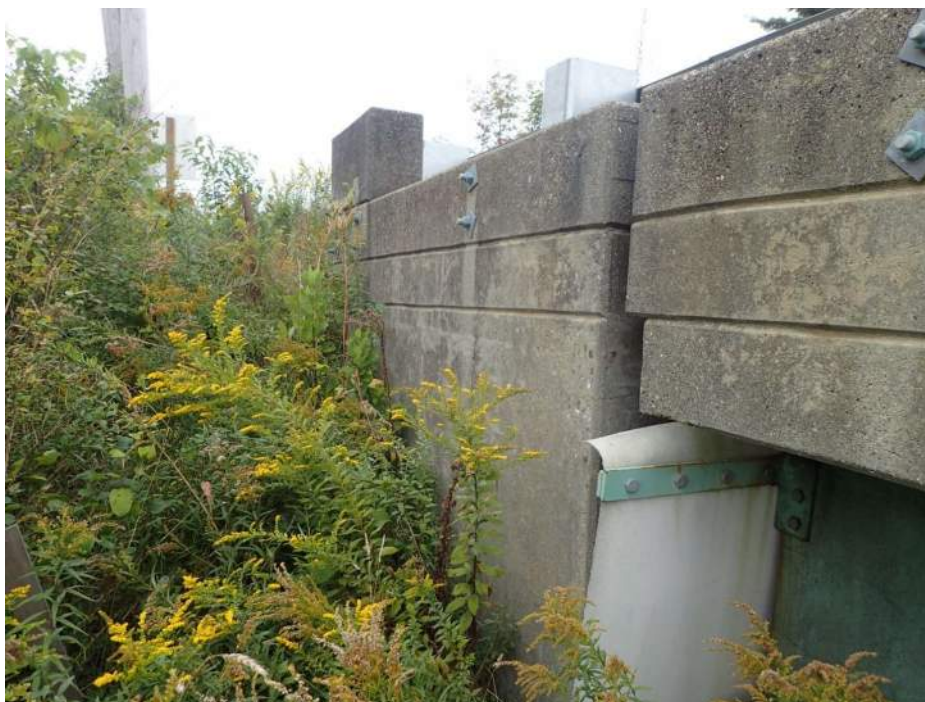
PHOTO 40 Condition

Description Abutment 1 South return wall

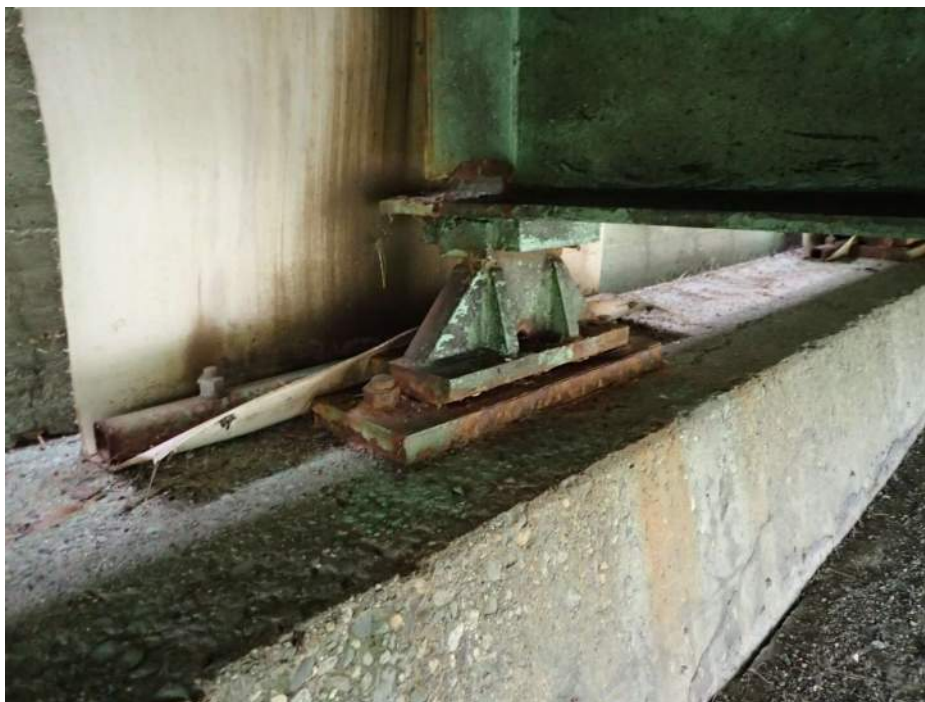
PHOTO 42 Condition

Description Abutment 1 - Gdr 3 rocker bearing

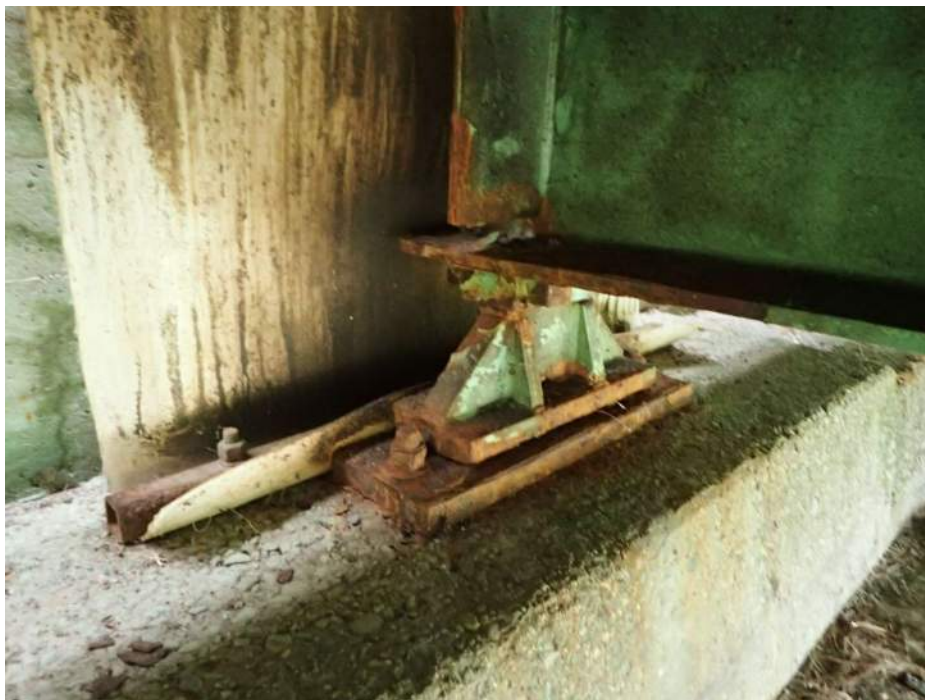
PHOTO 45 Condition

Description Abutment 1 - Gdr 2 rocker bearing

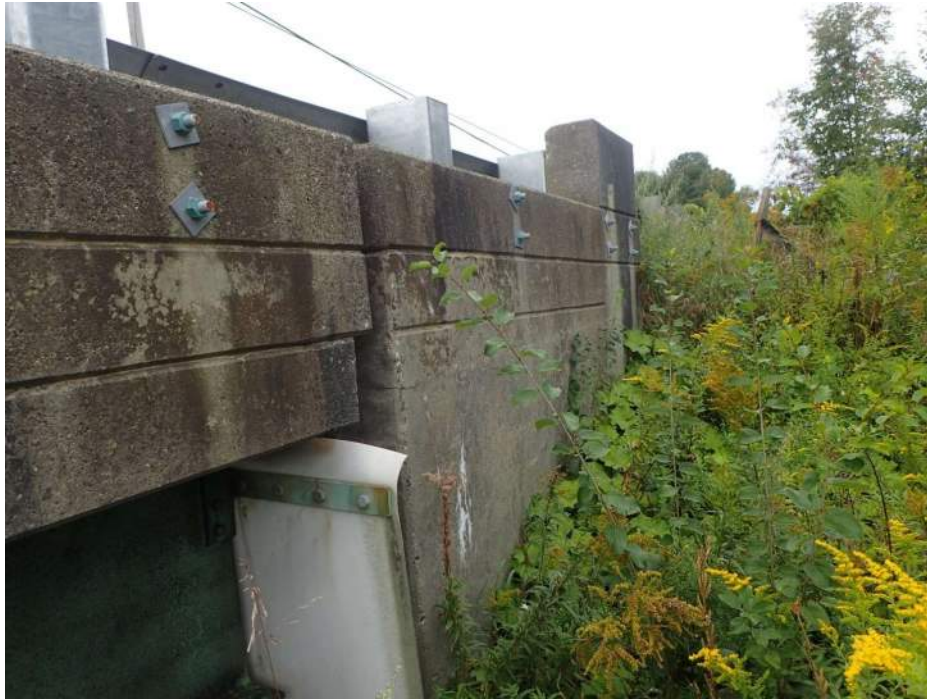
PHOTO 47 Condition

Description Abutment 1 North return wall

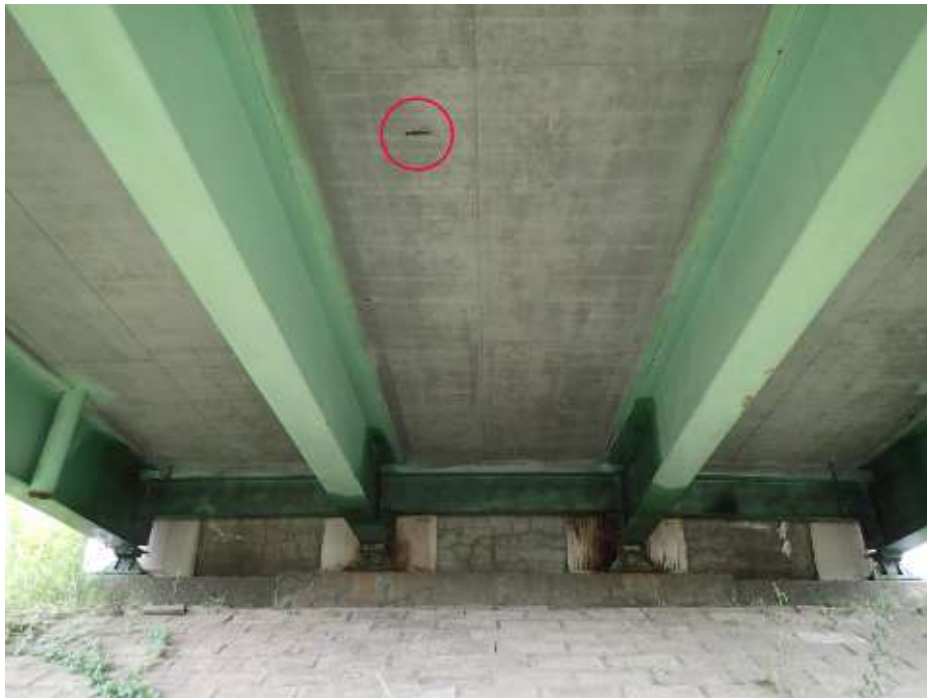
PHOTO 48 Condition

The underside of the deck exhibits scattered small to large shallow spalling with exposed rebar in all spans.

Description Span 1 - Underside of deck & steel framing, looking towards Abutment 1, small spall with ECSR

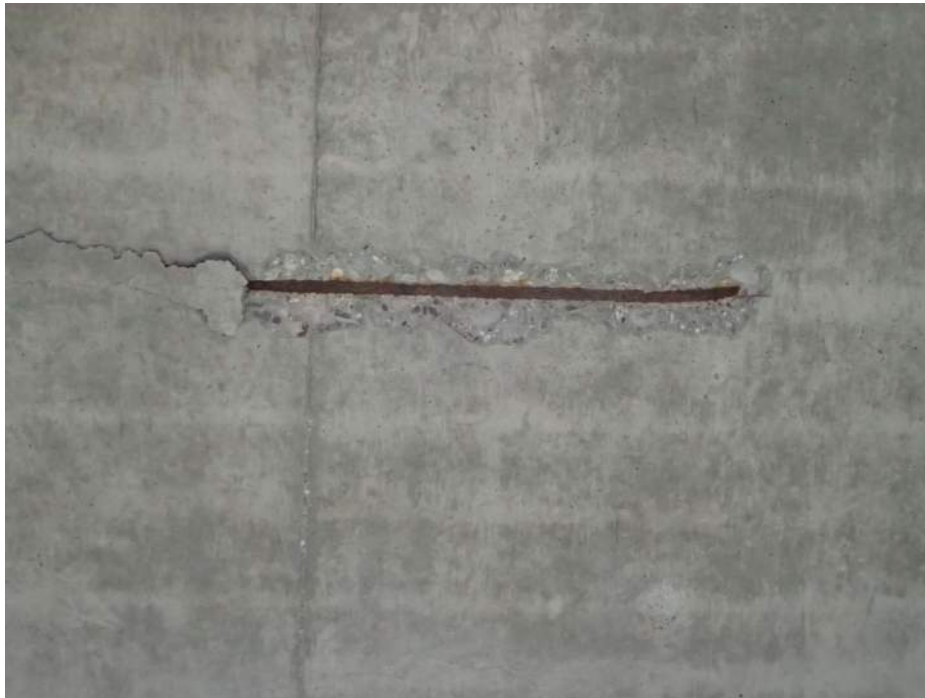
PHOTO 50 Condition

Description Span 1 - Underside of deck, spall with ECSR

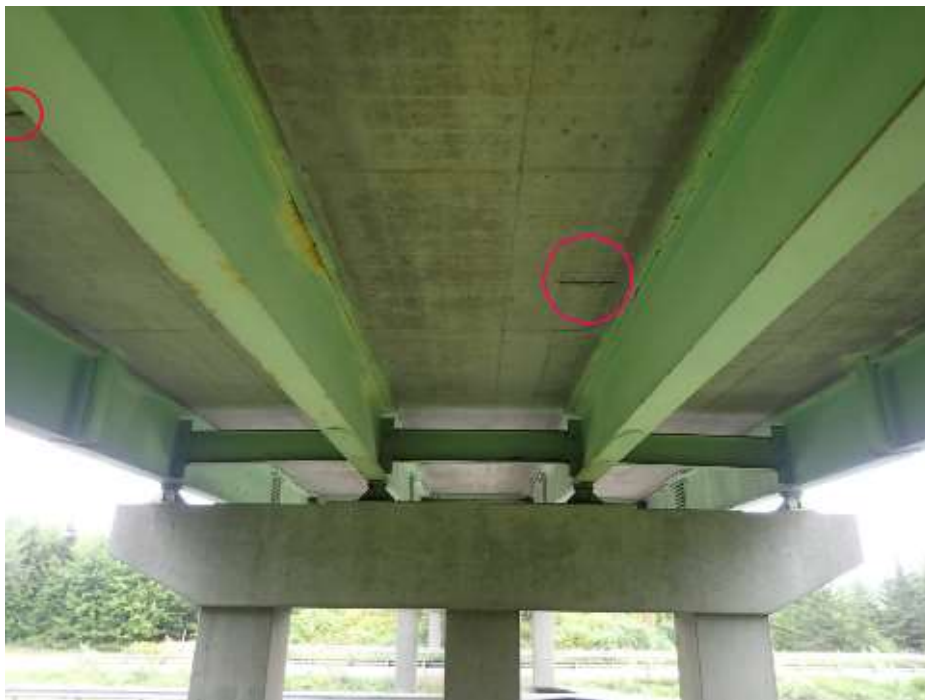
PHOTO 51 Condition

Description Span 1 - Underside of deck & steel framing, looking towards Pier 1, small spalls with ECSR

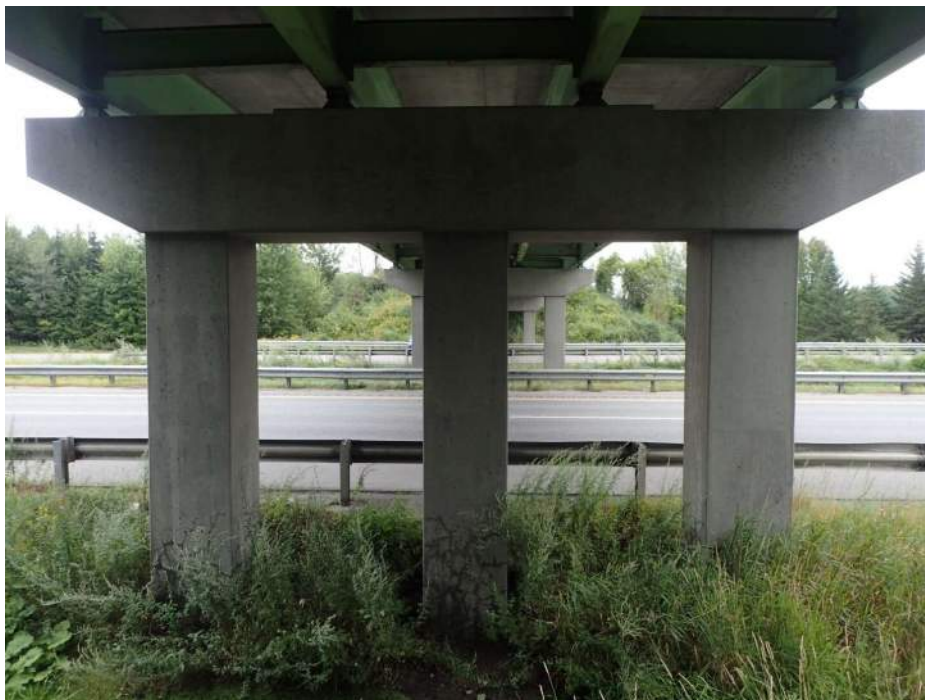
PHOTO 52 Condition

Description Pier 1 West elevation

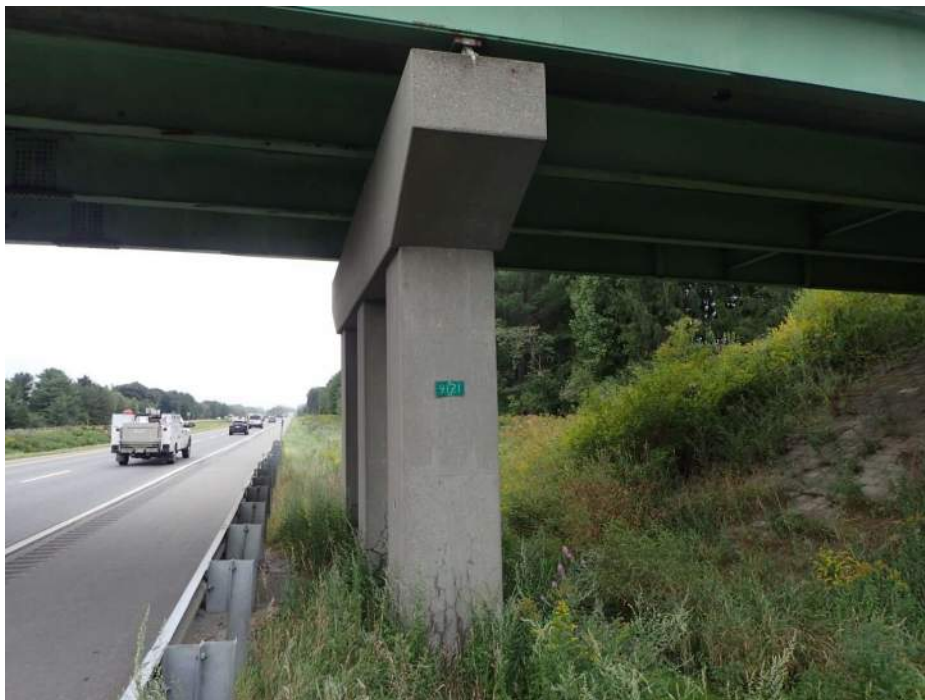
PHOTO 53 Condition

All columns have hairline map cracking with moisture staining for 3 feet high at the groundline.

Description Pier 1 North end - map cracking from ground level up 4'

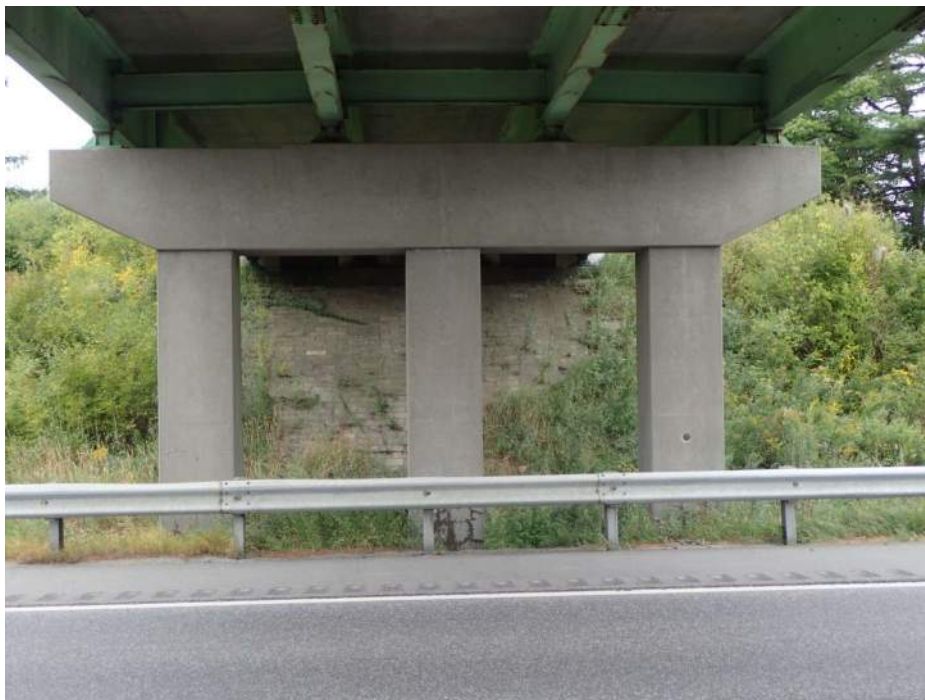
PHOTO 54 Condition

Description Pier 1 East elevation

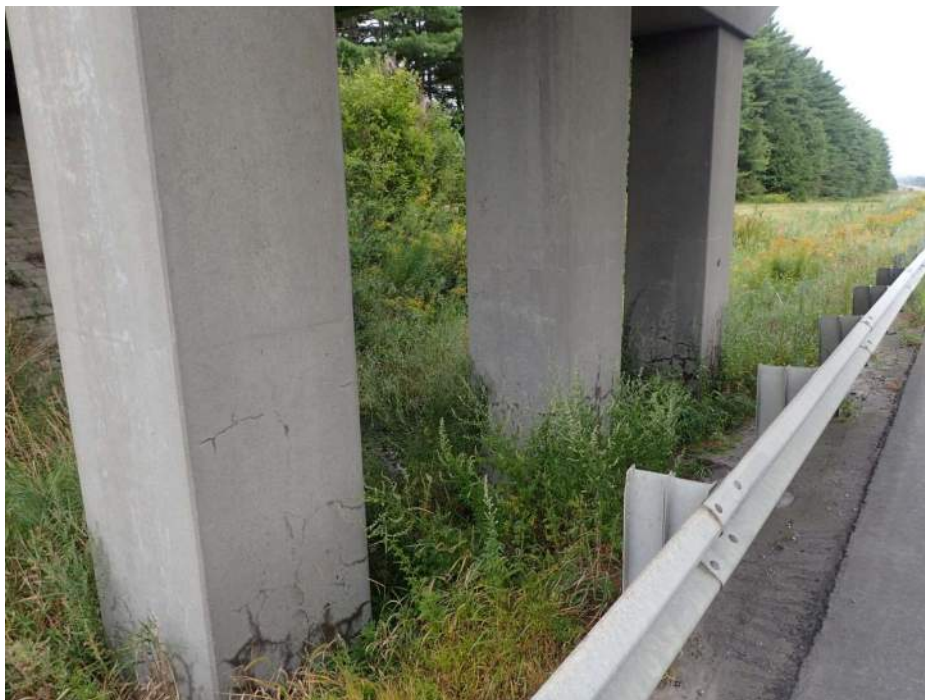
PHOTO 55 Condition

Description Pier 1 East elevation - map cracking from ground level up 3' to 5'
