Inspector: TYLIN, TYLIN
Inspection Date: 09/06/2024

Structure Number: 5784
Facility Carried: DRUMMOND RD

Highway Bridge Inspection Report

Bridge Name: DRUMMOND ROAD / I-95

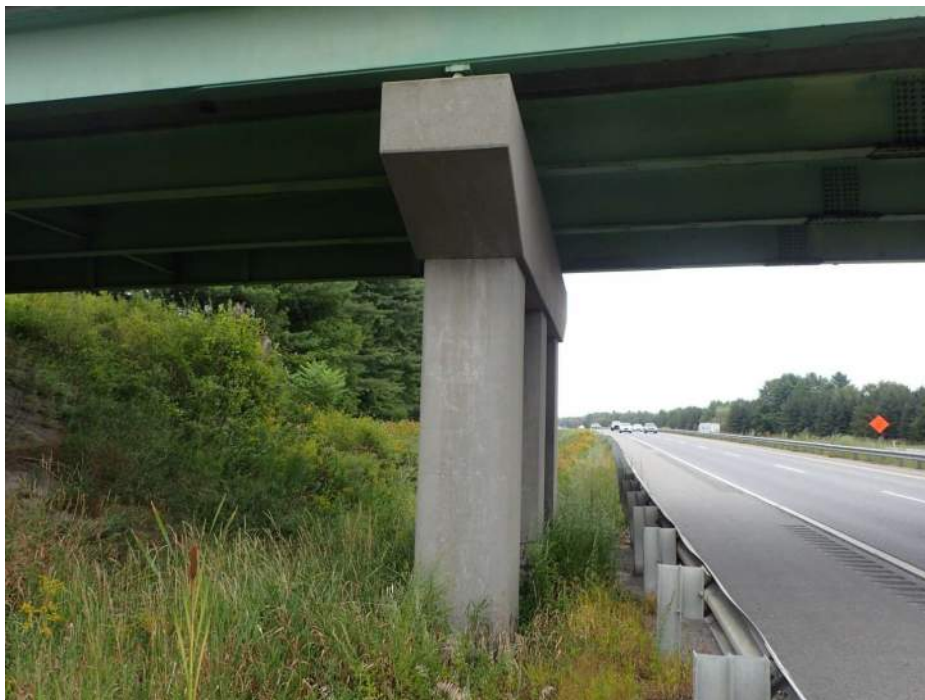
PHOTO 56 Condition

Description Pier 1 South end

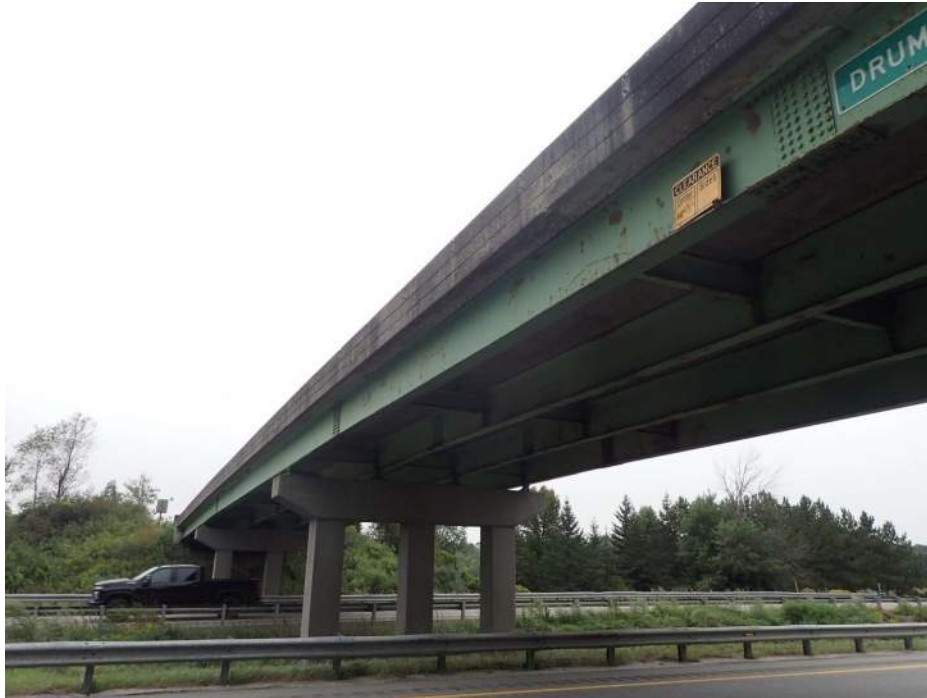
PHOTO 57 Condition

Description Span 2 over I95 SB - North Fascia, clearance marked as 14'-5"

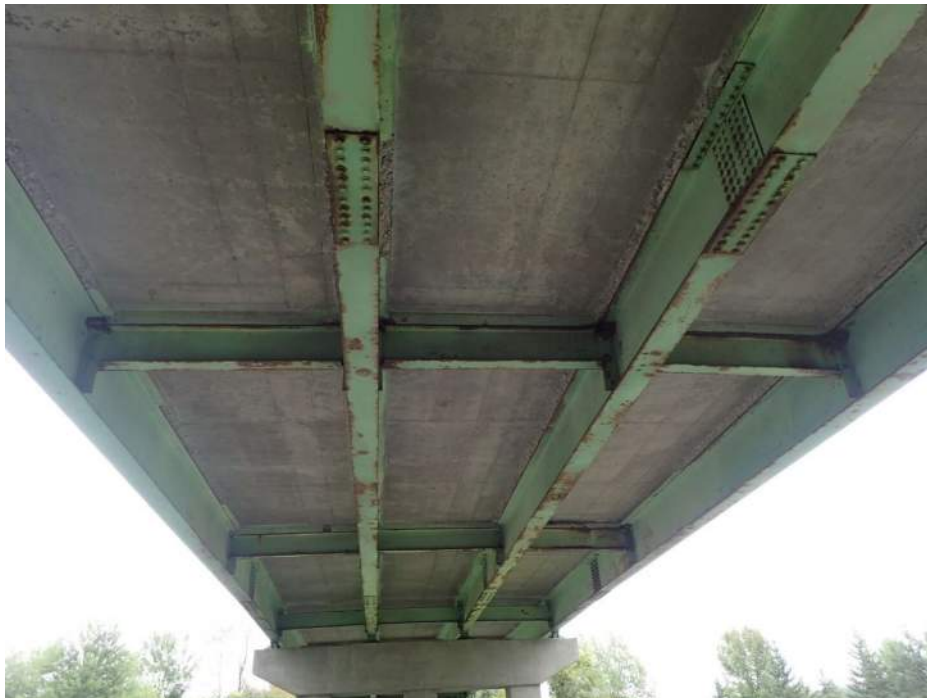
PHOTO 58 Condition

Description Span 2 over I95 SB - looking East, deck was constructed with haunches that extends past girder top flange 4" each side. Much of the haunch has spalled off. Some areas are still intact over the roadway.

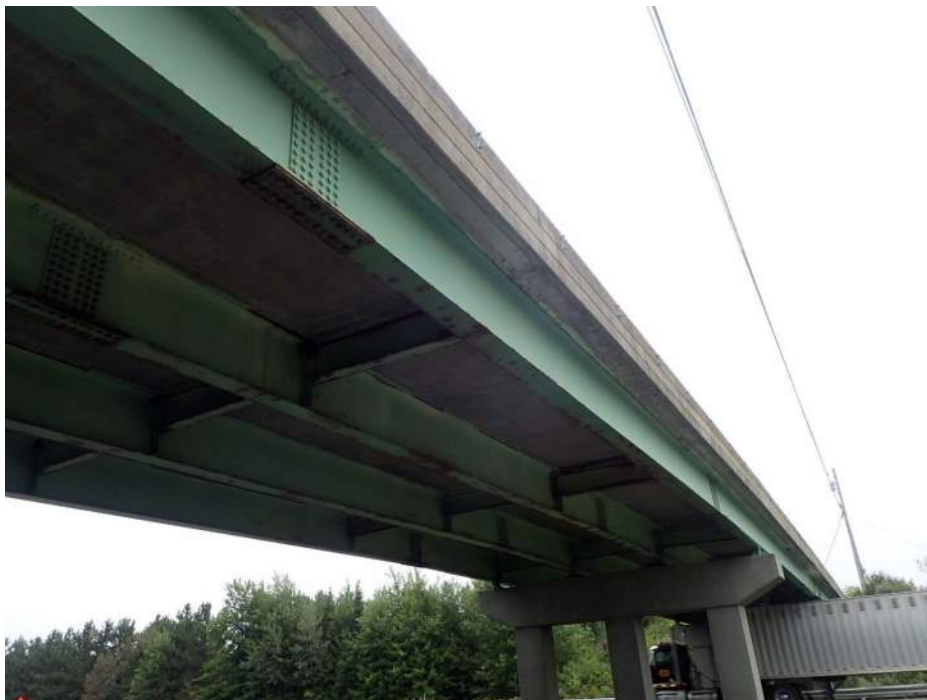
PHOTO 59 Condition

Description Span 2 over I95 SB - South fascia & overhang

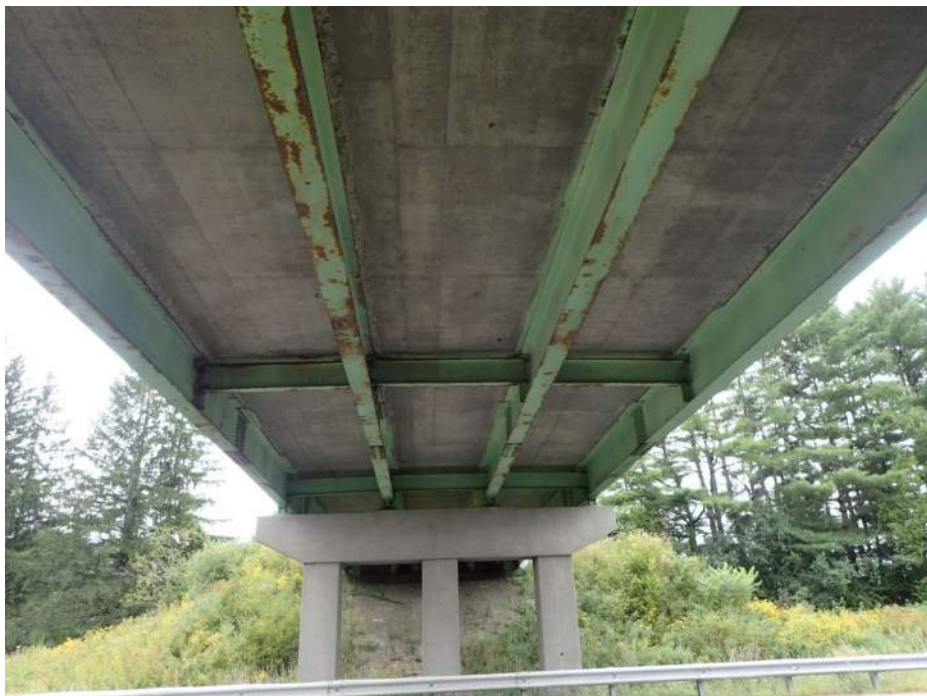
PHOTO 61 Condition

Description Span 2 over I95 SB - Underdeck & Framing, looking West

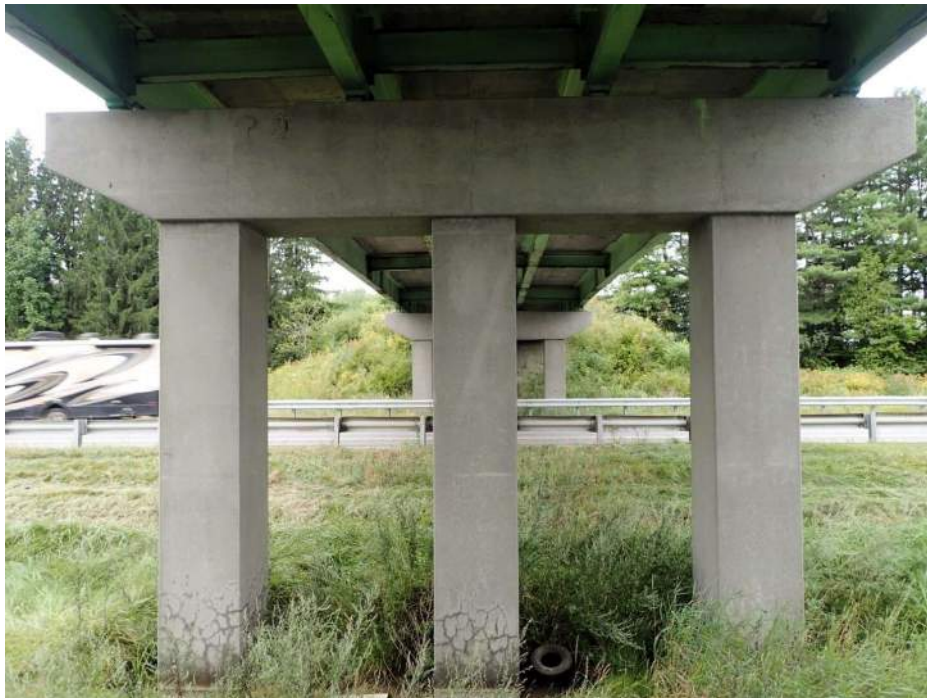
PHOTO 64 Condition

Description Pier 2 - West Elevation

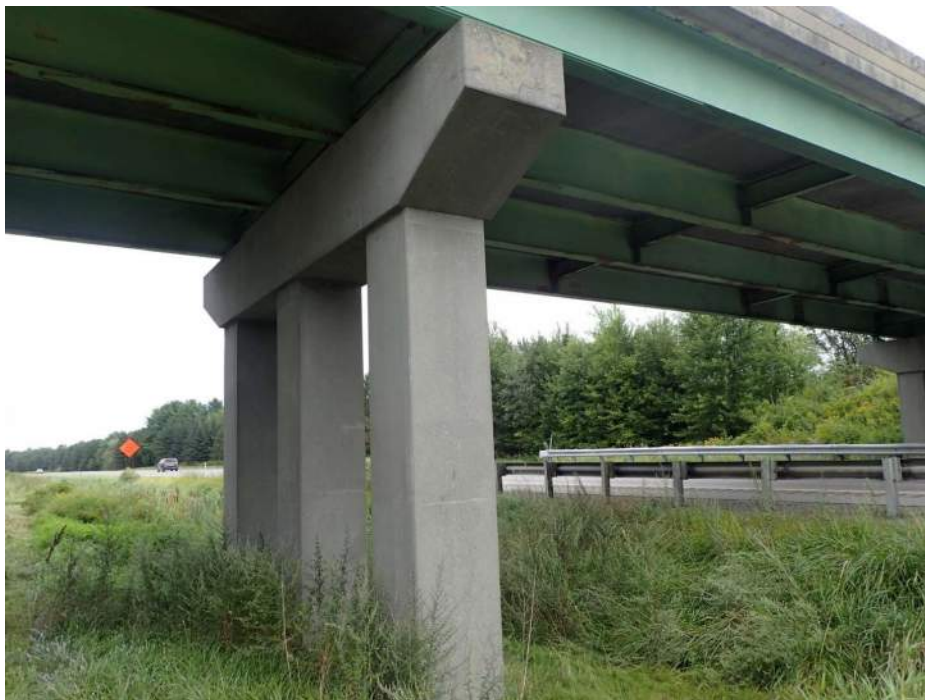
PHOTO 67 Condition

Description Pier 2 - North End - Map cracking from ground up approximately 3', some minor cracking on pier cap end

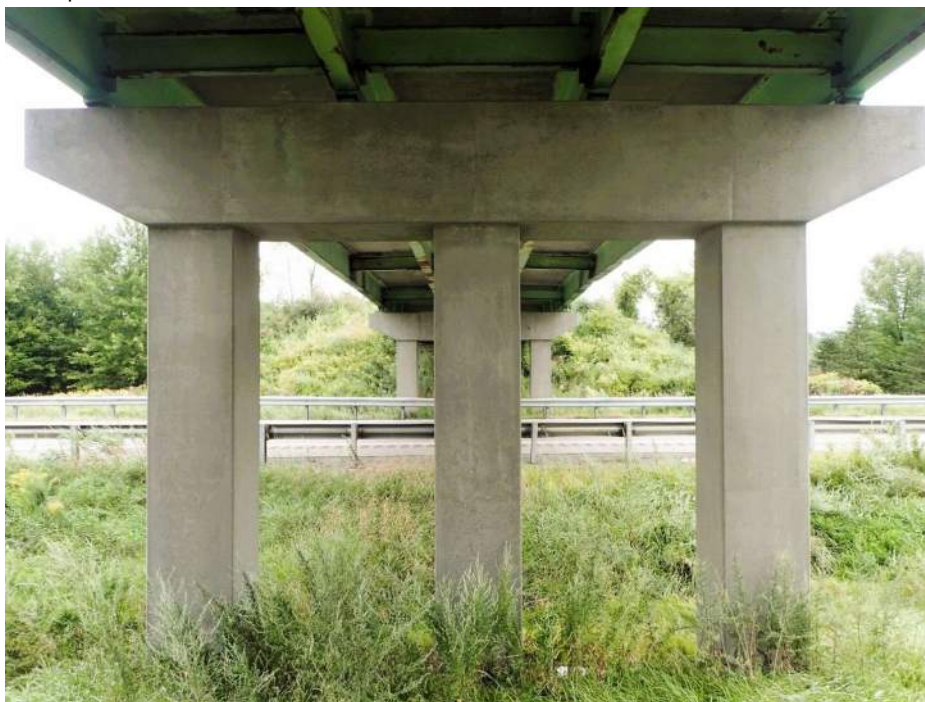
PHOTO 68 Condition

Description Pier 2 - East Elevation

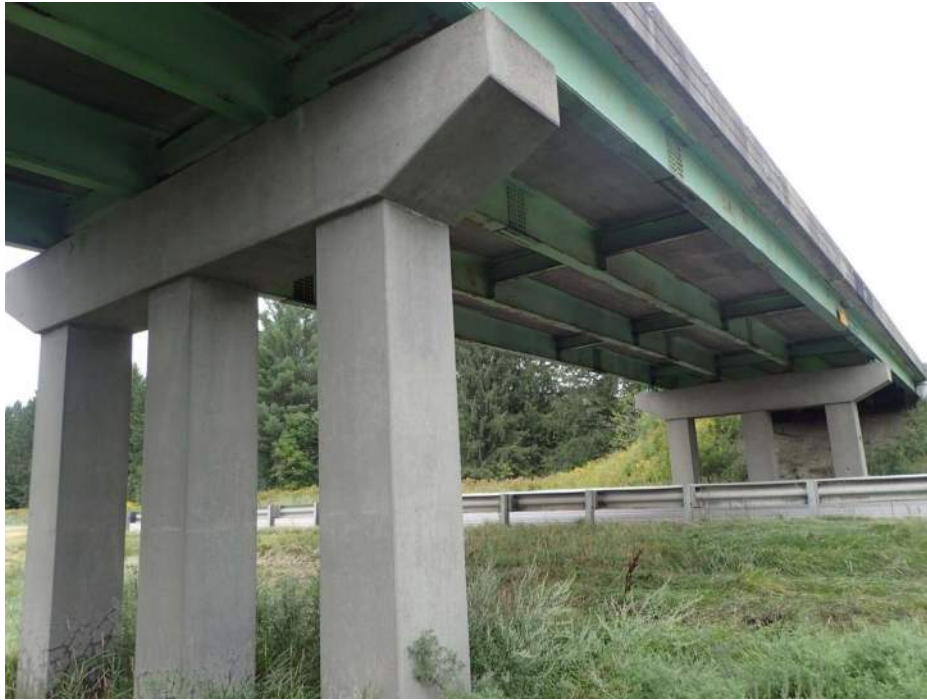
PHOTO 69 Condition
Description Pier 2 - South End

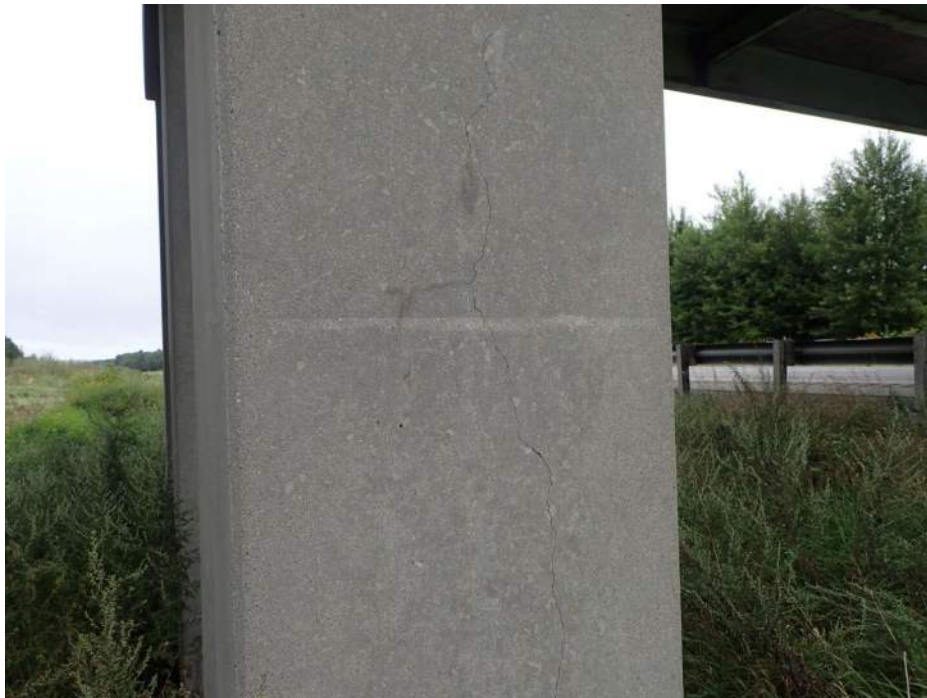
PHOTO 70 Condition
Description Pier 2 - South End, vertical moderate crack (+/- 0.08"), typical of cracks on Piers

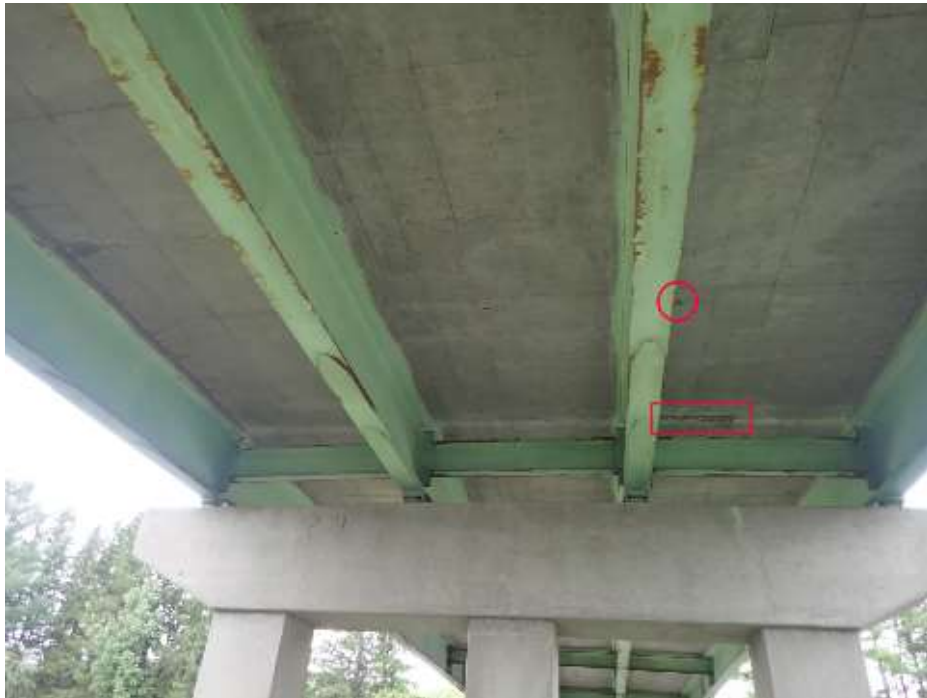
PHOTO 72 Condition

Description Span 3 over I95 NB - looking West, spalls with ECSR

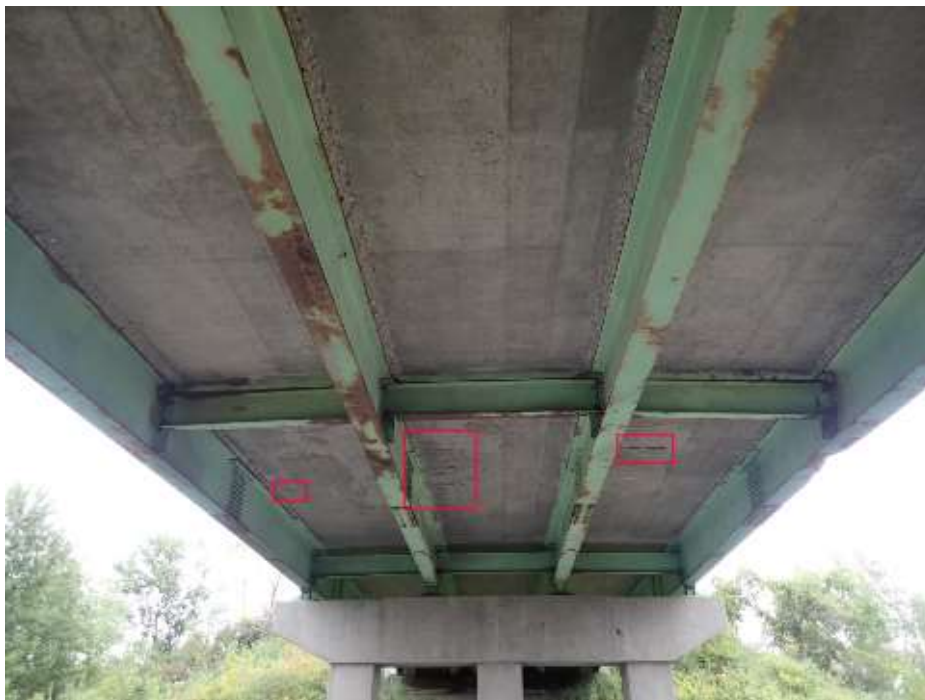
PHOTO 73 Condition

Description Span 3 over I95 NB - looking East, spalls with ECSR, next photo is closeup of bay 2 & 3 spalls

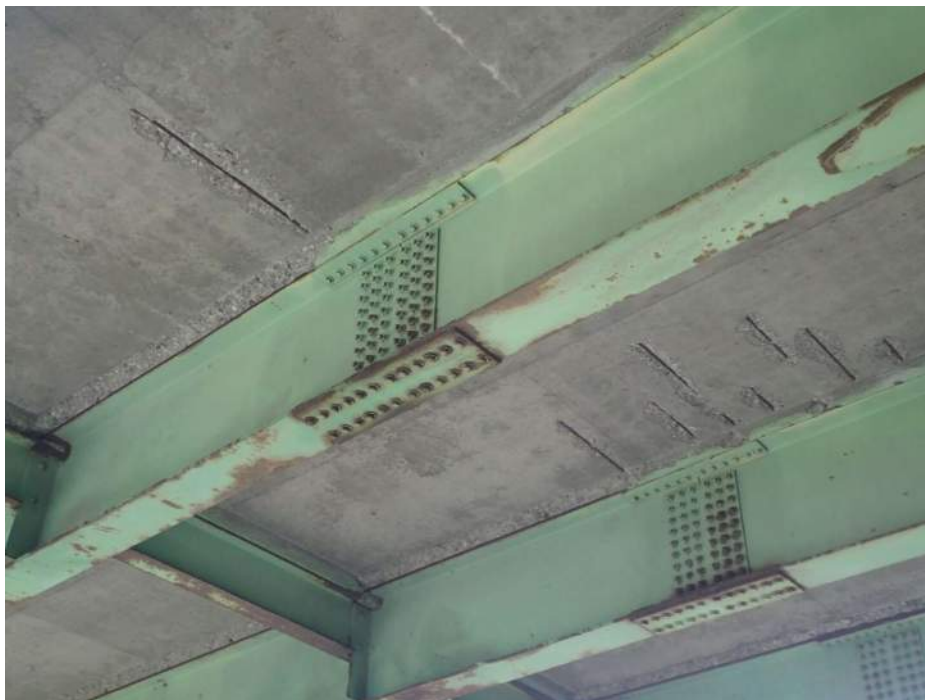
PHOTO 74 Condition

Description Span 3 over I95 NB - 2 & 3 spalls

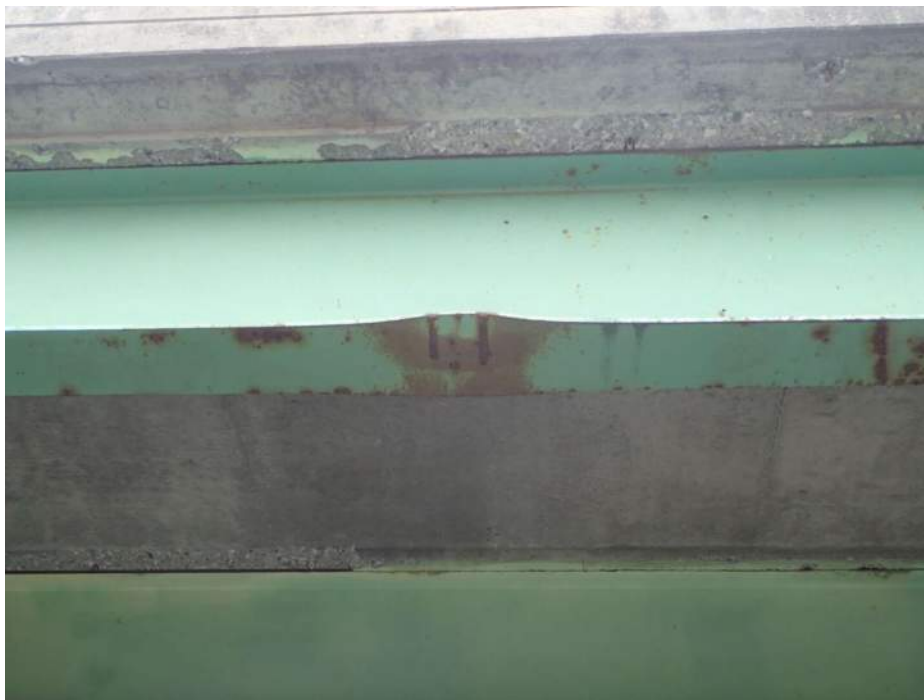
PHOTO 76 Condition

Description Span 3 over I95 NB - Girder 4 impact damage

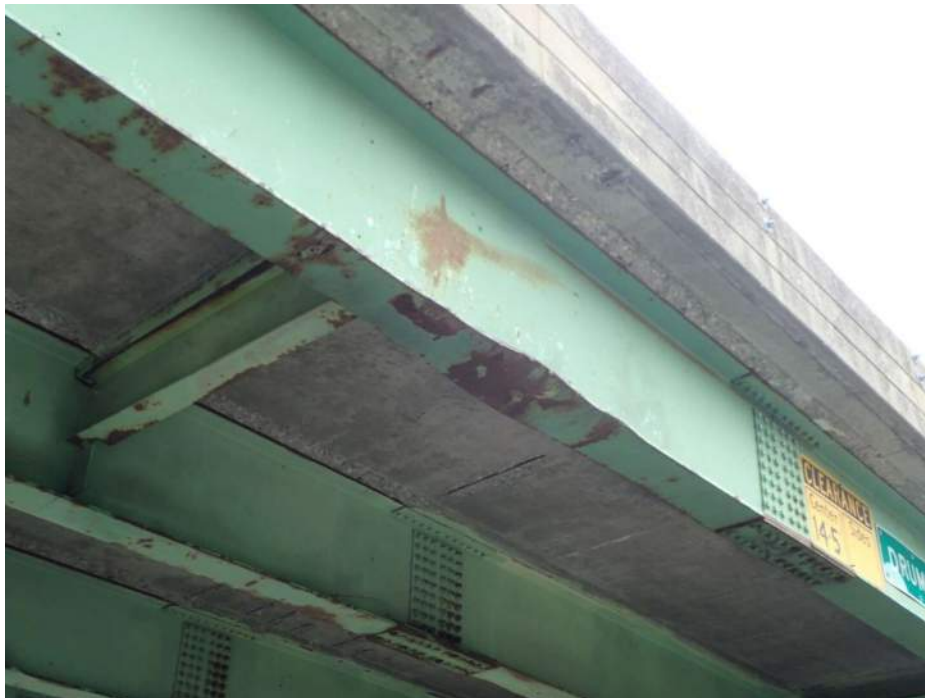
PHOTO 77 Condition

Description Span 3 over I95 NB - Girder 4 impact damage, vertical clearance marked at 14'-5"

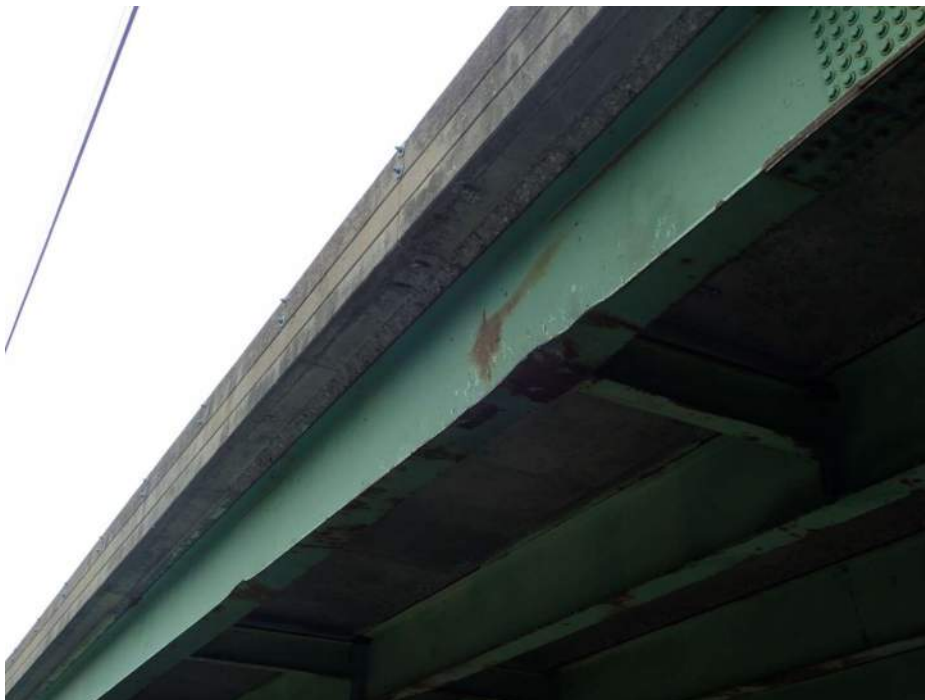
PHOTO 78 Condition

Description Span 3 over I95 NB - Girder 4 impact damage

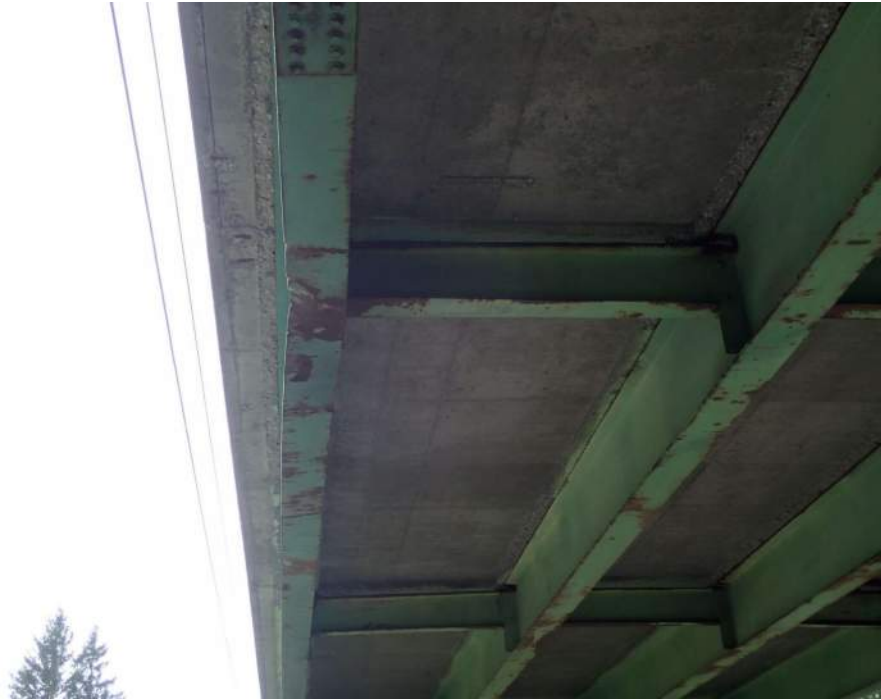
PHOTO 79 Condition

Description Span 3 over I95 NB - Girder 4 impact damage

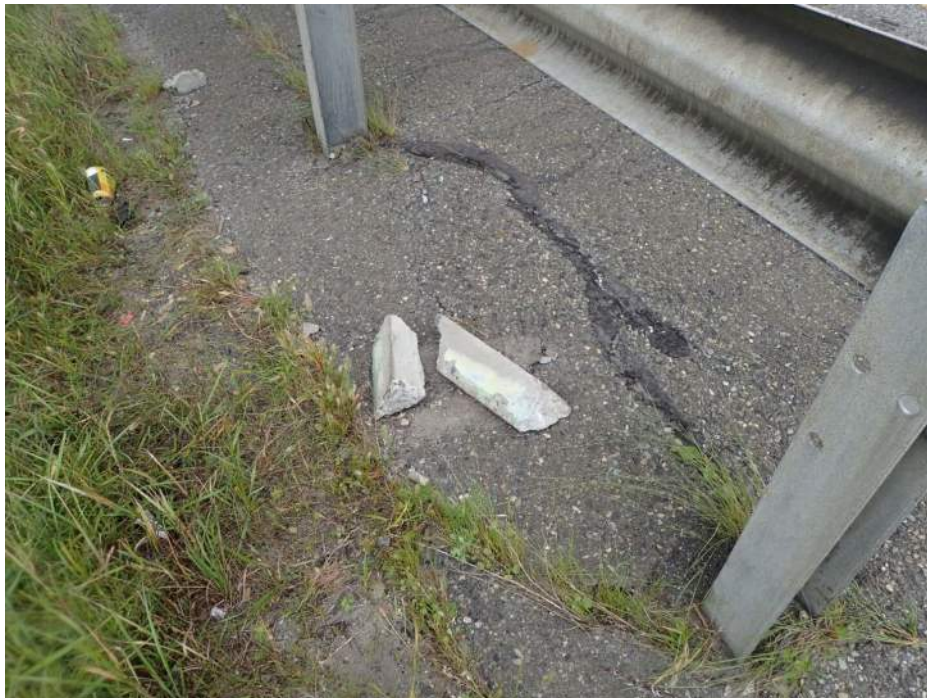
PHOTO 80 Condition

Description Span 3 over I95 NB - some haunch that has recently spalled off. Found on left shoulder. Issue reported to MaineDOT. Much of the haunch is still in place over the lanes posing a potential hazard to motorists.

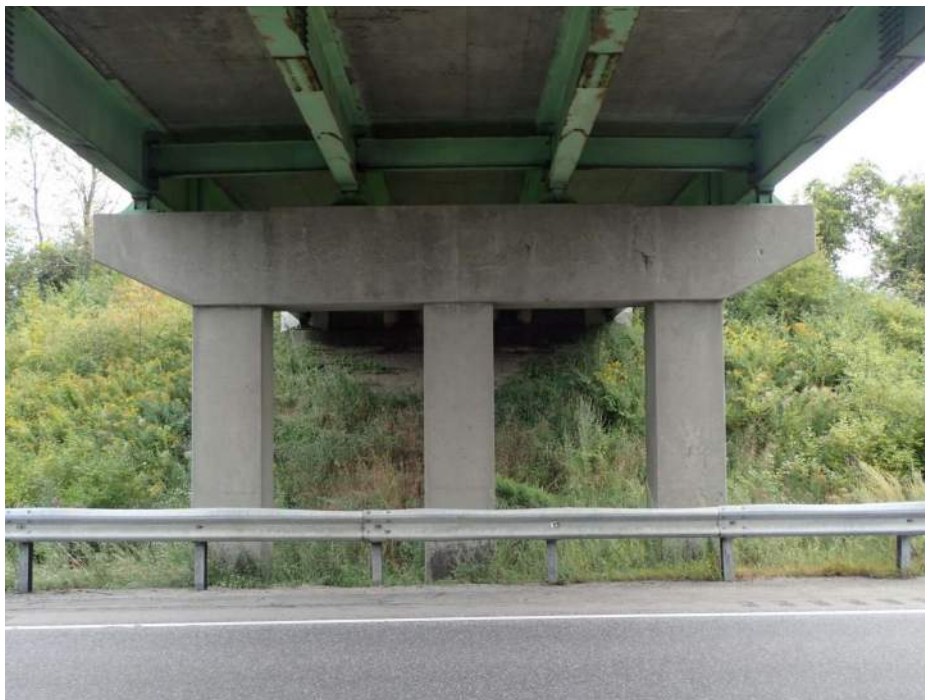
PHOTO 81 Condition
Description Pier 3 - West elevation

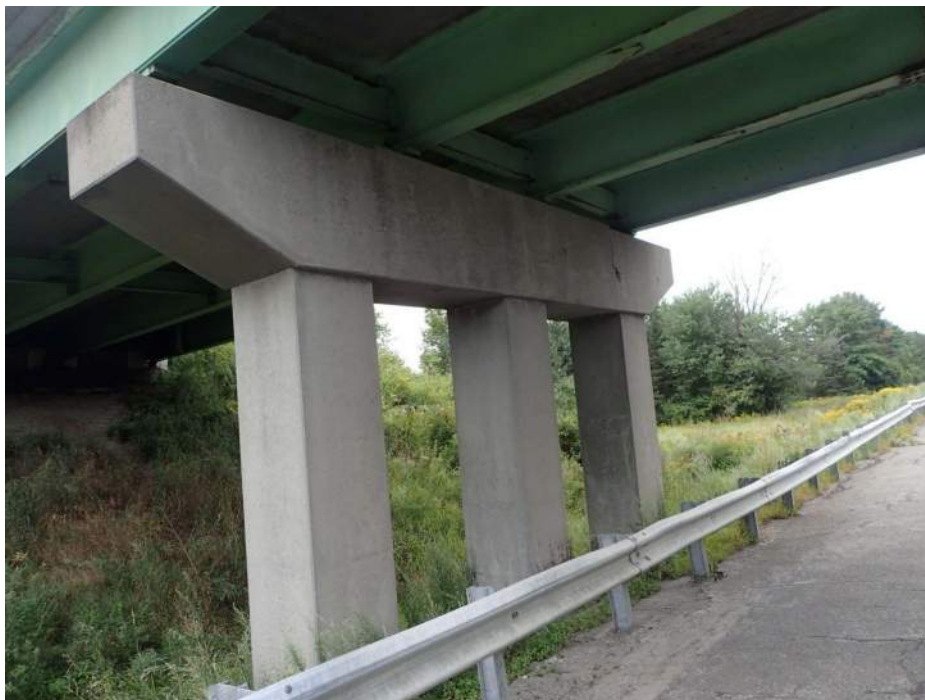
PHOTO 82 Condition
Description Pier 3 - West elevation

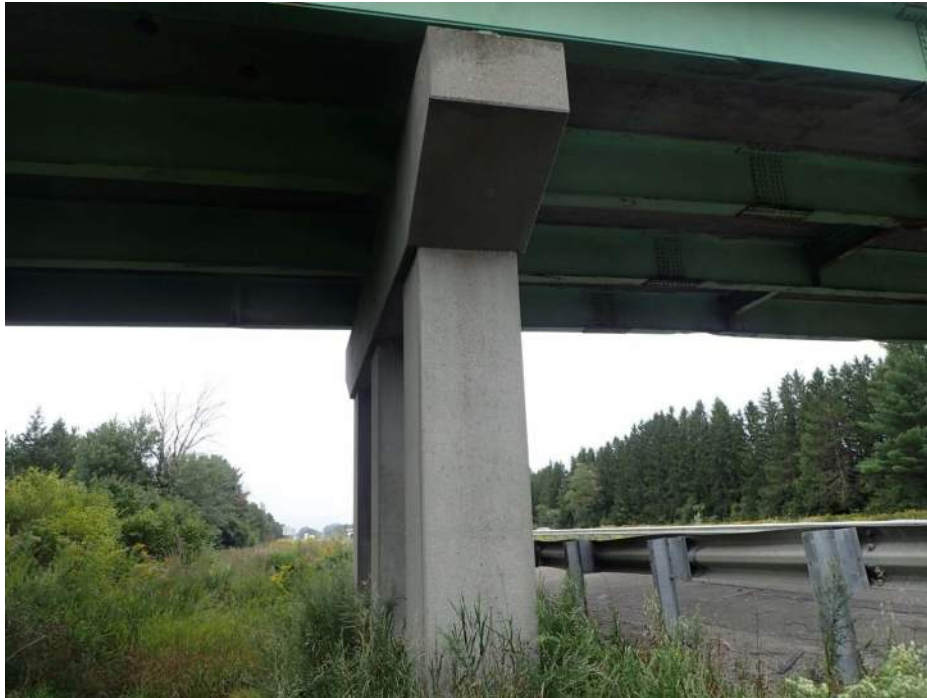
PHOTO 83 Condition

Description Pier 3 - North End

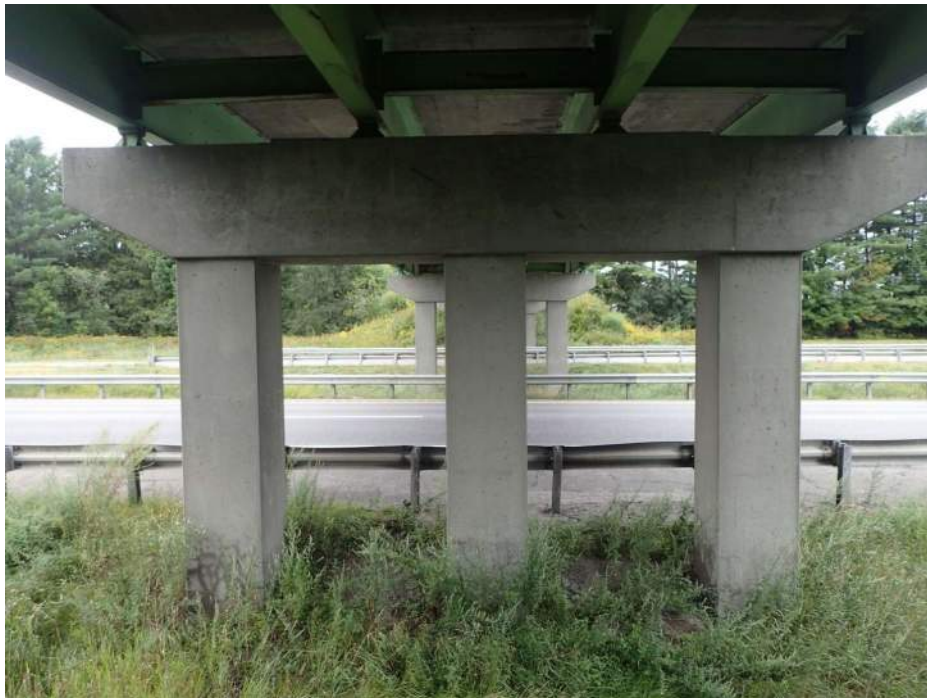
PHOTO 84 Condition

Description Pier 3 - East elevation

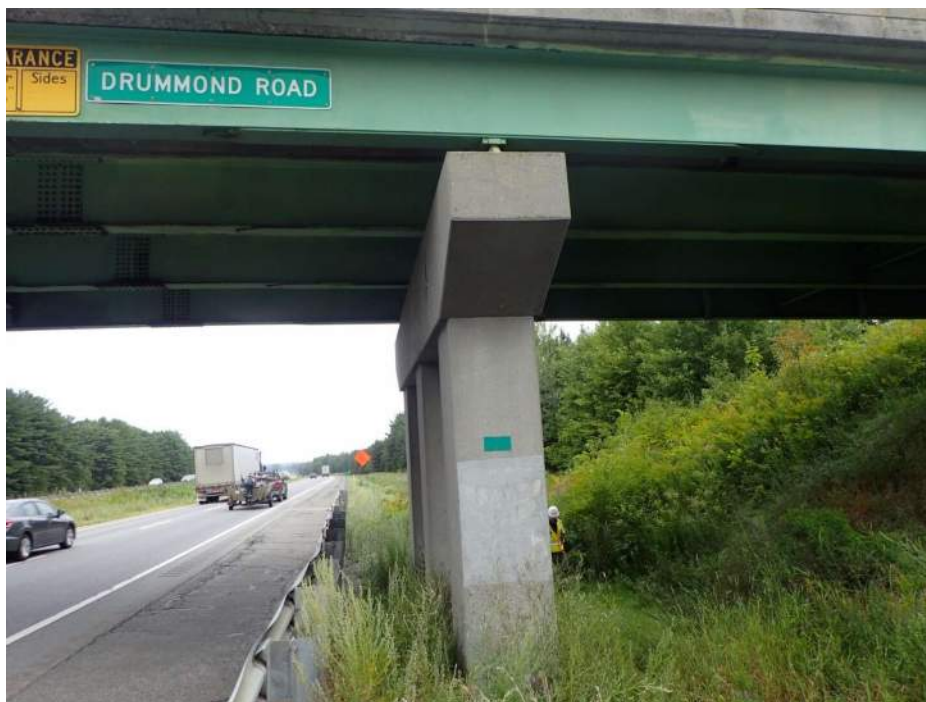
PHOTO 85 Condition
Description Pier 3 - South End

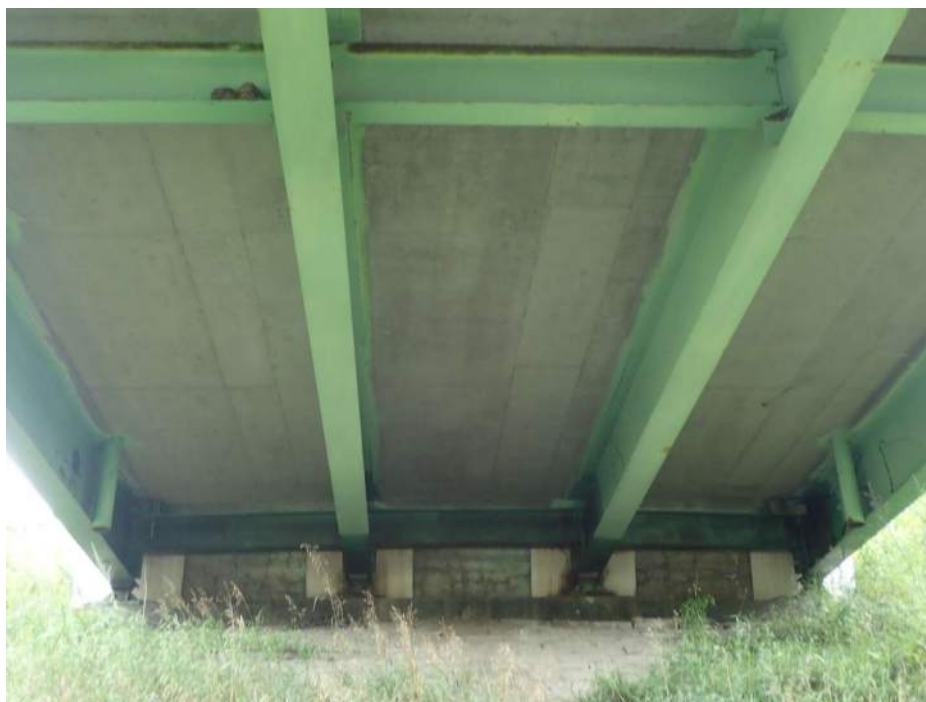
PHOTO 86 Condition
Description Span 4 - Deck underside & framing, looking East to Abutment 2

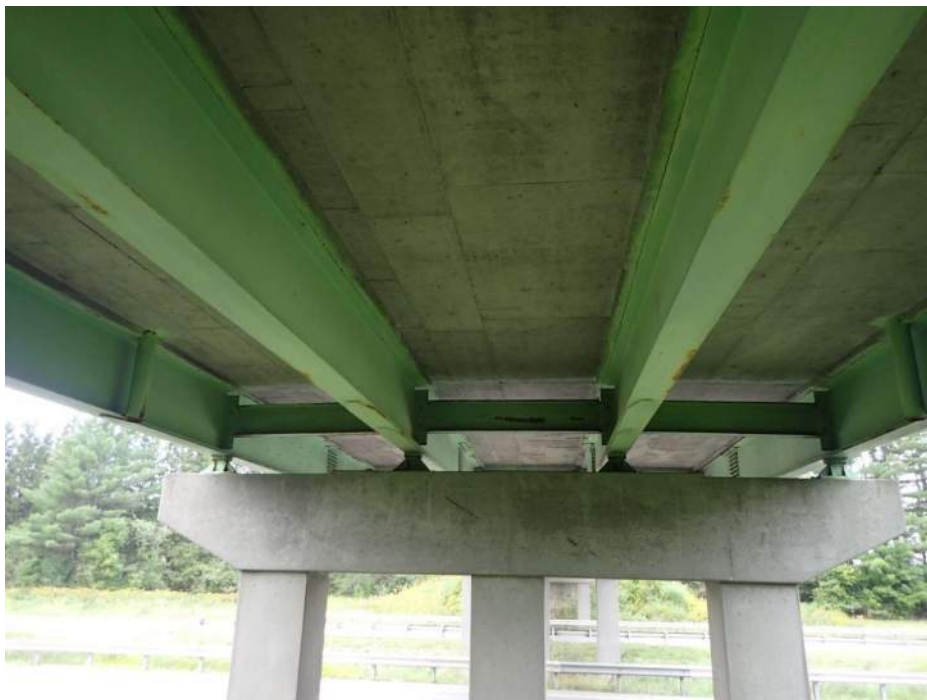
PHOTO 87 Condition

Description Span 4 - Deck underside & framing, looking West to Pier 3

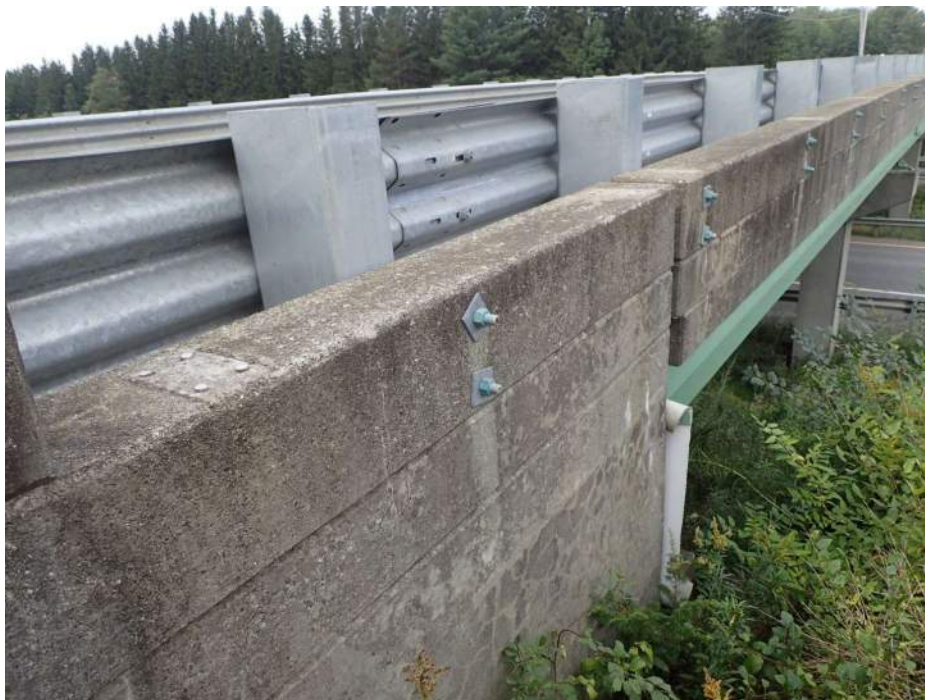
PHOTO 89 Condition

Description Abutment 2 - North return wall

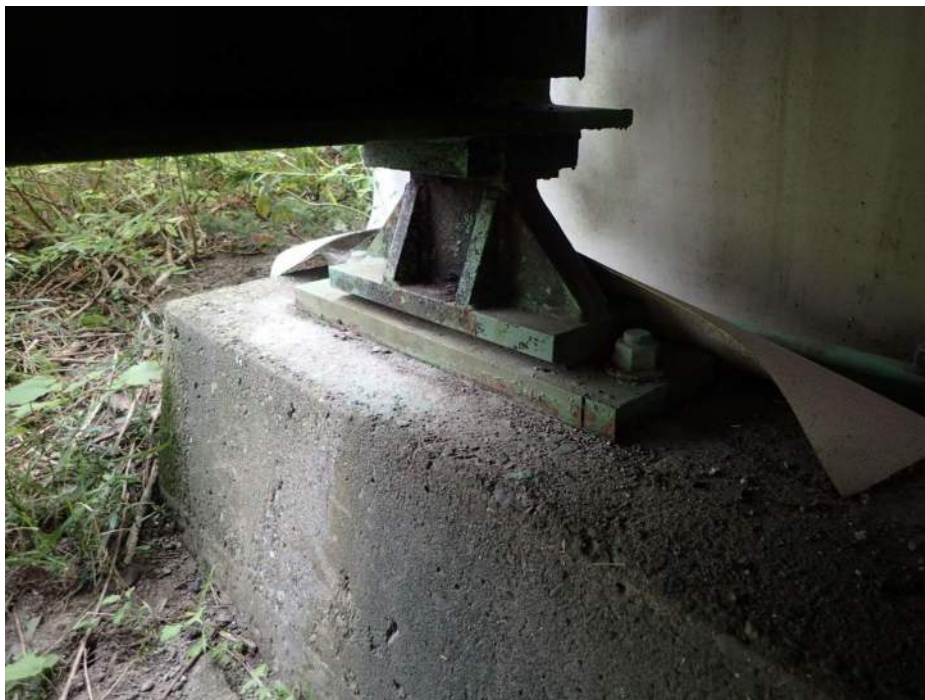
PHOTO 90 Condition

Description Abutment 2 - Girder 1 rocker bearing

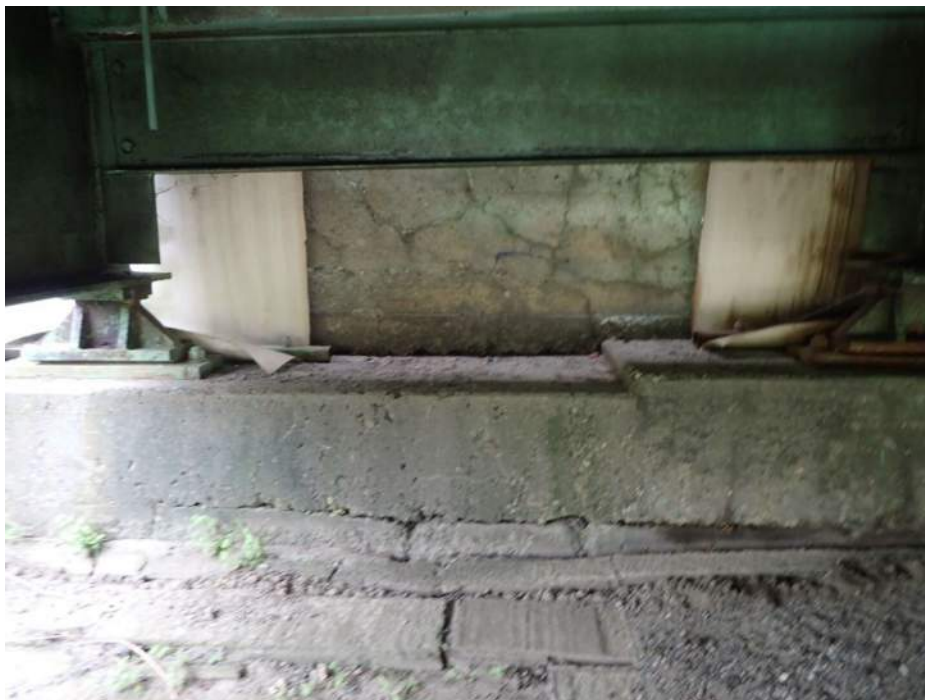
PHOTO 91 Condition

Description Abutment 2 - Bay 1, Girder 1 & 2, map cracking on backwall & wide cracking on breast wall

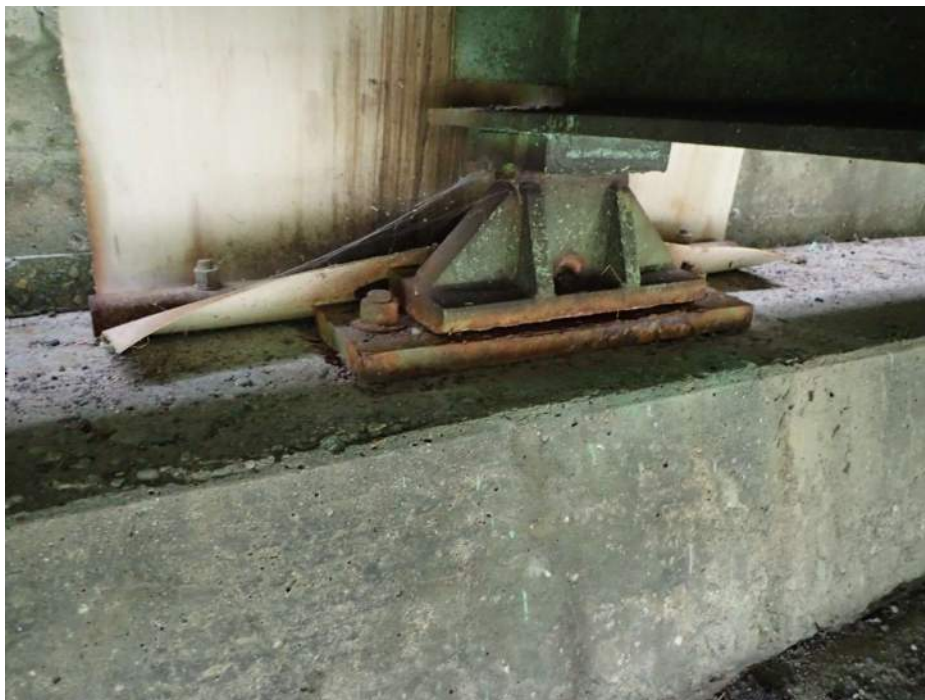
PHOTO 92 Condition

Description Abutment 2 - Girder 2 rocker bearing

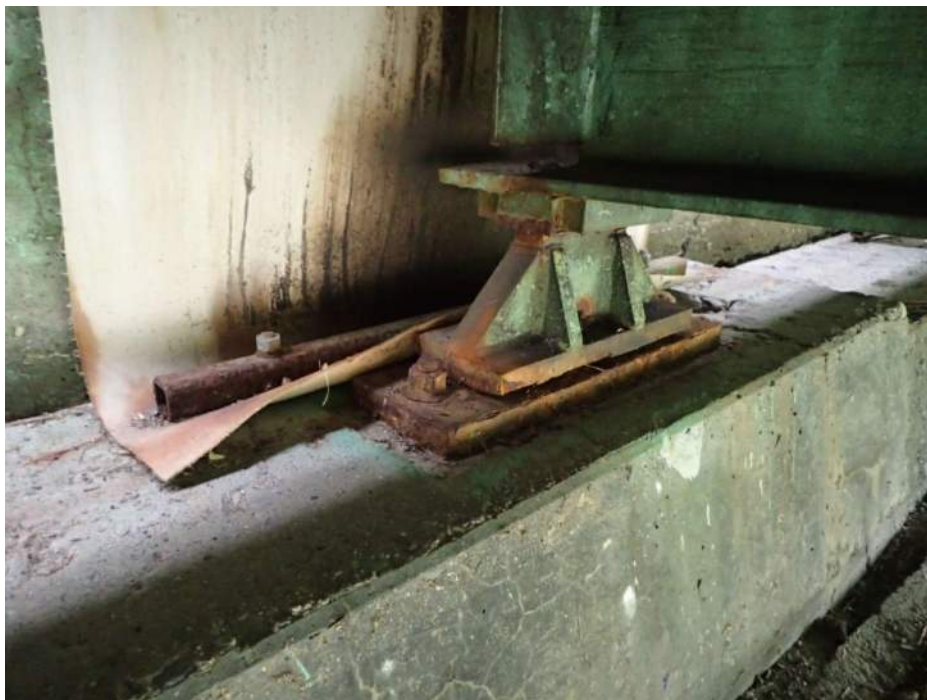
PHOTO 94 Condition

Description Abutment 2 - Girder 3 rocker bearing

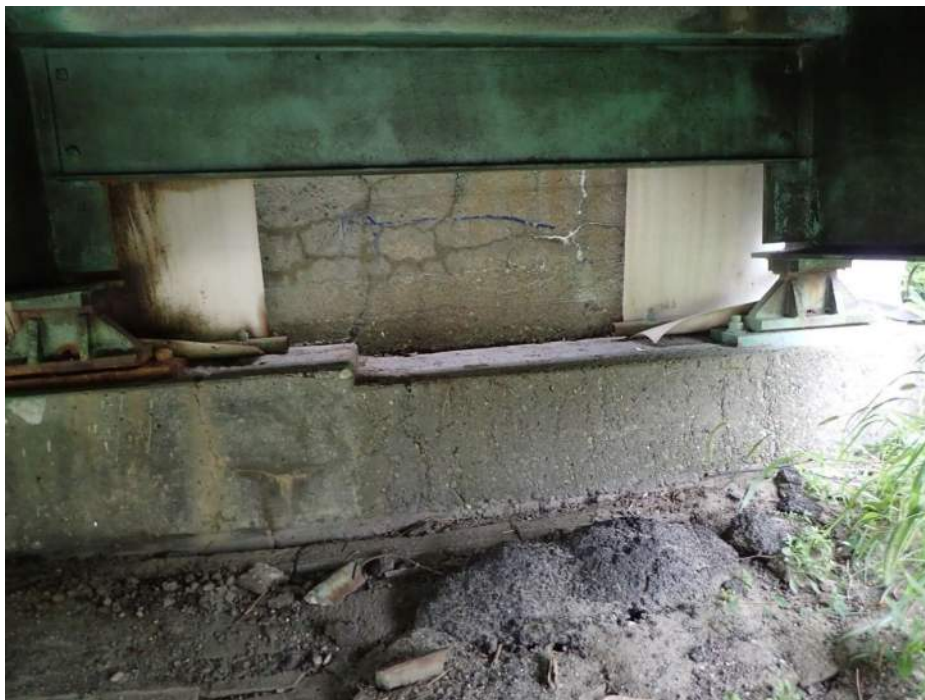
PHOTO 95 Condition

Description Abutment 2 - Bay 3, Girder 3 & 4, light map cracking on backwall & breastwall

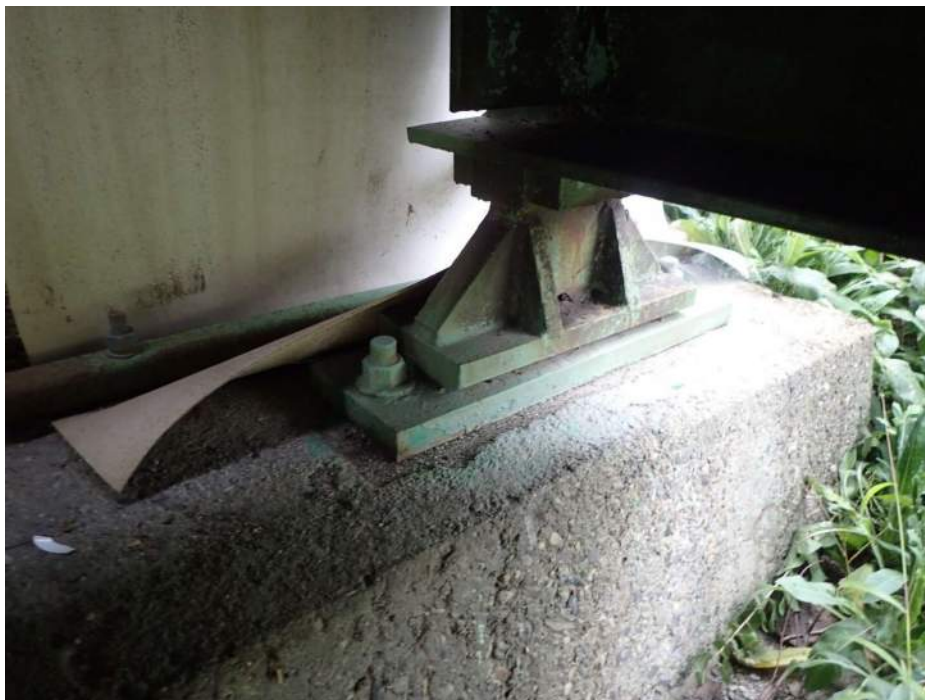
PHOTO 96 Condition

Description Abutment 2 - Girder 4 rocker bearing

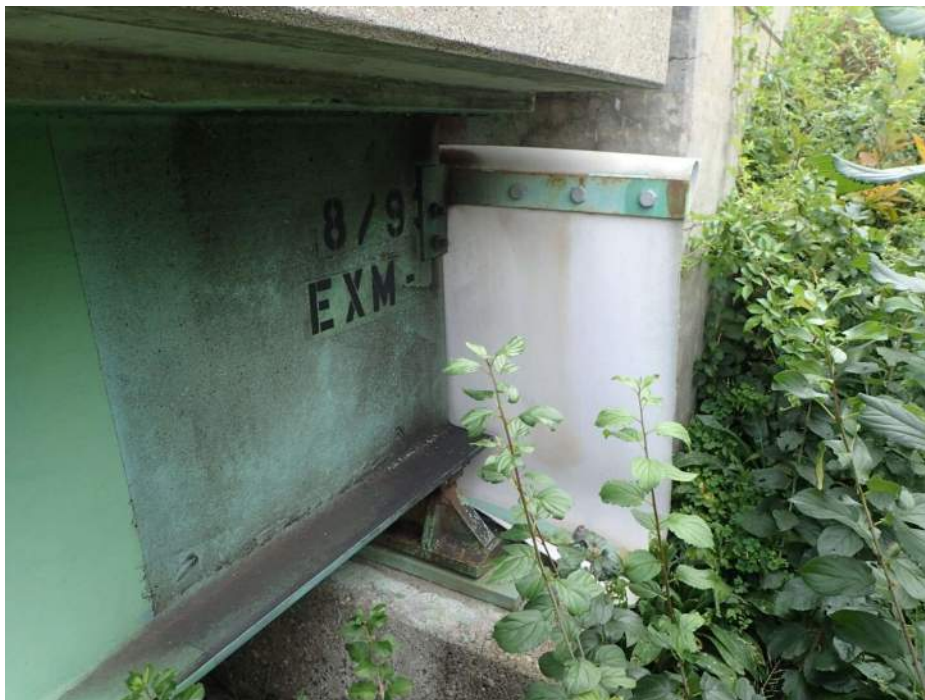
PHOTO 97 Condition

Description Abutment 2 - Girder 4 end

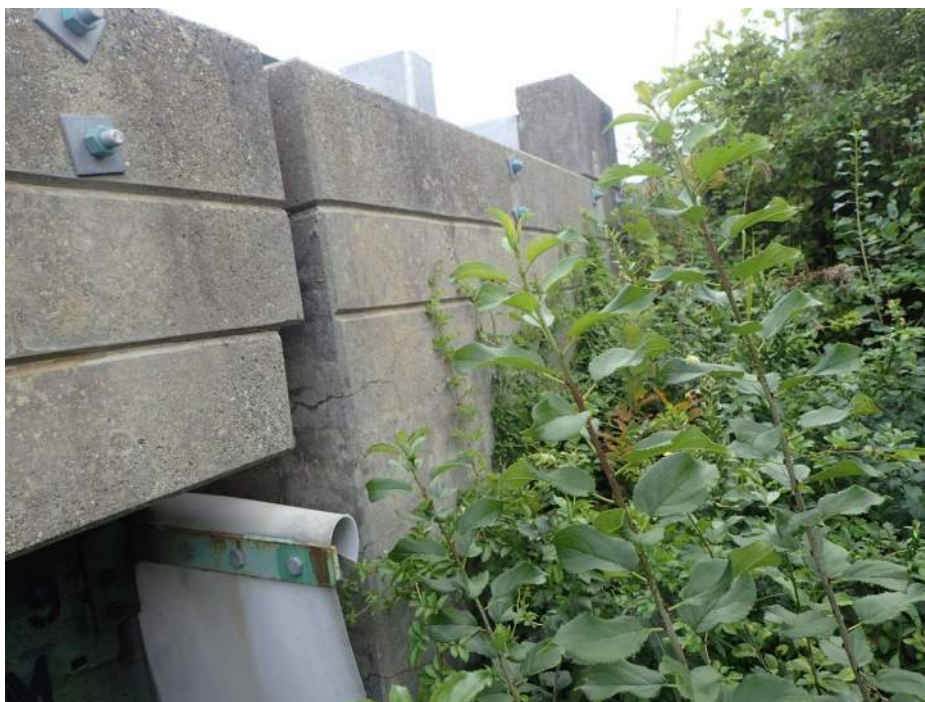
PHOTO 98 Condition

Description Abutment 2 - South return wall
