Inspector: TYLIN, TYLIN
Inspection Date: 09/06/2024

Structure Number: 5784
Facility Carried: DRUMMOND RD

Highway Bridge Inspection Report

Bridge Name: DRUMMOND ROAD / I-95

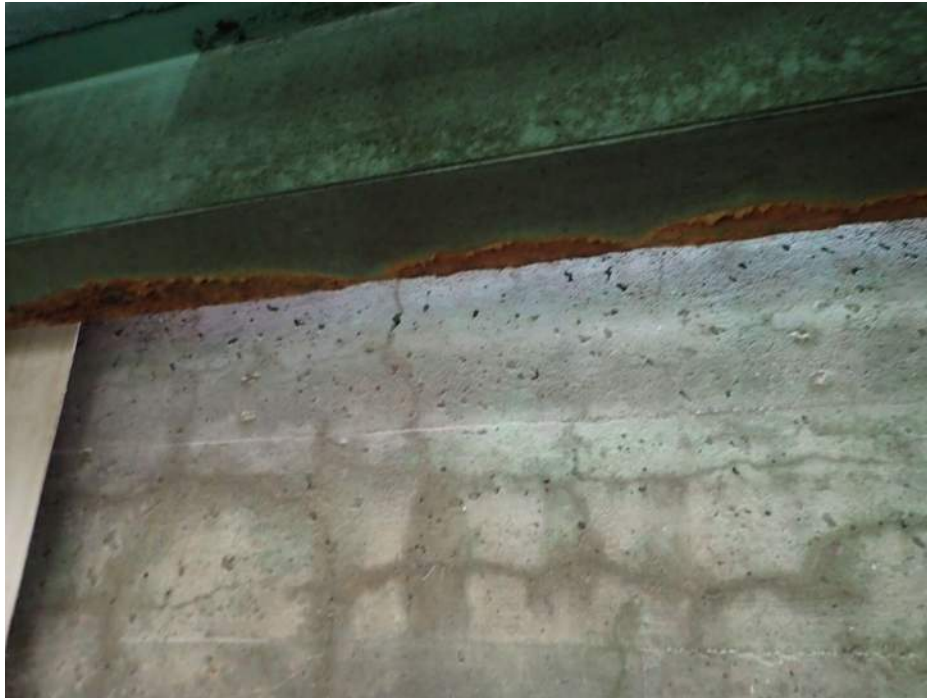
PHOTO 99 Condition
Description Abutment 2 - rusting on joint side of diaphragm, typical
