Structure Number: 5785
Facility Carried: TOWN FARM RD

Highway Bridge Inspection Report

Inspection Type(s): Routine

Bridge Name: TOWN FARM RD / I-95

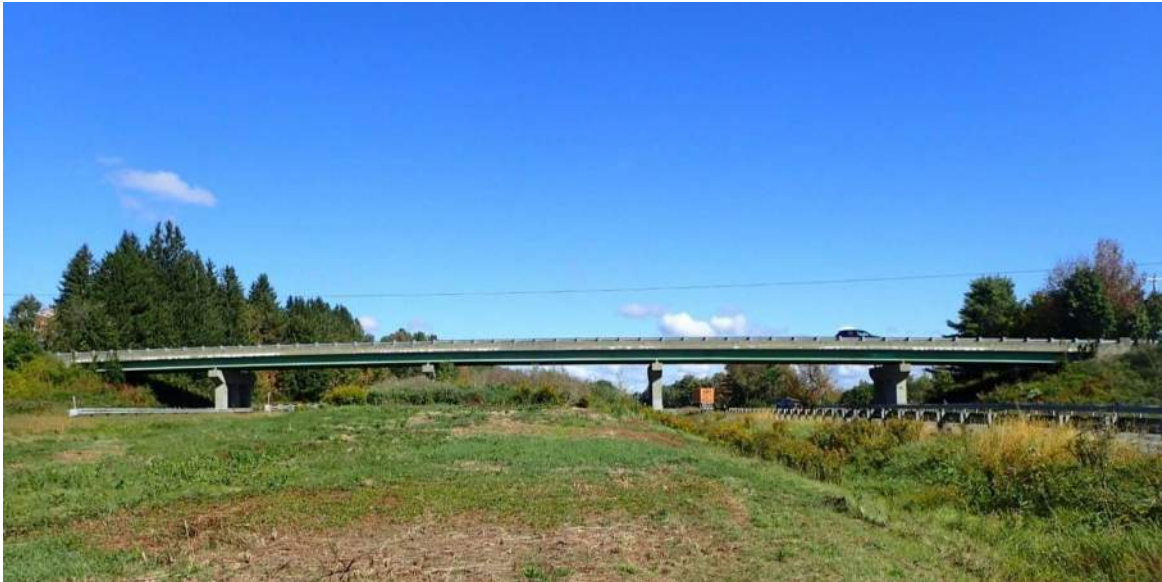
PHOTO 1 Elevation

Description South Elevation

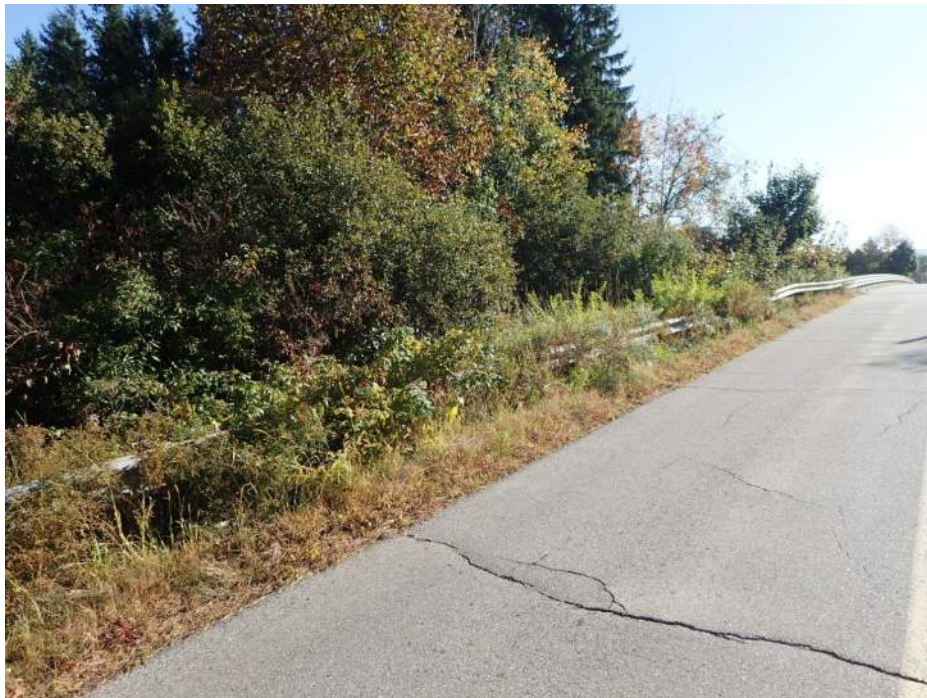
PHOTO 2 Condition

Description West Approach

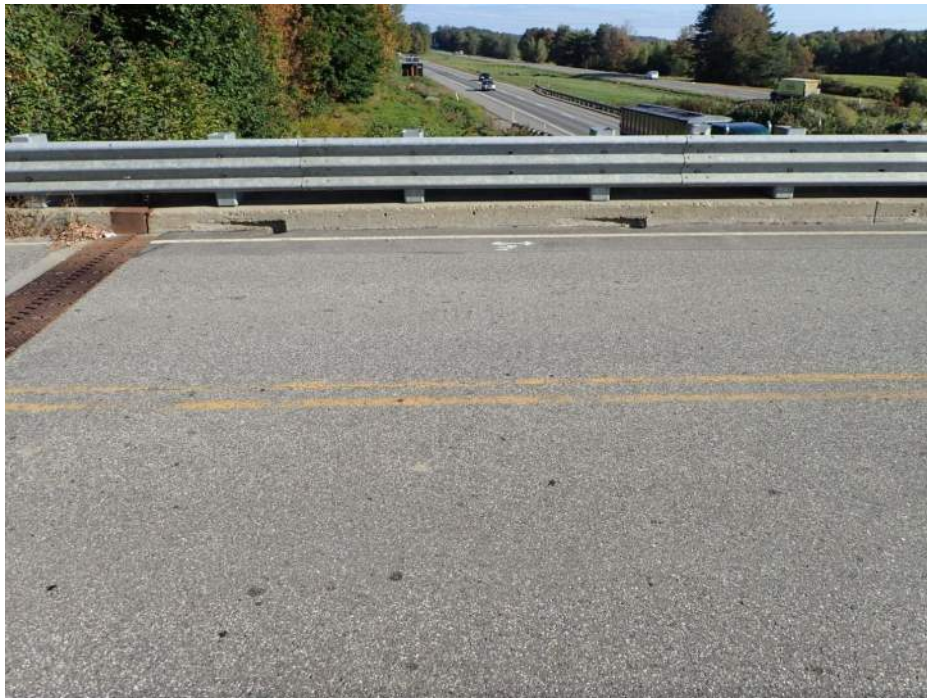
PHOTO 12 Condition

Description Bridge Deck & North Railing 1 of 4 - longitudinal cracking down center of bridge. Some partial width transverse cracking sparsely scattered throughout on deck.

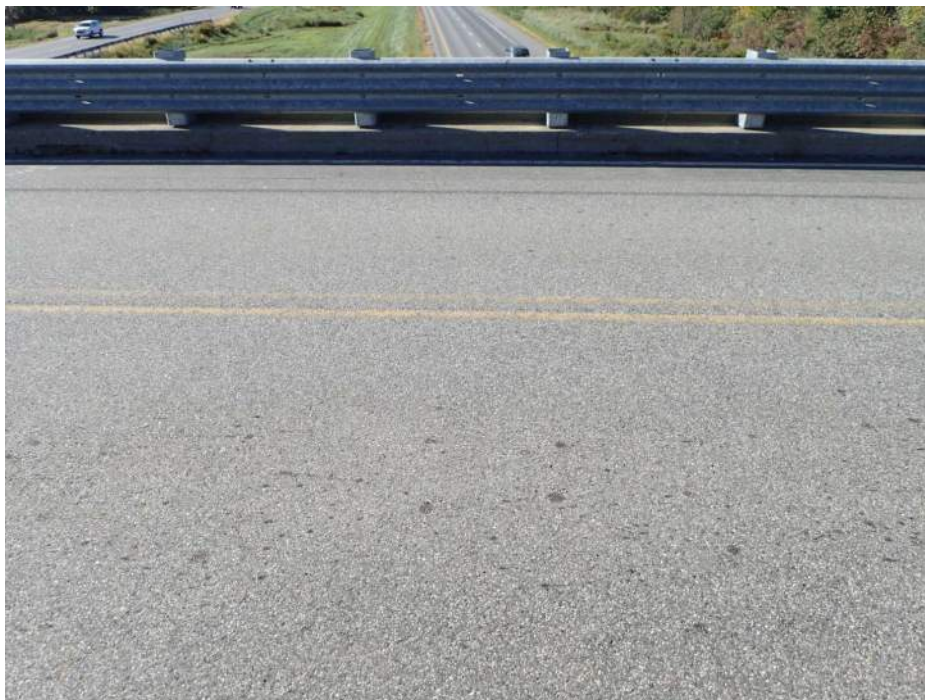
PHOTO 20 Condition

Description Bridge Deck & South Railing 2 of 3

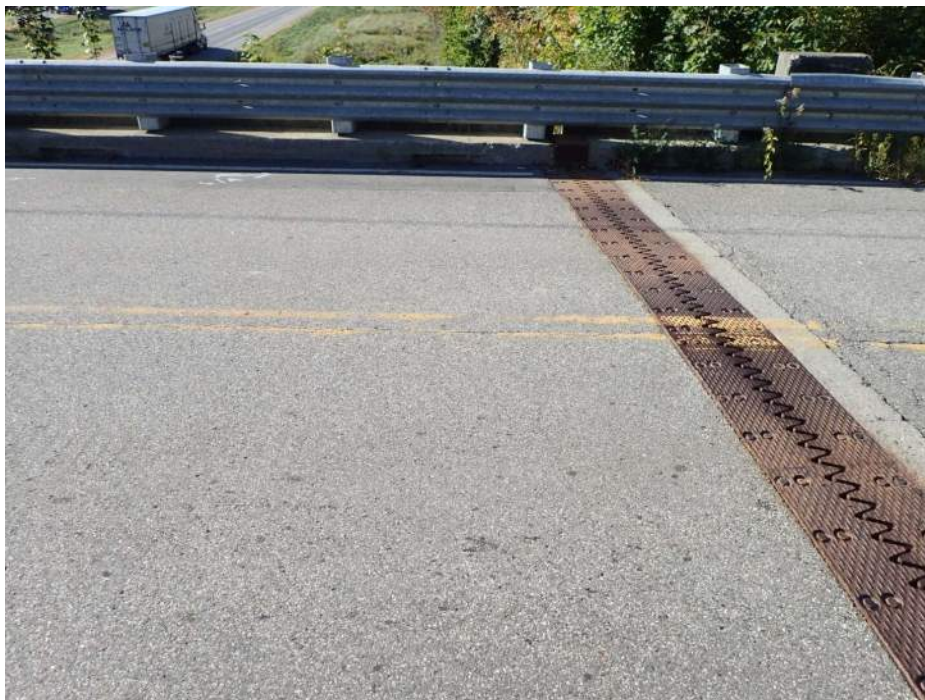
PHOTO 21 Condition

Description Bridge Deck & South Railing 3 of 3

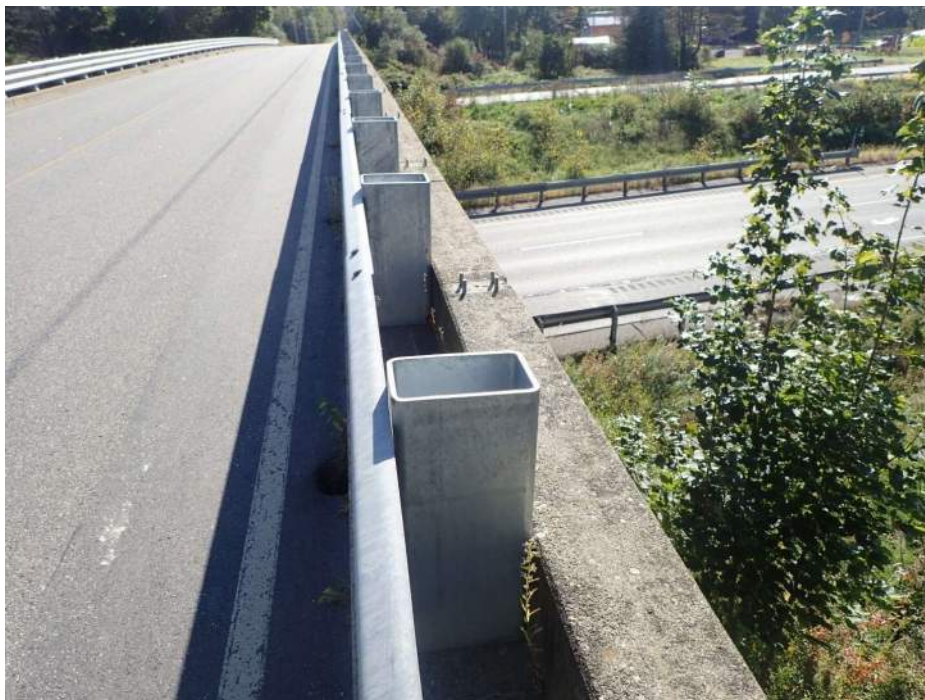
PHOTO 22 Condition

Description Post & Thrie-beam, retrofitted bridge railing (Typ.)

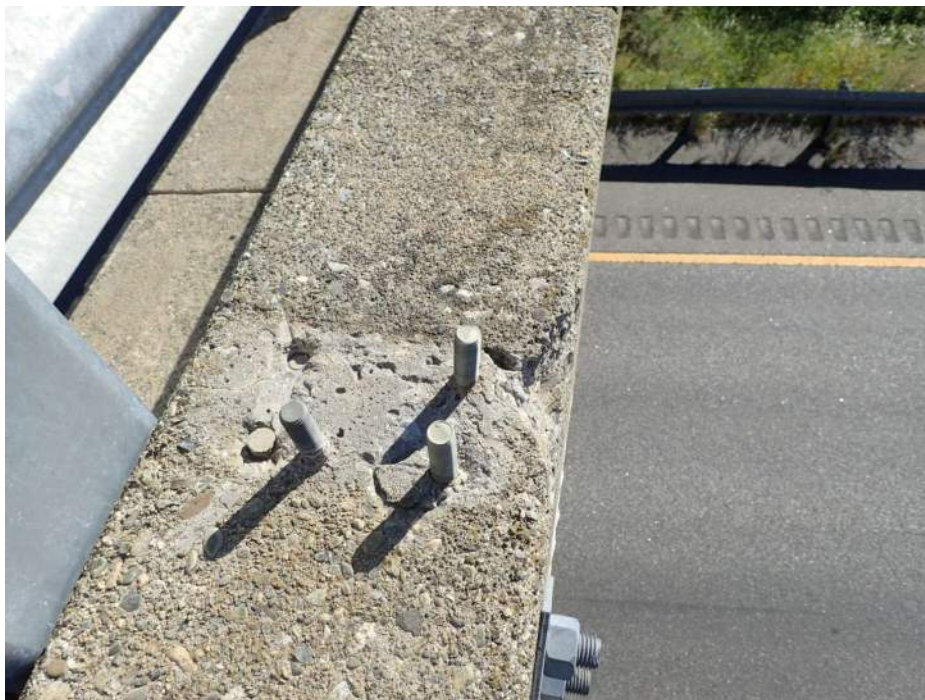
PHOTO 25 Condition

The concrete parapets exhibit minor spalls on both sides of the bridge for the entire length of the structure. The retrofitted guardrail has a few missing or loose bolts to the guardrail posts. The parapets have exposed anchor bolts from the original parapet mounted aluminum bridge railing, with moderate transverse cracking and shallow spalls, typical on both sides of the bridge and 50% of old post locations. There is minor spalling at NE expansion dam joint in curb. Both joints are in satisfactory condition.

Description Many small spalls located at old aluminum post mounts.

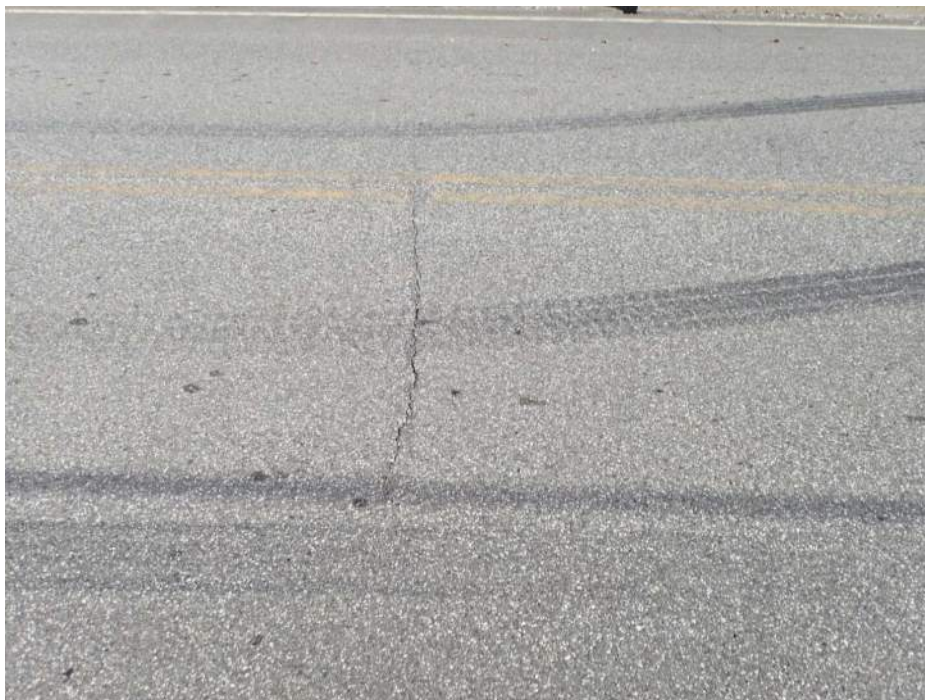
PHOTO 26 Condition

Description Bridge Deck - some scattered cracking, typ. Marked on sketches.

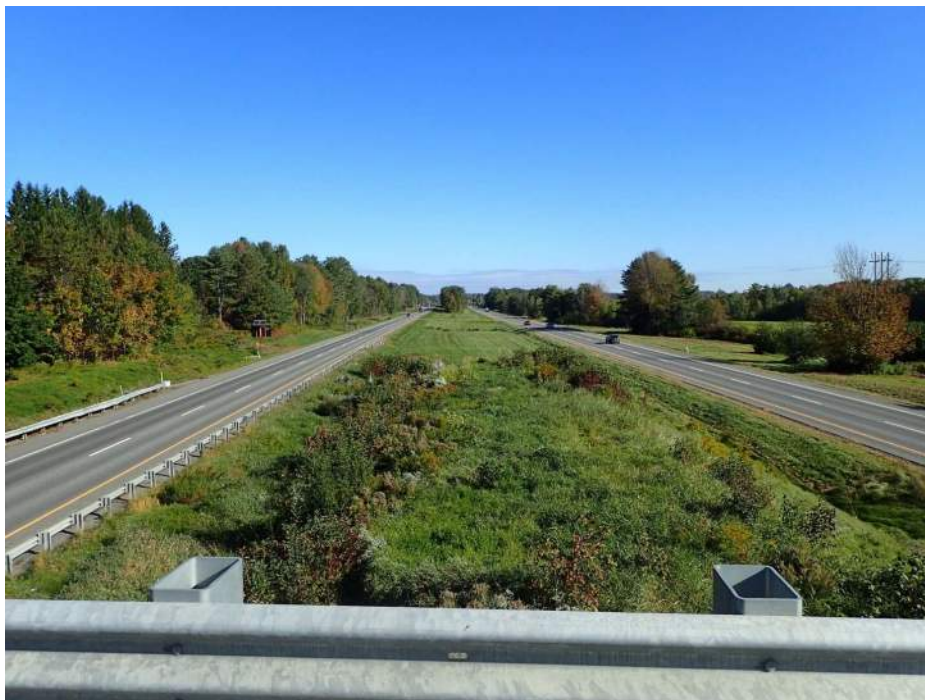
PHOTO 27 Condition

Description North View - I95 passing under bridge (South view similar)

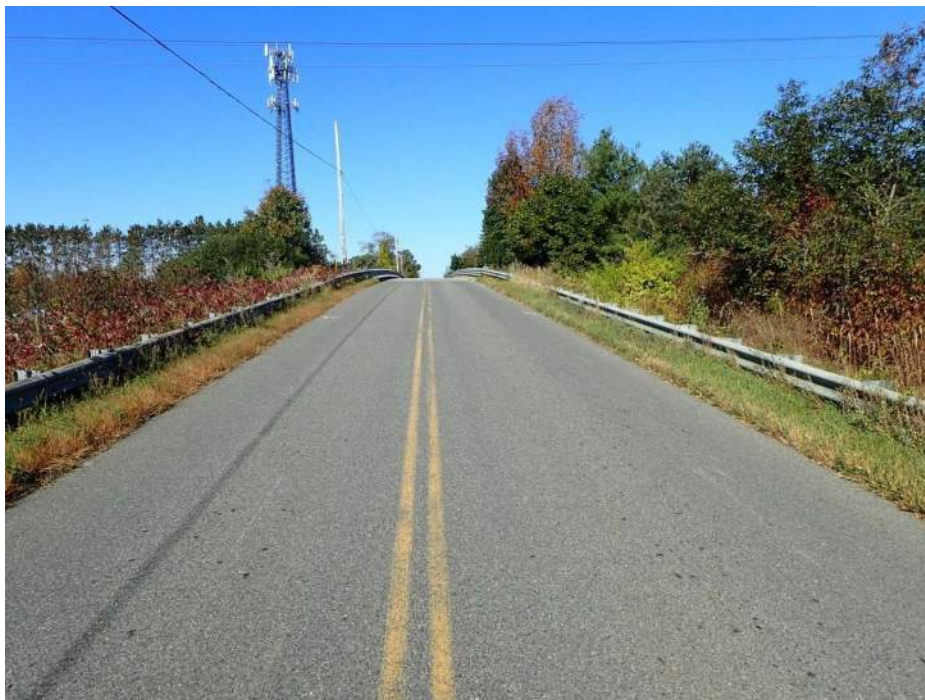
PHOTO 28 Condition

Description East Approach

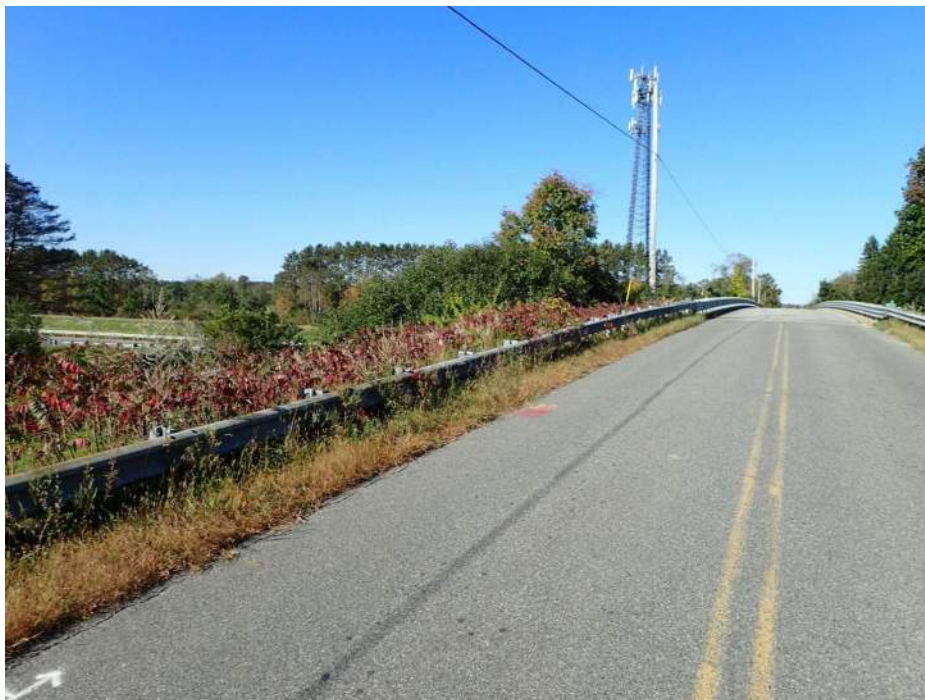
PHOTO 29 Condition

Description East Approach

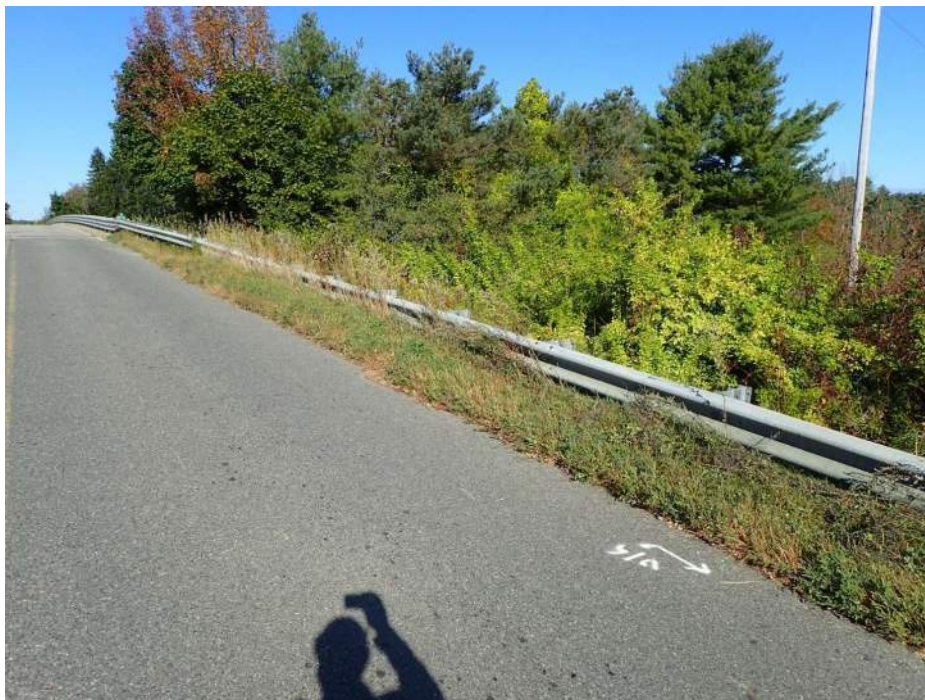
PHOTO 30 Condition

Description East Approach

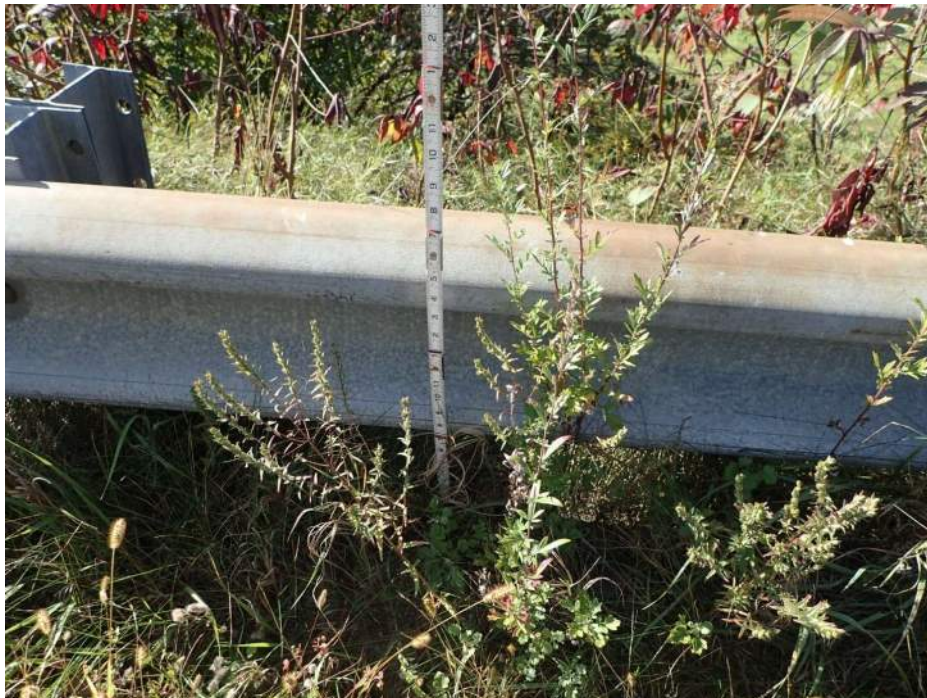
PHOTO 32 Condition

Description East Approach - top of South GR approx. 1'- 6 1/2" (18.5") in some areas.

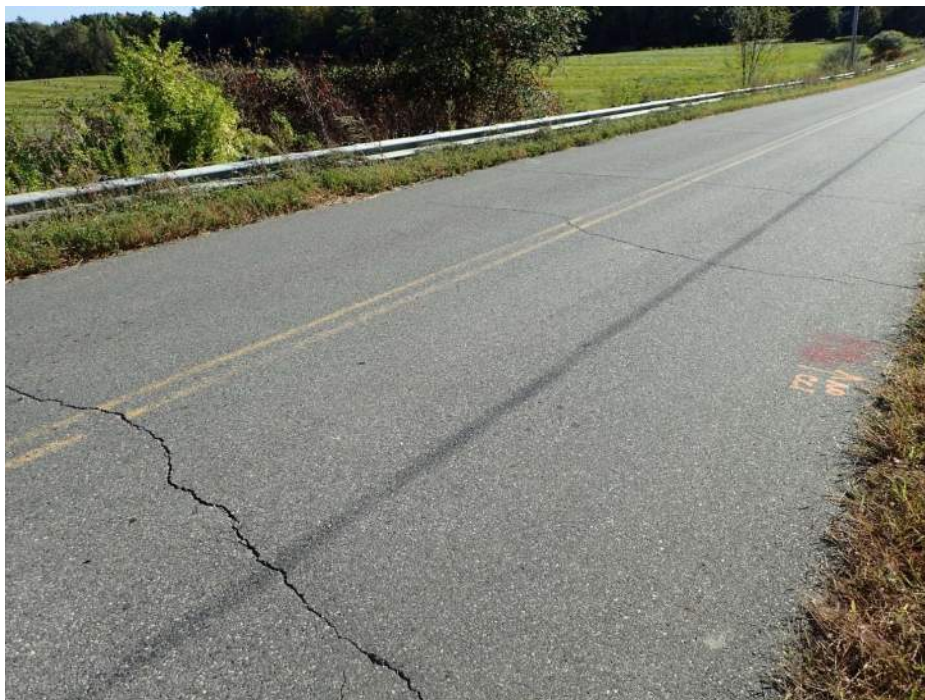
PHOTO 33 Condition

The east approach has scattered longitudinal wide cracks with associated settlement predominately in the southern travel lane. There is transverse cracking at the joint header and approximately 15' west of the joint. The bituminous pavement next next to the abutment backway header exhibits wide map cracking and is breaking up.

Description East Approach - wide transverse cracks

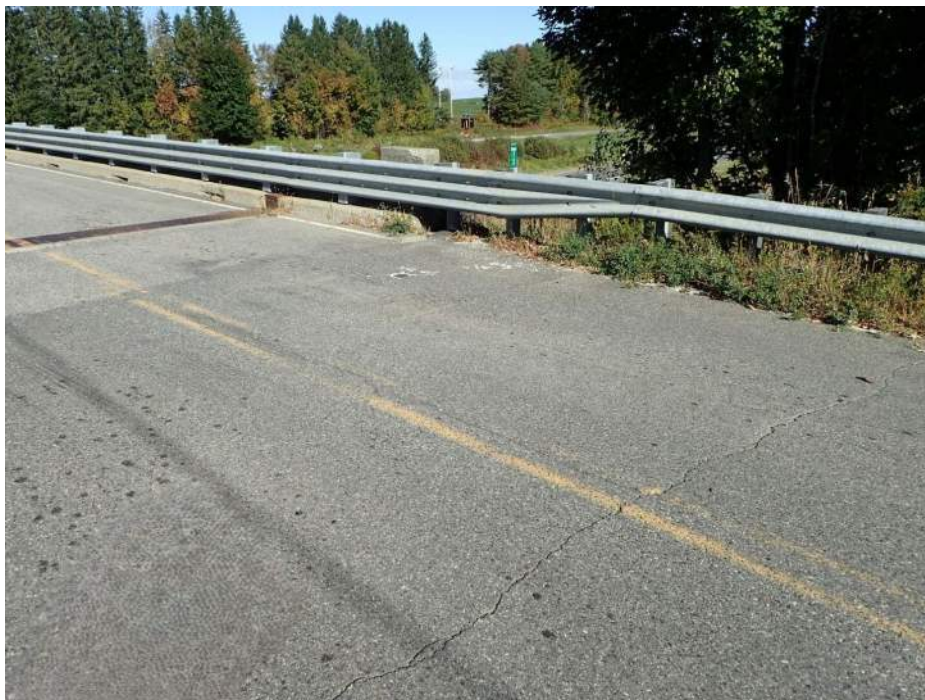
PHOTO 34 Condition

Description East Approach

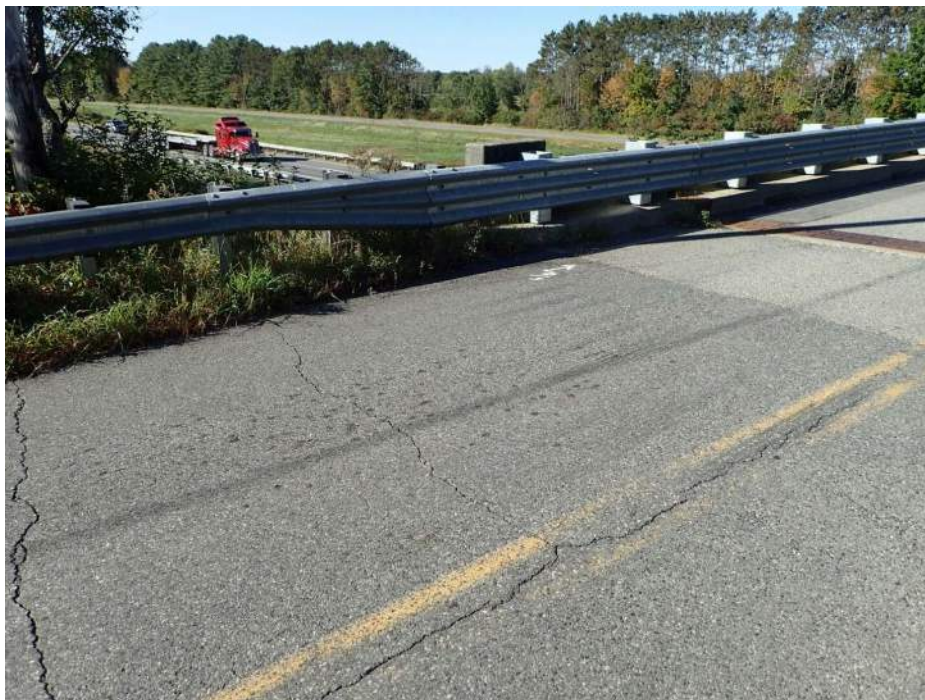
PHOTO 35 Condition

Description East Approach - wide longitudinal & transverse cracks

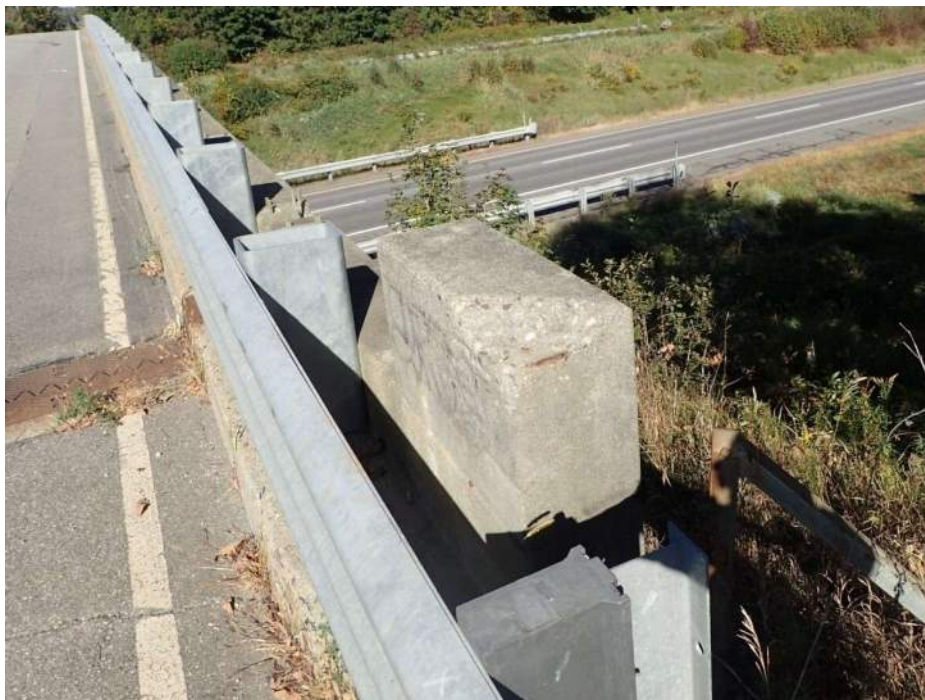
PHOTO 36 Condition

Description East Approach - Spall on north Endpost

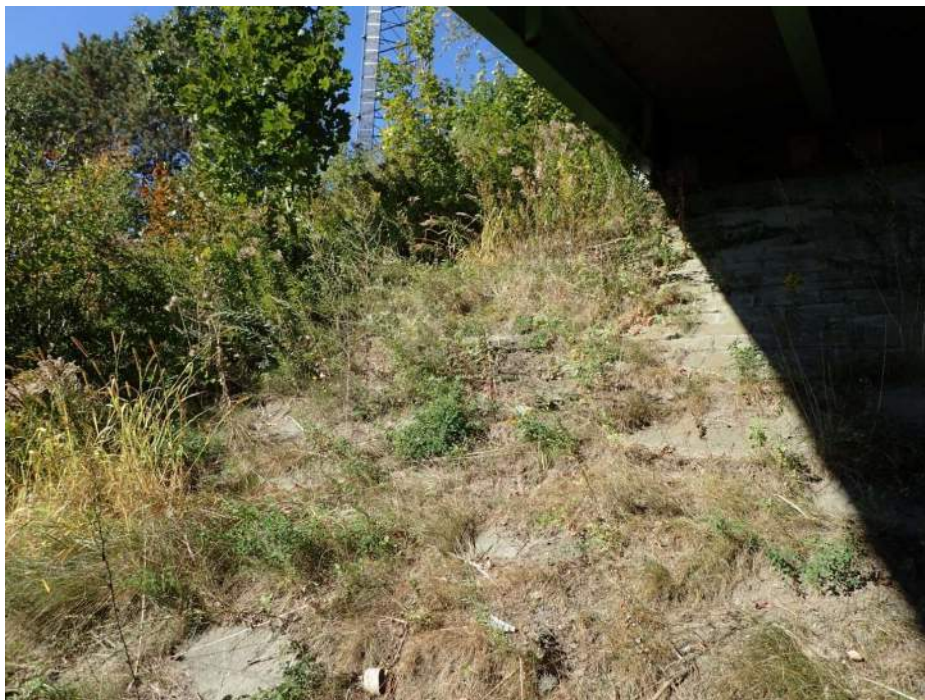
PHOTO 37 Condition

The slope protection exhibits random areas of settlement and sunken bricks along with uneven bricks and cracking in grout.

Description Abutment 1 - Slope protection, lots of vegetation on lower 1/2 of slope

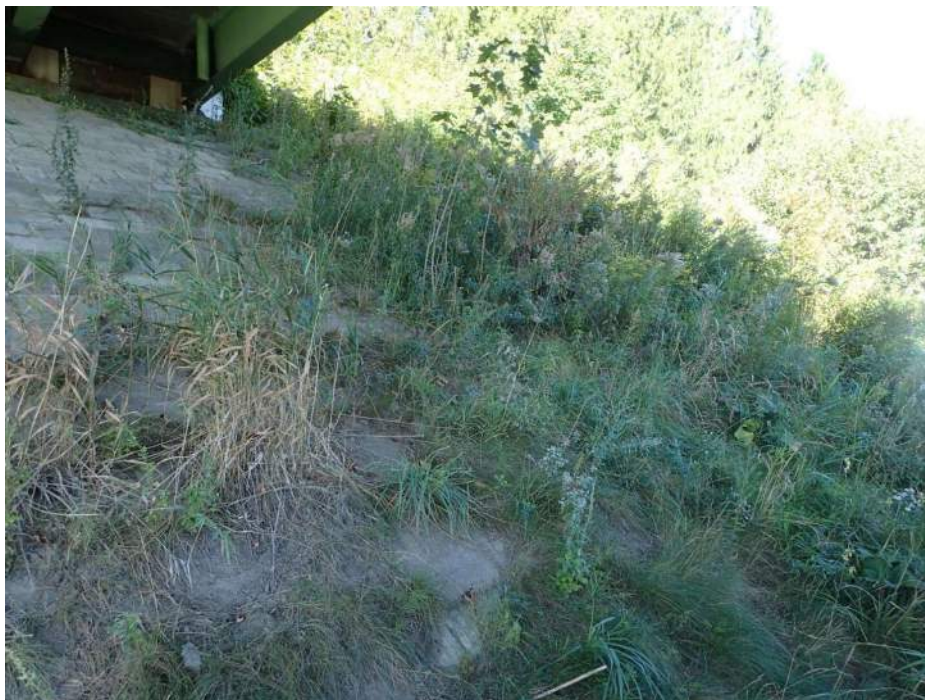
PHOTO 38 Condition

Description Abutment 1 - Slope protection, lots of vegetation on lower 1/2 of slope

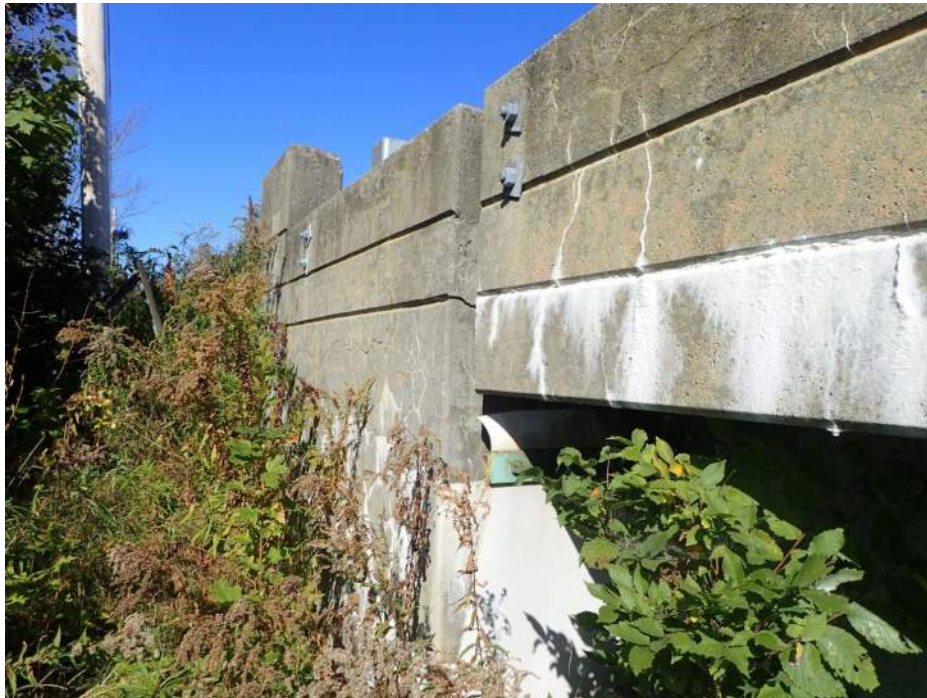
PHOTO 40 Condition

The southwest wingwall exhibits moderate pattern map cracking with efflorescence and a wide crack.

Description Abutment 1 - South return Wingwall, map cracking with efflorescence & horizontal wide crack, heavy efflorescence on fascia

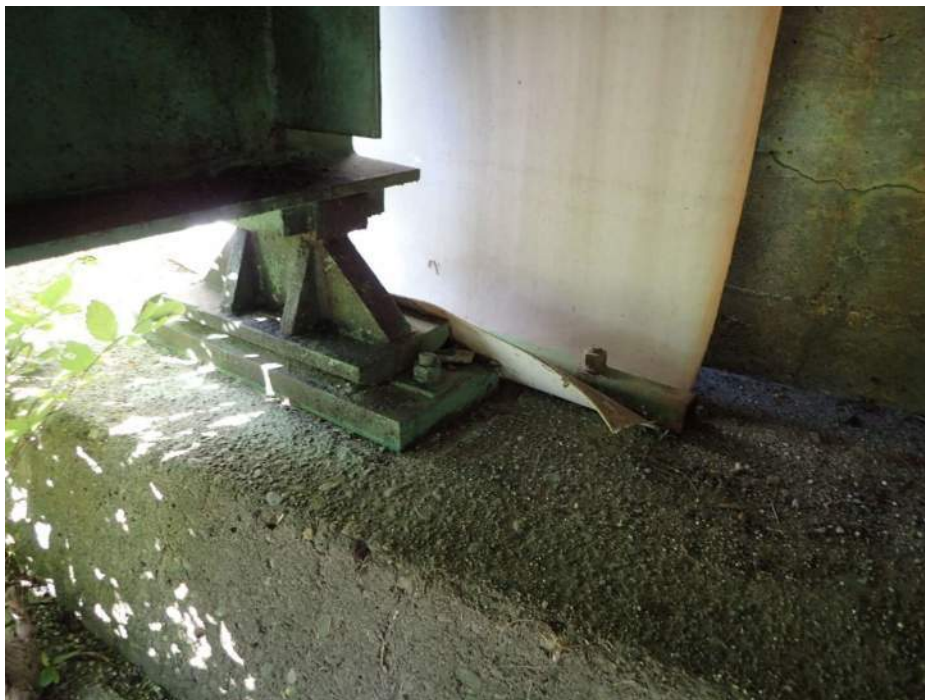
Exterior rocker bearings 1 & 4 exhibit scattered light surface corrosion. Interior rocker bearings 2 & 3 have heavy surface corrosion with some light pack rust on rockers & base plates. Pack rust may inhibit movement.

PHOTO 41 Condition
Description Abutment 1 - Girder 4 rocker bearing (60 F)

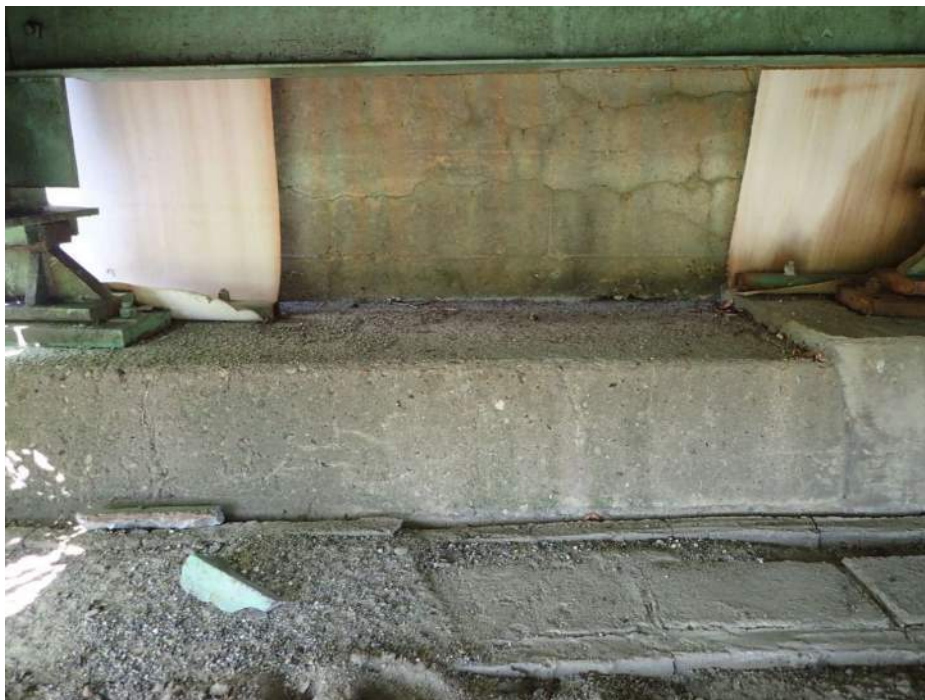
The abutment backwall exhibits scattered wide cracking and moderate pattern map cracking throughout. The bottom portion of the backwall and bearing seat exhibits light scaling throughout its entire length.

PHOTO 42 Condition
Description Abutment 1 - bay 3, girders 4 & 3, moderate cracking on backwall

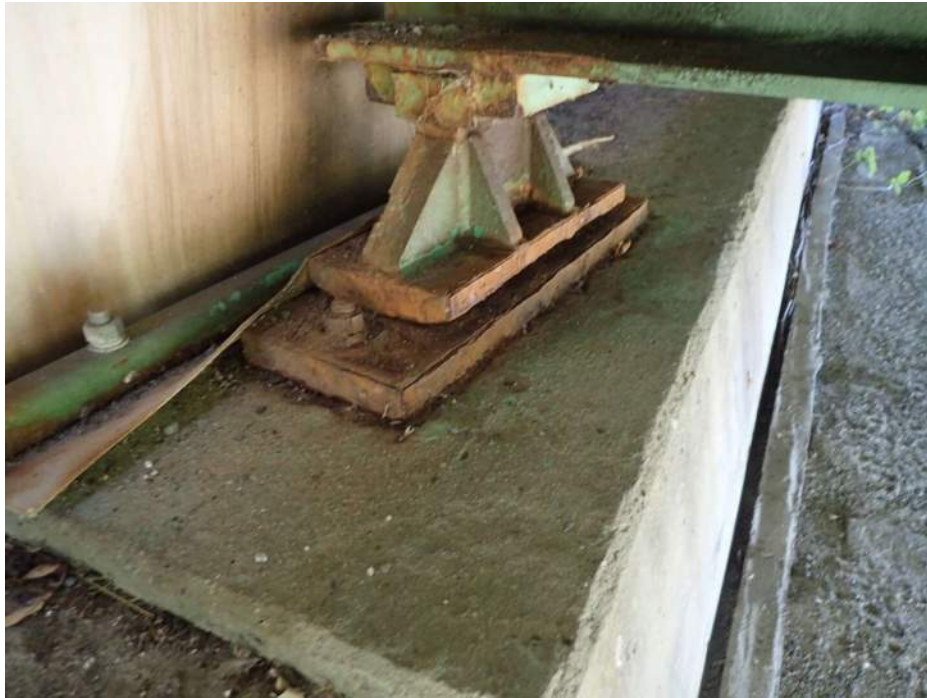
PHOTO 43 Condition
Description Abutment 1 - Girder 3 rocker bearing (60 F)

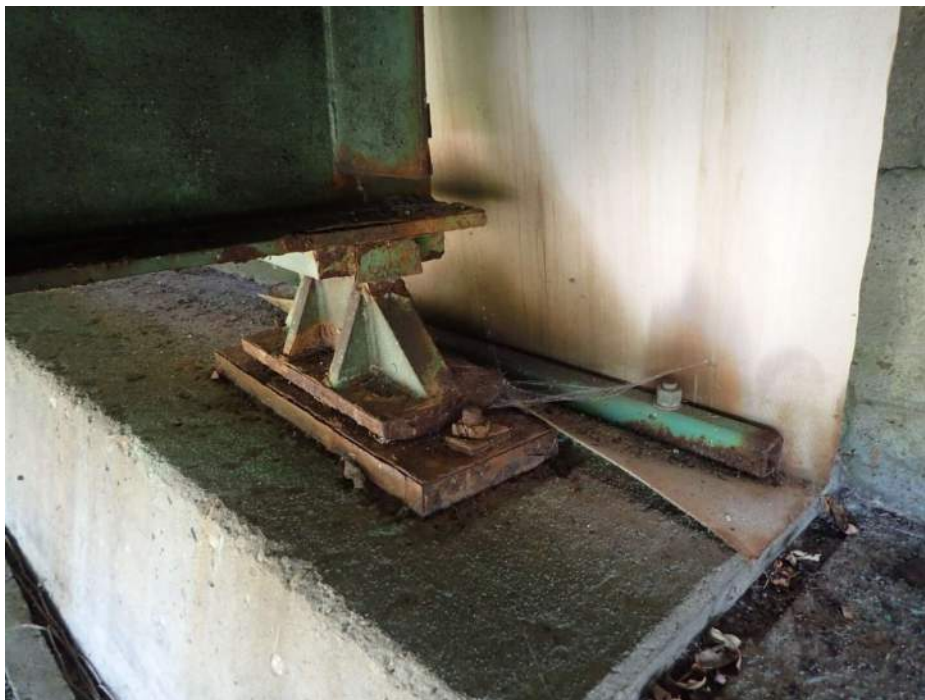
PHOTO 45 Condition
Description Abutment 1 - Girder 2 rocker bearing (60 F)

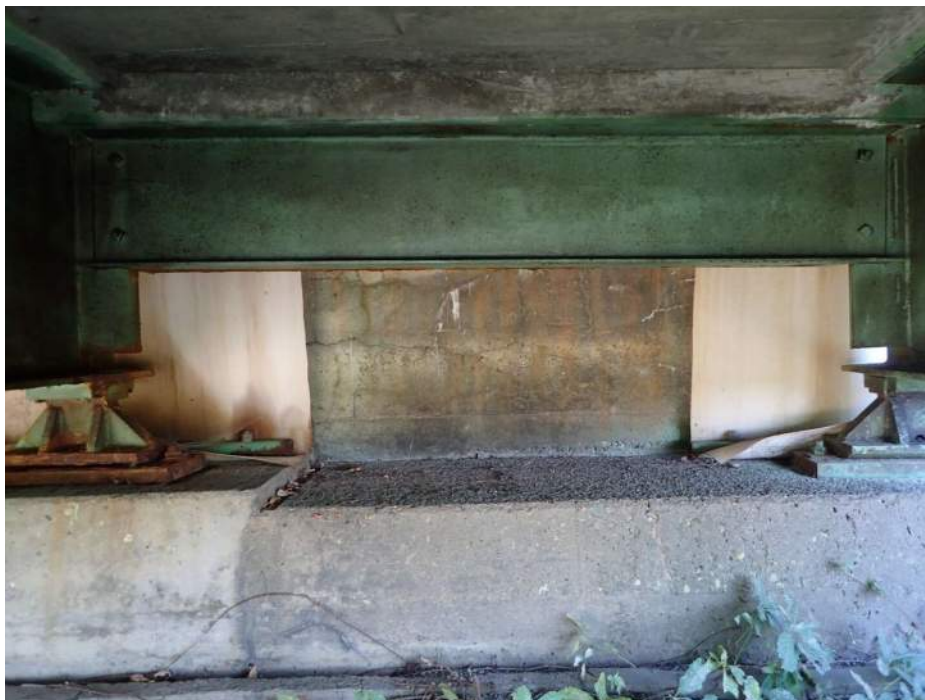
PHOTO 46 Condition
Description Abutment 1 - bay 1, girders 2 & 1, moderate cracking on backwall

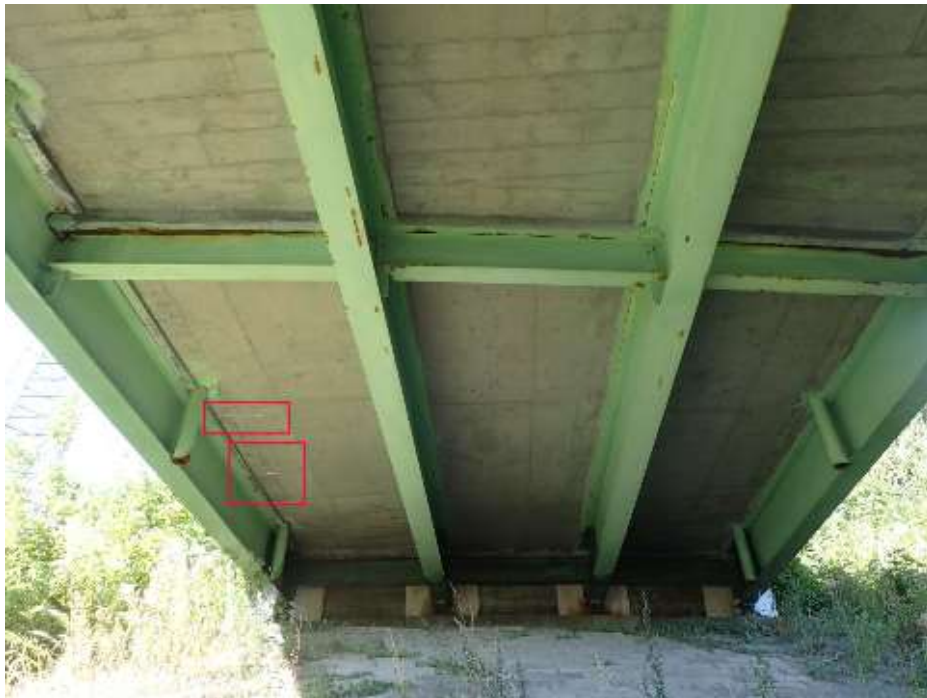
PHOTO 50 Condition

The underside of the deck exhibits minor scattered insignificant transverse cracking throughout all spans. All spans have minor cracking with efflorescence in south fascia and overhangs.

Description Span 1 - Deck & framing looking West, some minor cracking with light efflorescence

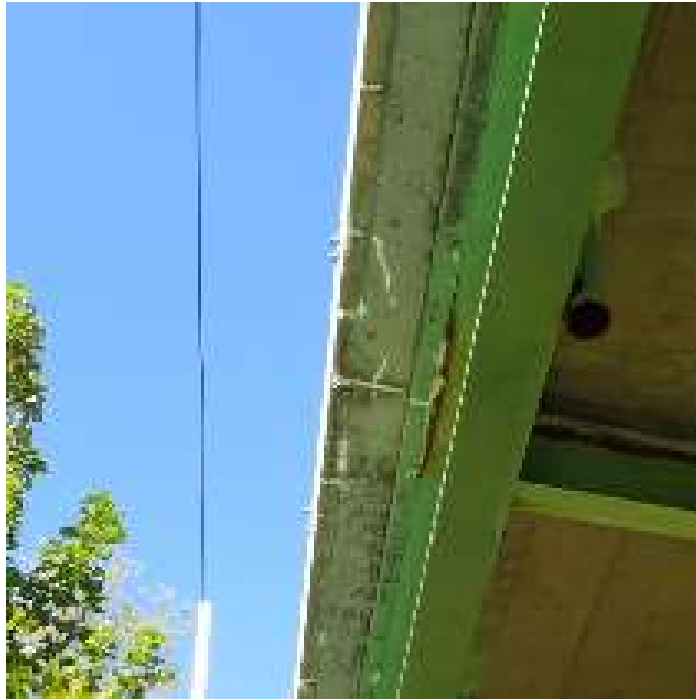
PHOTO 51 Condition

Description Span 1 - moderate cracking with efflorescence on overhang

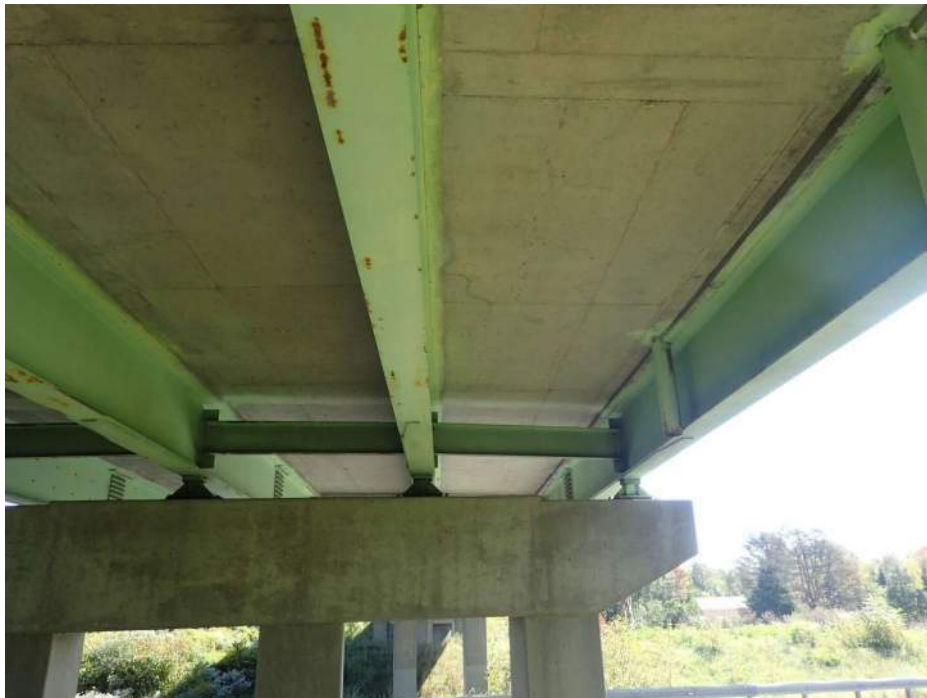
PHOTO 52 Condition

Description Span 1 - deck & framing looking east

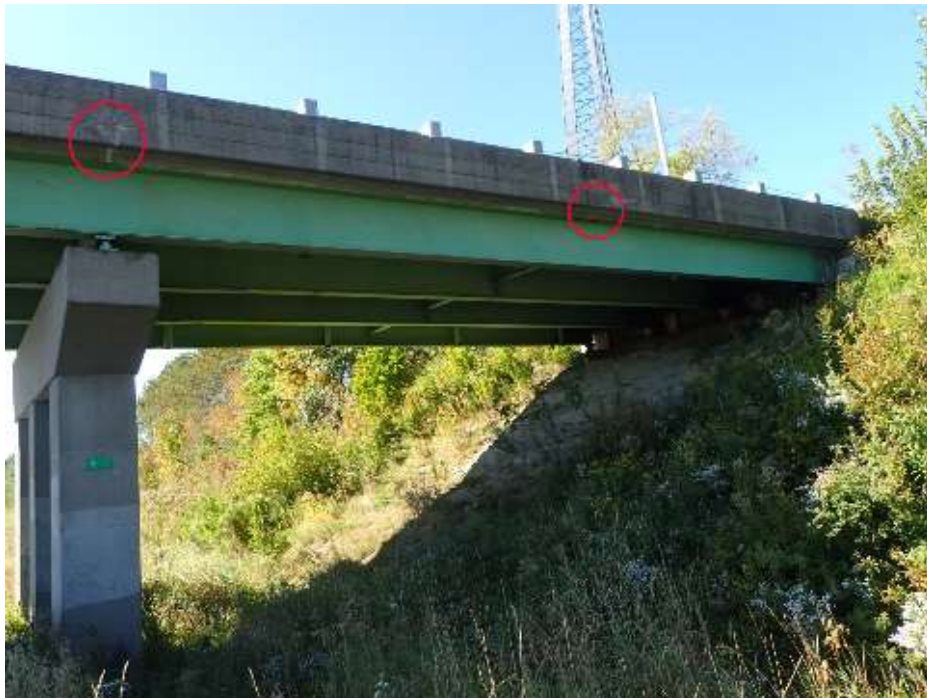
PHOTO 54 Condition

Description Span 1 - Scattered cracks with light efflorescence

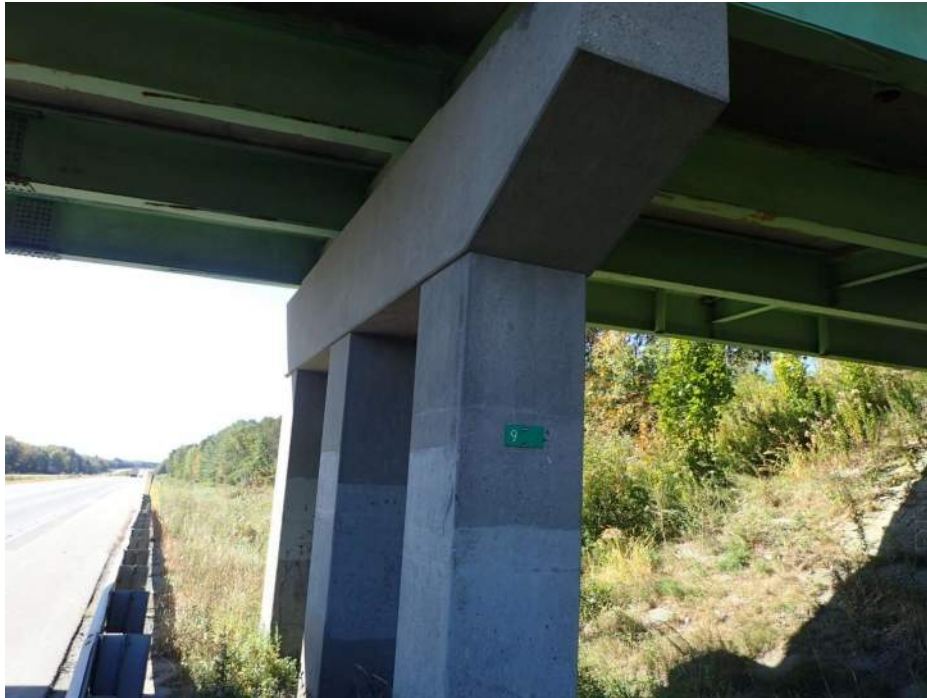
PHOTO 57 Condition

Description Pier 1 - North End

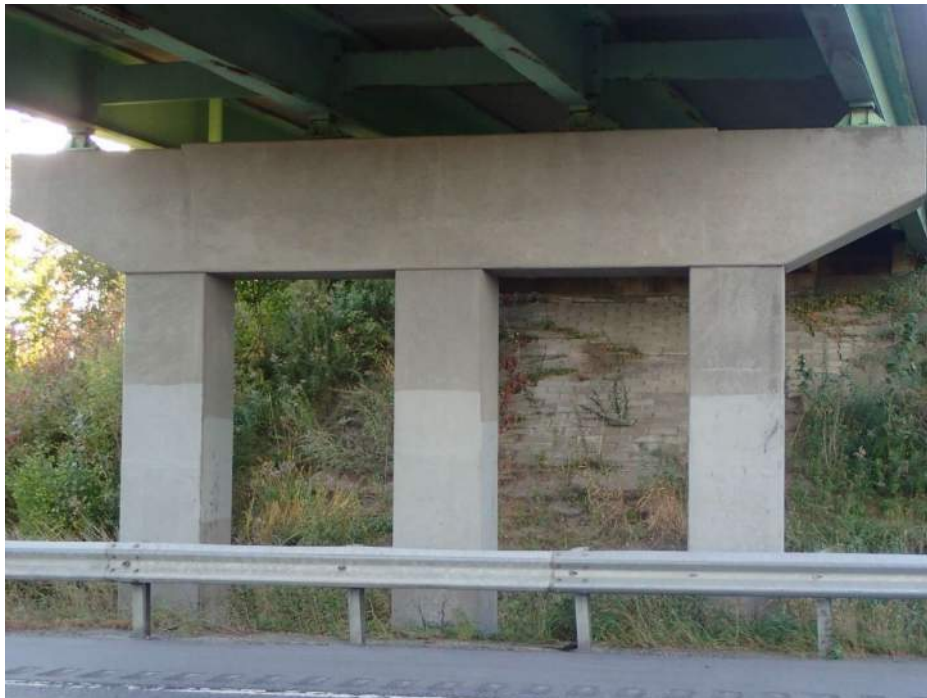
PHOTO 58 Condition

All piers have hairline cracking near existing ground levels and scattered moderate pattern map cracking throughout the columns. Pier 1 exhibits a wide vertical crack with associated delamination on the inside face.

Description Pier 1 - East Elevation

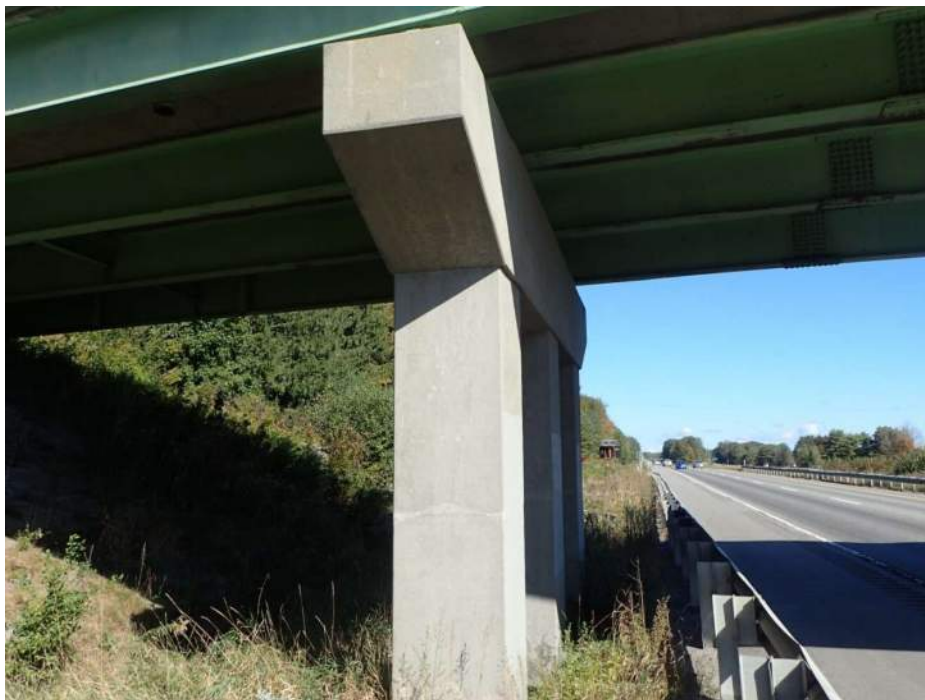
PHOTO 59 Condition

Description Pier 1 - South End

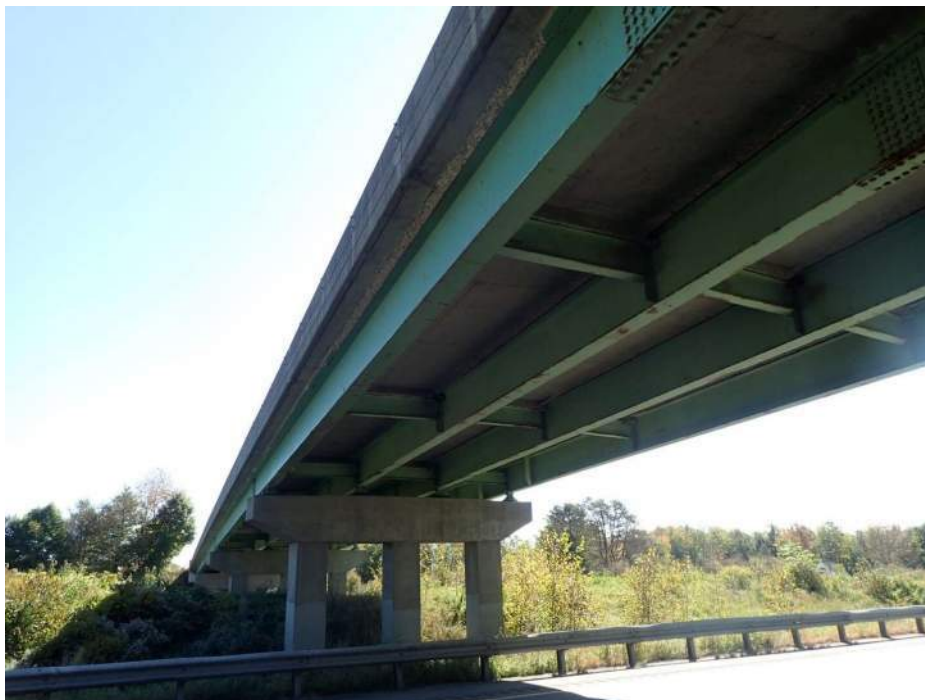
PHOTO 60 Condition

There is widespread spalled and delaminated haunches in Spans 2 and 4 (over roadway).

Description Span 2 - North overhang, deck - note: much of the haunch has spalled off. Haunch originally constructed with 4" overhang on either side of the girders.

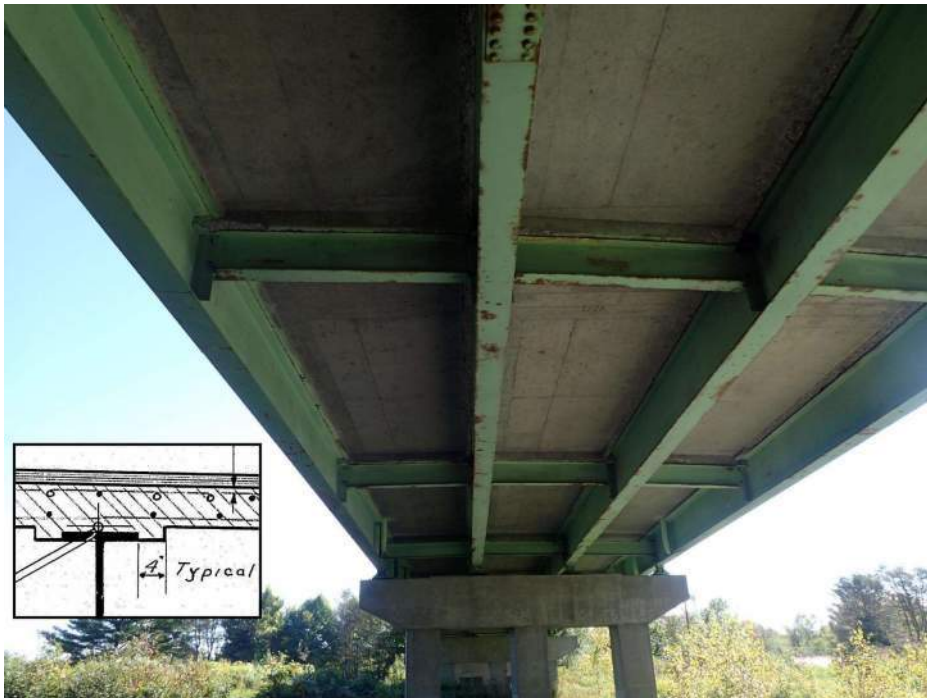
PHOTO 62 Condition
Description Span 2 - deck & framing looking East & typical haunch detail.
