Structure Number: 5785
Facility Carried: TOWN FARM RD

Highway Bridge Inspection Report

Inspection Type(s): Routine

Bridge Name: TOWN FARM RD / I-95

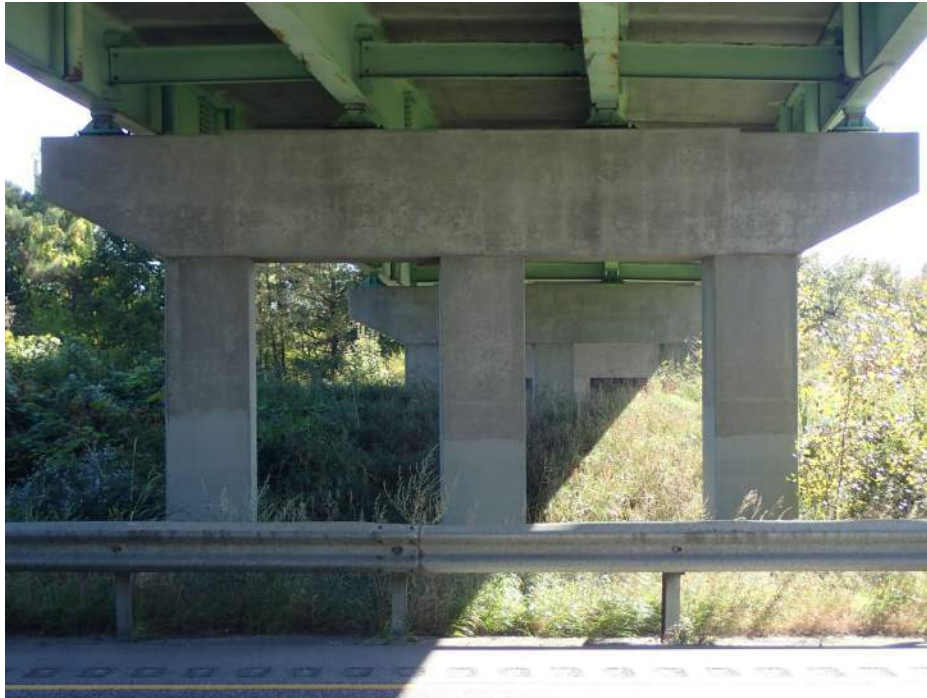
PHOTO 65 Condition
Description Pier 2 - West Elevation

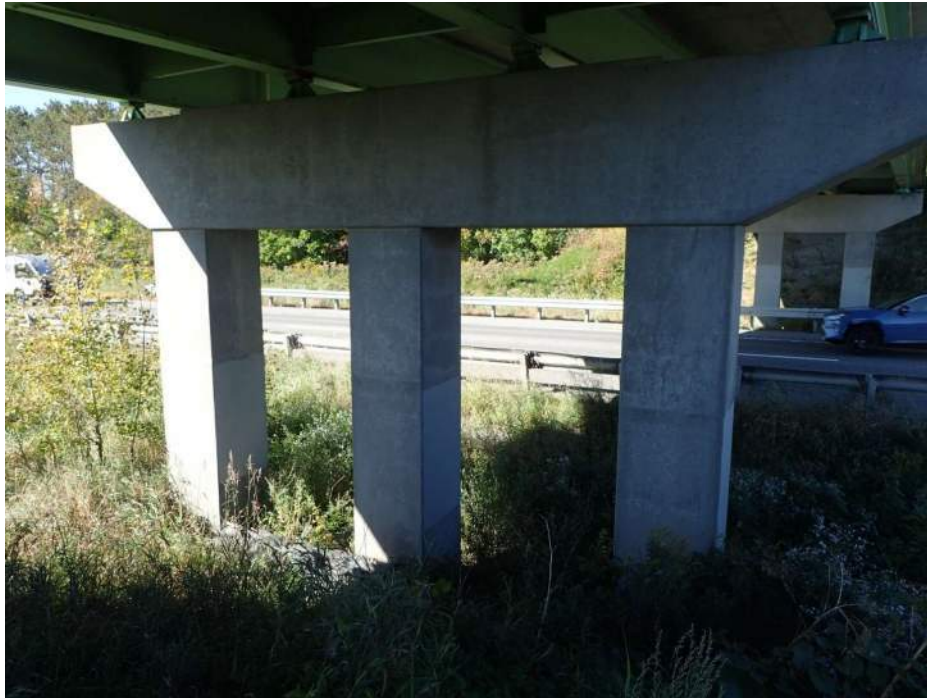
PHOTO 67 Condition

Description Pier 2 - East Elevation

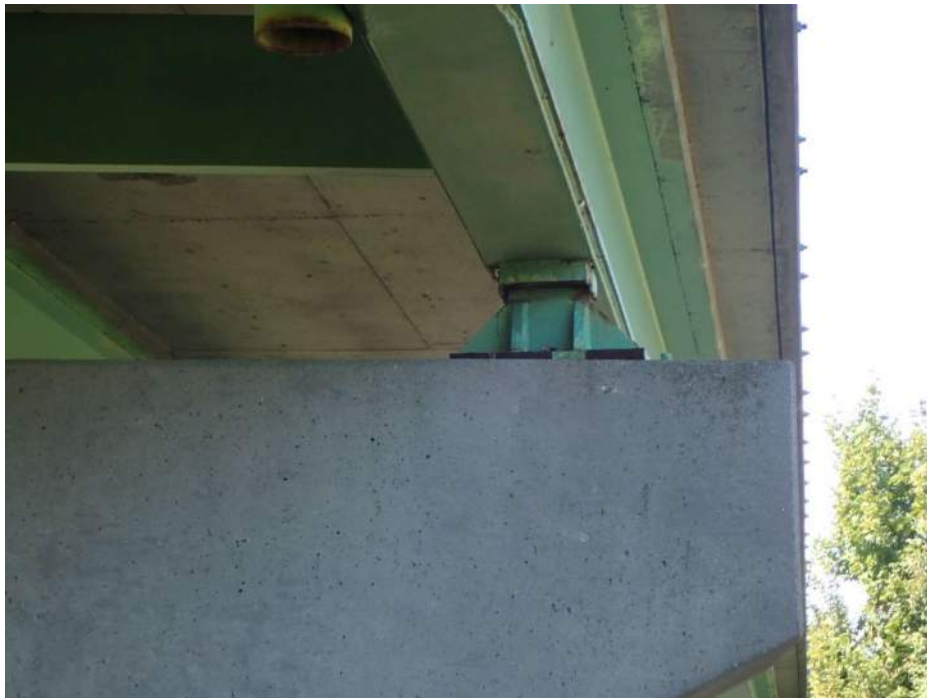
PHOTO 68 Condition

Description Pier 2 - Typical rocker bearing

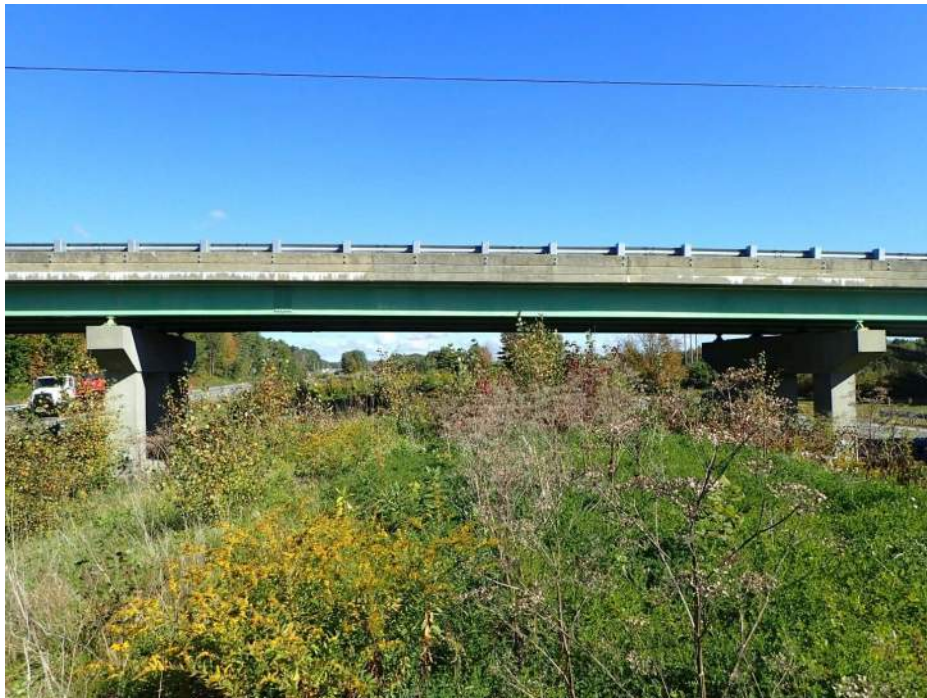
The underside of the deck exhibits minor scattered insignificant transverse cracking throughout all spans. All spans have minor cracking with efflorescence in south fascia and overhangs.

PHOTO 70 Condition
Description Span 3 - South Fascia, areas of heavy and moderate efflorescence.

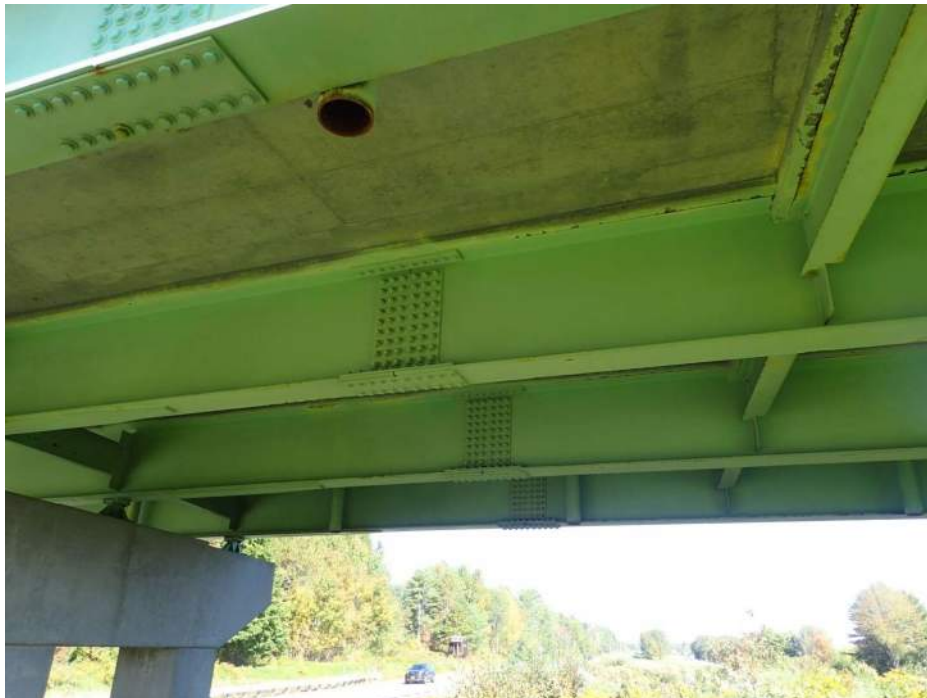
PHOTO 71 Condition

Description Span 3 - South overhang, some cracks with light efflorescence at diaphragms / joints (typ)

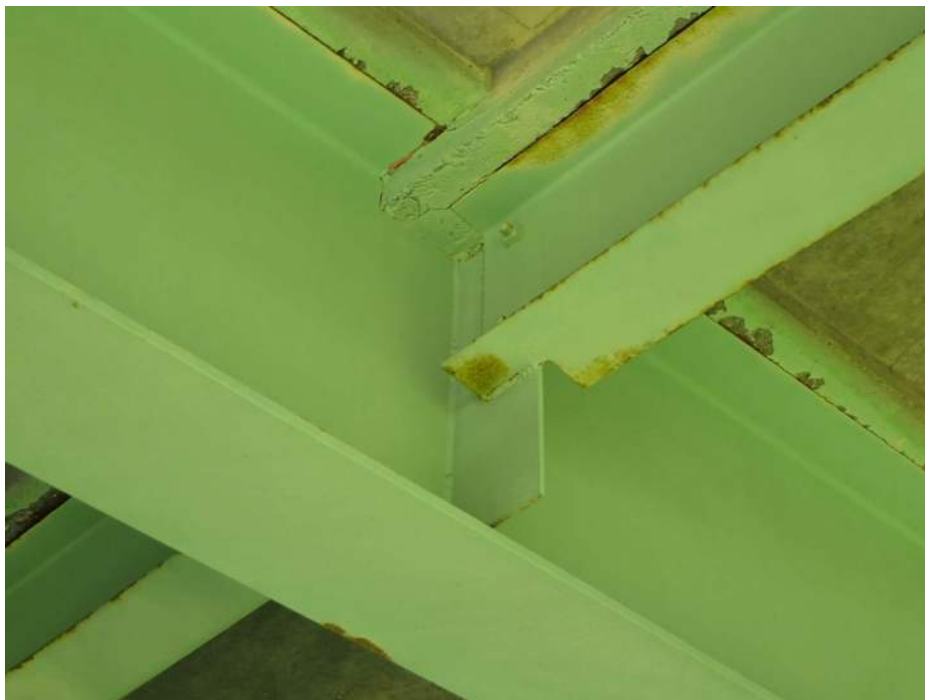
PHOTO 73 Condition

Description Span 3 - diaphragms installed with 4 bolts only, but have been welded in place (typical)

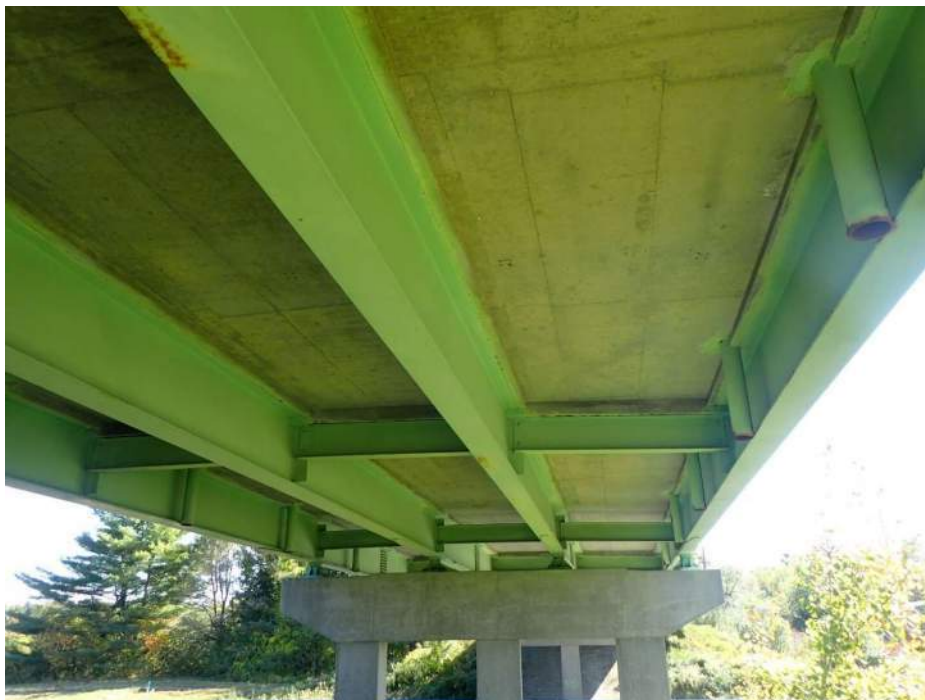
PHOTO 74 Condition

Description Span 3 - deck and framing, looking East

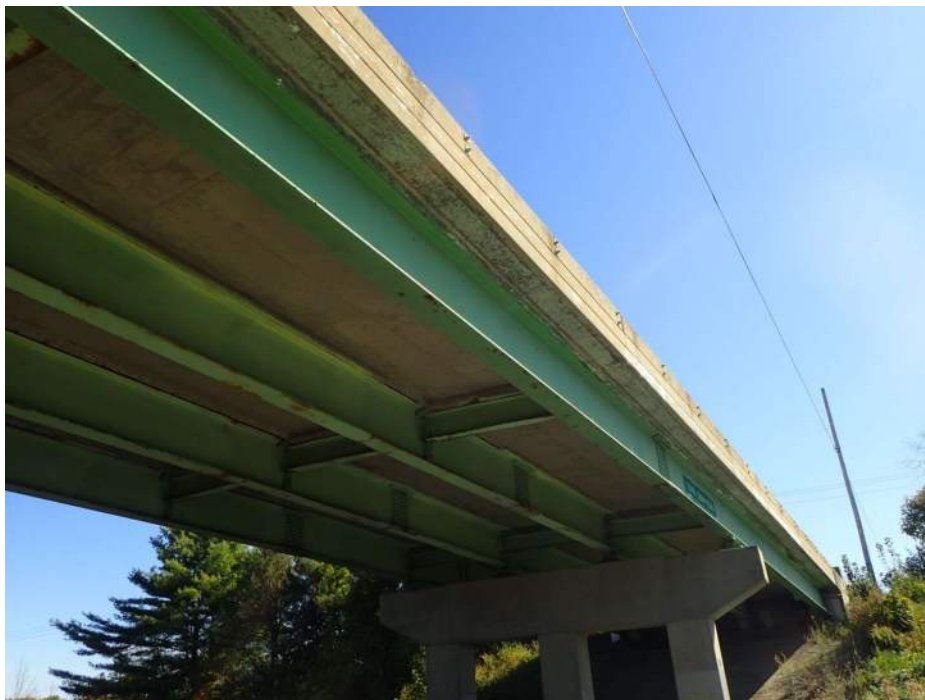
PHOTO 79 Condition

Description Span 4 - South Overhang

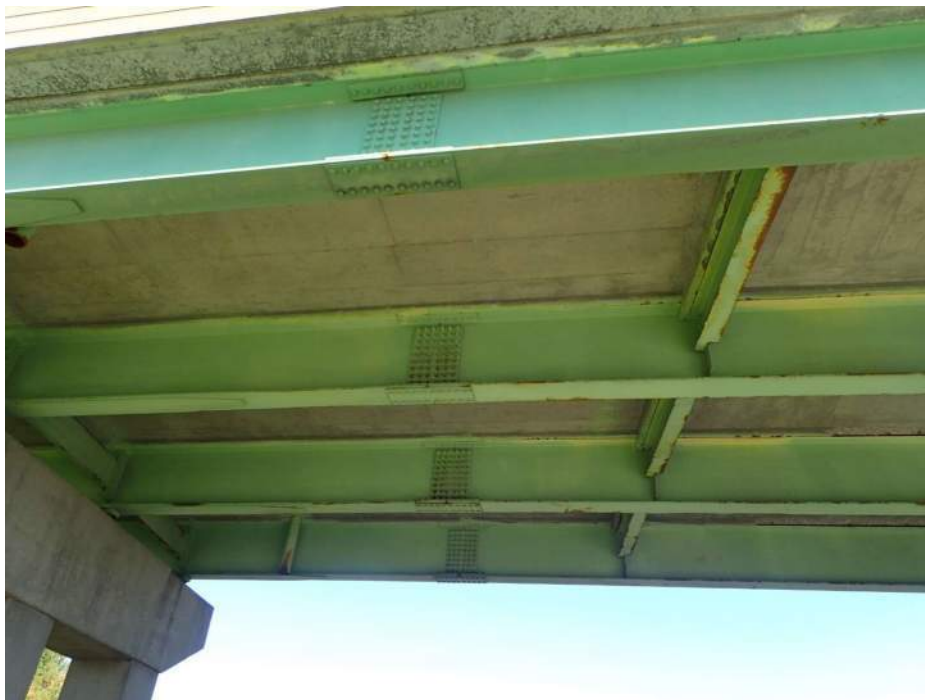
PHOTO 80 Condition

Description Span 4 - Splices

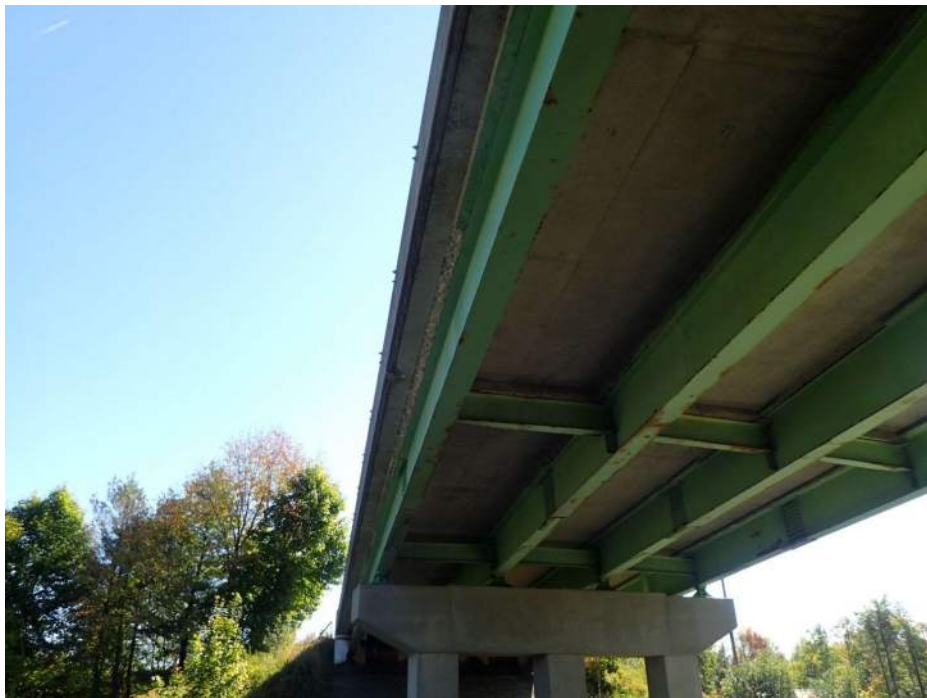
PHOTO 82 Condition

Description Span 4 - North Overhang

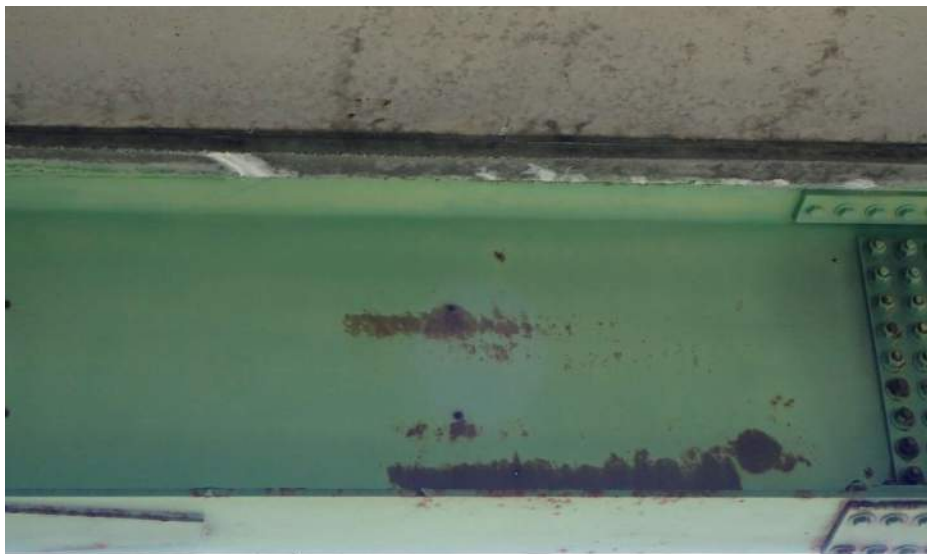
PHOTO 83 Condition

Description Span 4 - holes drilled in girder 4 not plugged

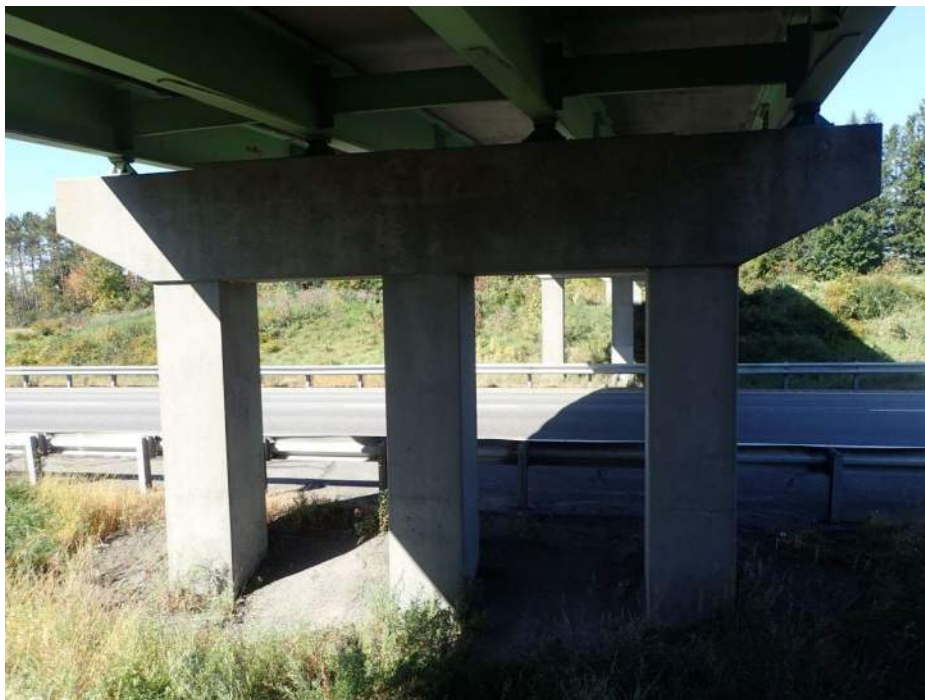
PHOTO 85 Condition

Description Pier 4 - East Elevation

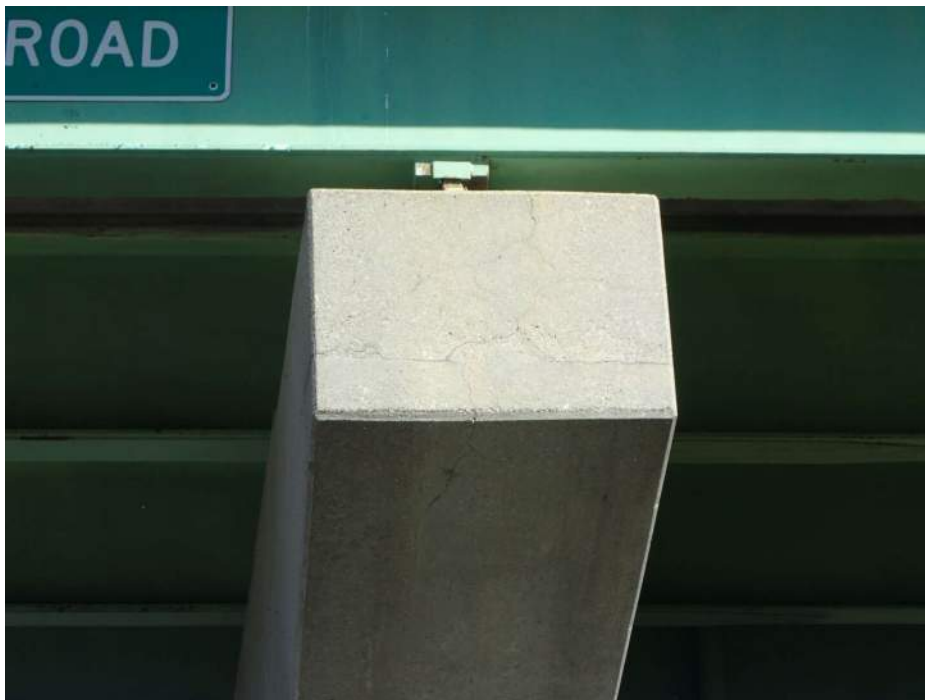
PHOTO 87 Condition

Description Pier 4 - South end, cap, cracking

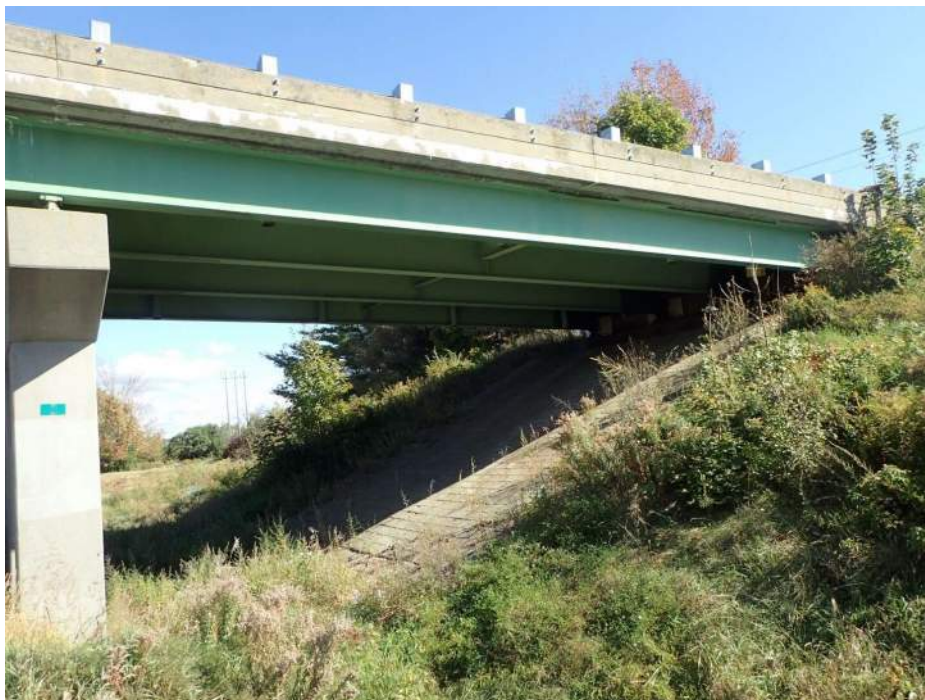
PHOTO 88 Condition

Description Span 5 - South Fascia - Heavy efflorescence

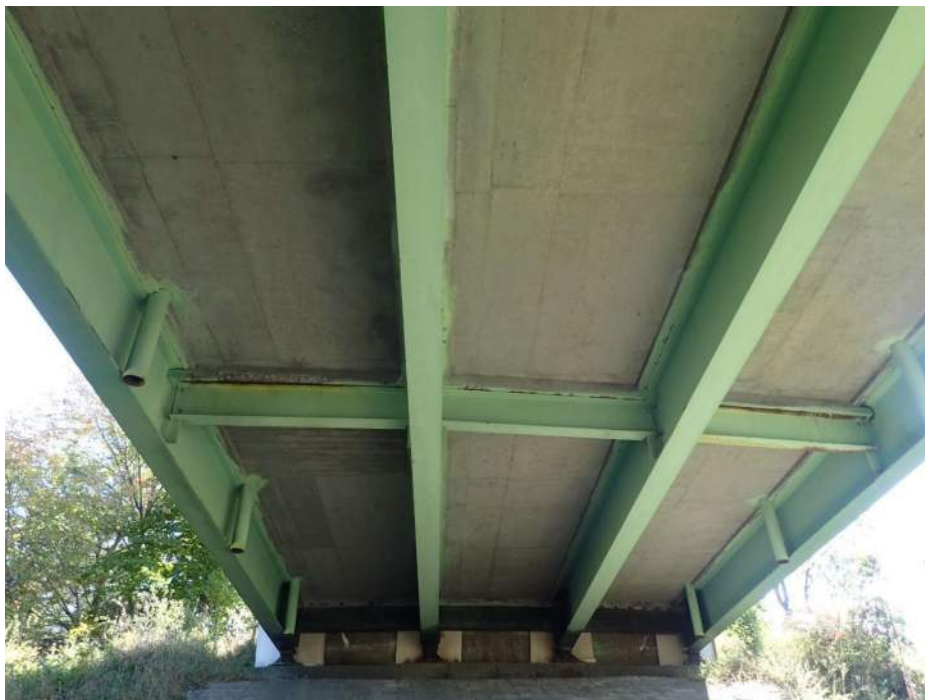
PHOTO 89 Condition

Description Span 5 - deck & framing looking East

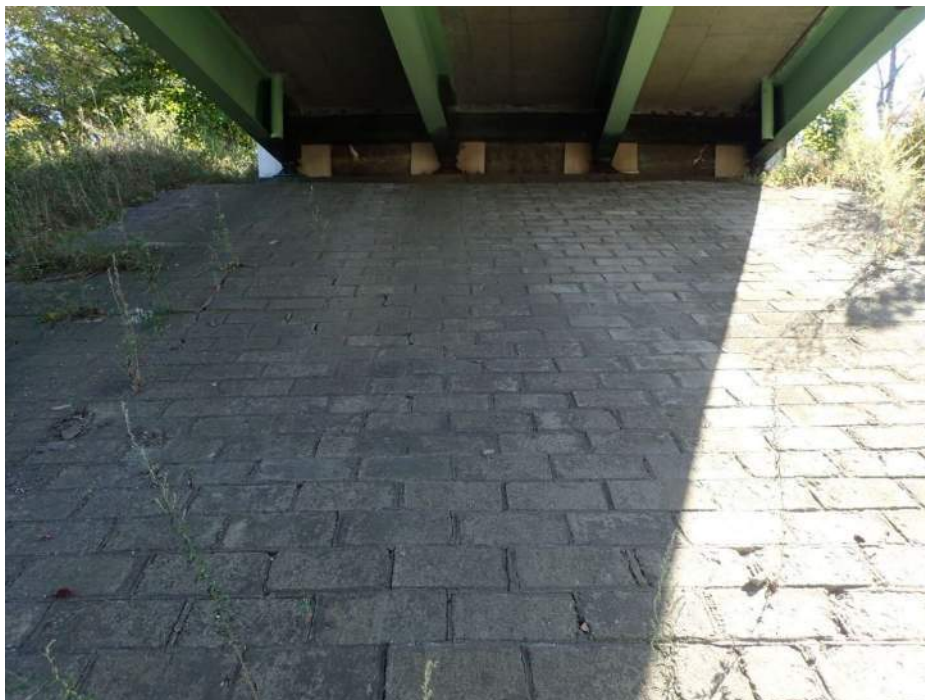
PHOTO 90 Condition

Description Abutment 2 - slope protection

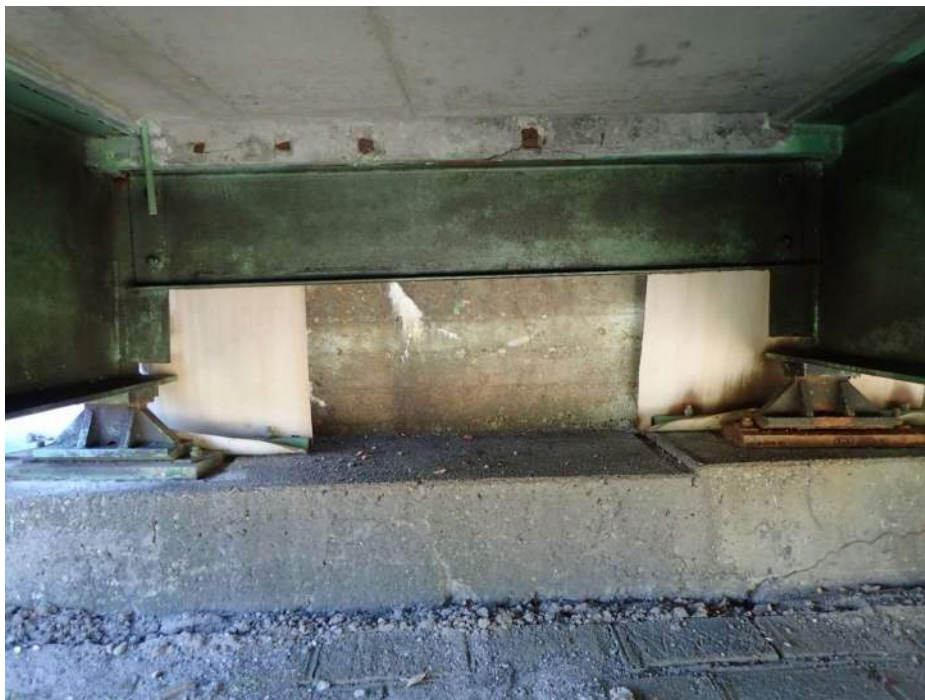
PHOTO 93 Condition

Description Abutment 2 - Bay 1, Girder 1 & 2, scattered cracking & efflorescence

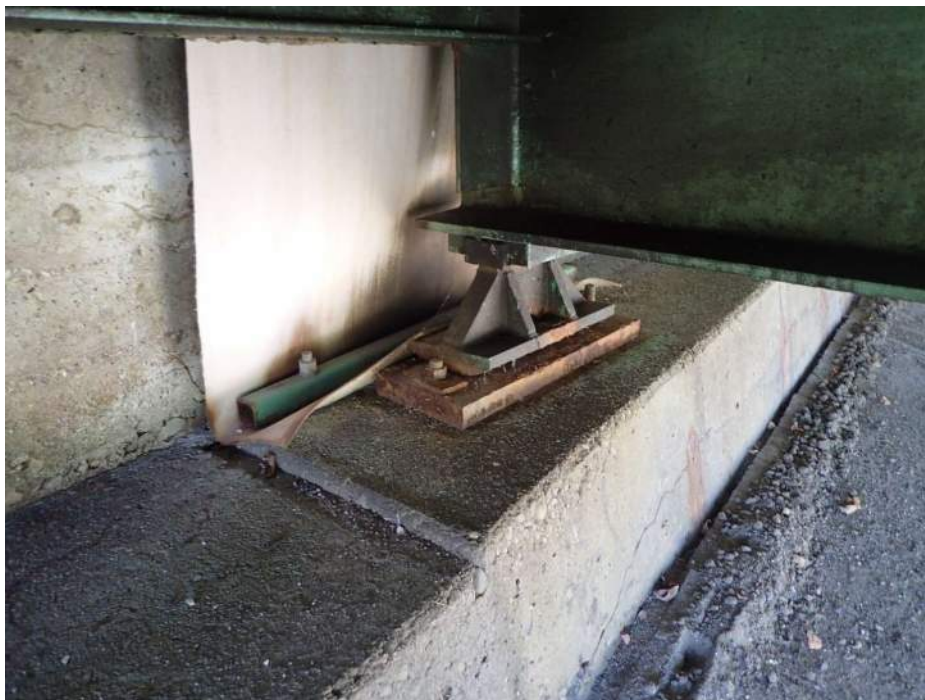
PHOTO 94 Condition

Description Abutment 2 - Girder 2 rocker bearing

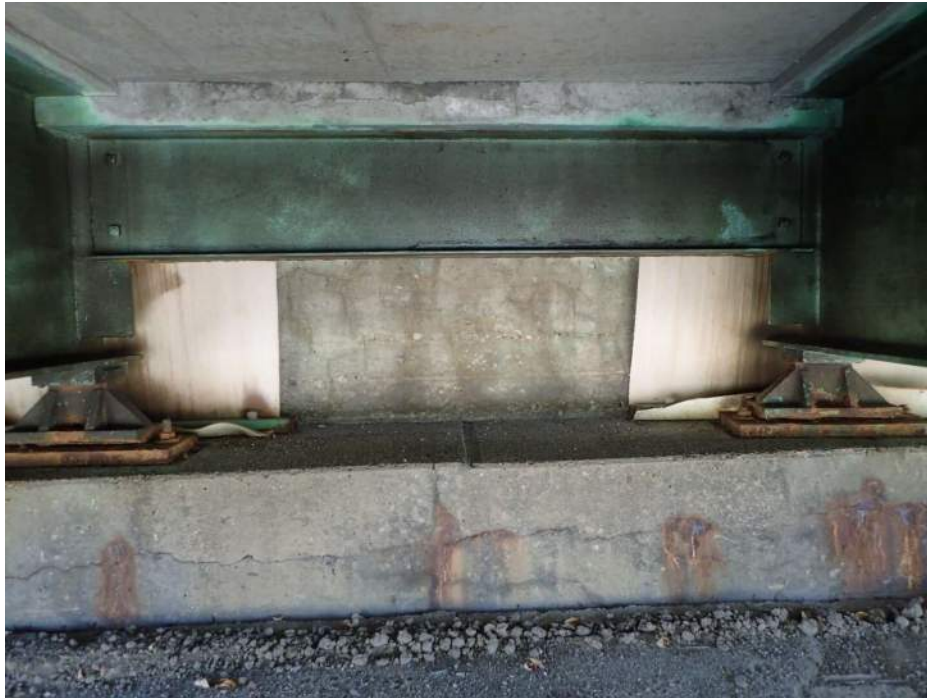
PHOTO 95 Condition

Description Abutment 2 - Bay 2, Girder 2 & 3, scattered cracking & rust staining

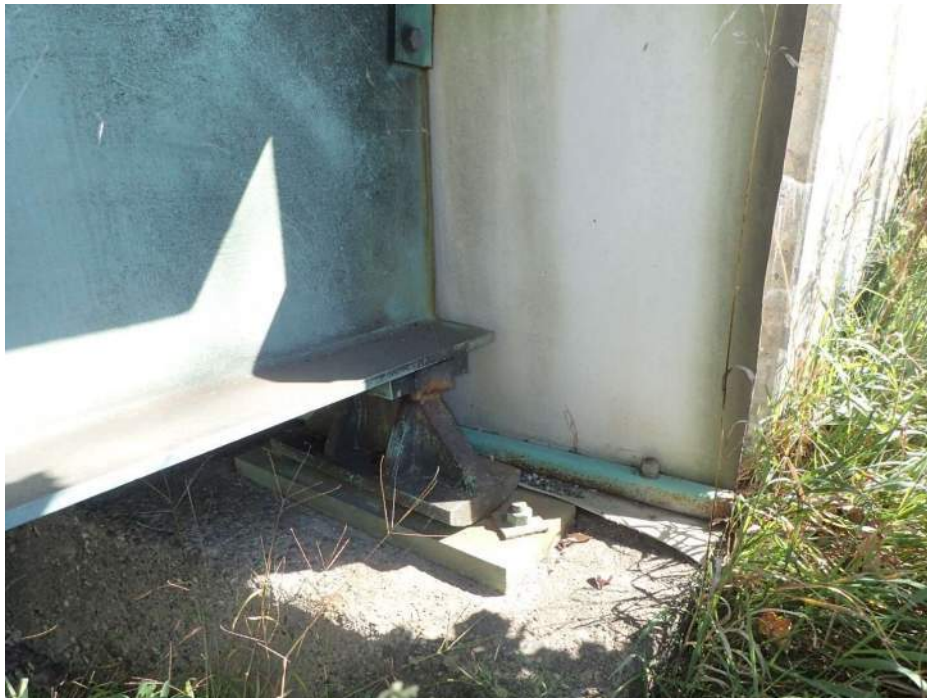
PHOTO 98 Condition

Description Abutment 2 - Girder 4 rocker bearing
